**PERMIT INFORMATION**

| <b>Permit Number:</b> C-1992-081<br><b>Mine Name:</b> Hayden Gulch Loadout<br><b>Operator:</b> Hayden Gulch Terminal, LLC<br><b>Operator Address:</b><br>Ms Miranda Kawcak<br><br>P.O. Box 670<br>Hayden, CO 81639 | <b>County:</b> Routt<br><b>Operation Type:</b> Loadout<br><b>Permit Status:</b> Active<br><b>Ownership:</b> Private<br><br><b>Operator Representative Present:</b><br><br>Na |

**INSPECTION INFORMATION**

| <b>Inspection Start Date:</b> January 11, 2021<br><b>Inspection Start Time:</b> 10:15<br><b>Inspection End Date:</b> January 11, 2021<br><b>Inspection End Time:</b> 10:30 | | <b>Inspection Type:</b> Aerial Inspection<br><b>Inspection Reason:</b> Normal I&E Program<br><b>Weather:</b> Clear | |

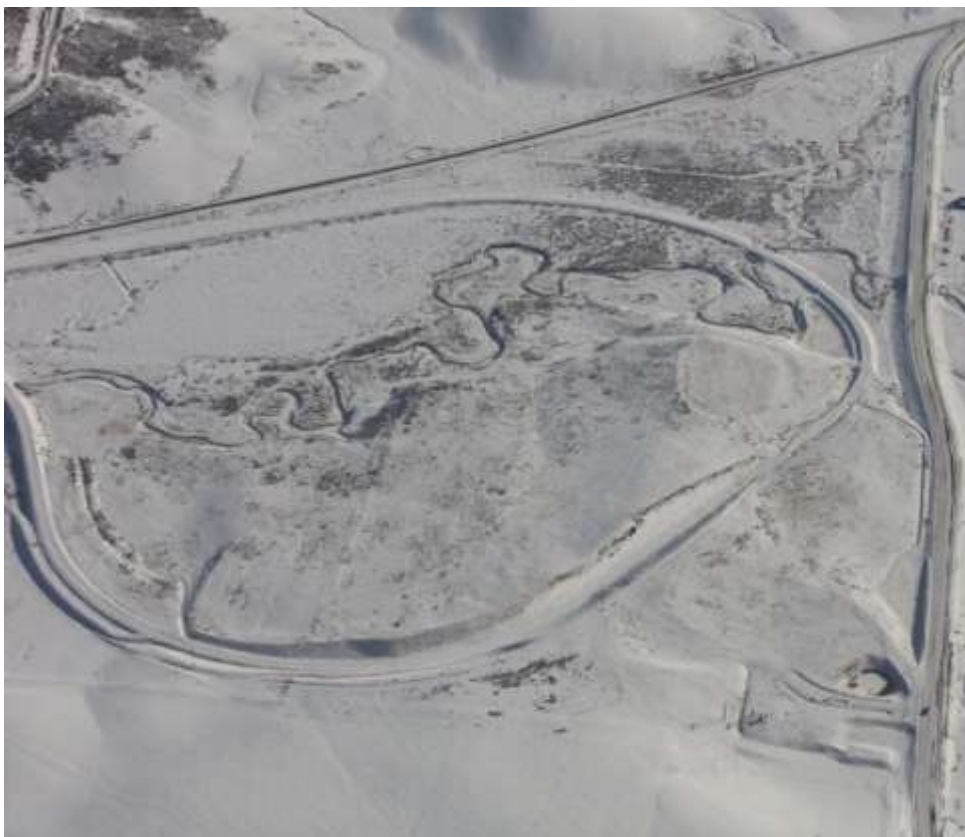
Train Loop shown below. Ponds appear snow covered and not likely holding additional water as vegetation is visible. The loop is currently being used by public as a walking trail.

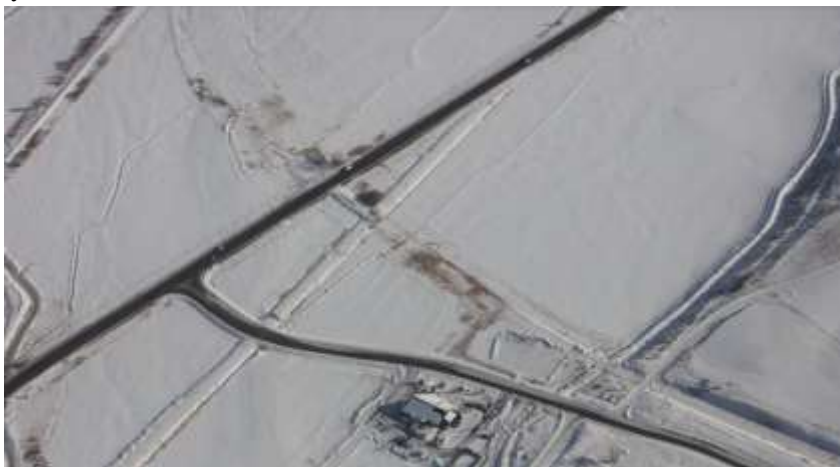
Community trail parking lot is shown below and appears to be plowed. North of Hwy 40 (top of the photo) shows the area still to be reclaimed and not part of the bond release area proposed for release in SL-2 currently under review by the Division.

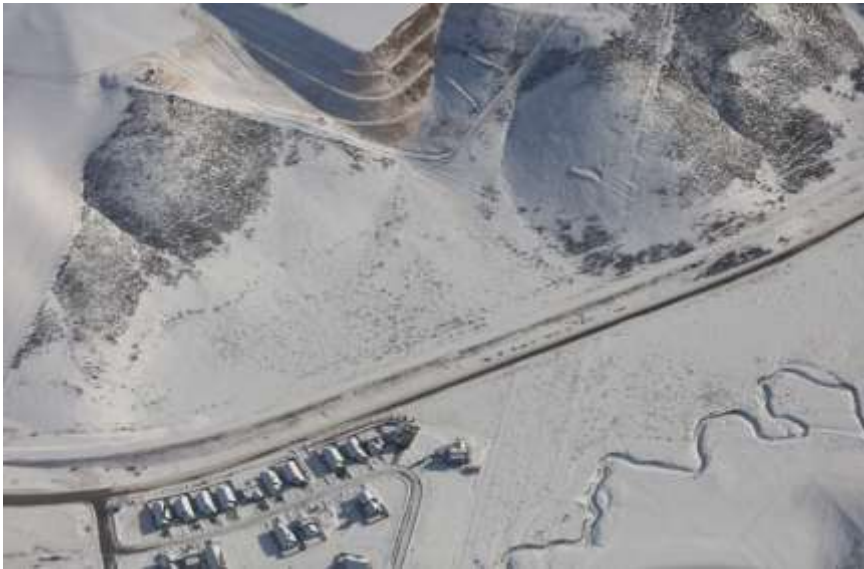
Shown below is the rail ballast currently in use as a community trail, just above the road in the photo. At the top of the photo is the airport and at the bottom a house development and Little Dry Creek.
