**COLORADO**  
Division of Reclamation,  
Mining and Safety  
Department of Natural Resources

<b>Permit Number:</b> C-1981-018 <b>Mine Name:</b> Deserado Mine <b>Operator:</b> Blue Mountain Energy, Inc. <b>Operator Address:</b> Mr. Kurtis Blunt 3607 County Road 65 Rangely, CO, 81648	<b>County:</b> Moffat, Rio Blanco <b>Operation Type:</b> Underground <b>Permit Status:</b> Active <b>Ownership:</b> Private
	<b>Operator Representative Present:</b>  NA
<b>Operator Representative Signature:</b> (Field Issuance Only)

<b>Inspection Start Date:</b> January 11, 2021 <b>Inspection Start Time:</b> 10:00 <b>Inspection End Date:</b> January 11, 2021 <b>Inspection End Time:</b> 10:05		<b>Inspection Type:</b> Aerial Inspection <b>Inspection Reason:</b> Normal I&E Program <b>Weather:</b> Clear	
<b>Joint Inspection Agency:</b>  None		<b>Joint Inspection Contacts:</b>  None	
<b>Post Inspection Agency:</b>  None		<b>Post Inspection Contacts:</b>  None	
<b>Inspector(s):</b>  Clayton Wein  Brock Bowles	<b>Inspector's Signature:</b>  <i>Clayton Wein</i>		<b>Signature Date:</b>  1/14/2021

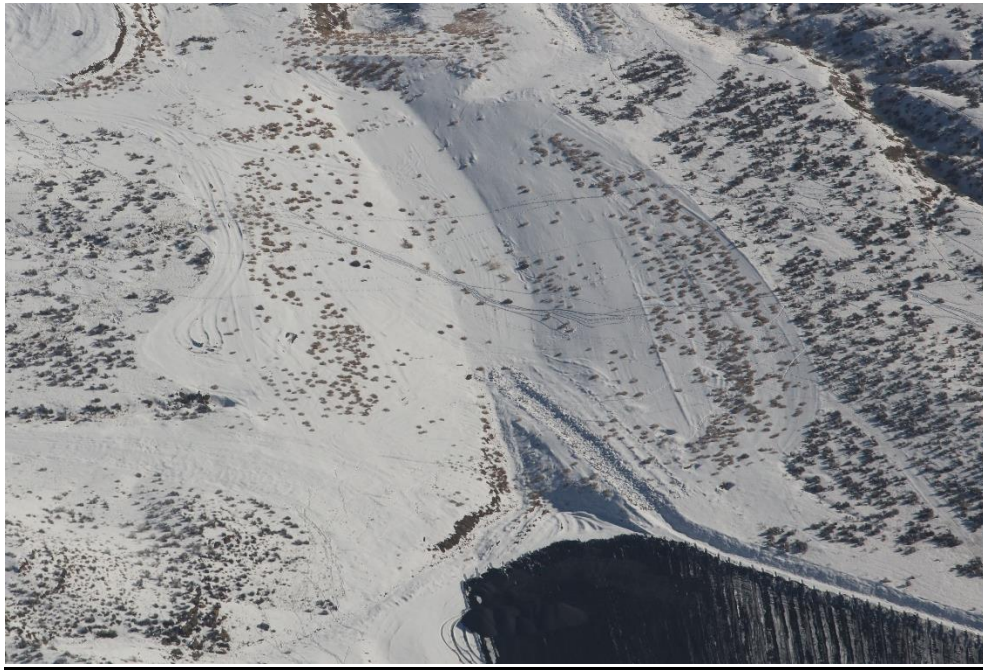
There is one pond located on the east end of the RP-A refuse area (Photo 1). The pond did not appear to be impounding water below the snow. The embankment was also covered with snow. There were no indications of instability or erosion.

**Photo 1:** The RP-A refuse pile pond covered with snow.

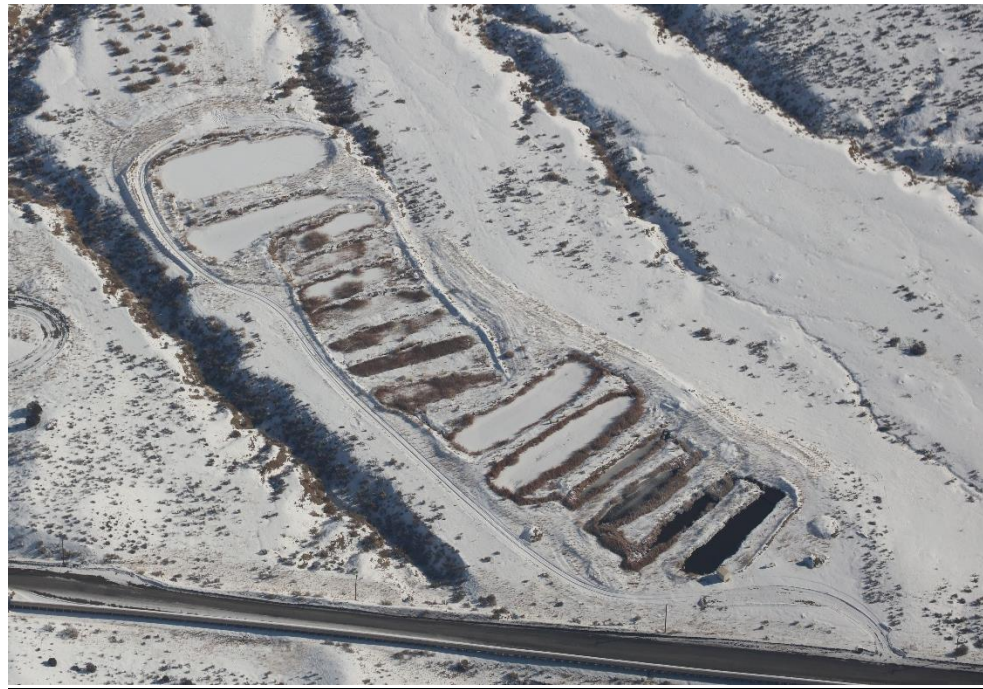
All 15 cells of the B Seam No. 1 Dewatering System were holding water (Photo 2). Only the first two cells in the system were not frozen or snow covered. The remaining cells were covered with ice and snow. The embankments were snow covered and stable. No erosional features were observed.

**Photo 2:** The B Seam No. 1 Dewatering System.

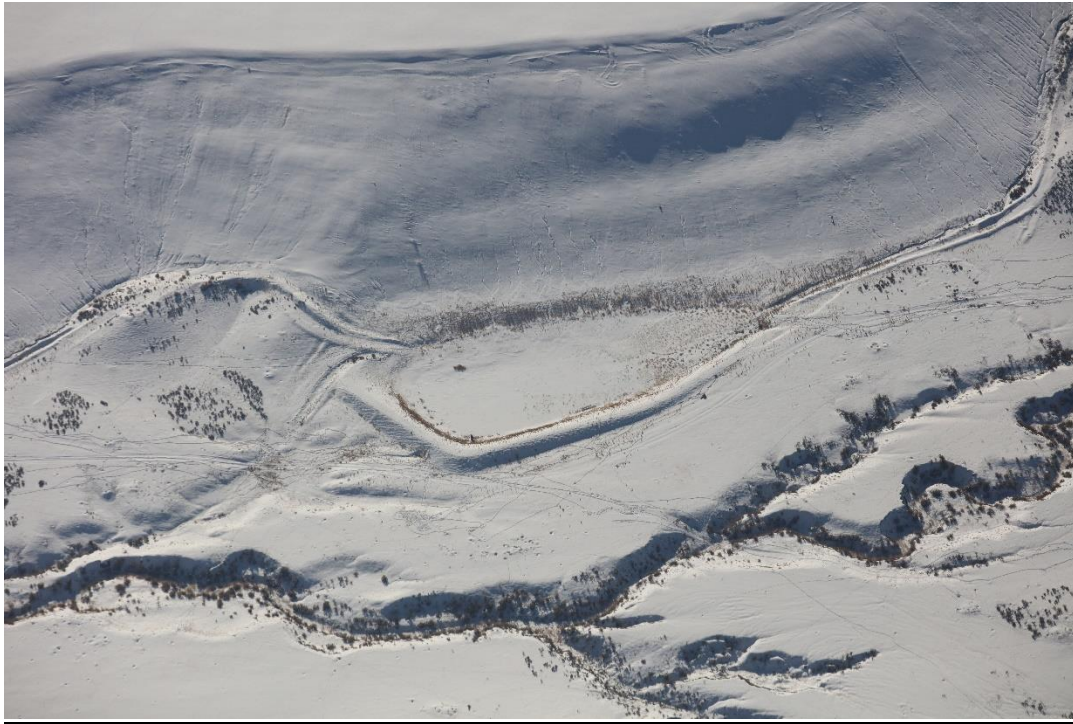
Three ponds; RP-2/3, RP-4 (Photo 3) and RP-5, are located at the northern bases of the RP-2/3/4 and RP-5a refuse piles. All of the ponds were observed to be covered with snow. The embankments of the ponds were stable and no erosional concerns were identified.

**Photo 3:** The snow covered RP-4 Pond.

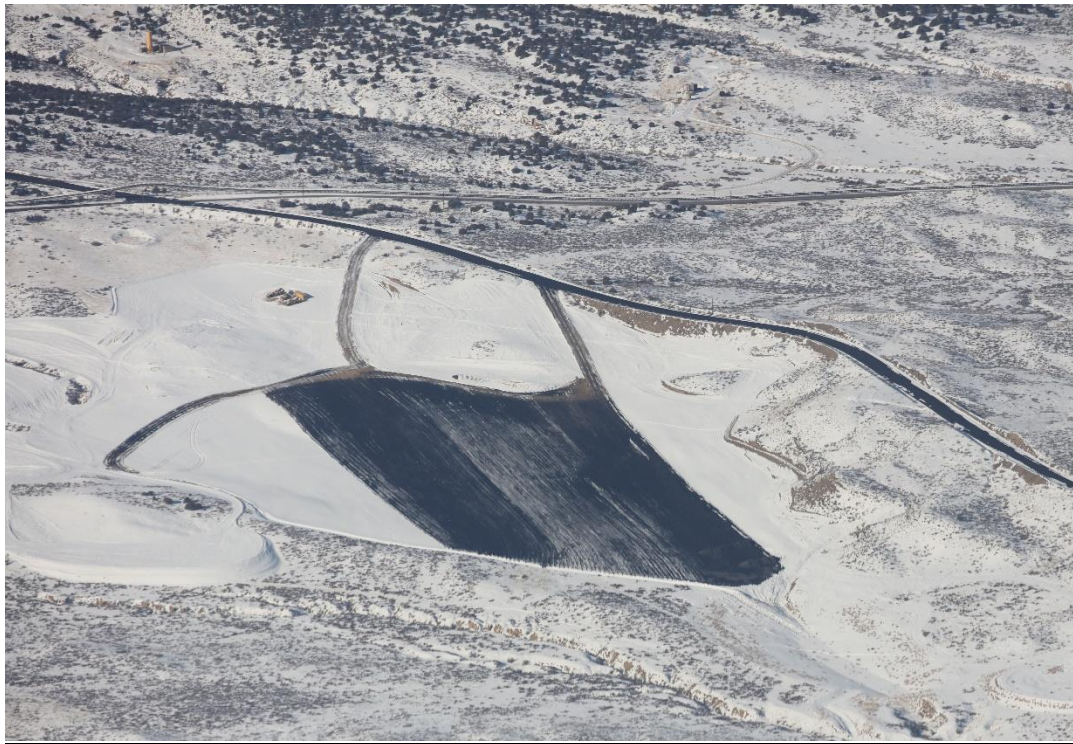
The RP-A refuse pile was partly covered with snow (Photo 4). The northern portion of the pile was observed to be exposed. Refuse appeared to be stockpiled on the northeast corner. The site was stable and there were no concerns of erosion identified.

**Photo 4:** The RP-A Refuse Pile.

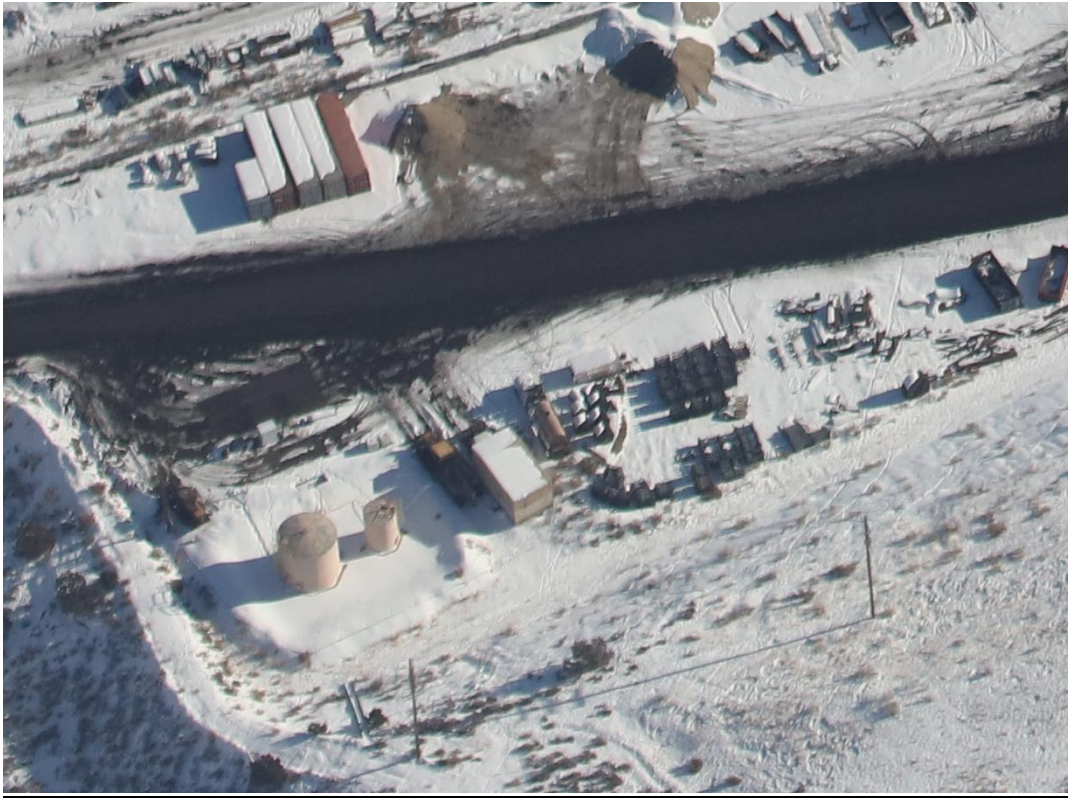
Support facilities at the mine site were observed to be covered with snow. The pads for the facilities were stable and no erosional features were observed.

**Photo 5:** The fuel storage area.

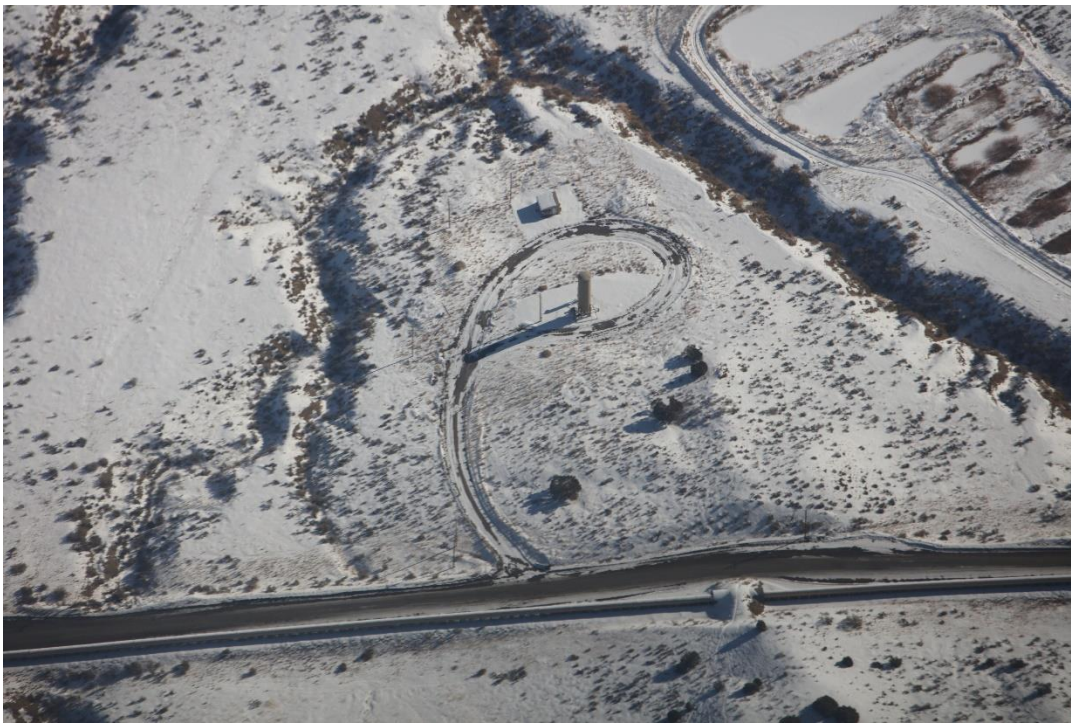
**Photo 6:** The RDH-4 Support Facility.

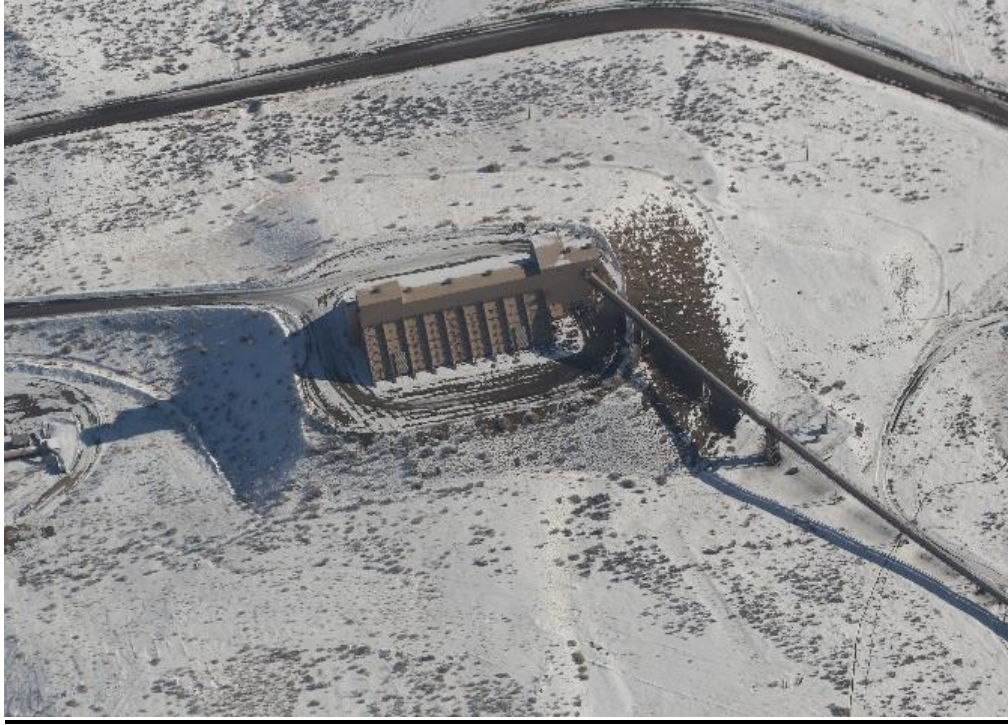
**Photo 7:** The Slot Storage Facility.
