**Re: Permit No. M-1980-244; Cripple Creek & Victor Gold Mining Company; Cresson Project; – Technical Revision 125 PAR Response – VLF 2 Phase 2B, Part 2 Record of Construction – Construction Quality Assurance Report**

**SQUAW GULCH VALLEY LEACH FACILITY  
PHASE 2B PART 2  
RECORD OF CONSTRUCTION REPORT Rev 1**

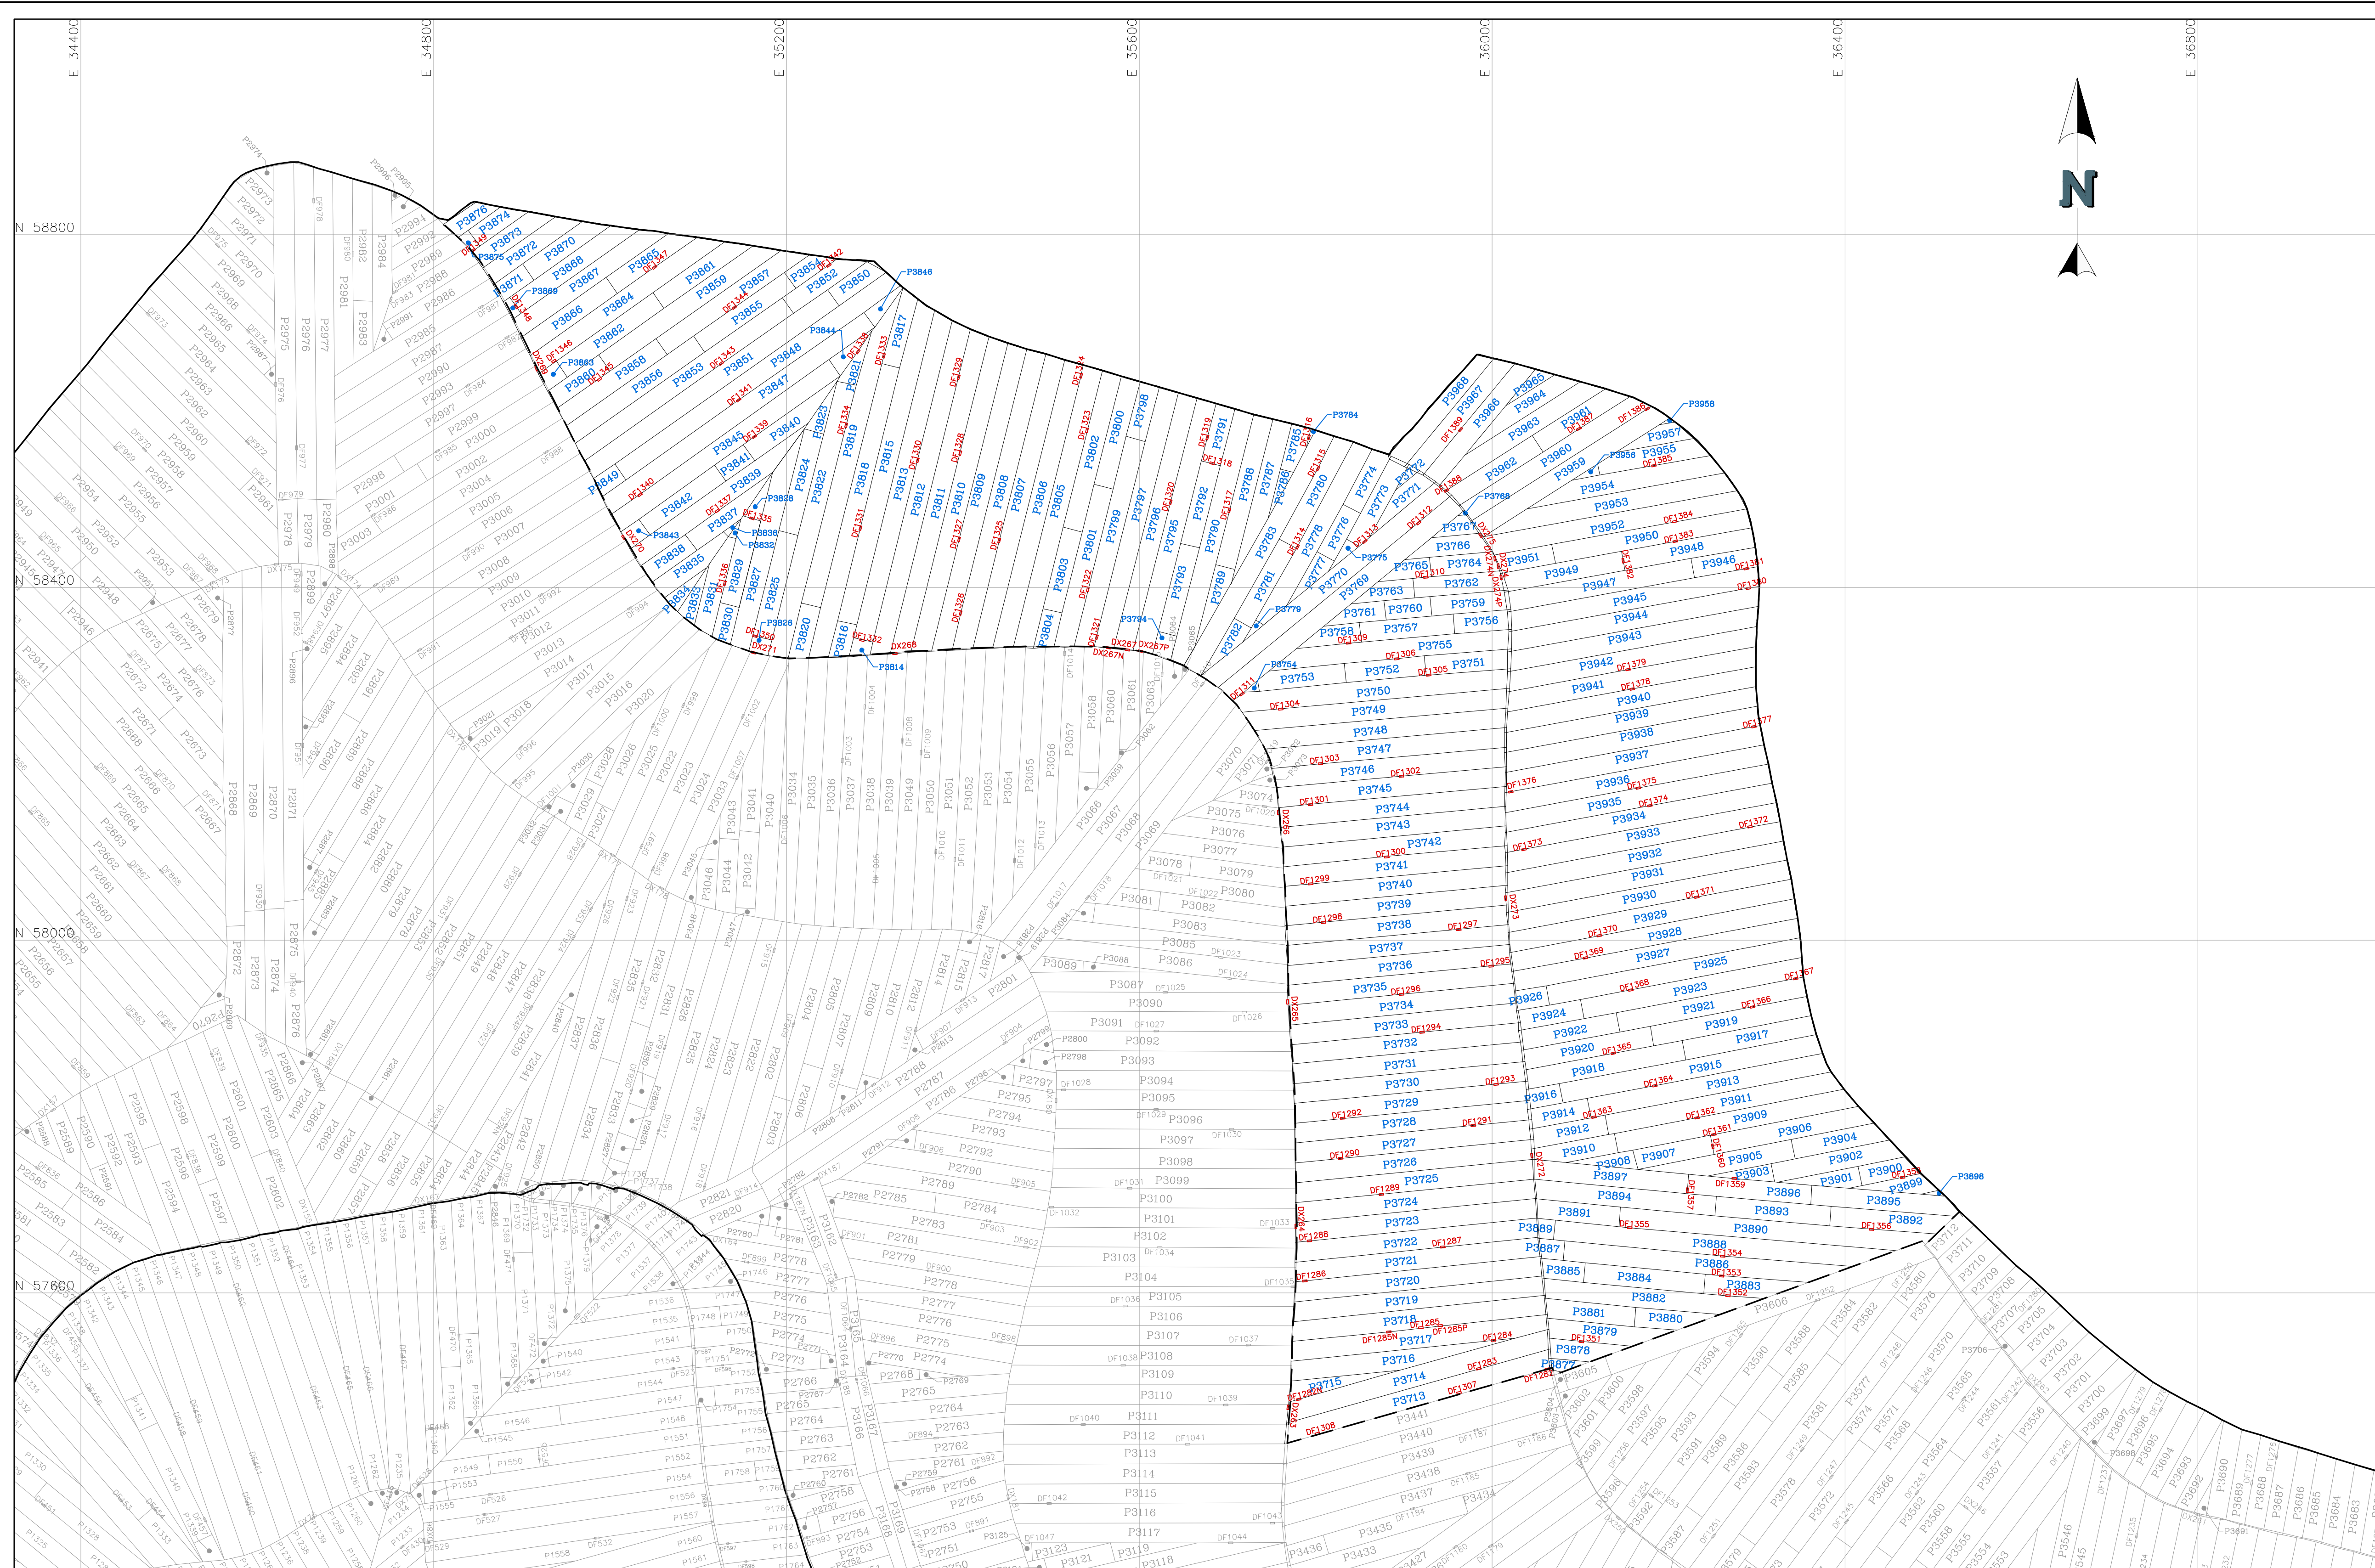
CLIENT	CRIPPLE CREEK & VICTOR GOLD MINING COMPANY
	PROJECT	SQUAW GULCH VALLEY LEACH FACILITY PHASE 2B PART 2
TITLE	GEOMEMBRANE PANEL LAYOUT AS-BUILT	FILENAME 0106.032.001P DRAWING NO. 6 REVISION 1

- c. In Appendix J 5.1 DF-1321 is located on P-3797/P-3801 but on Drawing No. 6 it is located on P-3797/P-3799, please resolve and update accordingly.

- d. In Appendix J 5.1 DF-1339 is located on P-3840/P-3844 but on Drawing No. 6 it is located on P-3840/P-3845, please resolve and update accordingly.

- e. In Appendix J 5.1 DF-1345 is located on P-3850/P-3860 but on Drawing No. 6 it is located on P-3858/P-3860, please resolve and update accordingly.

- f. In Appendix J 5.1 DF-1350 located on P-3825/P-3826 is missing from Drawing No. 6, update.
  - g. In Appendix J 5.1 DF-1387 is located on P-3960/P-3962 but on Drawing No. 6 it is located on P-3960/P-3961, please resolve and update accordingly.

- h. In Appendix J 5.1 DF-1388 is located on P-3963/P-3964 but on Drawing No. 6 it is located on P-3962/P-3963, please resolve and update accordingly.

- e) **The location of DF-1345 is P-3858/P-3860 and has been updated in Appendix J.5.1.**
  - f) **Enclosed, DF-1350 has been added to the correct location on Drawing No. 6.**
