MINERALS PROGRAM INSPECTION REPORT

MINE NAME: Steel Rose 1	MINE/PROSPECTING ID#: M-2006-031	MINERAL: Gold	COUNTY: Park
INSPECTION TYPE: Monitoring	INSPECTOR(S): Elliott R. Russell	INSP. DATE: July 18, 2019	INSP. TIME: 17:50
OPERATOR: Steel Rose I. Inc.	OPERATOR REPRESENTATIVE: Scott West	TYPE OF OPERATION: 110(2) - Hard Rock Limited Impact

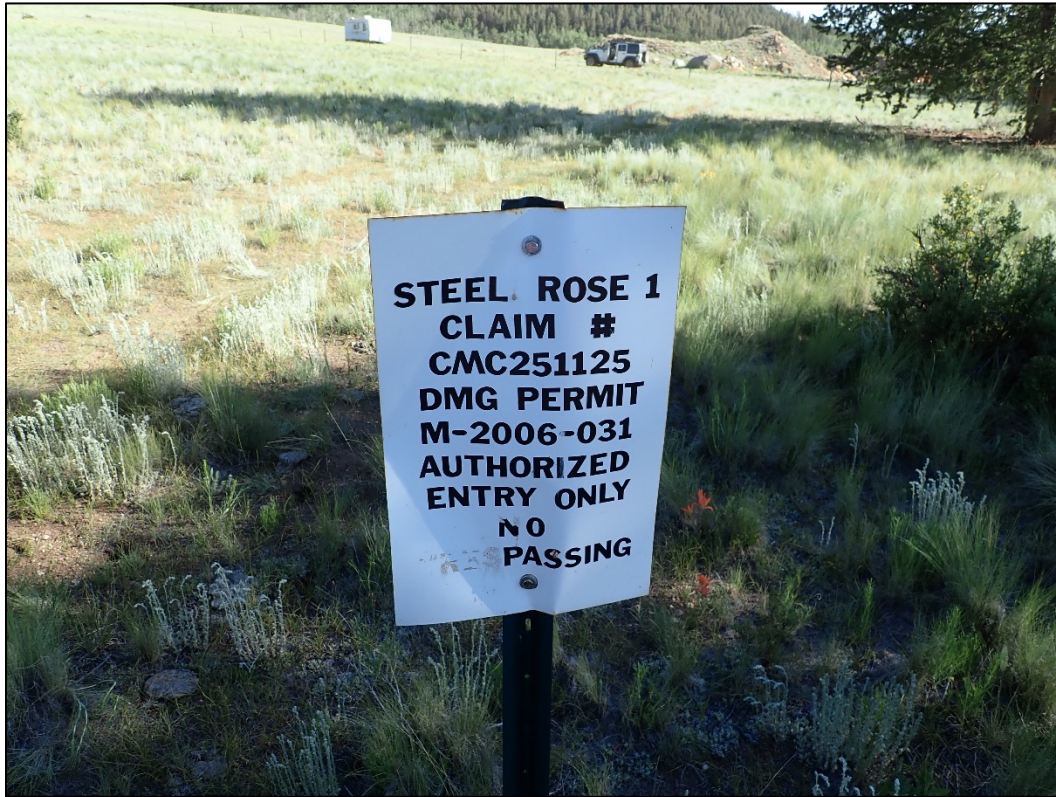
The Division met Scott West at the mine site entrance on the south side of Forest Service Road 226, south of La Salle Pass. The site was not active at the time of the inspection and no equipment was located on-site. The mine identification sign was posted at the entrance to the site and t-post markers were in place delineating the approved permit boundary.

Photo 1. Mine identification sign; looking south.

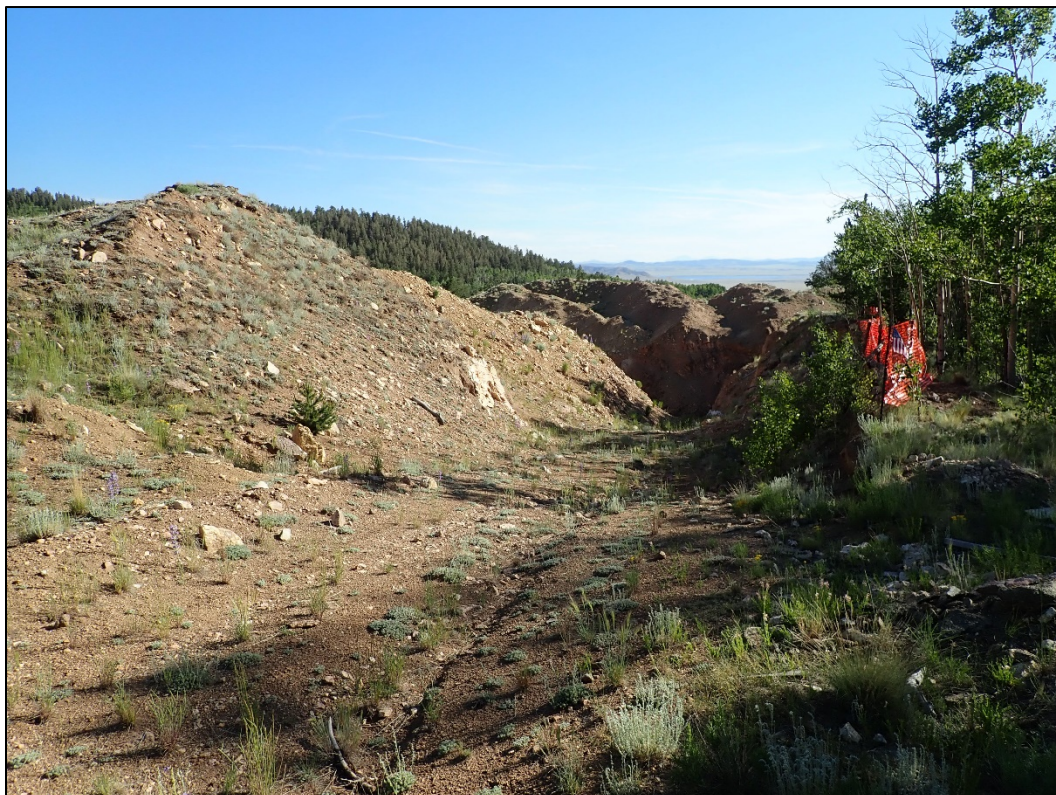
The site appeared to be in compliance with the approved mine plan. The Operator continues to mine within the existing trench which is shaped like an "L" with access points into the trench on the northeast and southeast sides. The trench is approximately 300 feet long by 50 feet wide by 40 feet deep. Several super sacks of ore were located within the trench ready for off-site shipment. Multiple overburden and topsoil stockpiles are scattered on the south and east sides of the trench. The Division observed a small infestation of thistles occurring on the southern slope of the western topsoil stockpile. The Operator will need to treat/remove these thistles to ensure the operation is in compliance with Rule 3.1.10(6) regarding noxious and other weed species.

Photo 2. Northern portion of the trench; looking southwest.

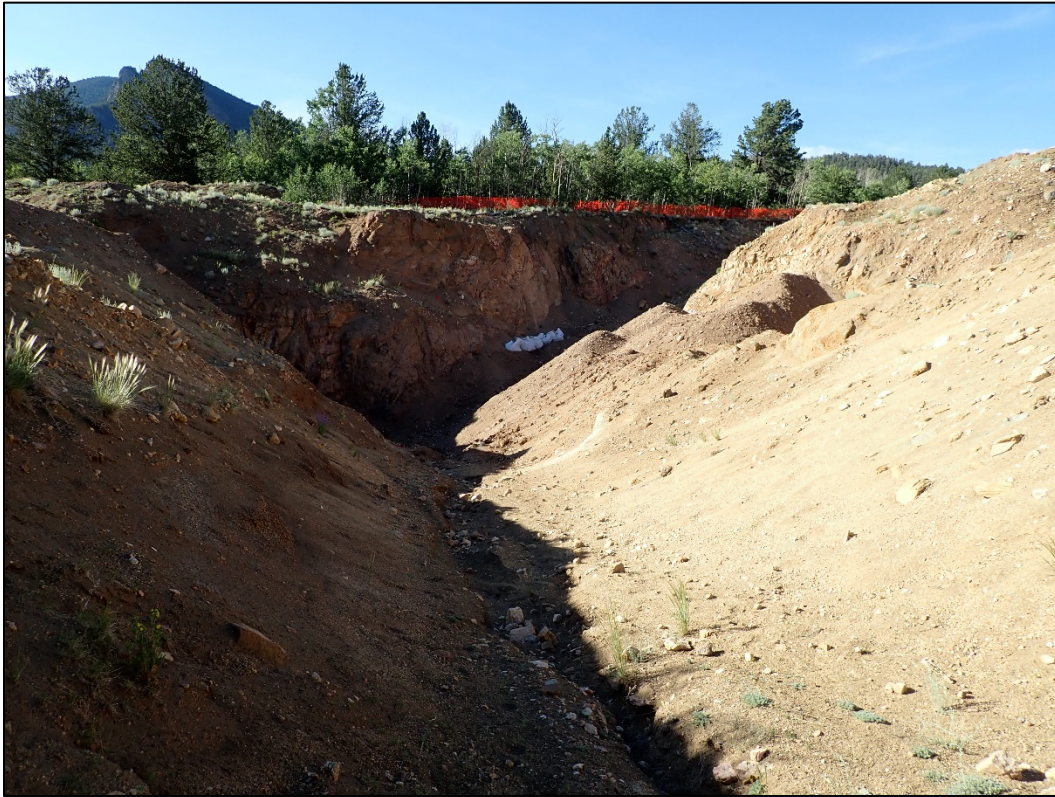
Photo 3. Southern portion of the trench; looking northwest.

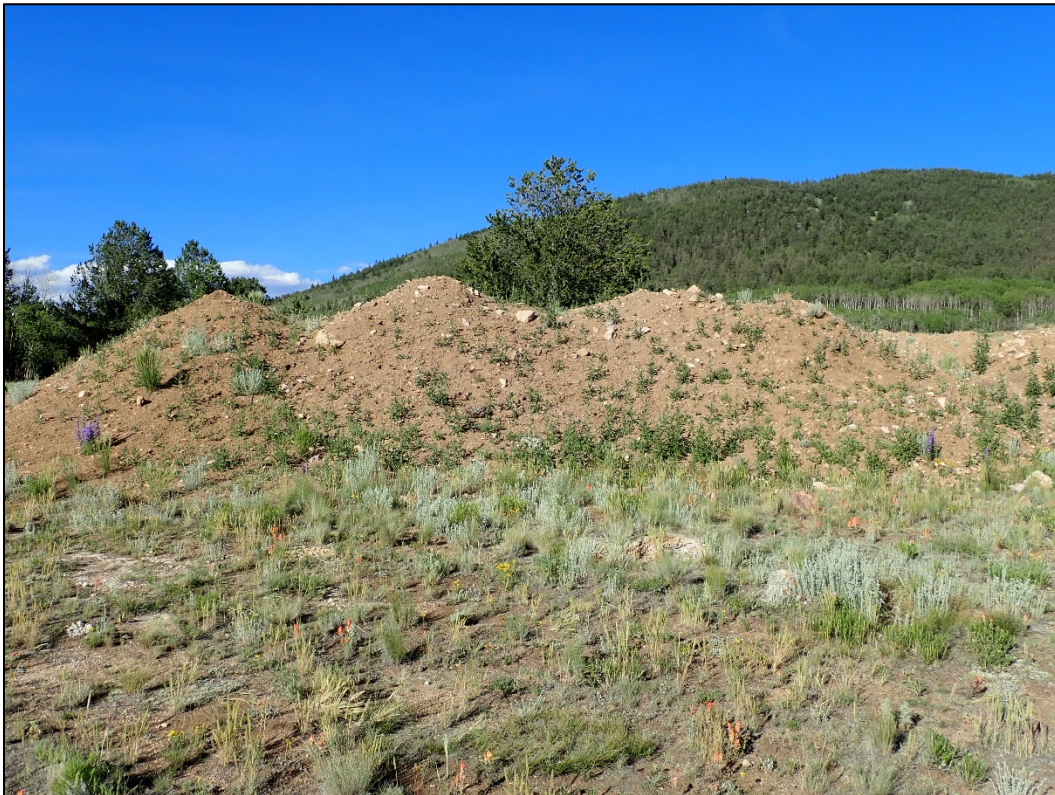
Photo 4. Topsoil stockpile with thistles; looking north.
