MINERALS PROGRAM INSPECTION REPORT
PHONE: (303) 866-3567

MINE NAME: Hitch Rack Ranch	MINE/PROSPECTING ID#: P-2014-016	MINERAL: Granite, granite gneiss	COUNTY: El Paso
INSPECTION TYPE: Surety Release Inspection	INSPECTOR(S): Timothy Cazier, P.E.	INSP. DATE: January 21, 2021	INSP. TIME: 08:30
OPERATOR: Transit Mix Concrete Co.	OPERATOR REPRESENTATIVE: Jerald Schnabel	TYPE OF OPERATION: ME - Mineral Exploration

REASON FOR INSPECTION: Surety Release Requested	BOND CALCULATION TYPE: None	BOND AMOUNT: \$12,098.83
DATE OF COMPLAINT: NA	POST INSP. CONTACTS: None	JOINT INSP. AGENCY: None
WEATHER: Clear	INSPECTOR'S SIGNATURE:

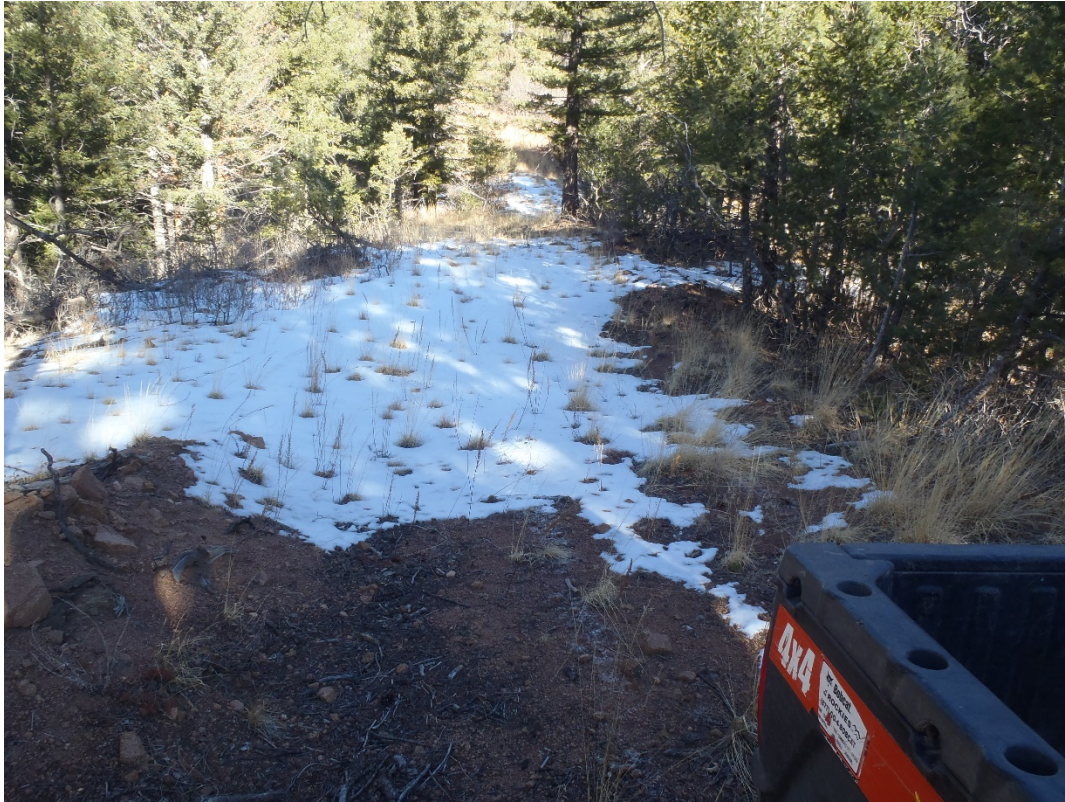
Revegetation: The pad for hole B-2 is unique in that it is a little more than 200 feet off the primary drill road. Vegetation was observed through the snow on this road (see **Photo 1**). A small amount of common mullein (List C) was observed at the HC003-15 drill pad (see **Photo 2**), but not enough to be considered problematic. No List A or B noxious weeds were observed.

Photo 1. Grasses establishing on access road to B-2.

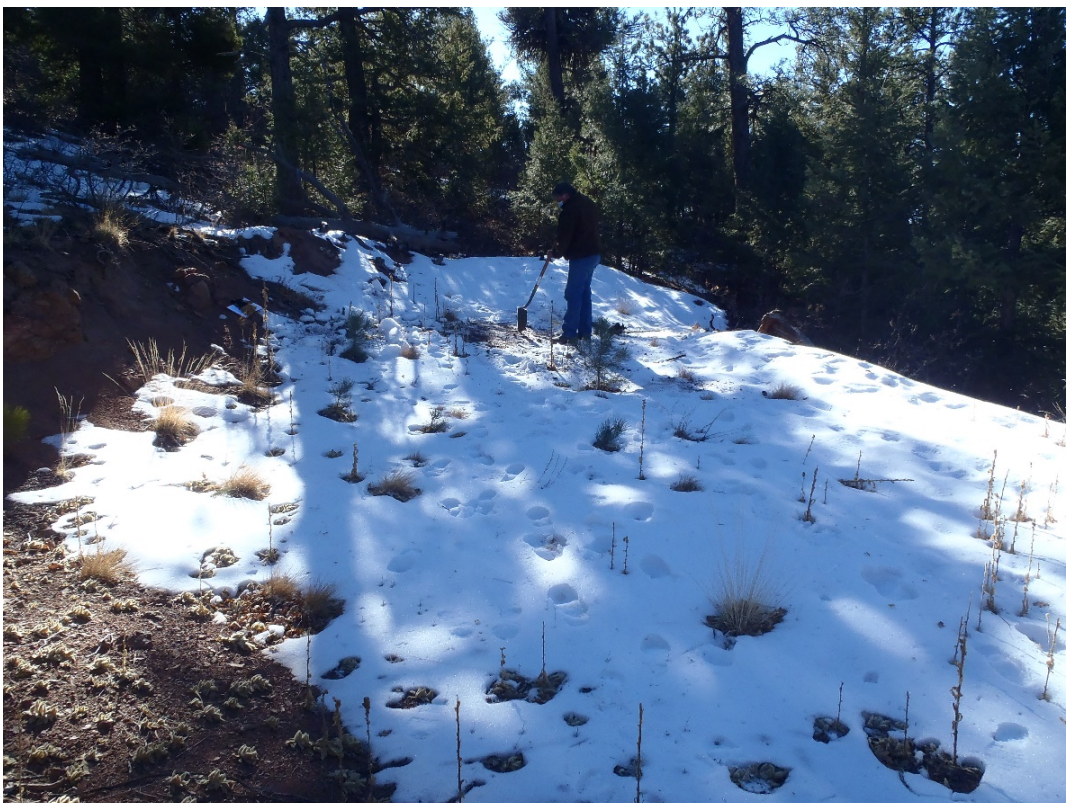
Photo 2. A small amount of mullein near B-4 & HC003-15.
