**MINERALS PROGRAM INSPECTION REPORT**  
**PHONE: (303) 866-3567**

<b>MINE NAME:</b> Barkley Pit	<b>MINE/PROSPECTING ID#:</b> M-2020-053	<b>MINERAL:</b> Borrow material for and aggregate	<b>COUNTY:</b> Logan
<b>INSPECTION TYPE:</b> Preoperation Inspection	<b>INSPECTOR(S):</b> Brock Bowles	<b>INSP. DATE:</b> January 27, 2021	<b>INSP. TIME:</b> 10:00
<b>OPERATOR:</b> Logan County	<b>OPERATOR REPRESENTATIVE:</b> Jeff Reeves	<b>TYPE OF OPERATION:</b> 112c - Construction Regular Operation	
<b>REASON FOR INSPECTION:</b> Preoperation Inspection	<b>BOND CALCULATION TYPE:</b> None	<b>BOND AMOUNT:</b> No Bond Held	
<b>DATE OF COMPLAINT:</b> NA	<b>POST INSP. CONTACTS:</b> None	<b>JOINT INSP. AGENCY:</b> None	
<b>WEATHER:</b> Clear	<b>INSPECTOR'S SIGNATURE:</b>

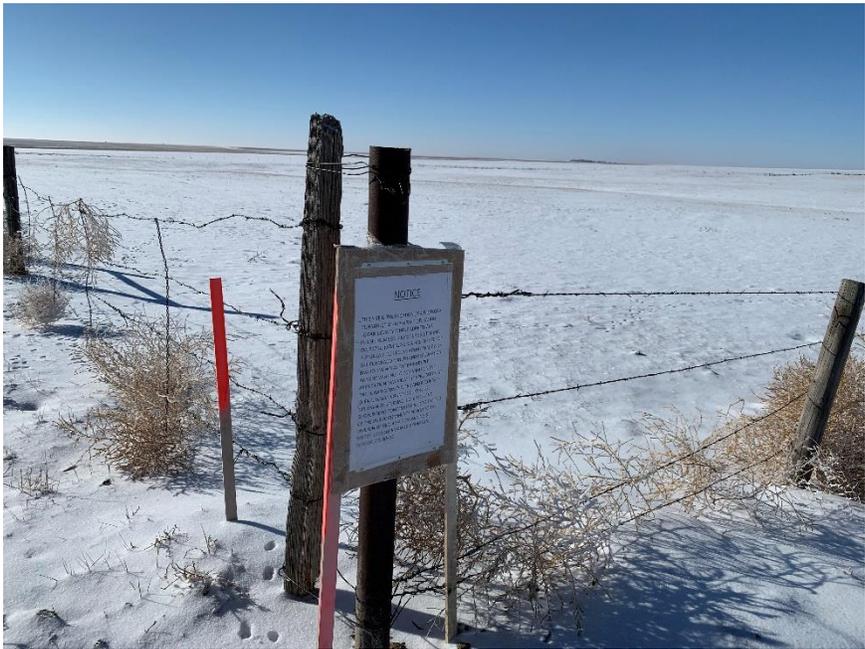
Photo 1 - Public Notice facing CR 10

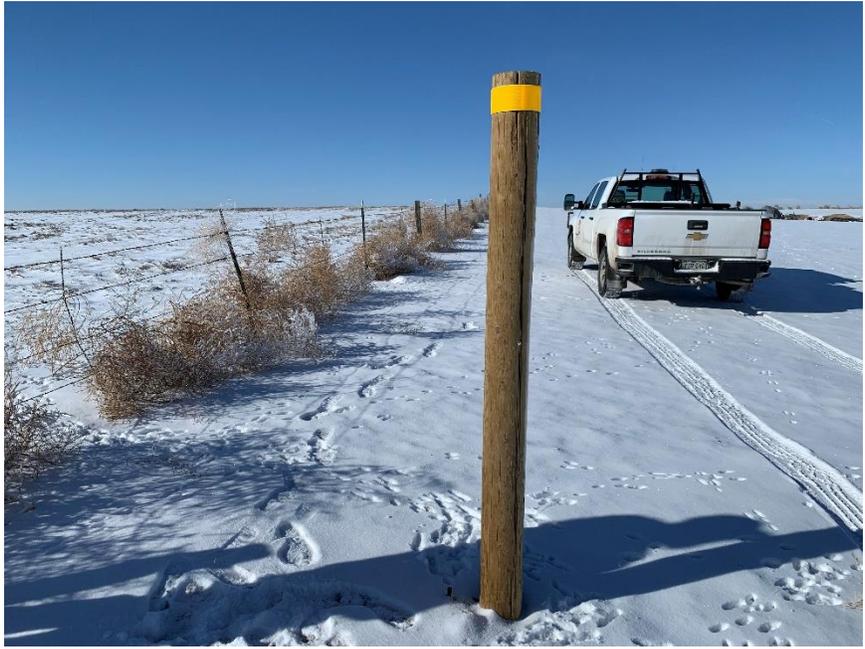
The permit boundary markers were in place (photo 2). The topography of the proposed mine site is mostly flat with an unnamed drainage situated along the western boundary (photo 3). The drainage has not been farmed and the grassy vegetation in this area was very short. The snow was approximately 1 inch deep and it covered most of the vegetation. No channel was noted in the drainage. On the southern end of the western boundary there is an excavation with a mound of soil and a collection of old machinery (photo 4). This excavation is pre-existing and is situated outside the proposed permit boundary.

Photo 2 - Boundary marker at south west corner

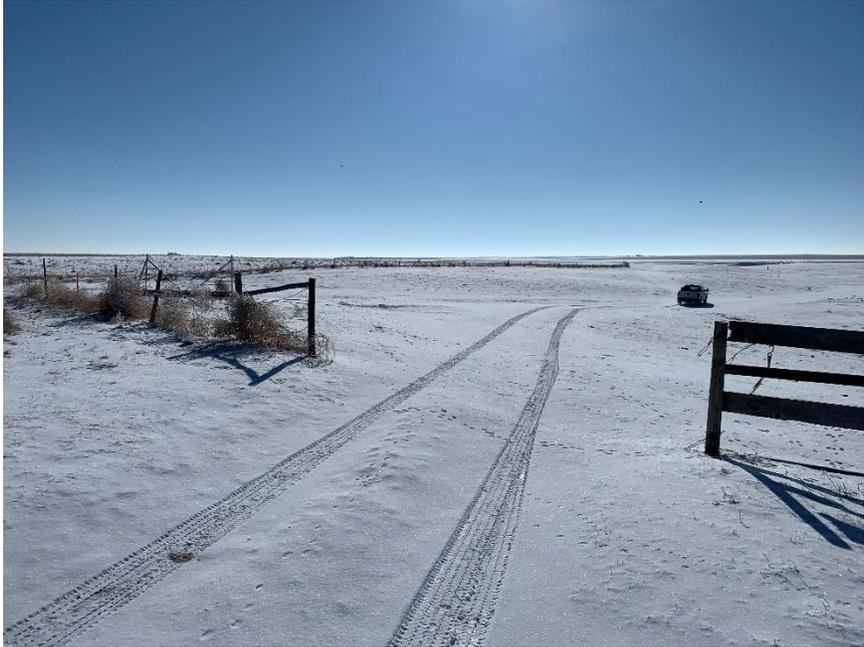
Photo 3 - Unnamed drainage on western boundary facing south from pit access road

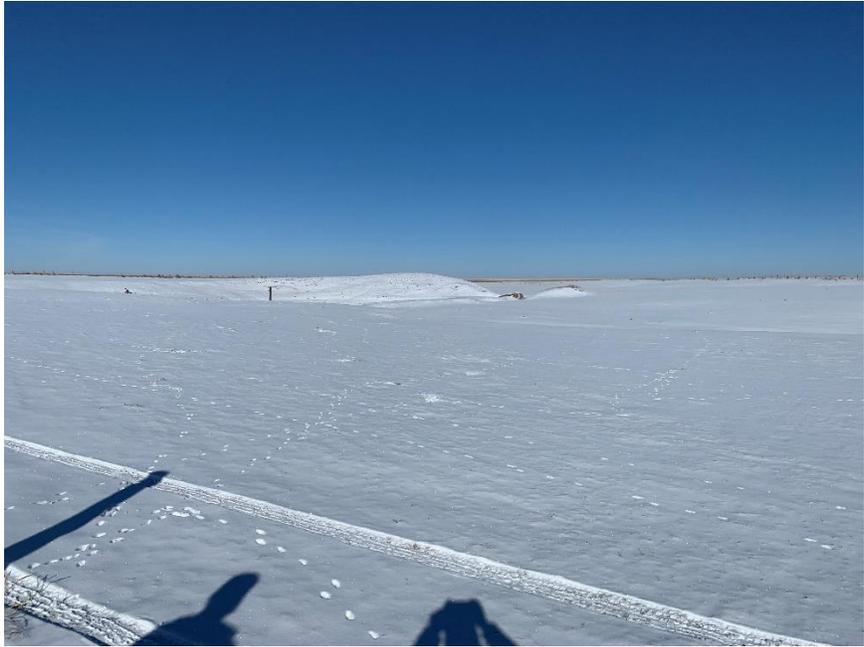
Photo 4 - Pre-existing disturbance outside the western permit boundary

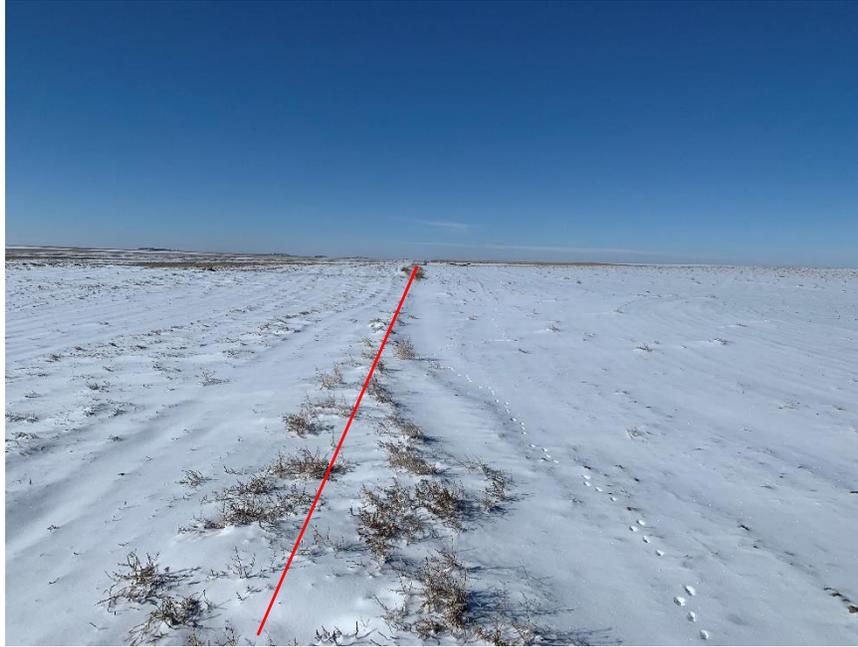
The eastern portion of the permit area is an agricultural field (photo 5). The field contained a stand of kochia plants but no agricultural crop stubble was noted. The field looked like it was disced sometime before it snowed. The ground was frozen making it very difficult to verify topsoil depths, although it was attempted.

Photo 5 – Southern permit boundary facing west, permitted area on right
