### MINERALS PROGRAM INSPECTION REPORT

<b>MINE NAME:</b> Snyder Quarry	<b>MINE/PROSPECTING ID#:</b> M-1977-210	<b>MINERAL:</b> Limestone (general)	<b>COUNTY:</b> El Paso
<b>INSPECTION TYPE:</b> Monitoring	<b>INSPECTOR(S):</b> Timothy Cazier, P.E.	<b>INSP. DATE:</b> January 21, 2021	<b>INSP. TIME:</b> 11:35
<b>OPERATOR:</b> Continental Materials Corporation	<b>OPERATOR REPRESENTATIVE:</b> Jerald Schnabel	<b>TYPE OF OPERATION:</b> 112c - Construction Regular Operation

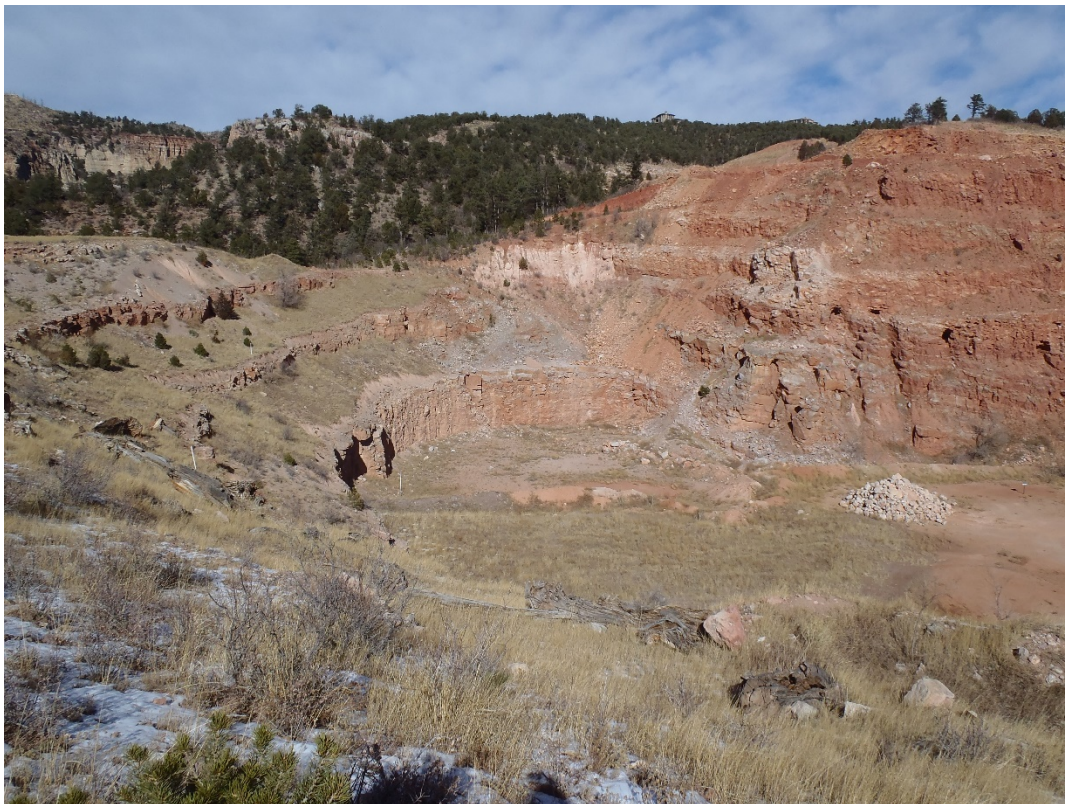
Backfilling and Grading: Two pits in the Phase WP area: one in the north (see **Photo 1**) and one in the south (see **Photos 2 and 3**) still require additional backfill. Based on the approved reclamation plan, there is up to 25 feet of backfill available near where the process plant was (see **Photo 4**) and more to the north in the vicinity of the north-south access road (see **Photo 5**). The site has not been mined to full extent of the approved mine plan. As such, there are some highwalls still configured as "pre-final benches" (reference AM-04 Exhibit D, p. 11) as shown in **Photo 6**. These benches are not wide enough to achieve the required overall slope approved in AM-04, nor for placing backfill for the purpose of establishing vegetation on the benches. The pit floor in the north end of the Phase AP area was not visited during this inspection, but based on the 2018 inspection, some highwall benching and/or backfilling will be necessary for the east facing highwall on the north end (see **Photos 7 and 8**). There is also an angle of repose slope on the west side of the north-south access road (see **Photo 9**) that is too steep to revegetate and does not meet the grades in the approved reclamation plan. Depending on whether this road is to remain (the approved plan leaves that up to local needs), it may be graded to flatter slopes, but likely would eliminate the road. The DRMS understands a possible change to the post mine land use may be forthcoming after approval of the pending succession of operator (SO) application. If this is the case, a revision will be required to the permit. If at the same time, the new Permittee has different reclamation plans, those could be part of the same revision. Both the existing Permittee and the potential Successor should be aware of the Mined Land Reclamation Board's Policy No. 30 regulating the Factor of Safety for highwall stability (<https://www.colorado.gov/pacific/drms/minerals-program-policies-and-guidance-documents>).

Photo 1. North pit in Phase WP area (looking NW).

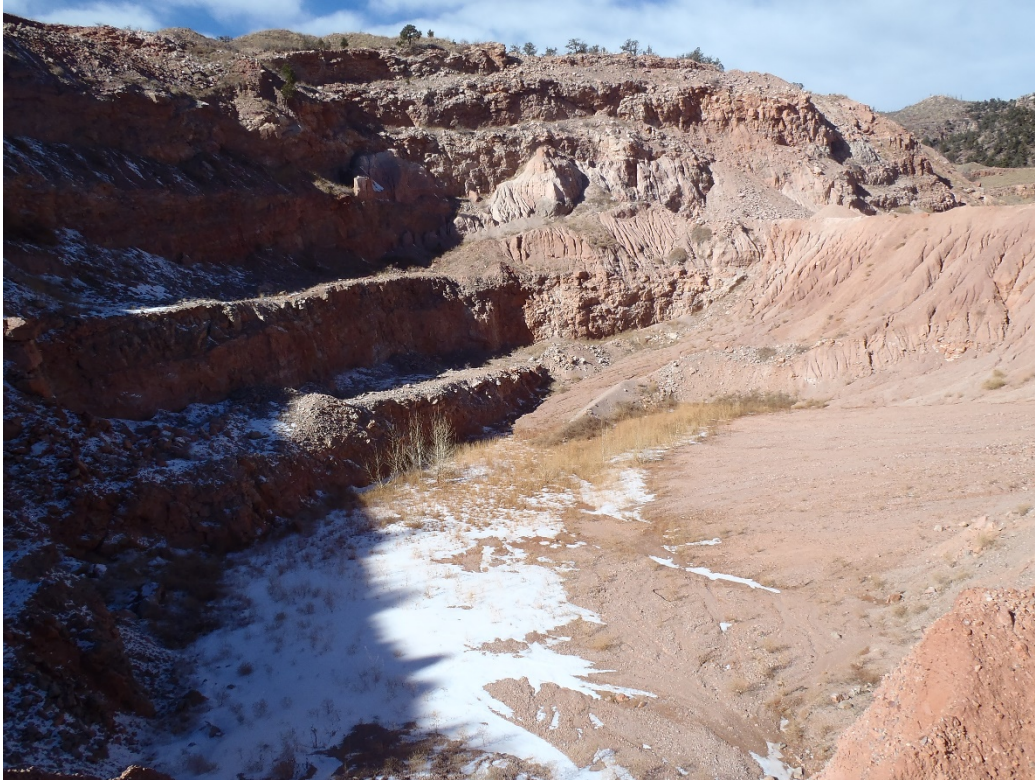
Photo 2. West side of south pit in Phase WP area (looking north).

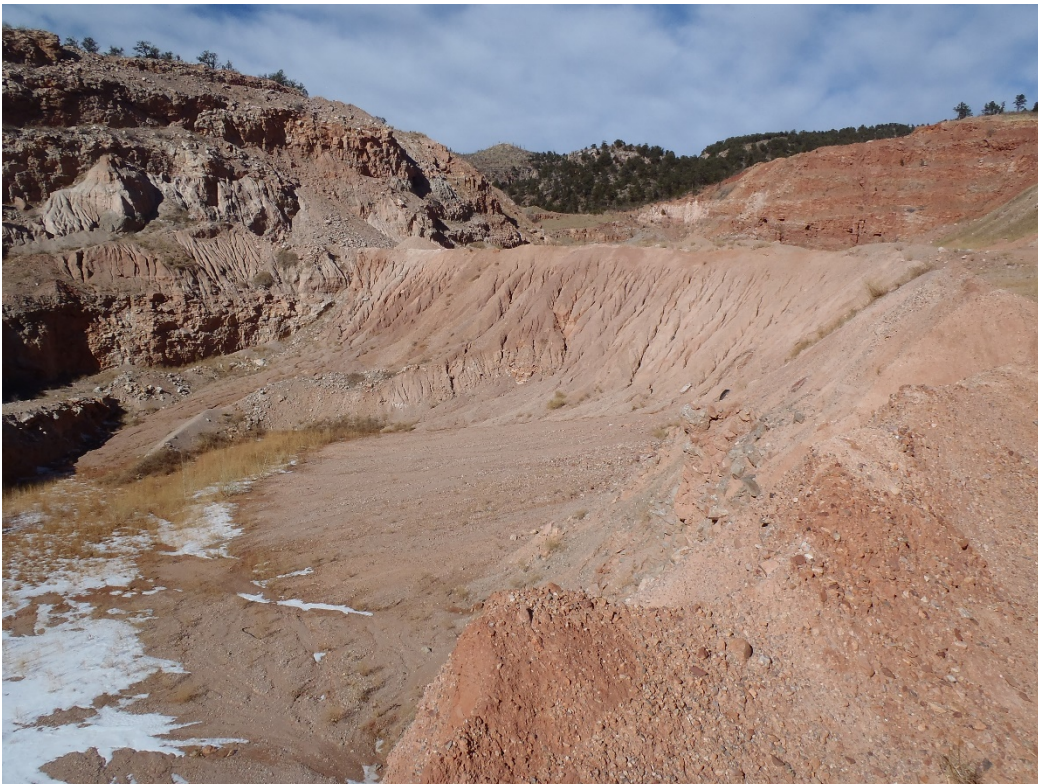
Photo 3. East side of south pit in Phase WP area (looking north).

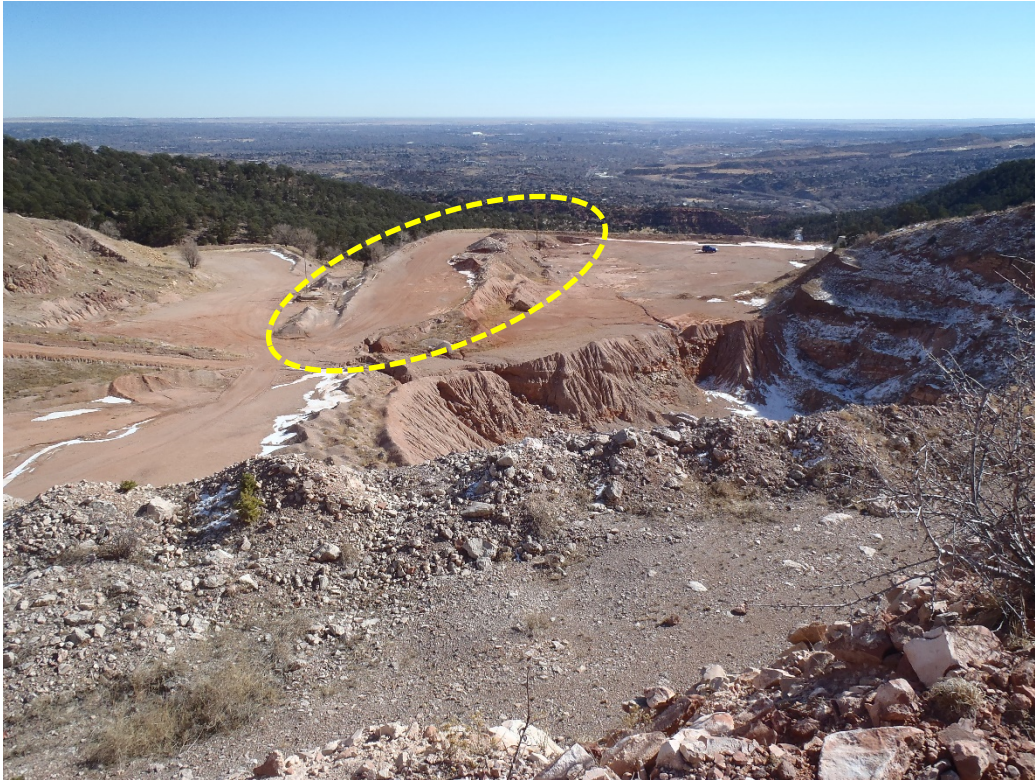
Photo 4. Available backfill near former processing area (looking SE).

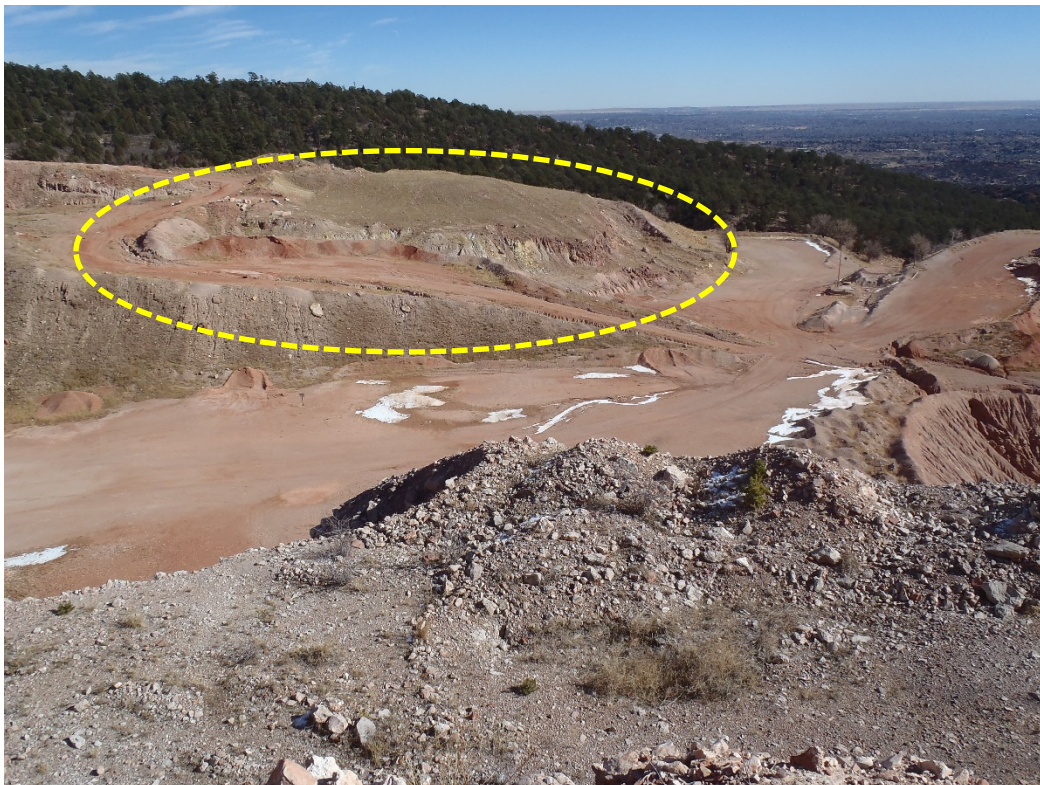
Photo 5. Available backfill/growth media near north-south access road (looking east).

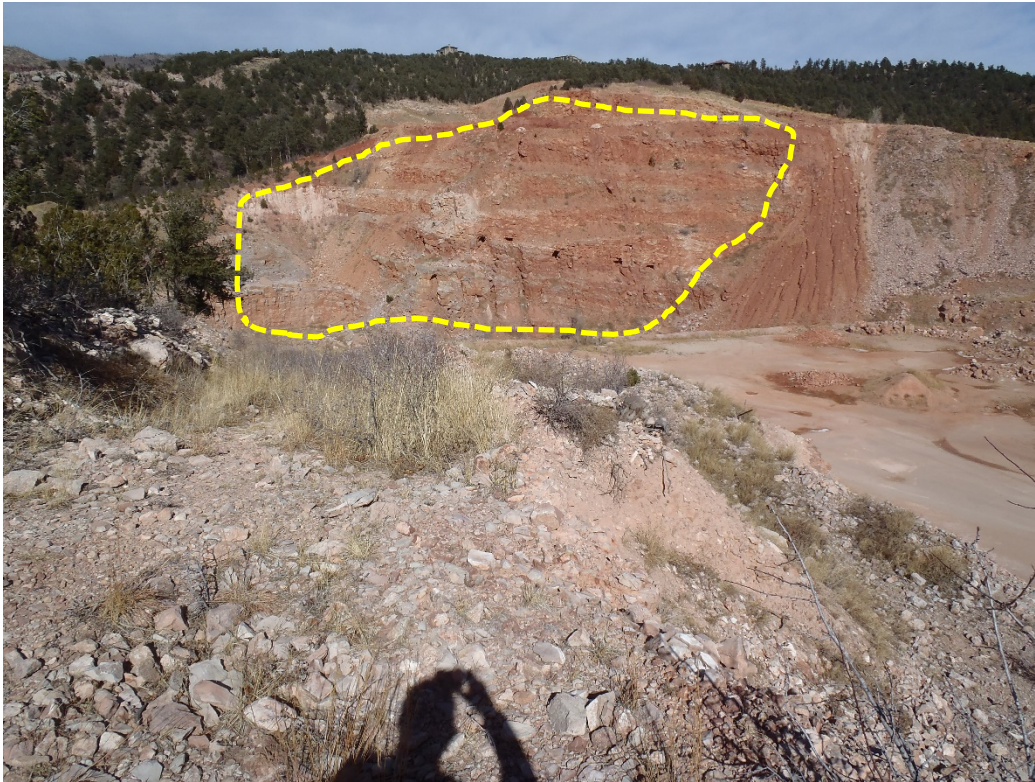
Photo 6. Pre-final benches on north end of Phase WP pit.

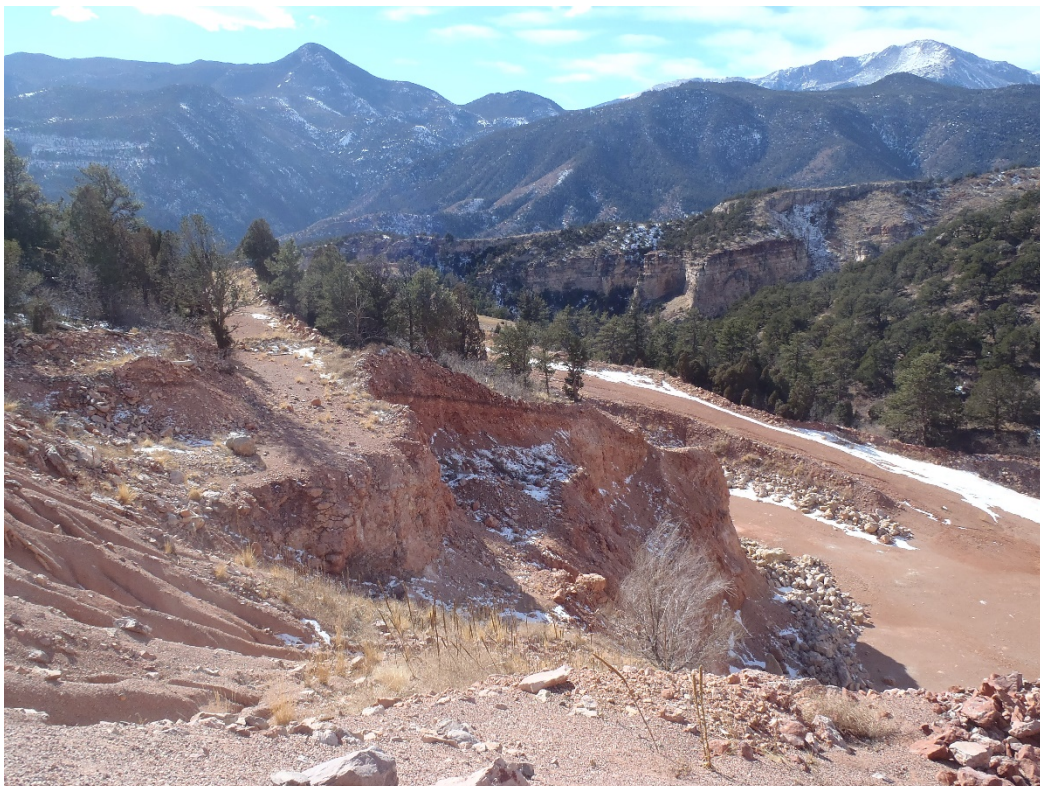
Photo 7. East highwall in north/Phase AP pit (looking SW from crest).

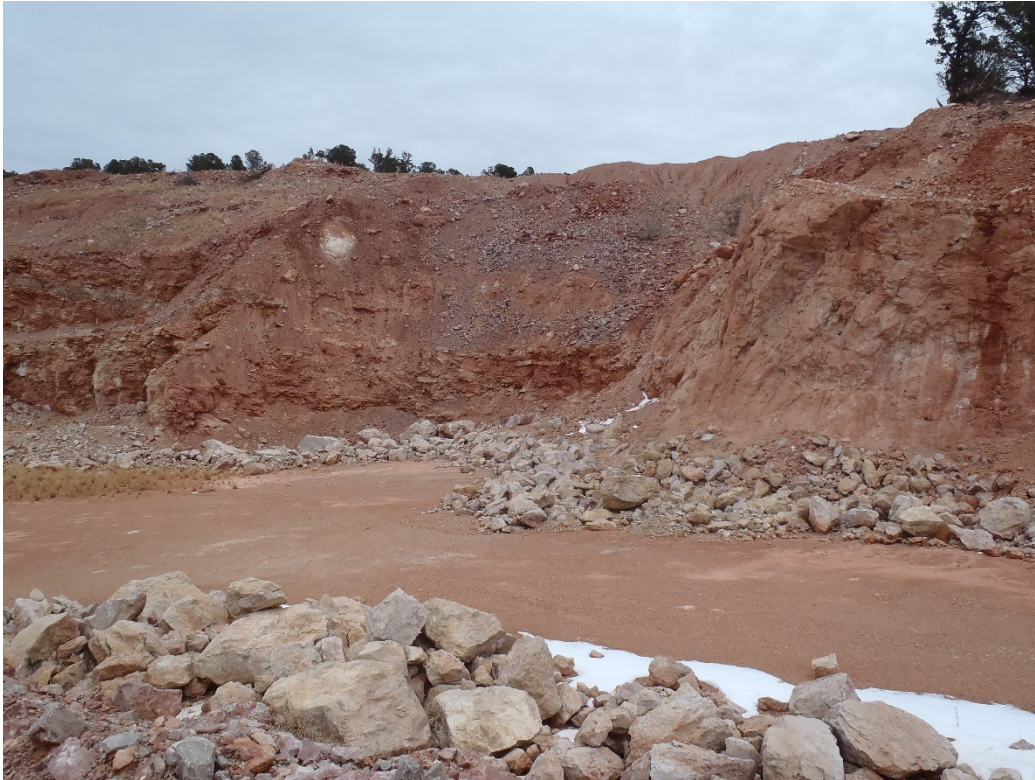
Photo 8. 2018 inspection photo of east highwall in north/Phase AP pit (looking NE from pit floor).

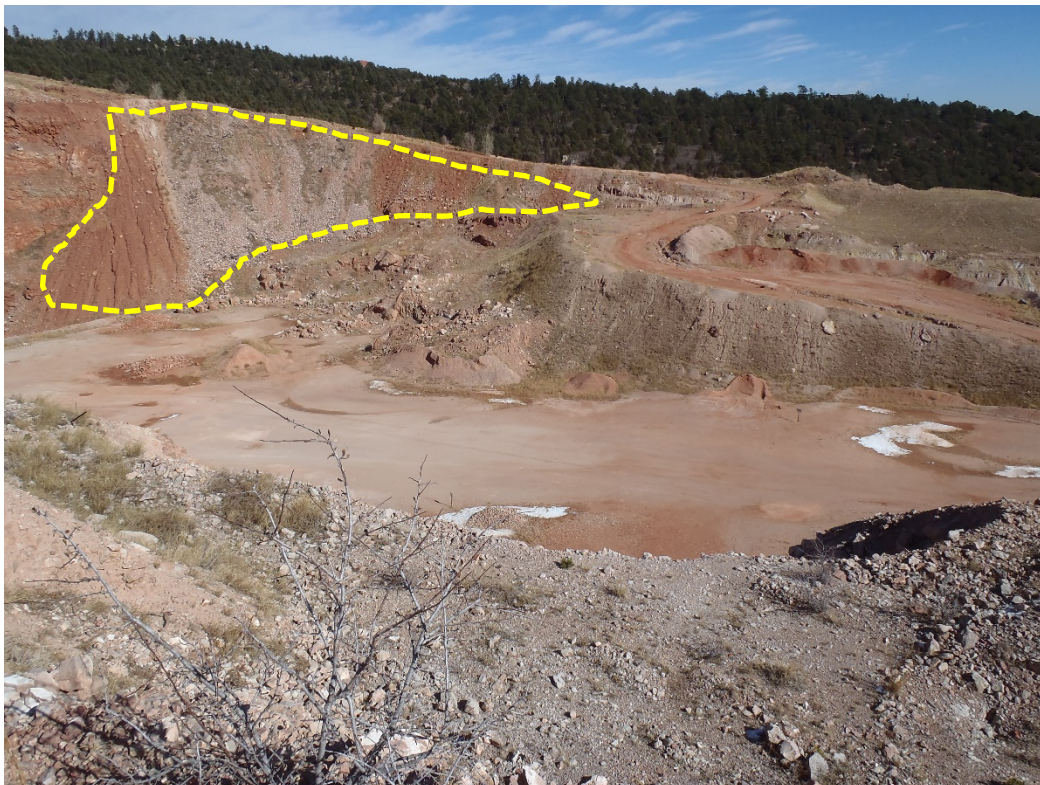
Photo 9. Angle of repose slope on west side of north-south access road (looking east).

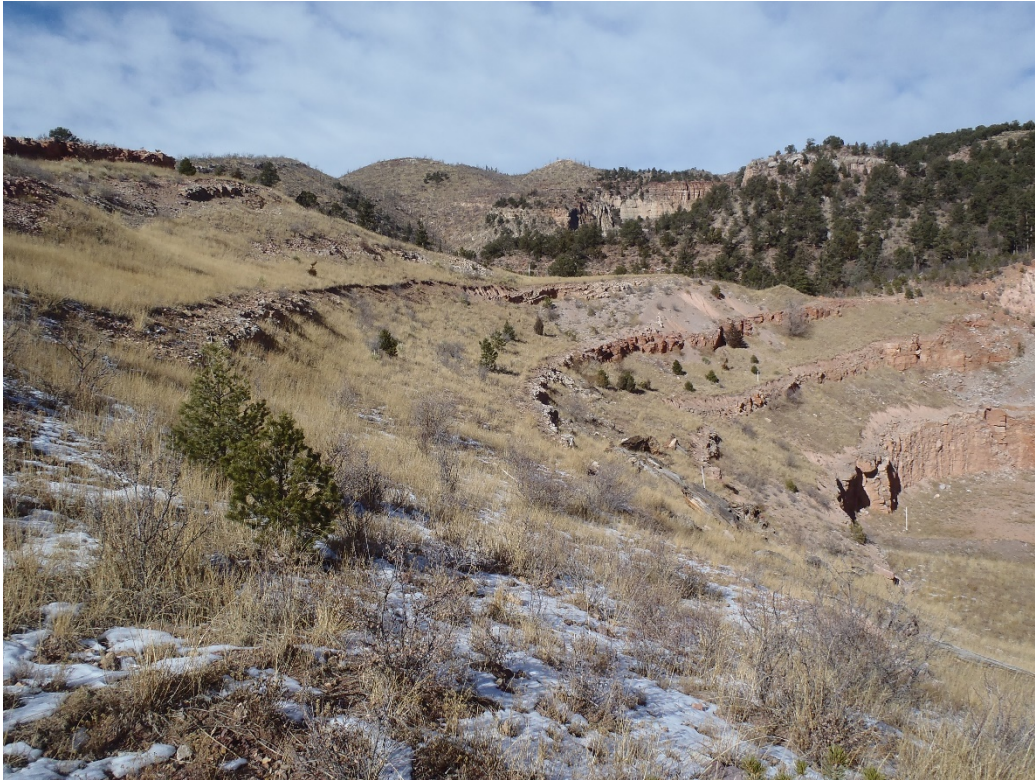
**Reclamation Success:** Concurrent reclamation has been completed in the west area, now outside the permit boundary (see **Photo 10**) and is in progress on the south side of the visual berm.

Photo 10. Reclaimed benches on west side, now outside permit boundary (looking north).

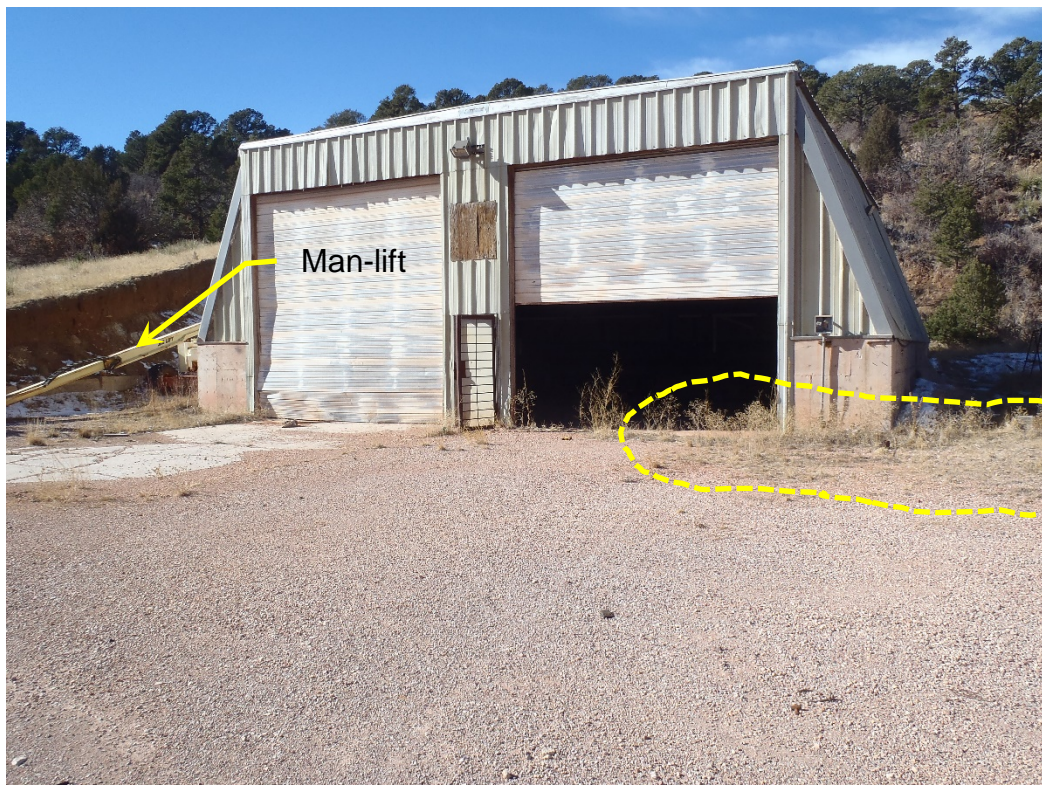
**PROBLEM/POSSIBLE VIOLATION:** Problem 2: There are state-listed noxious weeds (knapweed) present on site. This is a problem for failure to employ weed control methods for state listed noxious weed species within the permitted area, and to reduce the spread of weeds to nearby areas as required by Section 3.1.10 (6) of the rule.

**Revegetation:** Knapweed (probably Diffuse) was observed near the shop (see **Photo 11**) and on the north-south access road (see **Photo 12**). **Knapweed is a noxious weed List B species not cited as Problem 2 on page 1 of this report.**

Photo 11. Shop Building (knapweed circled).

**CORRECTIVE ACTIONS:** Implement the approved weed control plan and provide proof to the DRMS that this has been done by the corrective action date.

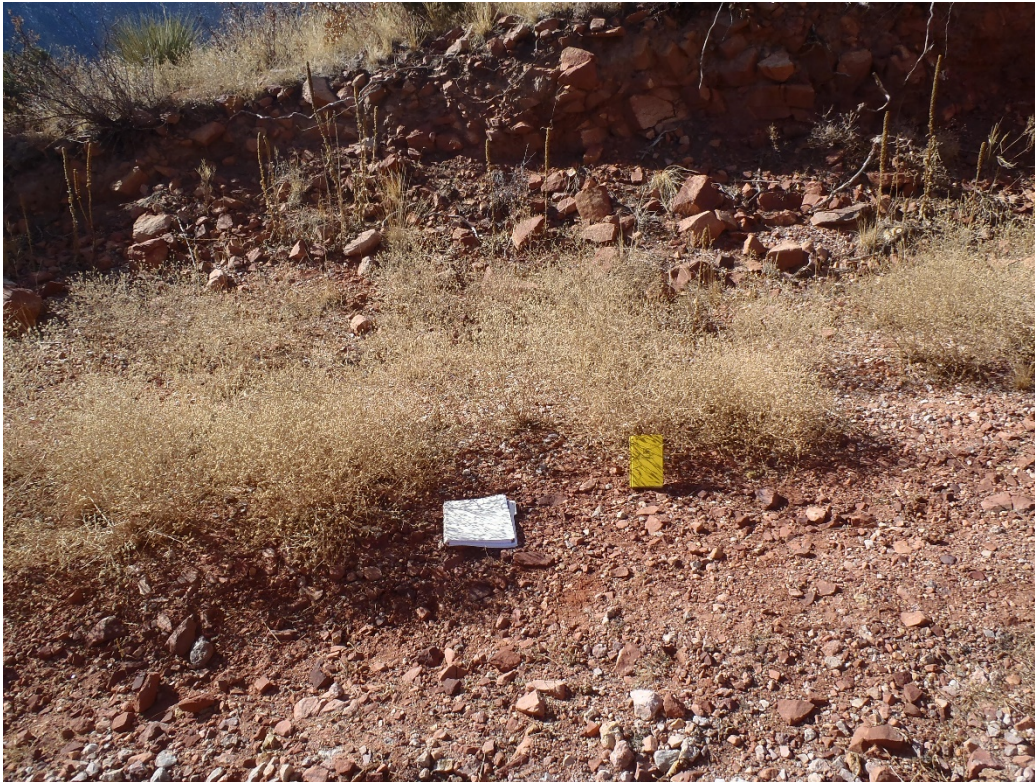
Photo 12. Knapweed in north-south access road.

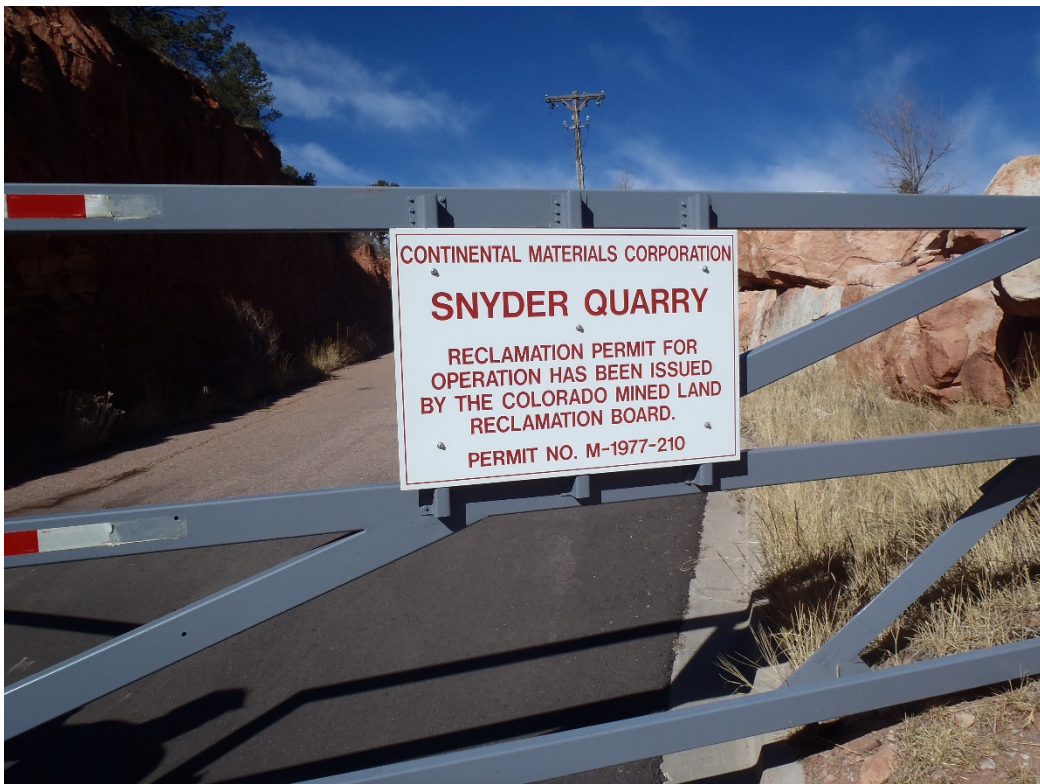
**Signs and Markers:** The permit sign was properly posted (see **Photo 13**) and boundary markers were observed to delineate the permit boundary (see **Photo 14**).

Photo 13. Permit sign at entrance.

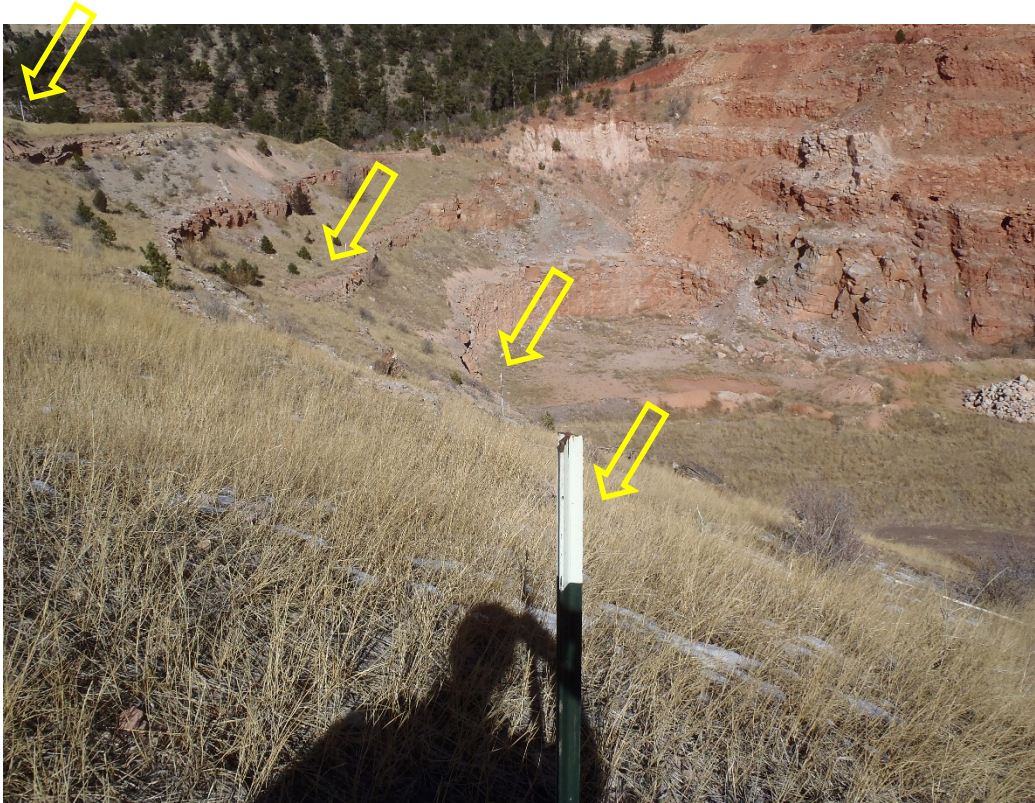
Photo 14. West side repositioned boundary markers (looking north, arrows point to 4 markers).

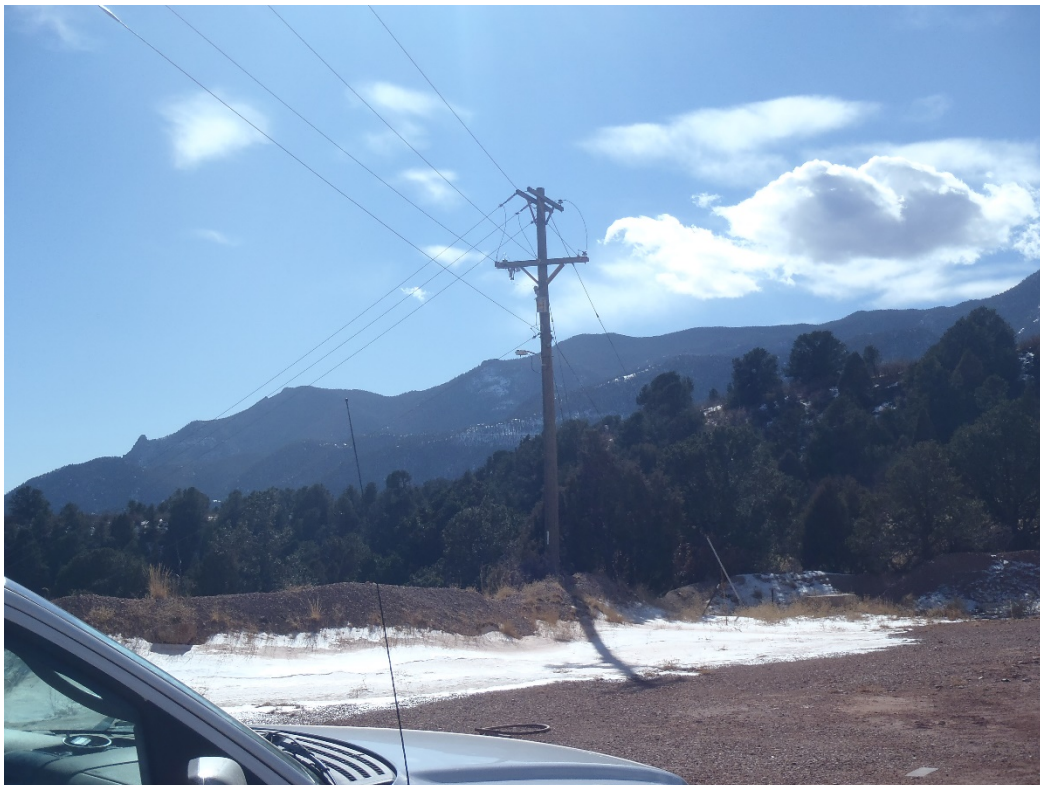
**Structures:** A power line was observed to the shop (see **Photo 15**) which runs along the site access road (see **Photo 16**). Mr. Schnabel was uncertain as to whether the line is owned by CMC or Black Hills Energy. If the powerline is owned by the utility company, a structures damage compensation agreement is required and will be required by the permit Successor. As stated above under the TR-03 Reclamation Plan summary, the shop is to remain post reclamation as an asset. The shop is in a significant state of disrepair (see **Photo 17**), including a gaping hole on the north side of the building. Given the state of the building, the DRMS will require significant renovations in order to consider it an asset. Without these renovations, the DRMS will require demolition of the

Photo 15. Overhead powerline near shop (looking SW).

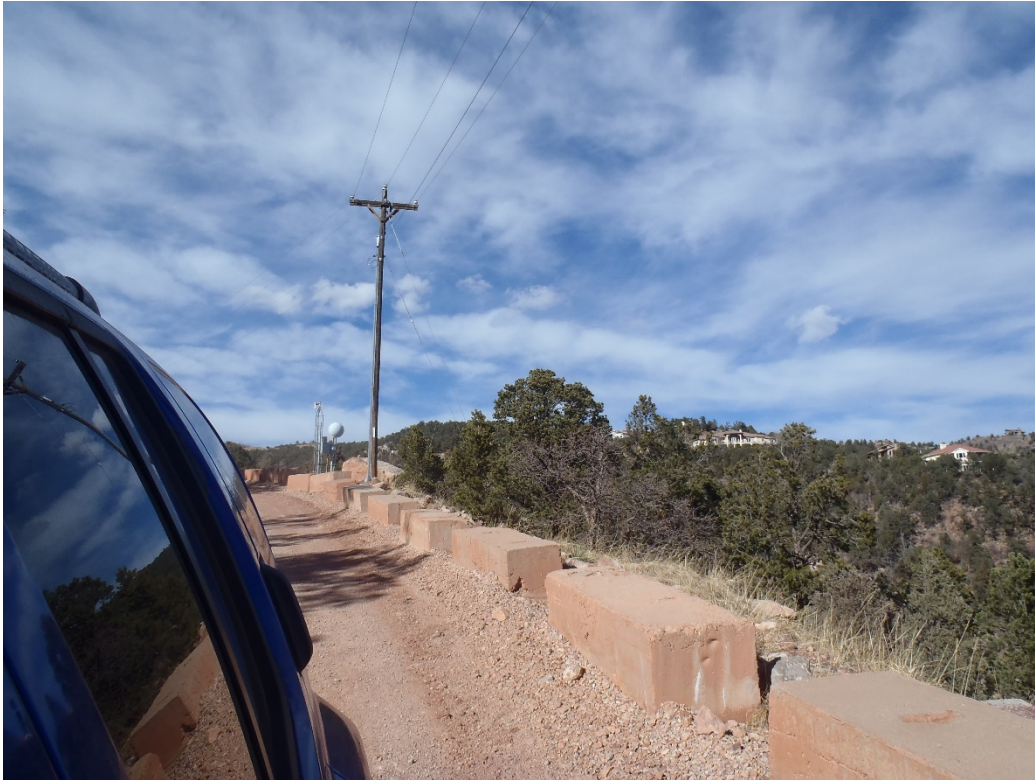
Photo 16. Overhead powerline along site access road (looking NW).

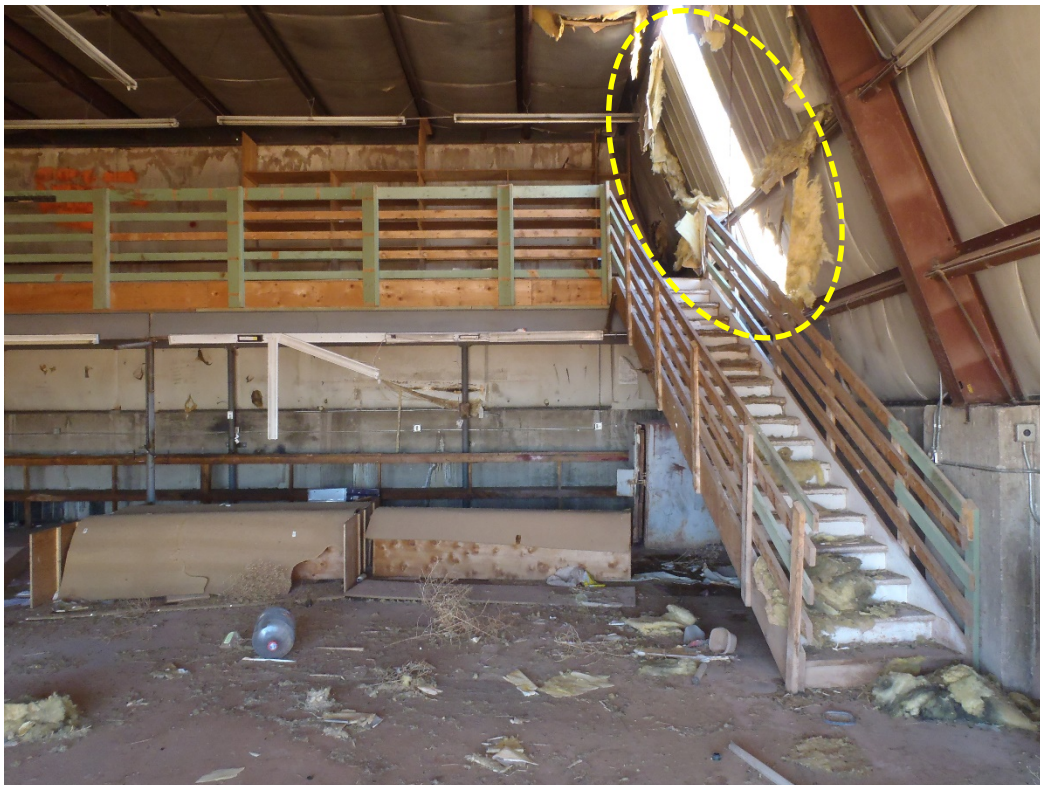
shop prior to reclamation liability release.

Photo 17. Interior of shop (note gaping hole on right).
