### MINERALS PROGRAM INSPECTION REPORT PHONE: (303) 866-3567

<b>MINE NAME:</b> Portland Limestone Quarry	<b>MINE/PROSPECTING ID#:</b> M-1977-344	<b>MINERAL:</b> Limestone (general)	<b>COUNTY:</b> Fremont
<b>INSPECTION TYPE:</b> Monitoring	<b>INSPECTOR(S):</b> Timothy Cazier, P.E.	<b>INSP. DATE:</b> July 16, 2020	<b>INSP. TIME:</b> 09:30
<b>OPERATOR:</b> Holcim (US) Inc.	<b>OPERATOR REPRESENTATIVE:</b> Julio Villon & Tom Newman	<b>TYPE OF OPERATION:</b> 112c - Construction Regular Operation

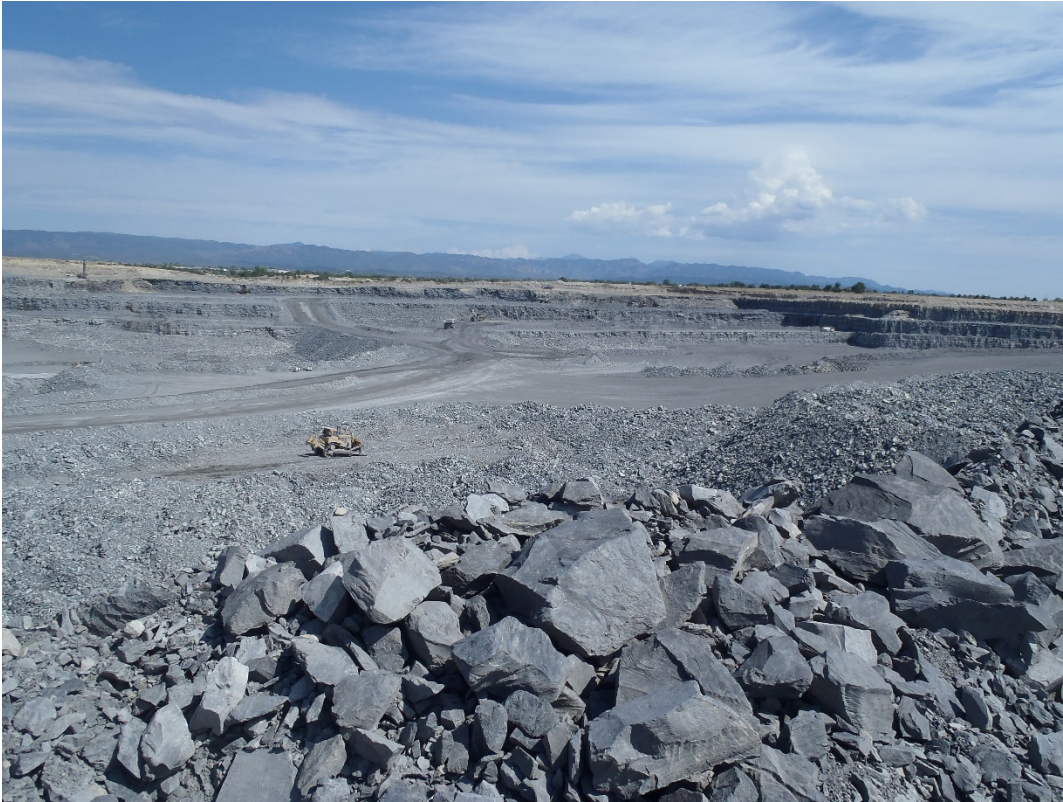
Excess Spoil and Dev. Waste: Overburden is stockpiled on the south side of the active pit and pushed into the pit (see **Photo 1**) as the mining progresses north. Overburden was being removed on the northeast corner of the active pit (see **Photo 2**)

Photo 1. Pit backfill from south side (looking NE).

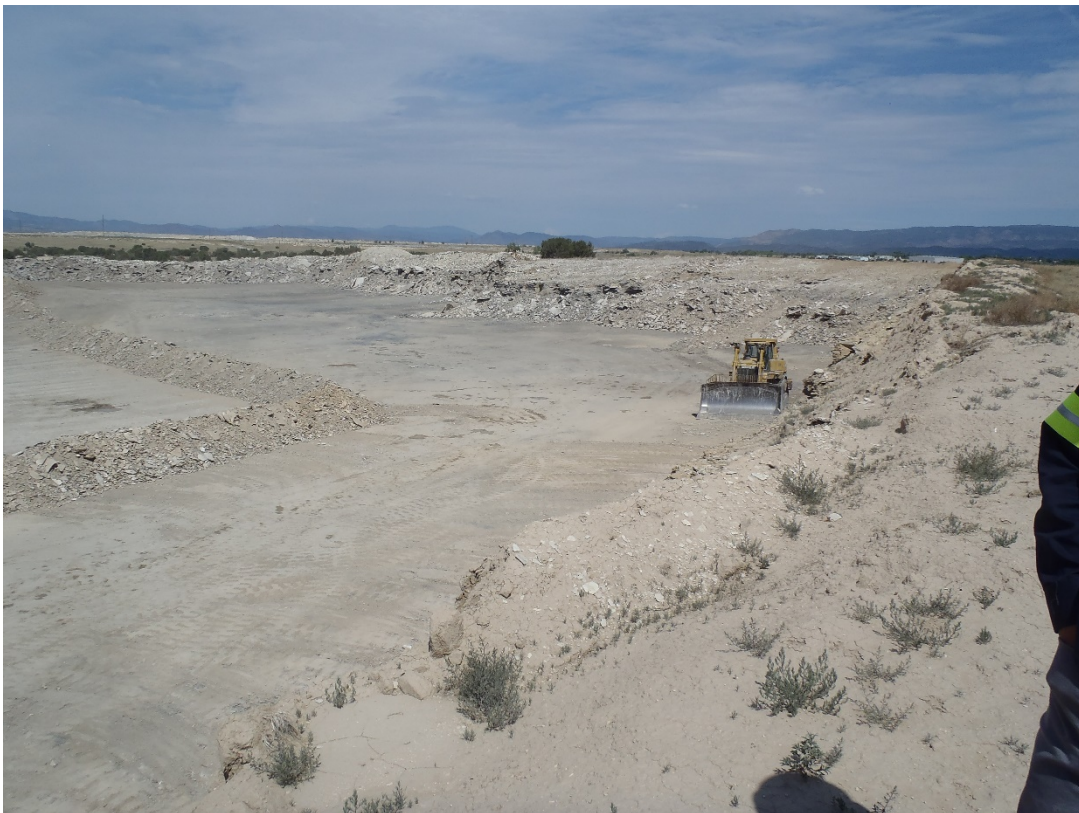
Photo 2. Overburden removal on NE corner of active pit (looking NW).

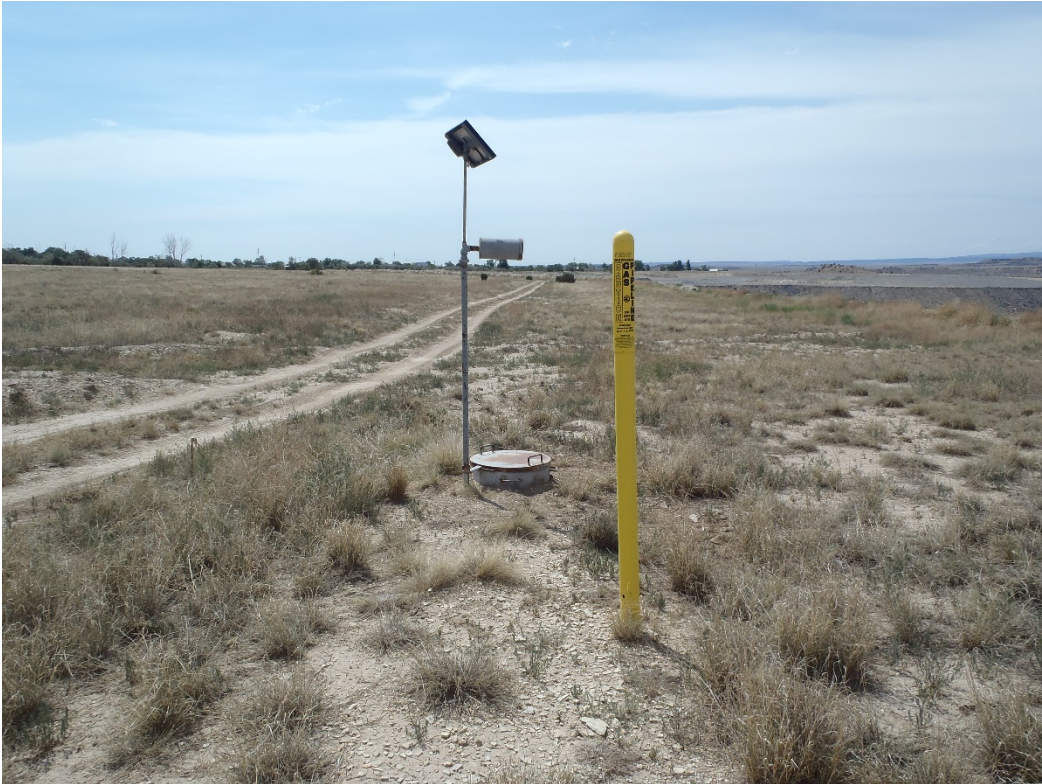
Explosives: A permanent seismograph was observed on the north side of the active pit near the gas line (see **Photo 3**).

Photo 3. Permanent seismograph near gas line (north side, looking SE).

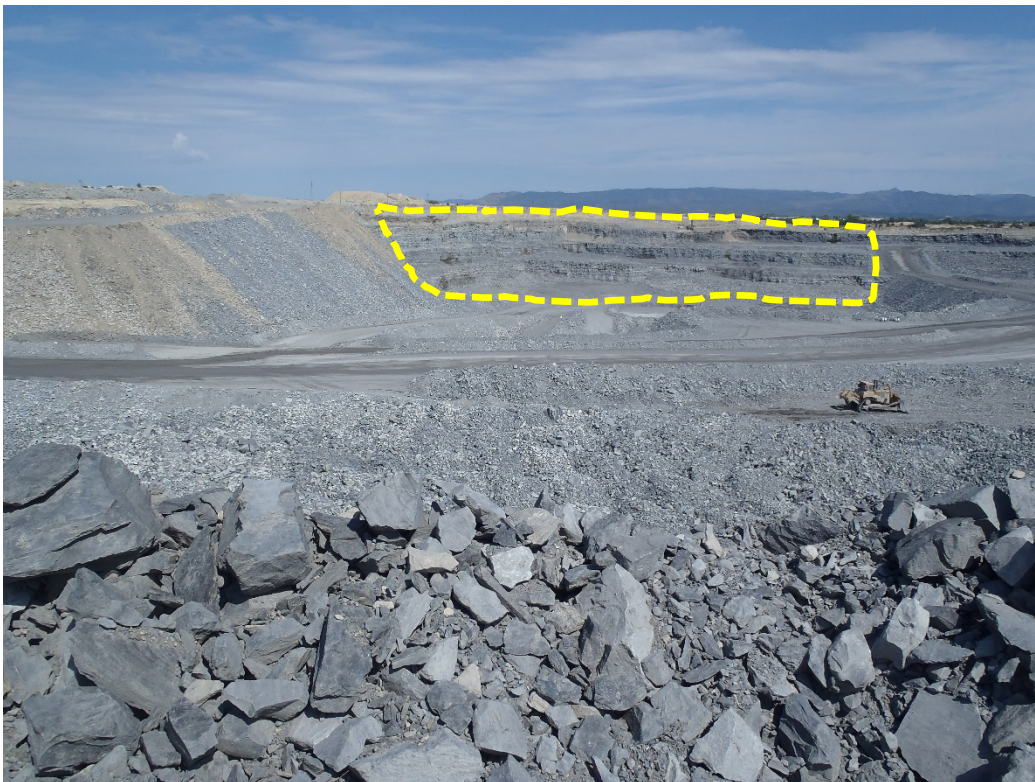
Gen. Compliance with Mine Plan: The operation appeared to be in compliance with the approved mine plan. The maximum allowed disturbed area appears to be 1,600 acres. Google Earth was used to measure the disturbed area, which was estimated to be approximately 775 acres, based on 2019 imagery. This is consistent with the 784 acres of affected area in the 2020 annual report. Highwalls are benched at about 35 feet in height

and appeared stable (see **Photo 4**).

Photo 4. North highwall in active pit (looking north).

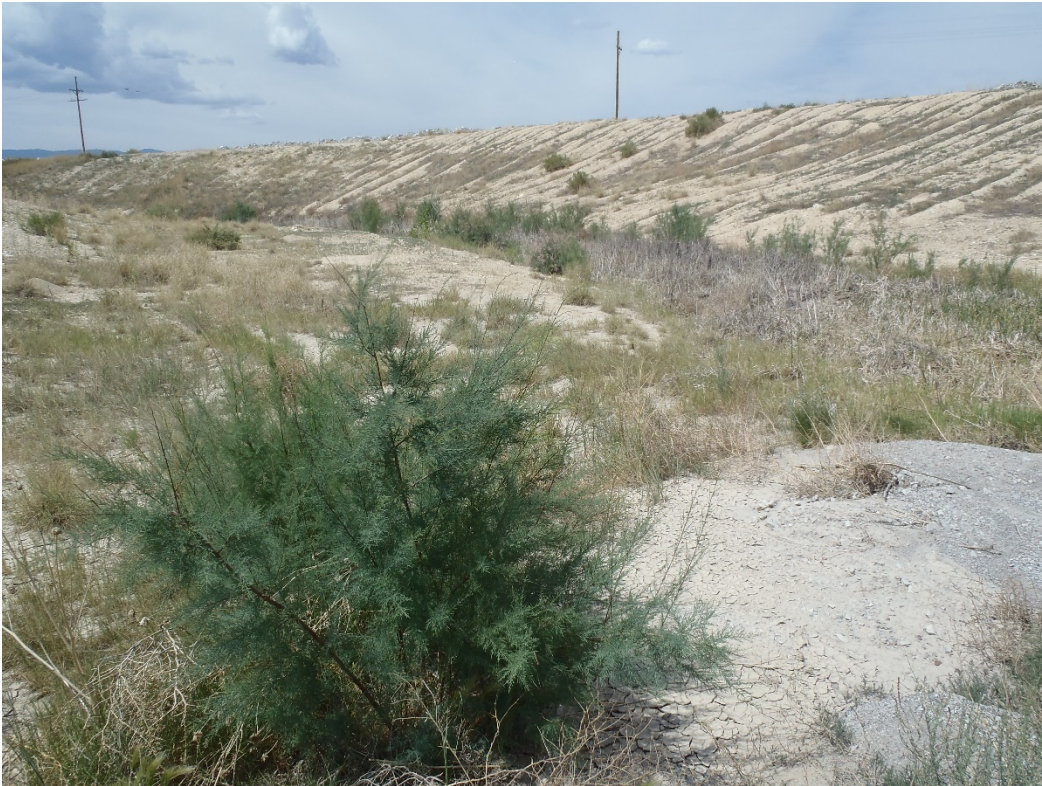
Revegetation: A few tamarisk (salt cedar) plants were observed near the Beaver Creek diversion channel (see **Photo 5**). This is a noxious weed List B species, but the number of plants observed was not considered significant, so it was not cited as a problem. However, [the Operator should implement a weed control program to reduce the number of tamarisk plants on site](#), as they can quickly become a problem.

Sediment Control: Some minor erosion was observed along the Beaver Creek diversion channel (see **Photo 5**). No BMPs were needed at the time of the inspection, but [Holcim is strongly encouraged to get vegetation established on these slopes before erosion becomes problematic](#) and fills in the diversion channel to the point of reducing its capacity.

Photo 5. Tamarisk (foreground) and minor erosion rills on slope above diversion channel (looking south from north access road).

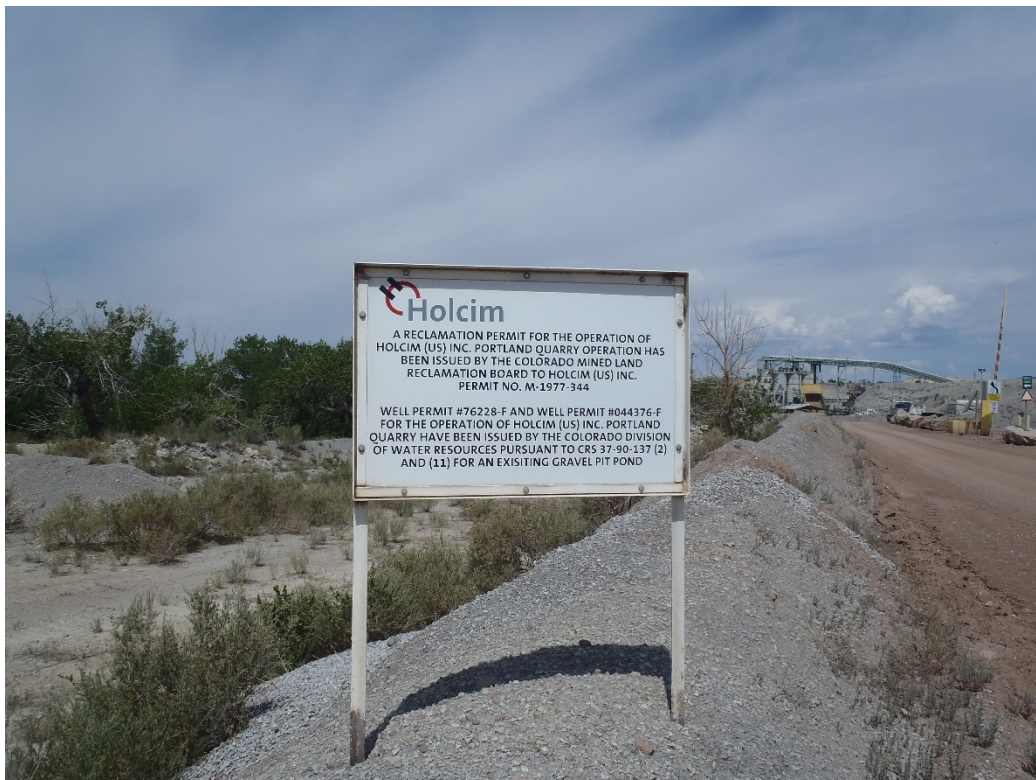
Signs and Markers: The permit sign was properly posted (see **Photo 6**) and markers were observed to delineate the affected area boundary (see **Photo 7**).

Photo 6. Permit sign at entrance.

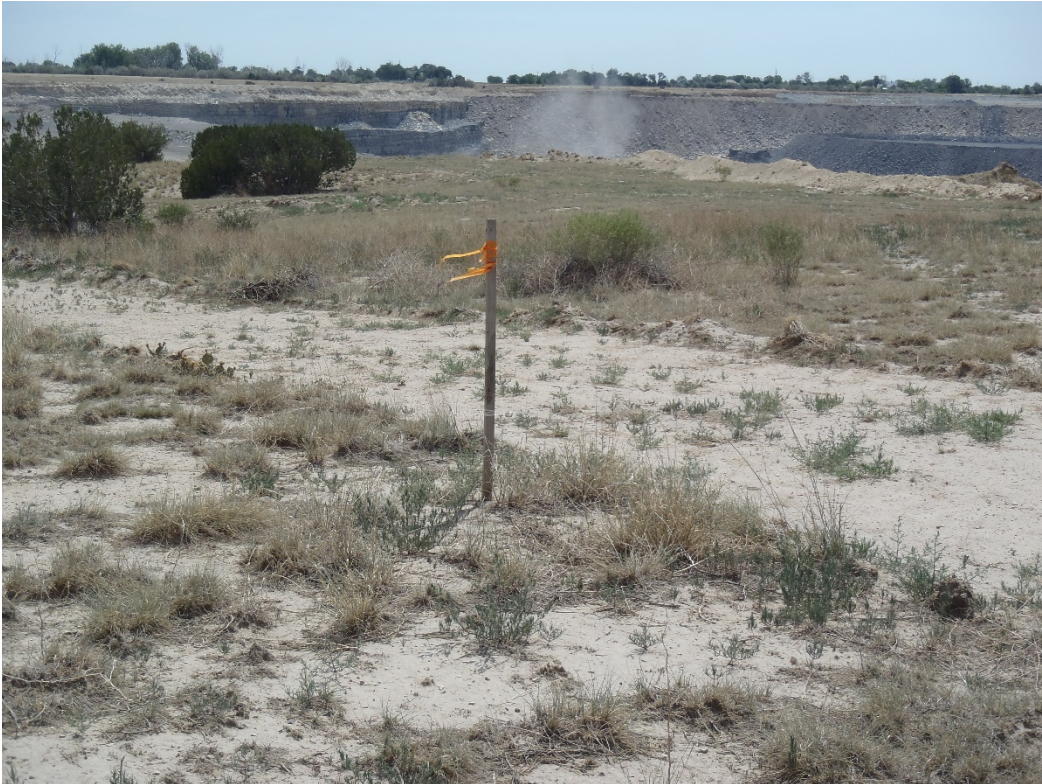
Photo 7. Typical affected area boundary marker (west side of pit, looking east).

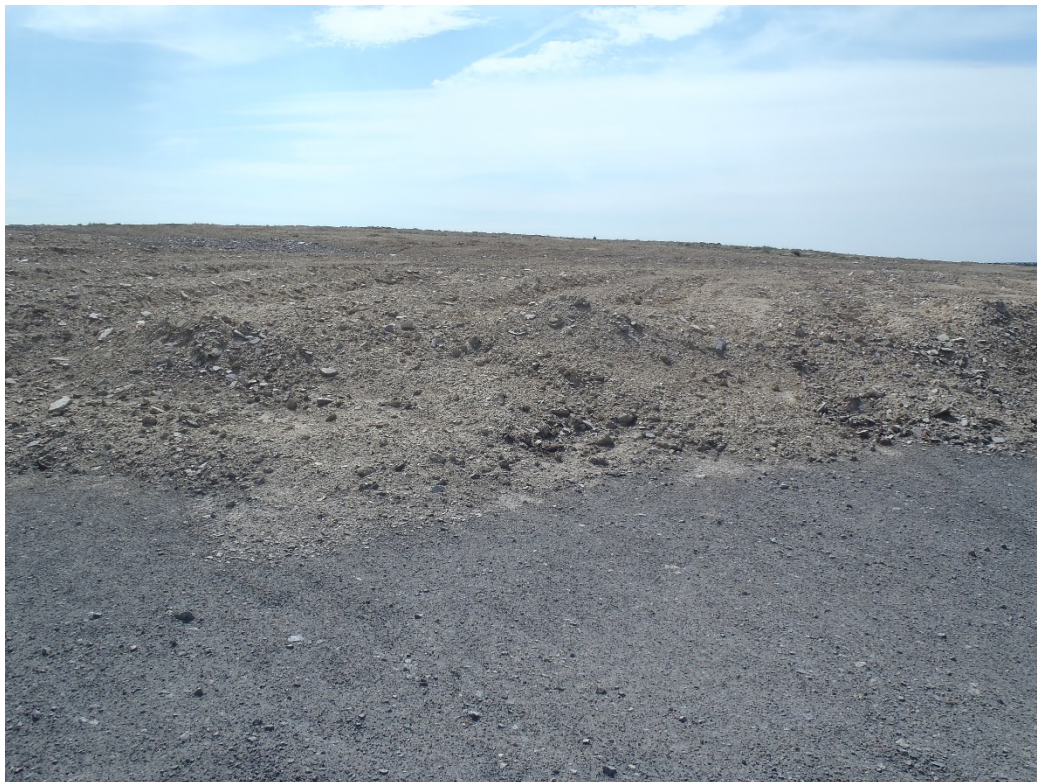
Topsoil: Growth media placement was observed on the south side of the active pit area (see **Photos 8 and 9**).

Photo 8. Growth media placement (south of pit, looking SE).

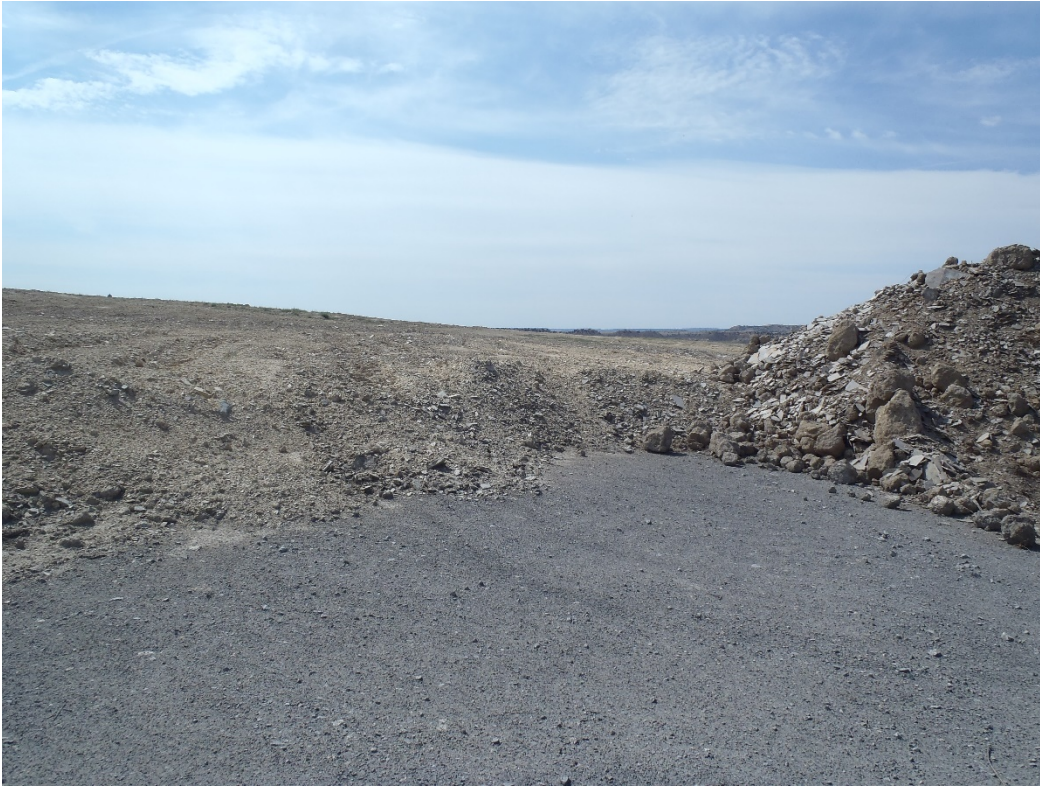
Photo 9. Growth media stockpile (stockpile on right).
