MINERALS PROGRAM INSPECTION REPORT
PHONE: (303) 866-3567

MINE NAME: San Luis Project	MINE/PROSPECTING ID#: M-1988-112	MINERAL: Gold and silver	COUNTY: Costilla
INSPECTION TYPE: Monitoring	INSPECTOR(S): Lucas West	INSP. DATE: December 28, 2020	INSP. TIME: 10:00
OPERATOR: Battle Mountain Resources, Inc.	OPERATOR REPRESENTATIVE: Julio Madrid	TYPE OF OPERATION: 112d-3 - Designated Mining Operation	
REASON FOR INSPECTION: Normal I&E Program	BOND CALCULATION TYPE: None	BOND AMOUNT: \$7,400,000.00	
DATE OF COMPLAINT: NA	POST INSP. CONTACTS: None	JOINT INSP. AGENCY: None	
WEATHER: Snowing	INSPECTOR'S SIGNATURE:

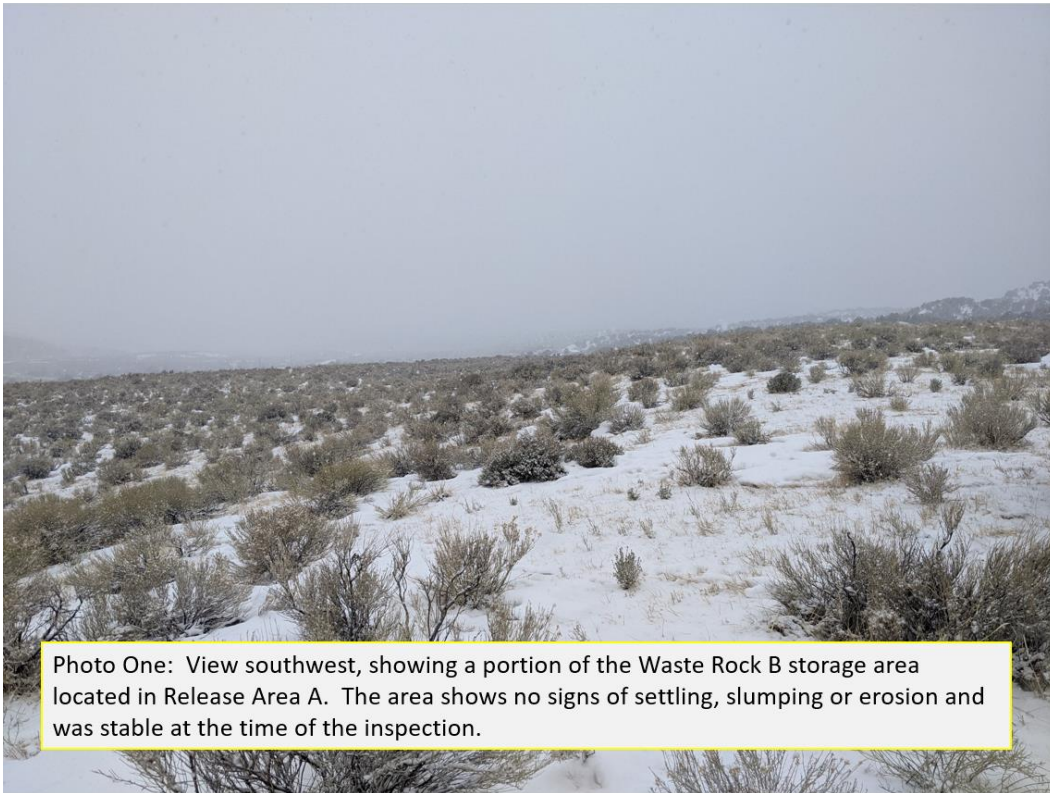
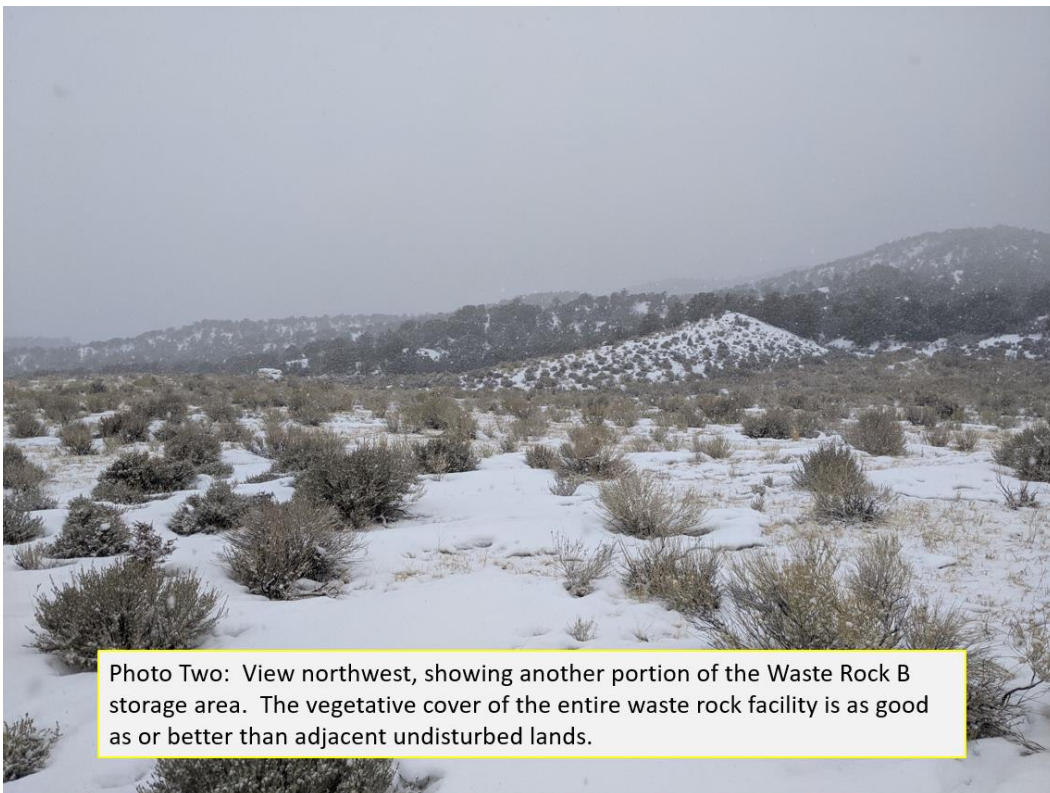
Release Area A: Release Area A consists of a total of 77 acres, 59 of which were undisturbed. The undisturbed areas exhibit native vegetation and topography with no signs of erosion or State Listed Noxious Weeds. The remaining 18 Acres consist of the reclaimed Waste Rock B storage area which can be seen in Photos One and Two. The Waste Rock B storage area has been graded, capped and revegetated in accordance with the approved Reclamation Plan. The grading and backfill was stable at the time of the inspection and no signs of settling, slumping or significant erosion was observed. The vegetative cover on the waste rock storage area was dense, diverse and showed multiple year's biomass indicating it is capable of self-regeneration. The vegetation is as good as or better than the vegetation of adjacent undisturbed areas. The entire Release Area A is considered fully reclaimed in accordance with the approved Reclamation Plan.

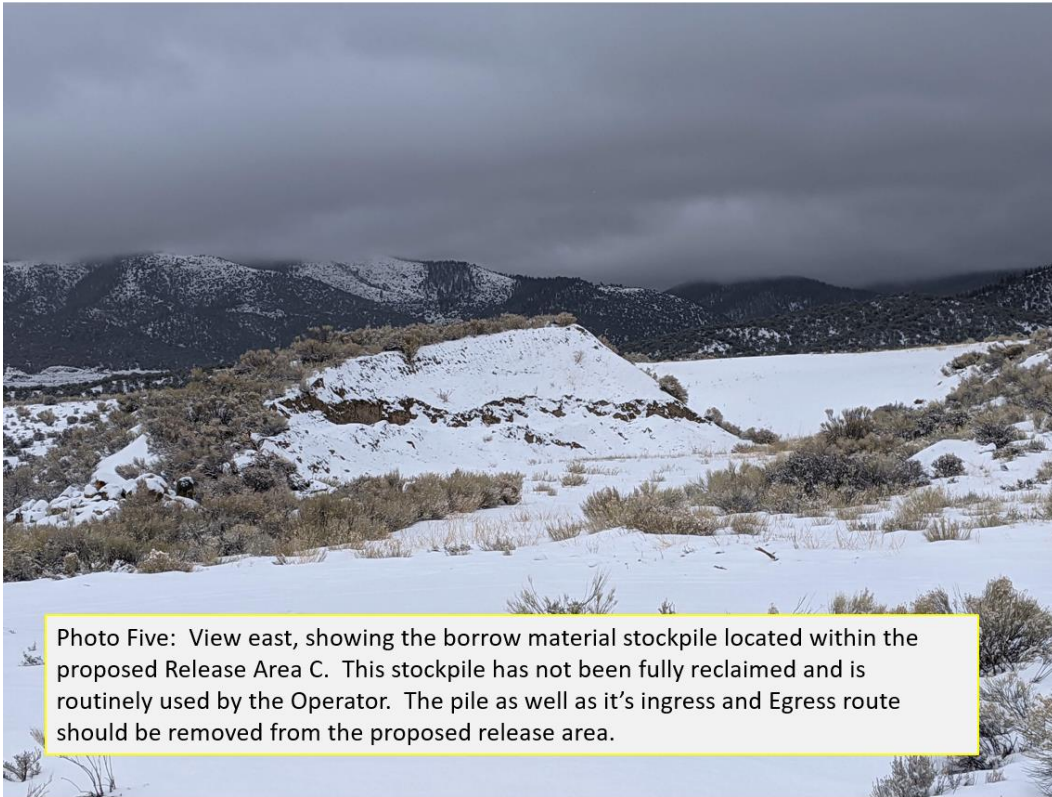
Release Area C: Release Area C totals 39 Acres that contains the old Mill Area, South Waste Rock Storage Area and 24.5 Acres of Undisturbed lands. Both the South Waste Rock Storage Area and old Mill Area have been graded, capped and revegetated. The grading and earthwork was stable at the time of the inspection and no signs of settling or slumping were observed. All areas located within Release Area C, which can be seen in Photos Three and Four, are well vegetated. The vegetative cover is as good as or better than the adjacent undisturbed areas. An error was noticed in the release request during this inspection. Within Release Area C, a large stockpile of borrow material exists adjacent to the access road that is still utilized by the Operator, shown in Photo Five. This stockpile can be seen in Photo Five. On site discussions with the Operator's

Representatives indicate that the stockpile was unintentionally included in the release area and should be removed from the release request as the stockpile is still, and will continue to be utilized in the future. Due to this discrepancy the Release Request was deemed incomplete for filing. A Notice of Completeness letter with requirements for correction was sent to the Operator on January 11, 2021. The area of the borrow material stockpile should be removed from the release request and reflected on updated maps and acreage calculations. Once the materials are updated the revision can be considered complete, the public notice procedures can commence and upon completion of the public comment period, hearing no objections, a decision can be rendered.

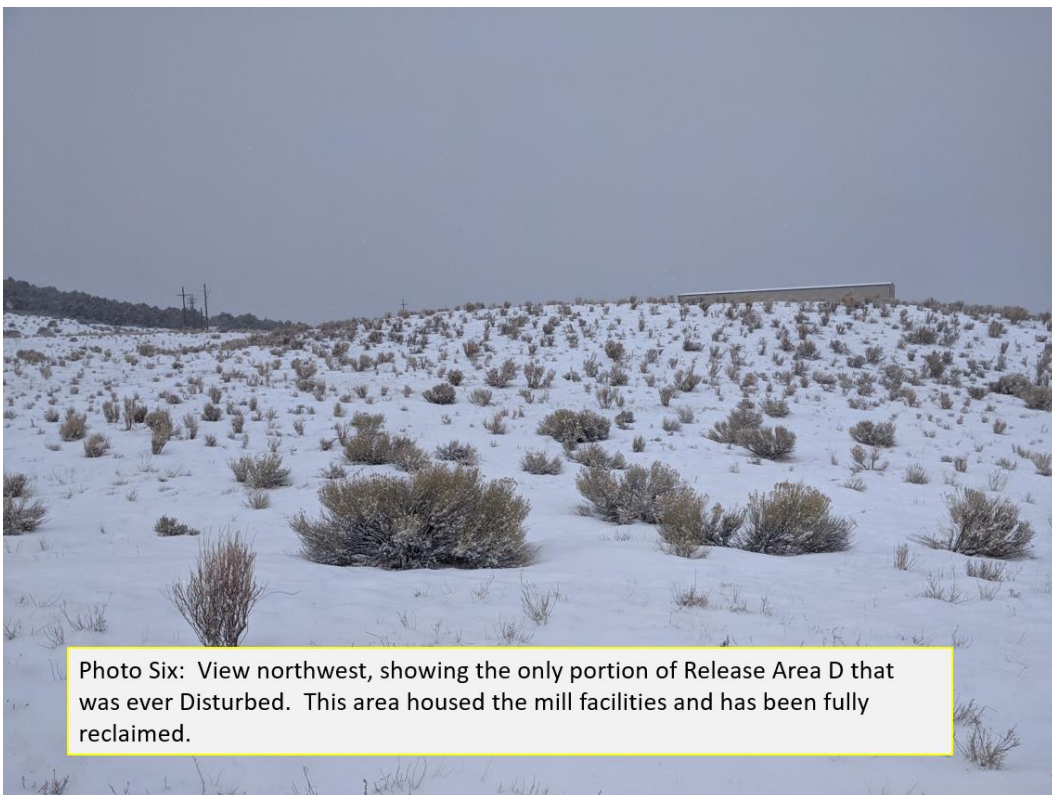
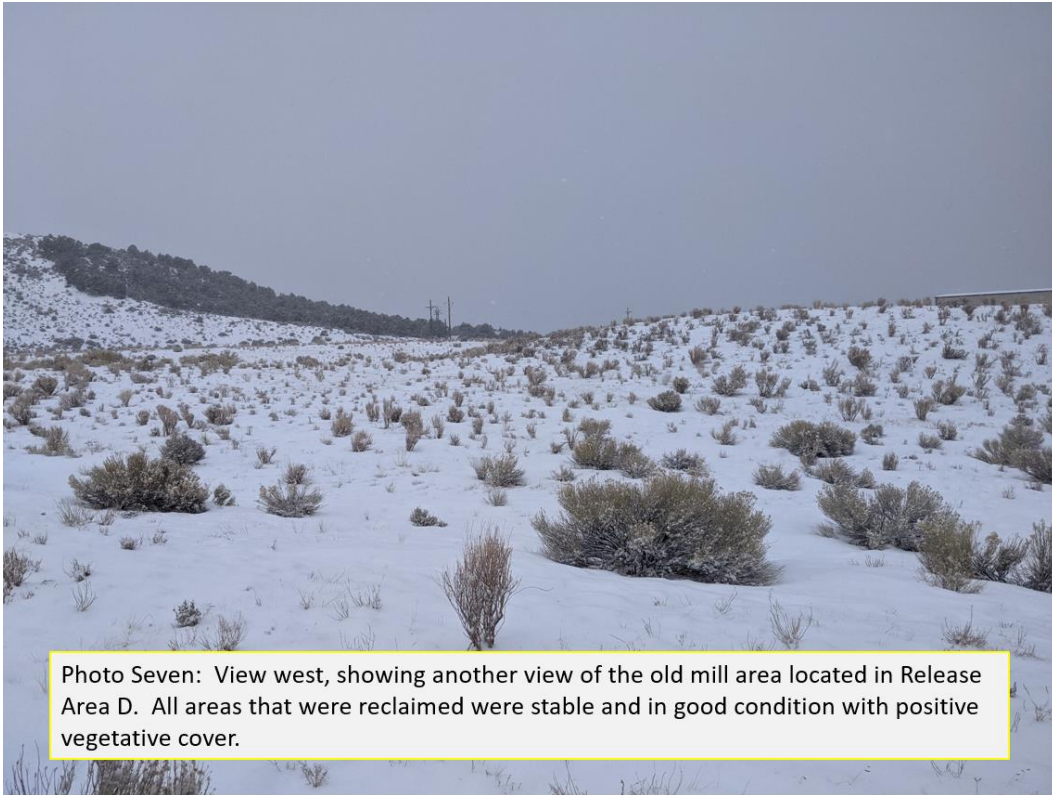
Release Area D: Release Area D consists of 190.1 Acres, of which only 6.3 were ever disturbed. The 6.3 disturbed acres located in this area housed other Mill Facilities, shown in Photo Six and Seven, and has been fully reclaimed. The area was graded, capped with topsoil and revegetated. The grading and earthwork was stable at the time of the inspection and so signs of settling or slumping was observed. The vegetative cover was dense, diverse and as good as or better than the adjacent undisturbed areas. The old Mill Facility area located within Release Area D is considered fully reclaimed in accordance with the approved Reclamation Plan. The remaining 183.8 Acres of Release Area D consist of undisturbed lands that are ready to be removed from the permit area.
