MINERALS PROGRAM INSPECTION REPORT
PHONE: (303) 866-3567

MINE NAME: Grisenti Farms Gravel Pit	MINE/PROSPECTING ID#: M-2001-005	MINERAL: Sand and gravel	COUNTY: Fremont
INSPECTION TYPE: Monitoring	INSPECTOR(S): Timothy Cazier	INSP. DATE: August 11, 2020	INSP. TIME: 11:00
OPERATOR: Continental Materials Corporation	OPERATOR REPRESENTATIVE: Jerry Schnabel	TYPE OF OPERATION: 112c - Construction Regular Operation	
REASON FOR INSPECTION: Normal I&E Program	BOND CALCULATION TYPE: Partial Bond	BOND AMOUNT: \$115,300.00	
DATE OF COMPLAINT: NA	POST INSP. CONTACTS: None	JOINT INSP. AGENCY: None	
WEATHER: Clear	INSPECTOR'S SIGNATURE:

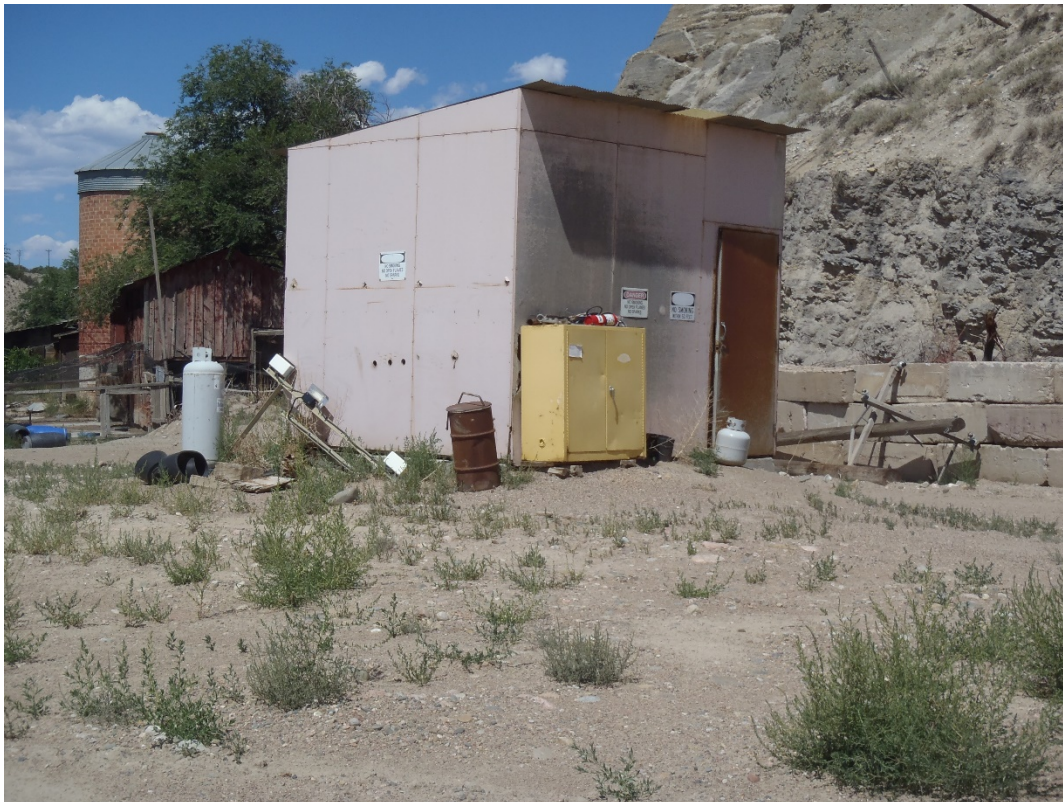
Acid And Toxic Materials: A storage shed was observed along with an external cabinet (see **Photo 1**). Mr. Schnabel thought it was the landowners building. This will need to be confirmed prior to reclamation reliability release. No spills or leaks were observed. .

Photo 1. Storage/Lubricant Shed NW of Phase 2 pond (looking NW).

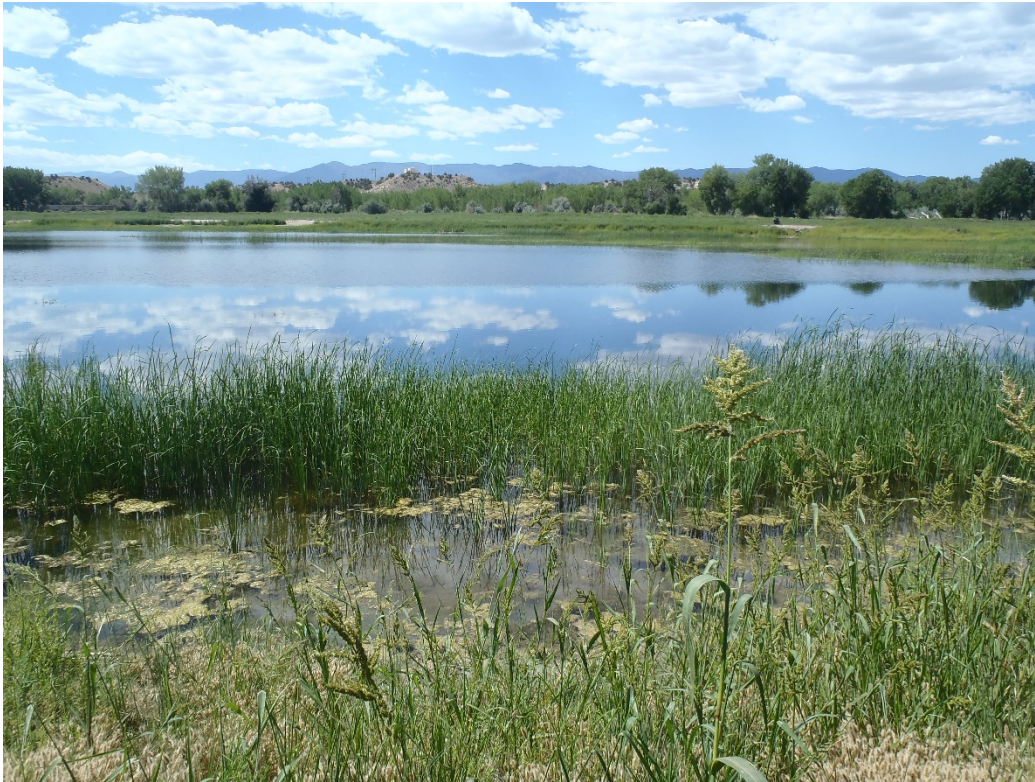
Backfilling and Grading: The site is in final reclamation (see **Photo 2**). All grading appeared to have been completed with the exception of a small stockpile on the northwest side of the East Pond (see **Photo 3**).

Photo 2. Phase 2 Pond reclamation (looking SE).

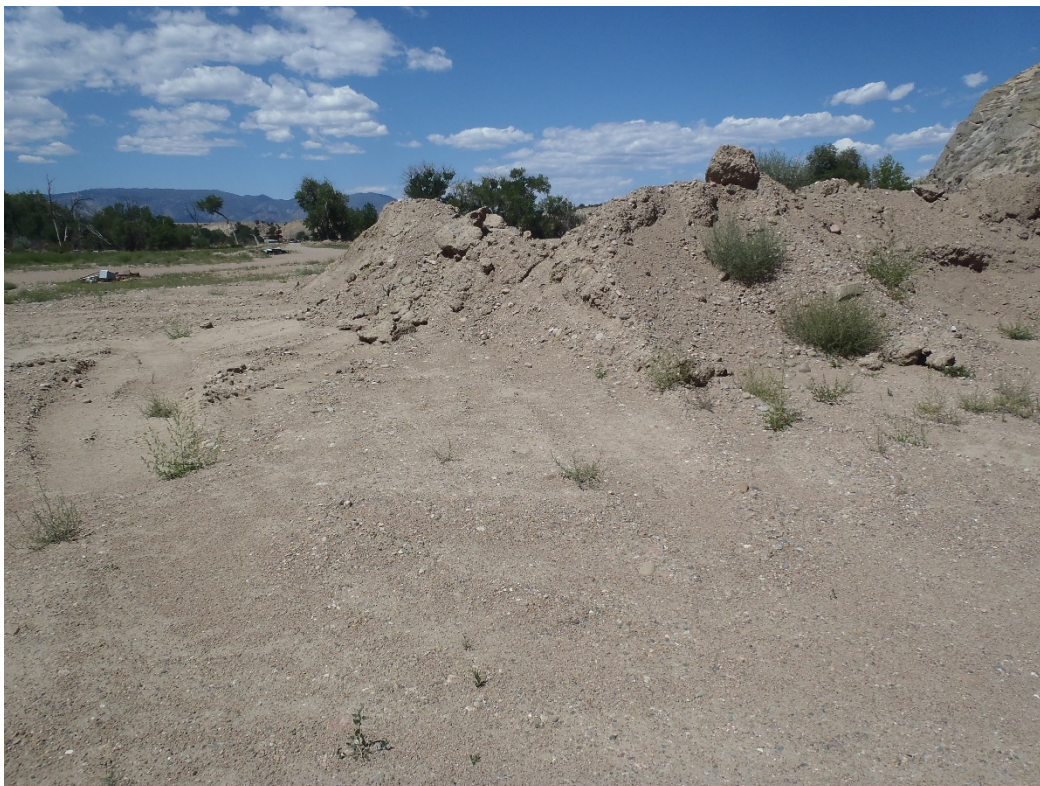
Reclamation Success: Grading and topsoil placement has been completed, excepting the aforementioned small stockpile. Mr. Schnabel stated the topsoiled areas had been drill seeded in either the fall of 2019 or the spring of 2020 and seeded as per the approved reclamation plan.

Photo 3. Small stockpile requiring regrading NW of Phase 2 pond (looking west).

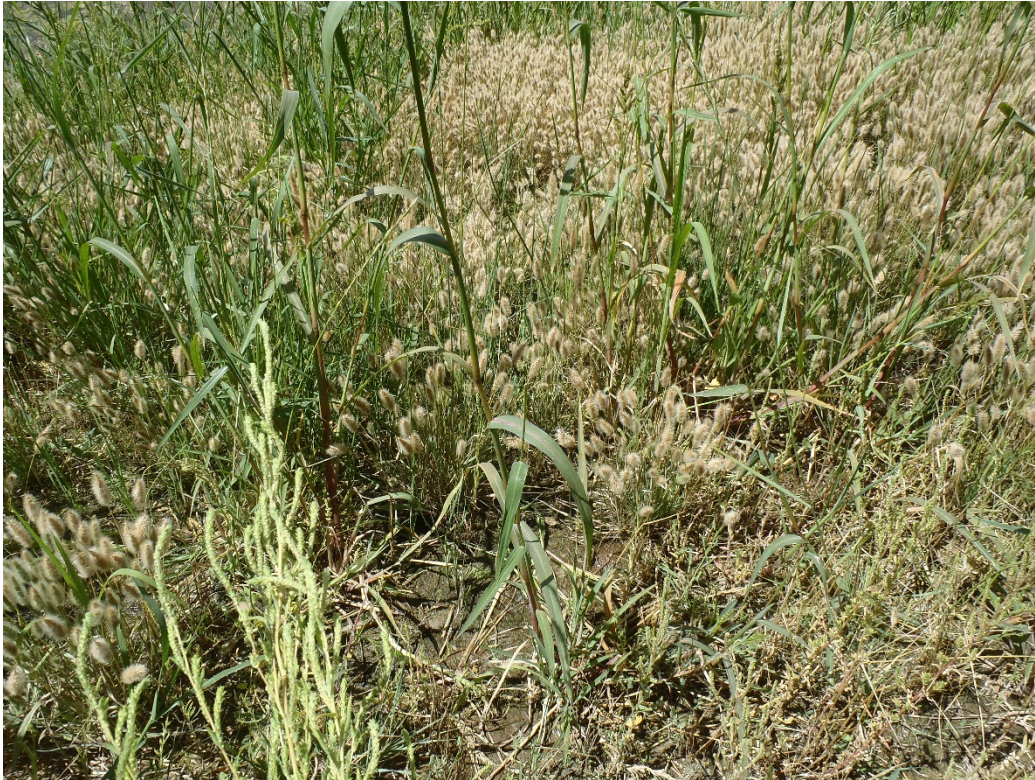
Revegetation: Although there were some areas where the grass was becoming established (see **Photo 4**), most of the seeded area was covered with kochia, despite the irrigation efforts (see **Photo 5**) A small amount of tamarisk was observed (see **Photo 6**) on the east side of the west pond. This is a noxious weed List B species,

Photo 4. Grasses establishing near Phase 2 pond.

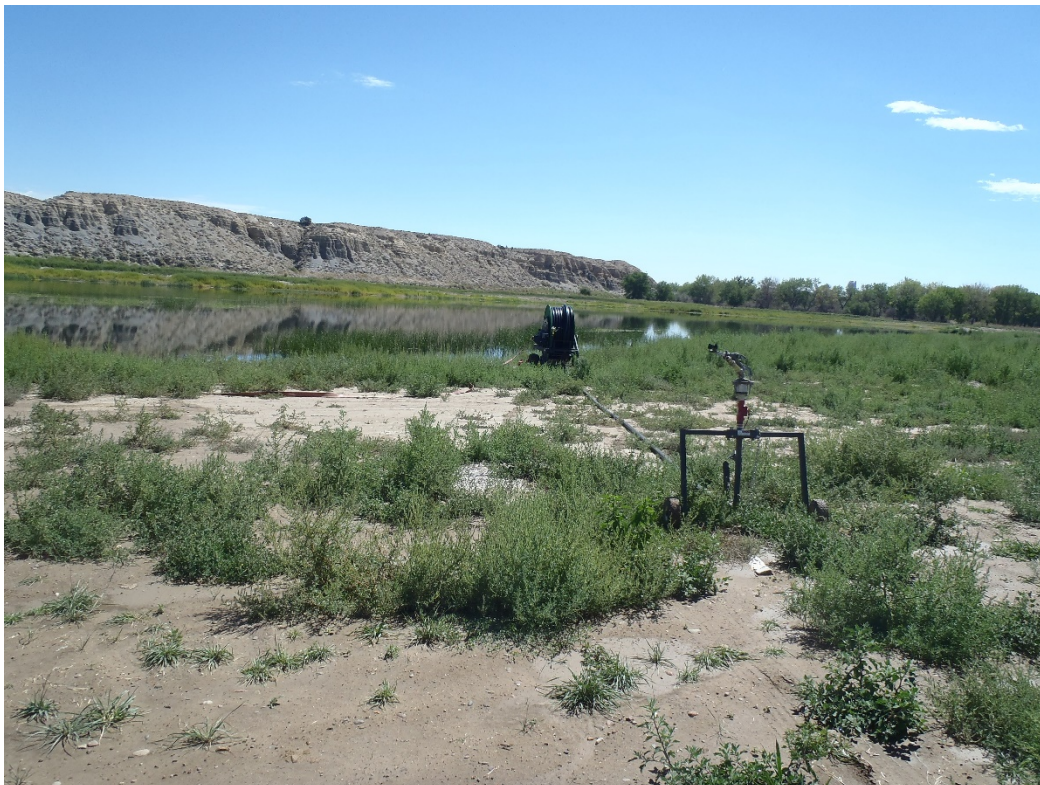
Photo 5. Irrigation sprinkler SE of Phase 2 pond (looking NE, pump near pond).

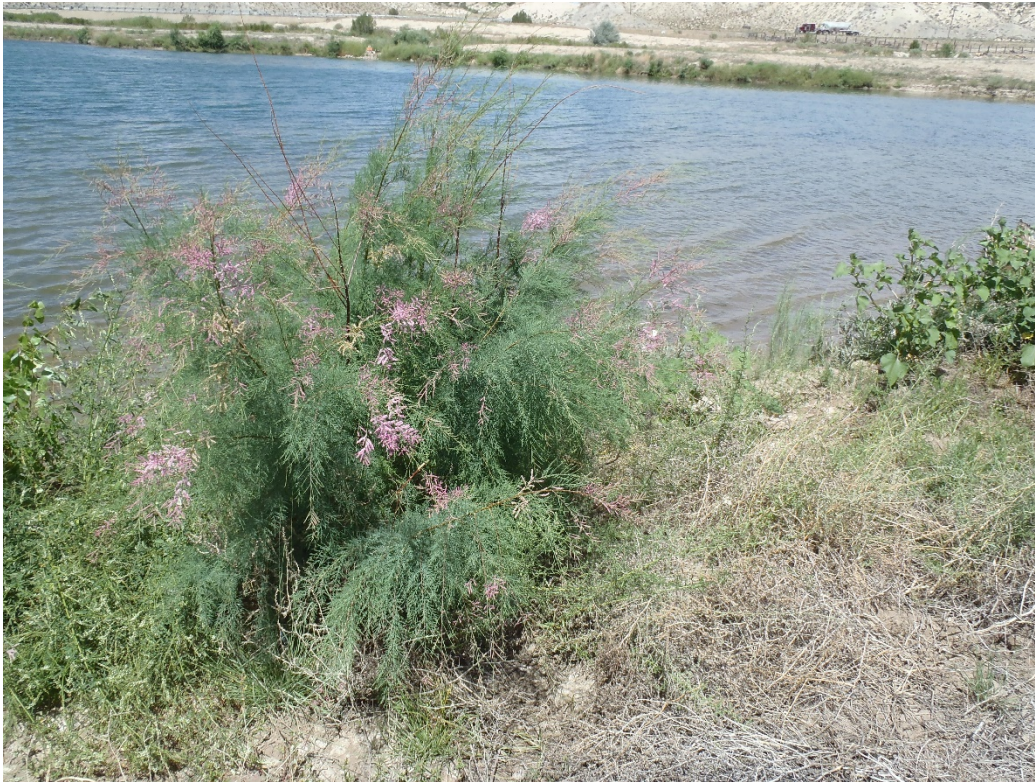
Photo 6. Tamarisk on east side of Phase 1 pond (looking NW).

but was not prevalent enough at the time of the inspection to not cite it as a problem. However, the Operator should implement a weed control program to control the tamarisk on site before it becomes a problem.

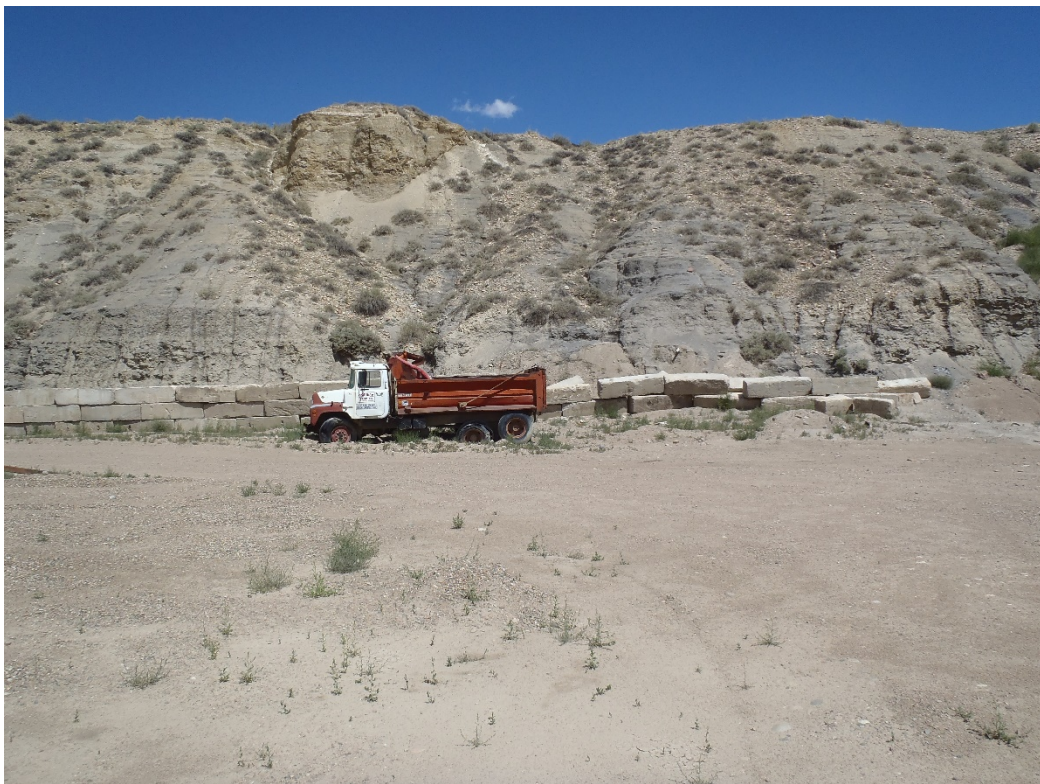
Support Facilities On-site: An old dump truck (see **Photo 7**) and a pile of miscellaneous small equipment parts (see **Photo 8**) will need to be removed prior to final release. Mr. Schnabel stated the fuel storage tank would be left on site for the landowner. The DRMS will need a letter from the landowner indicating this is acceptable.

Photo 7. Old dump truck on north side of Phase 2 pond to be removed (looking north).

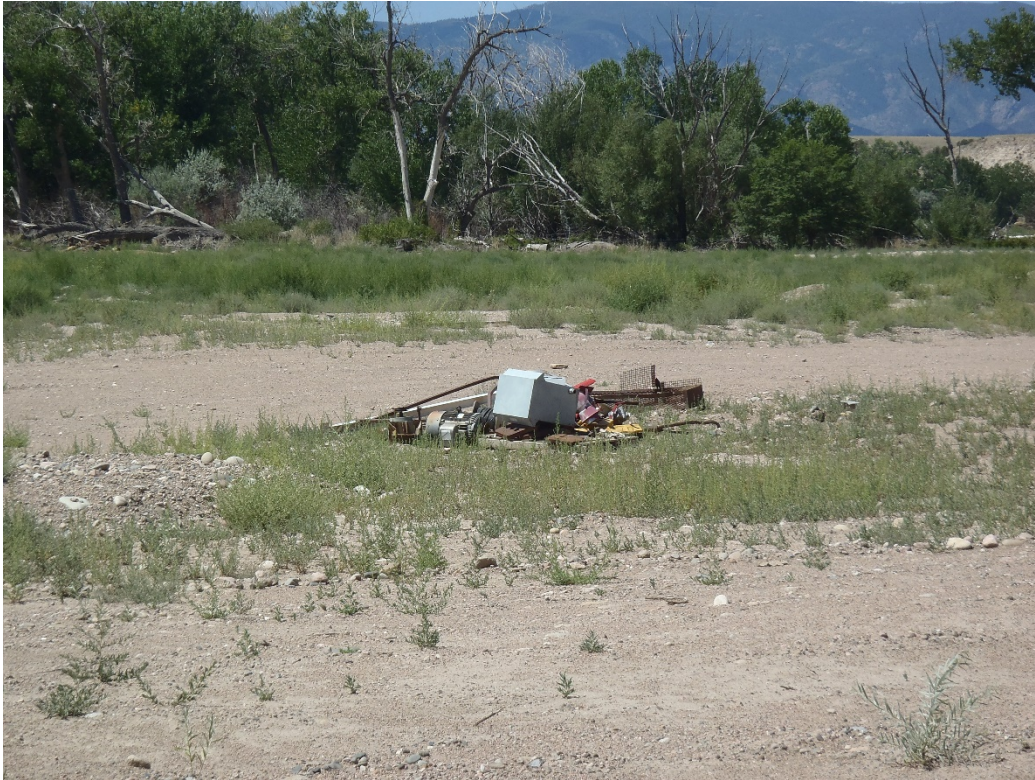
Photo 8. Miscellaneous small equipment parts (west side of phase 2 pond) .

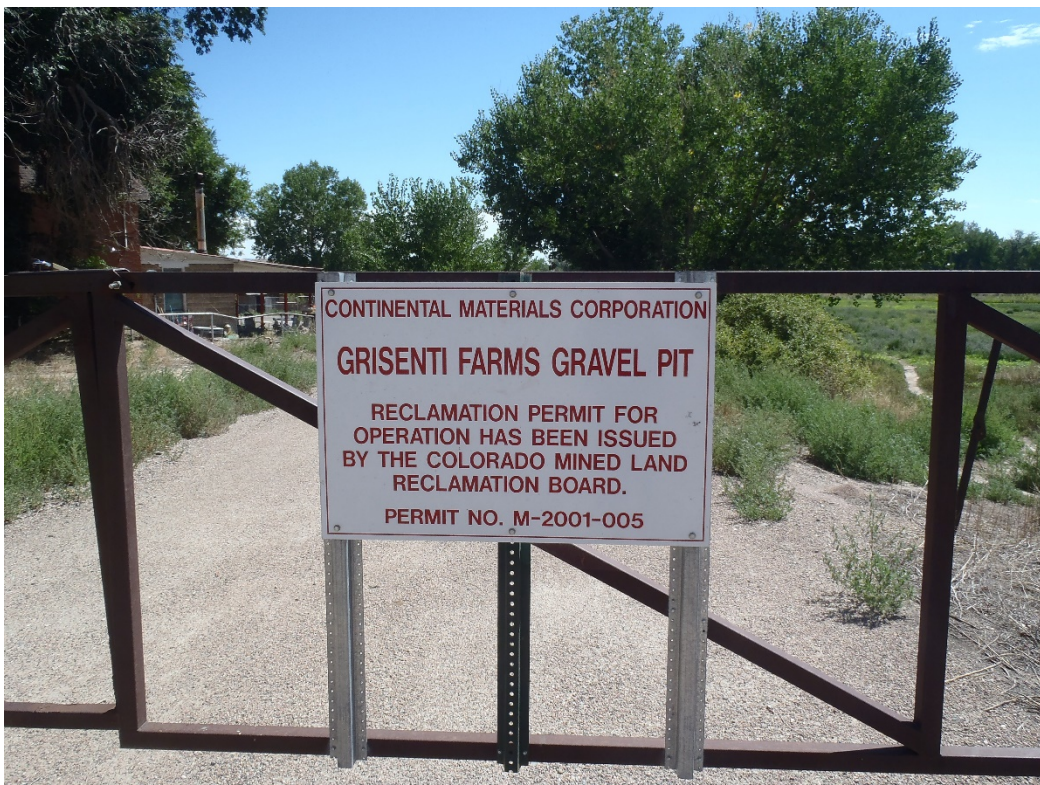
Signs and Markers: The permit sign was properly posted (see **Photo 9**).

Photo 9. Permit sign at entrance.

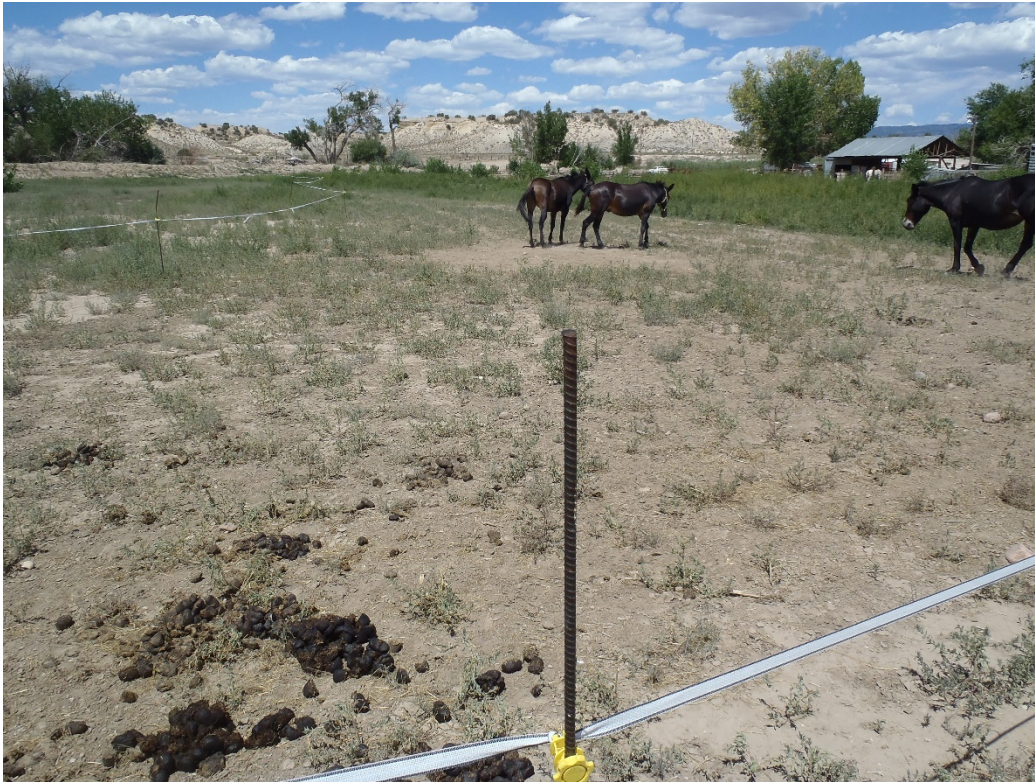
Topsoil: Topsoil has been placed. A test pad using mules to break up the soil was being implemented in the NW corner of the Phase 2 pit area (see **Photos 10 and 11**).

Photo 10. Topsoil test pad using mules to break up soil, NW of Phase 2 (looking NW).

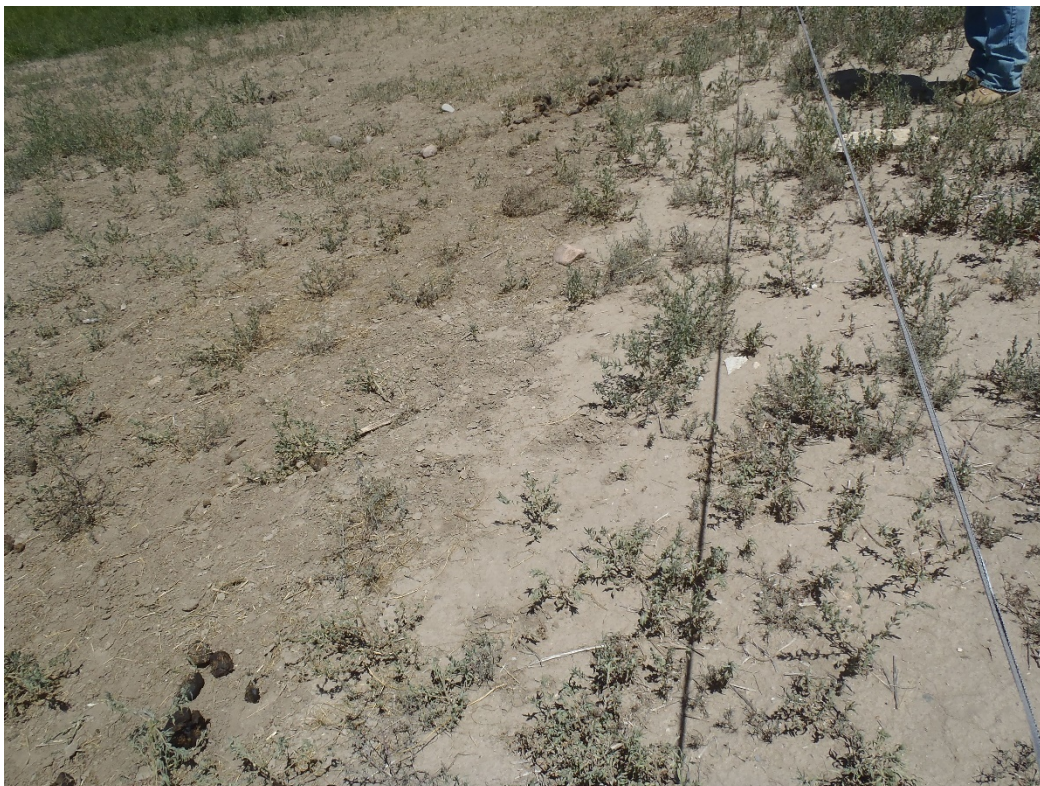
Photo 11. Topsoil mule test pad (mule accessible area on left).
