**MINERALS PROGRAM INSPECTION REPORT**  
**PHONE: (303) 866-3567**

<b>MINE NAME:</b> Cañon Dolomite Quarry	<b>MINE/PROSPECTING ID#:</b> M-1977-376	<b>MINERAL:</b> Dolomite	<b>COUNTY:</b> Fremont
<b>INSPECTION TYPE:</b> Surety-Related Inspection	<b>INSPECTOR(S):</b> Timothy Cazier	<b>INSP. DATE:</b> August 11, 2020	<b>INSP. TIME:</b> 12:50
<b>OPERATOR:</b> Canon Dolomite Quarry, LLC	<b>OPERATOR REPRESENTATIVE:</b> Randy DiLuzio, Lu Toxvard	<b>TYPE OF OPERATION:</b> 112c - Construction Regular Operation	
<b>REASON FOR INSPECTION:</b> Surety Related	<b>BOND CALCULATION TYPE:</b> None	<b>BOND AMOUNT:</b> \$232,000.00	
<b>DATE OF COMPLAINT:</b> NA	<b>POST INSP. CONTACTS:</b> None	<b>JOINT INSP. AGENCY:</b> None	
<b>WEATHER:</b> Clear	<b>INSPECTOR'S SIGNATURE:</b>

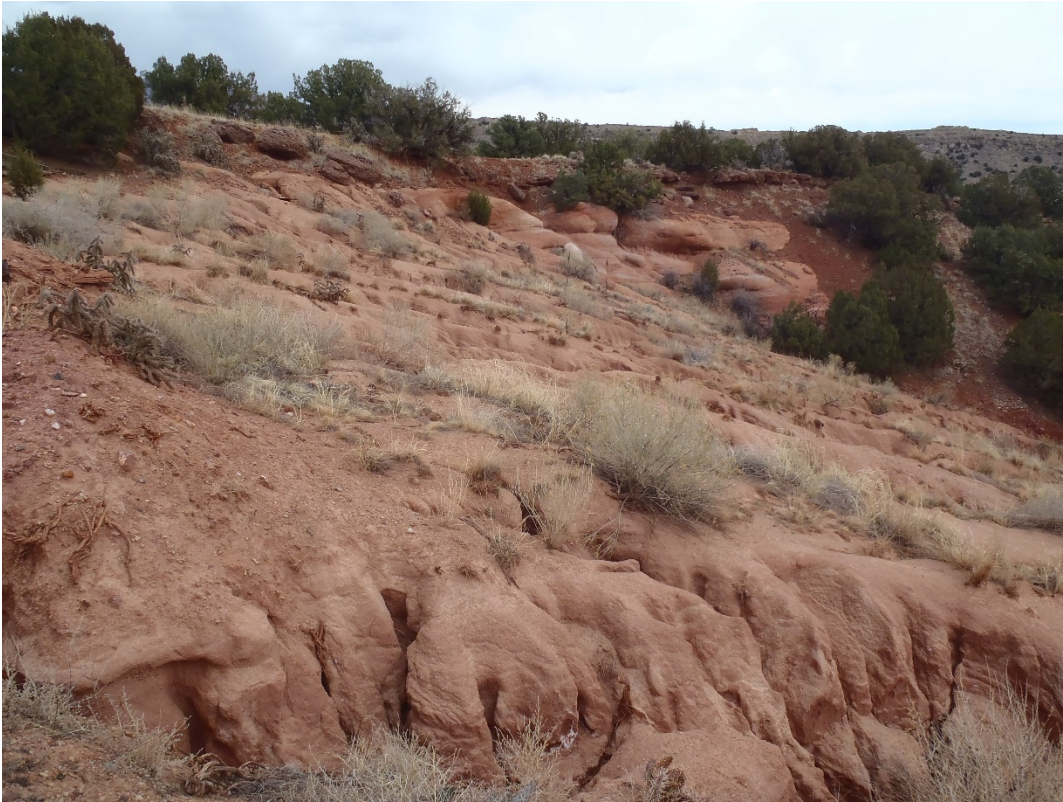
Backfilling and Grading: The fines disposal area in the southeast portion of the permit area was visited with the site representatives. The previously observed erosion rills (see **Photo 1**) had been graded out (see **Photo 2**), terrace benches (see **Photo 3**) for diverting runoff constructed, and the surface had been tracked with a dozer to roughen the surface (see **Photo 4**).

Photo 1. 2018 inspection photo prior to regrading (looking north).

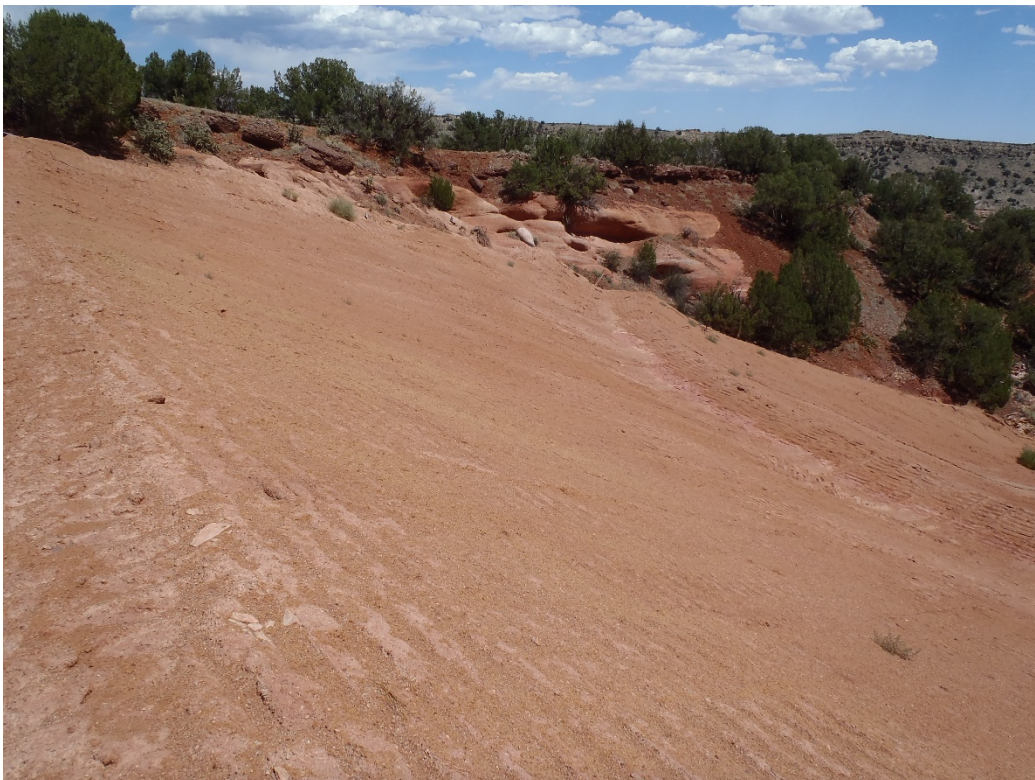
Photo 2. Regraded area & terrace channel (looking north from SW crest).

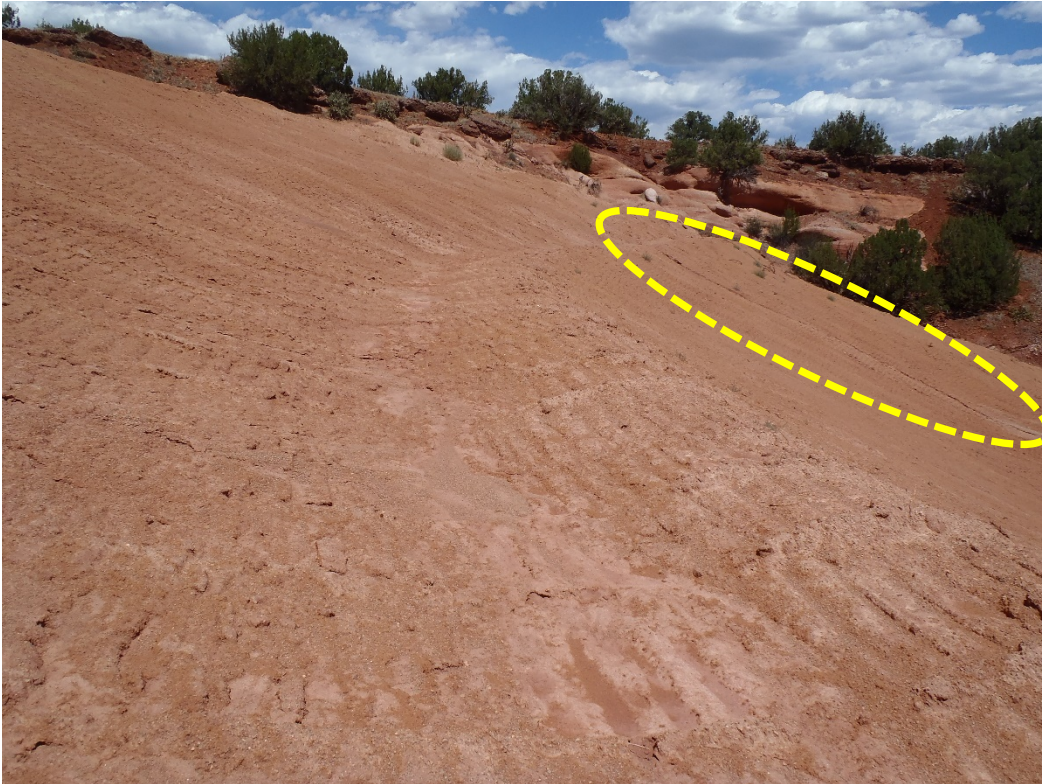
Photo 3. Terrace bench/channel & minor erosion rill (circled).

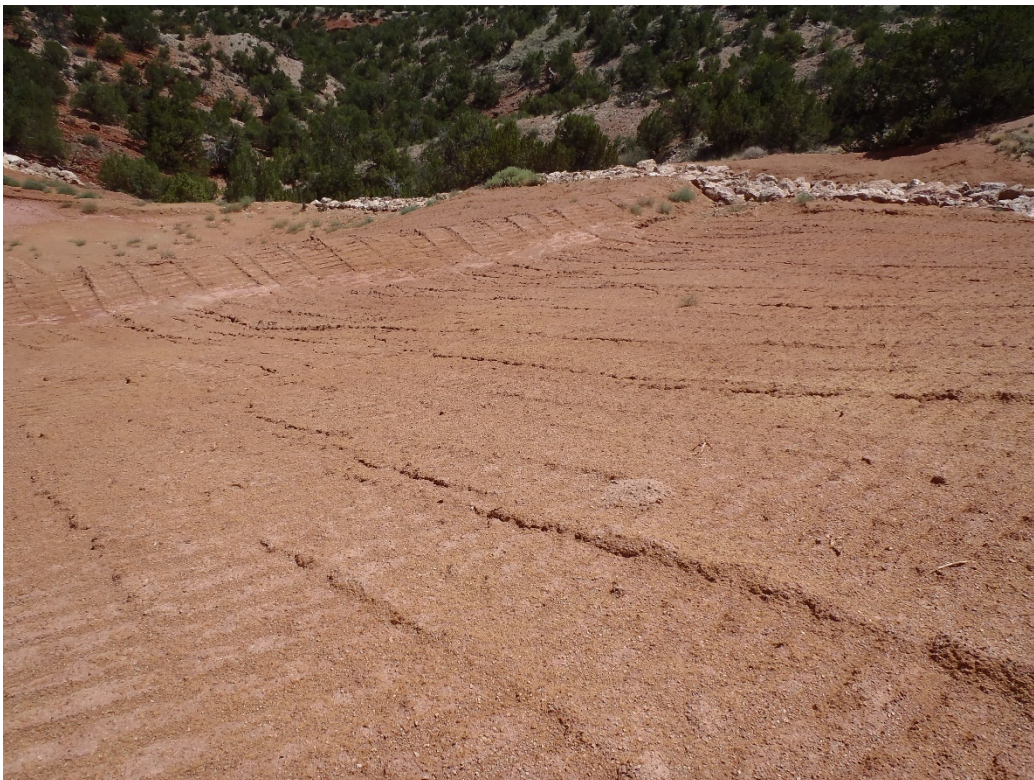
Photo 4. Dozer tracked surface above terrace channel (looking SE from crest).

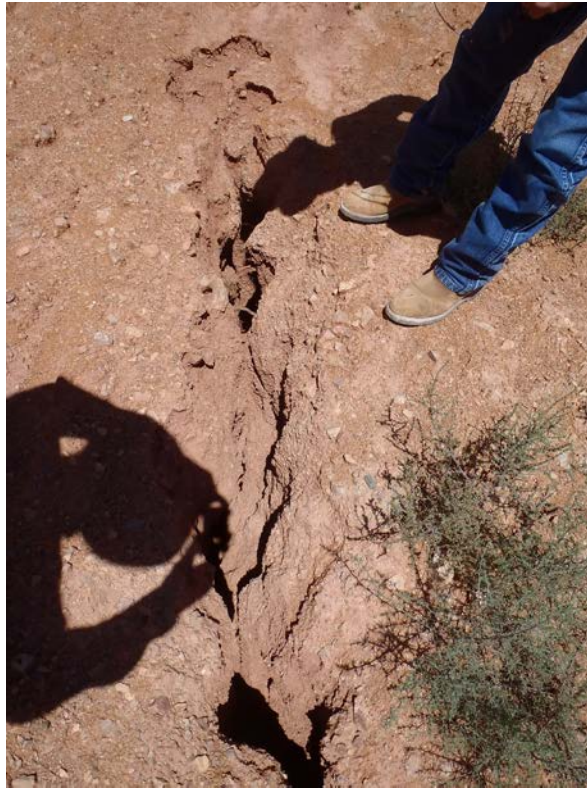
Sediment Control: Some minor erosion rills were observed (see **Photo 3**), but no BMPs were needed at the time of the inspection. A hydraulic sink (see **Photo 5**) was observed at the end of the terrace channel near the riprap channel. It was unclear at the time of the inspection where water discharged from the hole, but speculation suggested it discharged into the riprap channel. The DRMS recommends filling the sink hole.

Photo 5. Hydraulic sink near terrace channel intersection with riprap channel.

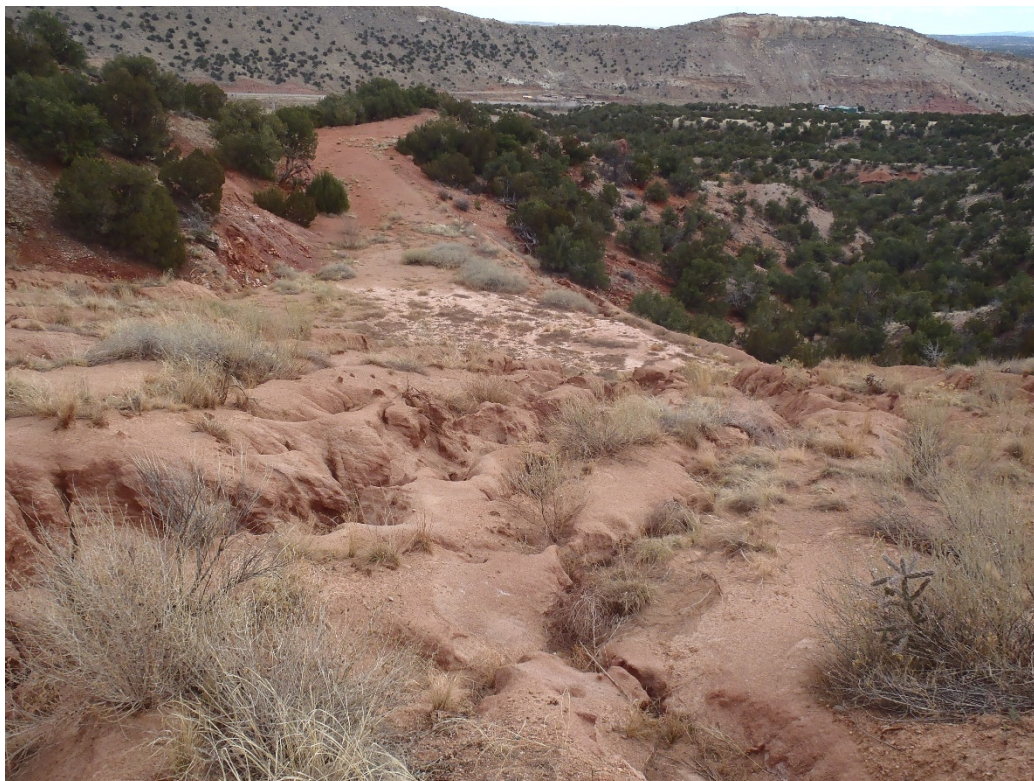
Storm Water MGT Plan: No oil or fuel spills observed. Riprap channels had been constructed on the south end of the regraded area and from a low spot in the access road below the fines disposal area (see **Photos 6 and 7**).

Photo 6. 2018 inspection photo prior to riprap channel construction (looking NE).

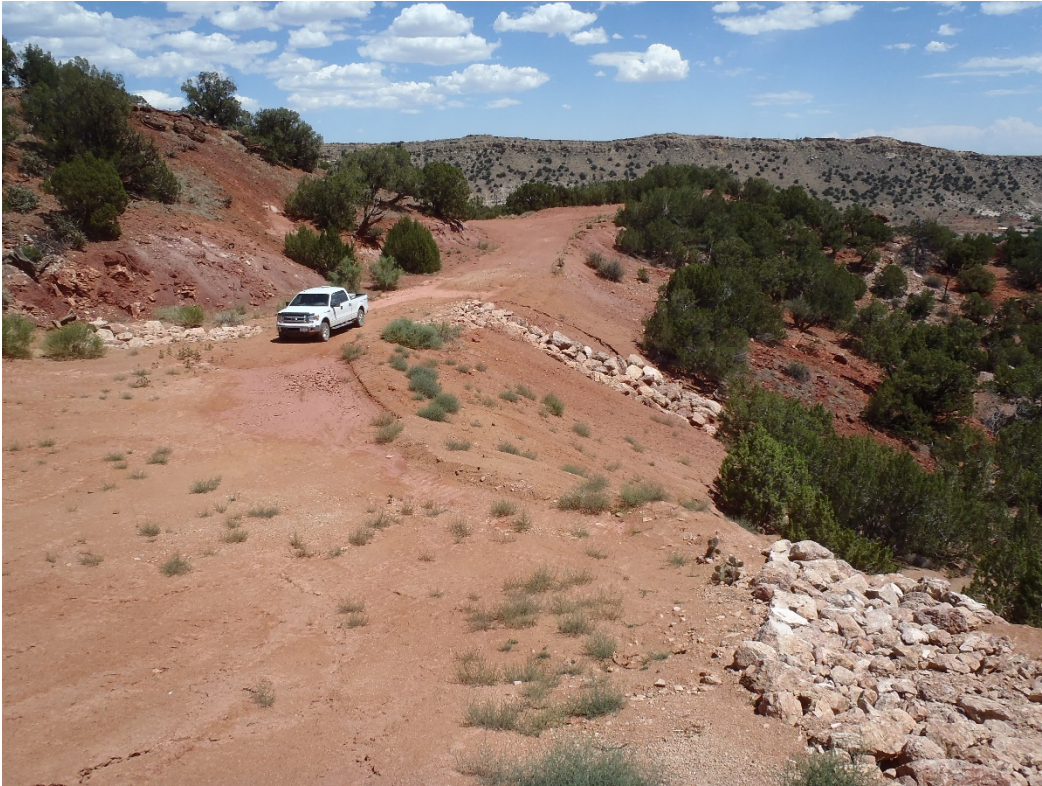
Photo 7. Riprap channels constructed on south edge of fines area & from lower access road.
