Pikeview Monitoring Report

To: Jerald Schnabel From: Paul Kos
Continental Materials Corp. Denver, CO 80222
File: December 2020 Monitoring Summary Date: January 31, 2021

Reference: December 2020 Geotechnical Monitoring Summary Pikeview Quarry

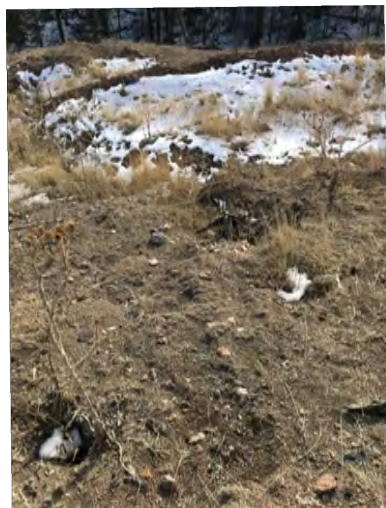
- Healed Cracks: A crack was observed on the slope adjacent to the slide where cracking had previously been observed. This crack runs parallel to the slide and appears to be “healed” and did not indicate any recent movement. (Note 6)

6. AREA ABOVE THE SLIDE

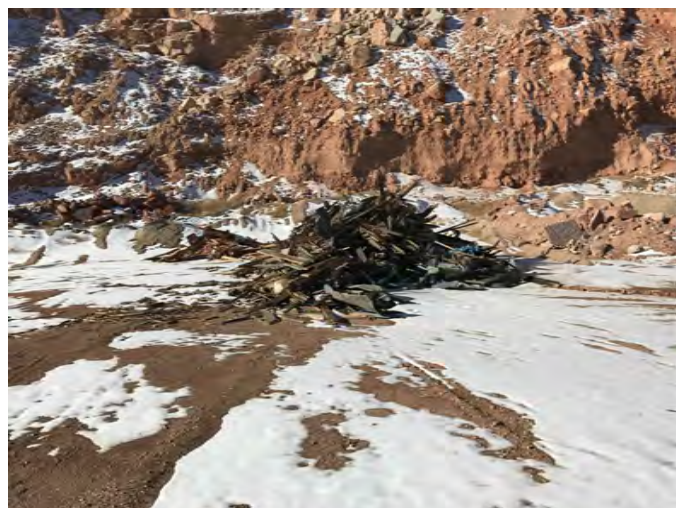
5. DEMOLITION DEBRIS PLACED AT TOE OF SLIDE

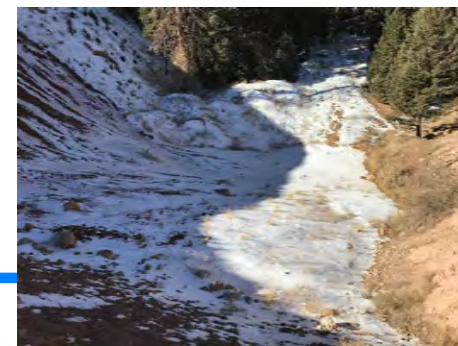
- Culverts: A 6-ft culvert was observed to be blocked on the upstream end. There is evidence that water is collecting at the inlet during rain events and likely seeping through the loose material and through the culvert. (Note 1).

1. AREA UPSTREAM OF BLOCKED CULVERT

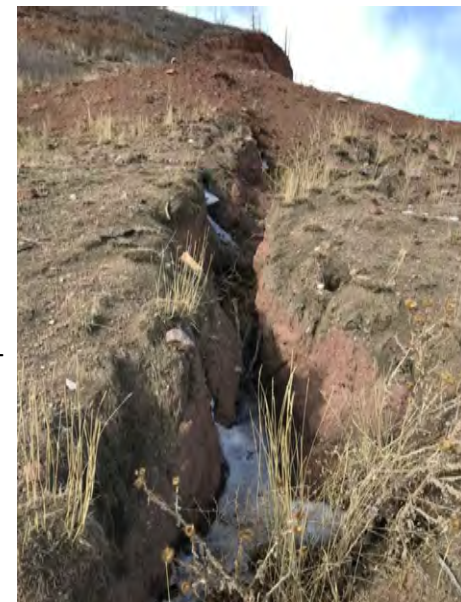
- Several new prisms were in the process of being placed during the site visit and will appear on the next report.
- Gullies: Gullies have formed on the slopes above the slide area as well as in the burn areas above the quarry. (Note 2)

2. EROSION GULLEY

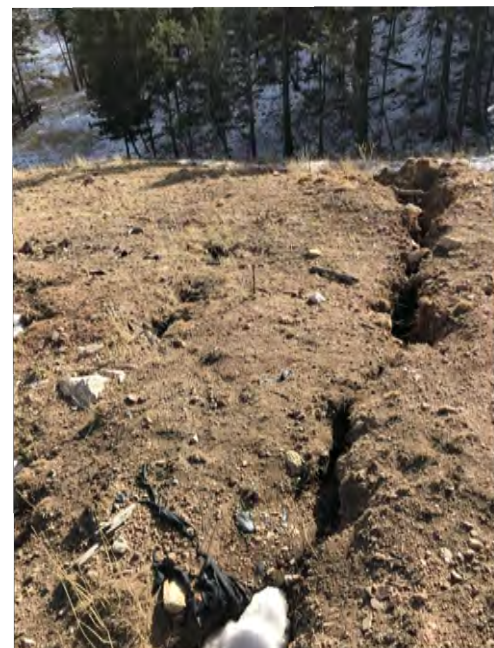
- Pooled Water: The grading at the top of the first ridge causes a small amount (0.03 ac) of water to pool.
- Open Cracks: An open crack was observed during this visit. This feature is in an area where cracking is expected to occur as a result of ongoing slope settlement and relaxation. The edges of the crack have eroded suggesting it is not a new feature. (Note 7)

7. OPEN CRACK PARALLEL TO SLIDE

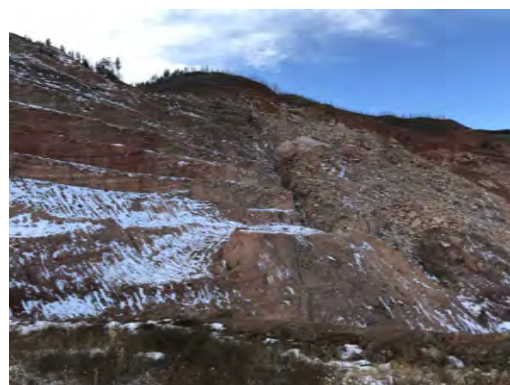
8. VIEW UP SOUTH ESCARPMENT

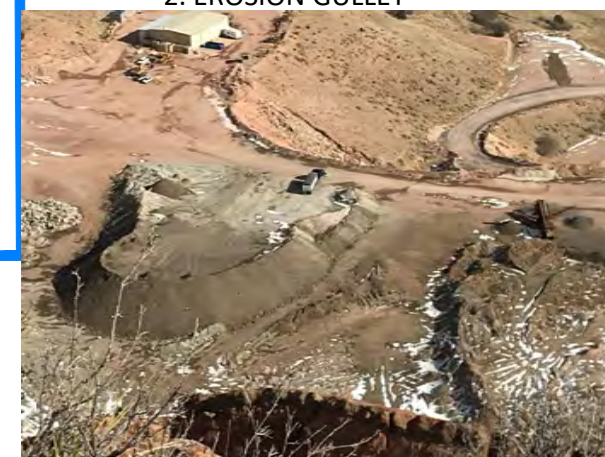
- Fill: Material is being imported and temporarily placed on the “production floor”. During the visit, different types of material including mulch and general fill were being deposited here for future placement. Based on the drone survey, approximately 2,195 cubic yards of temporary fill were imported during the month of December. (Note 3)

3. DEBRIS AND RUBBLE FILL AREA

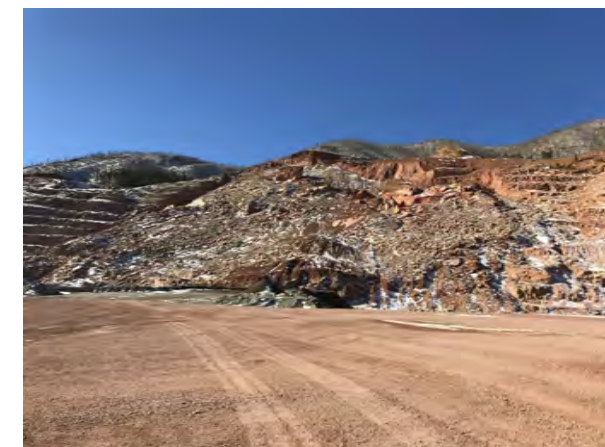
4. FILL DEPOSITED AT TOE OF SLIDE AREA

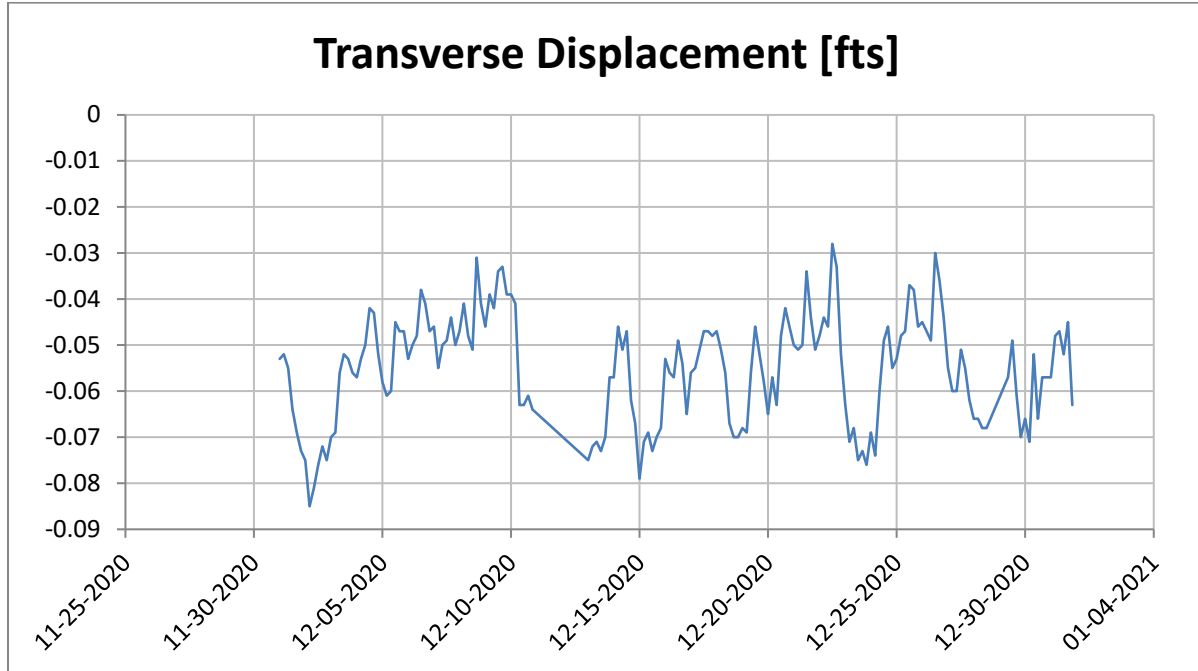
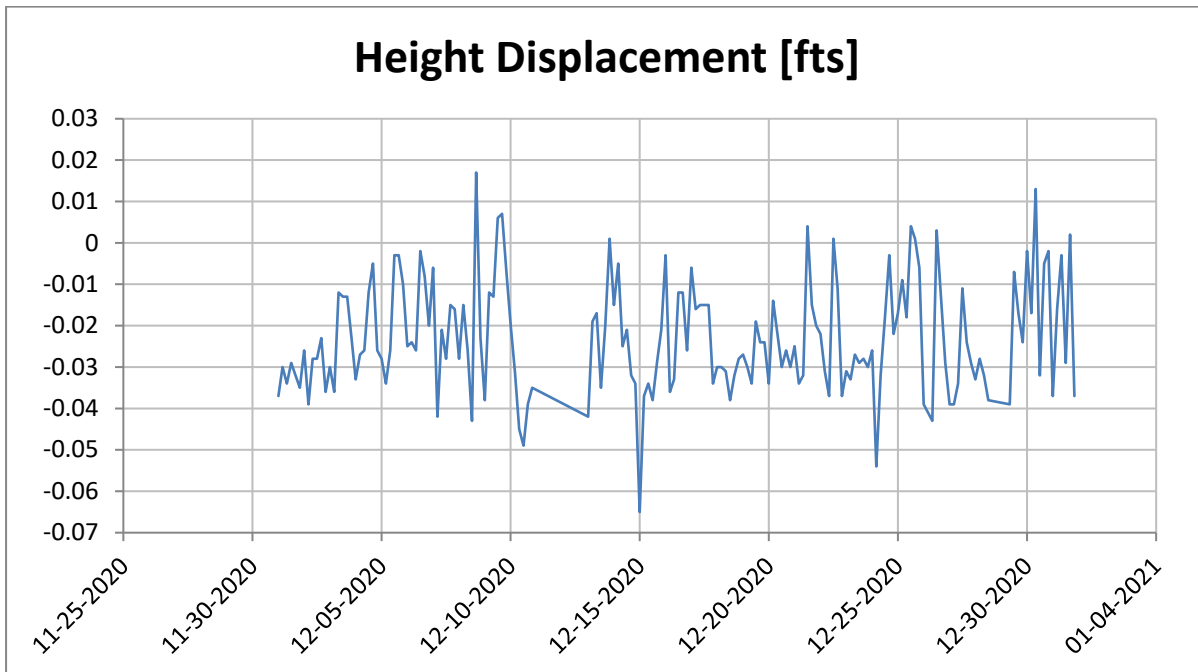
displacement over the life of the monitoring, which has been several years for all the prisms except P69. Prism P69 was moved on June 20, 2020, and the displacements included in Table 3 are the displacements since that date. According to Leica documentation, the survey accuracy is $\pm 4 \text{ mm} + 1.5 \text{ ppm}$ for prisms located greater than 500m from the station; these equates to an accuracy of $\pm 0.016 \text{ ft}$. The data show stable conditions with no movement for 16 of 17 prisms with recorded displacements limited to data scatter and not actual movements. Prism P63 is located at the toe of the landslide, and this location shows slope creep movements at slow velocities ($< 0.001 \text{ feet per day}$). Plots of the transverse and height displacements for each prism are included in Appendix B.

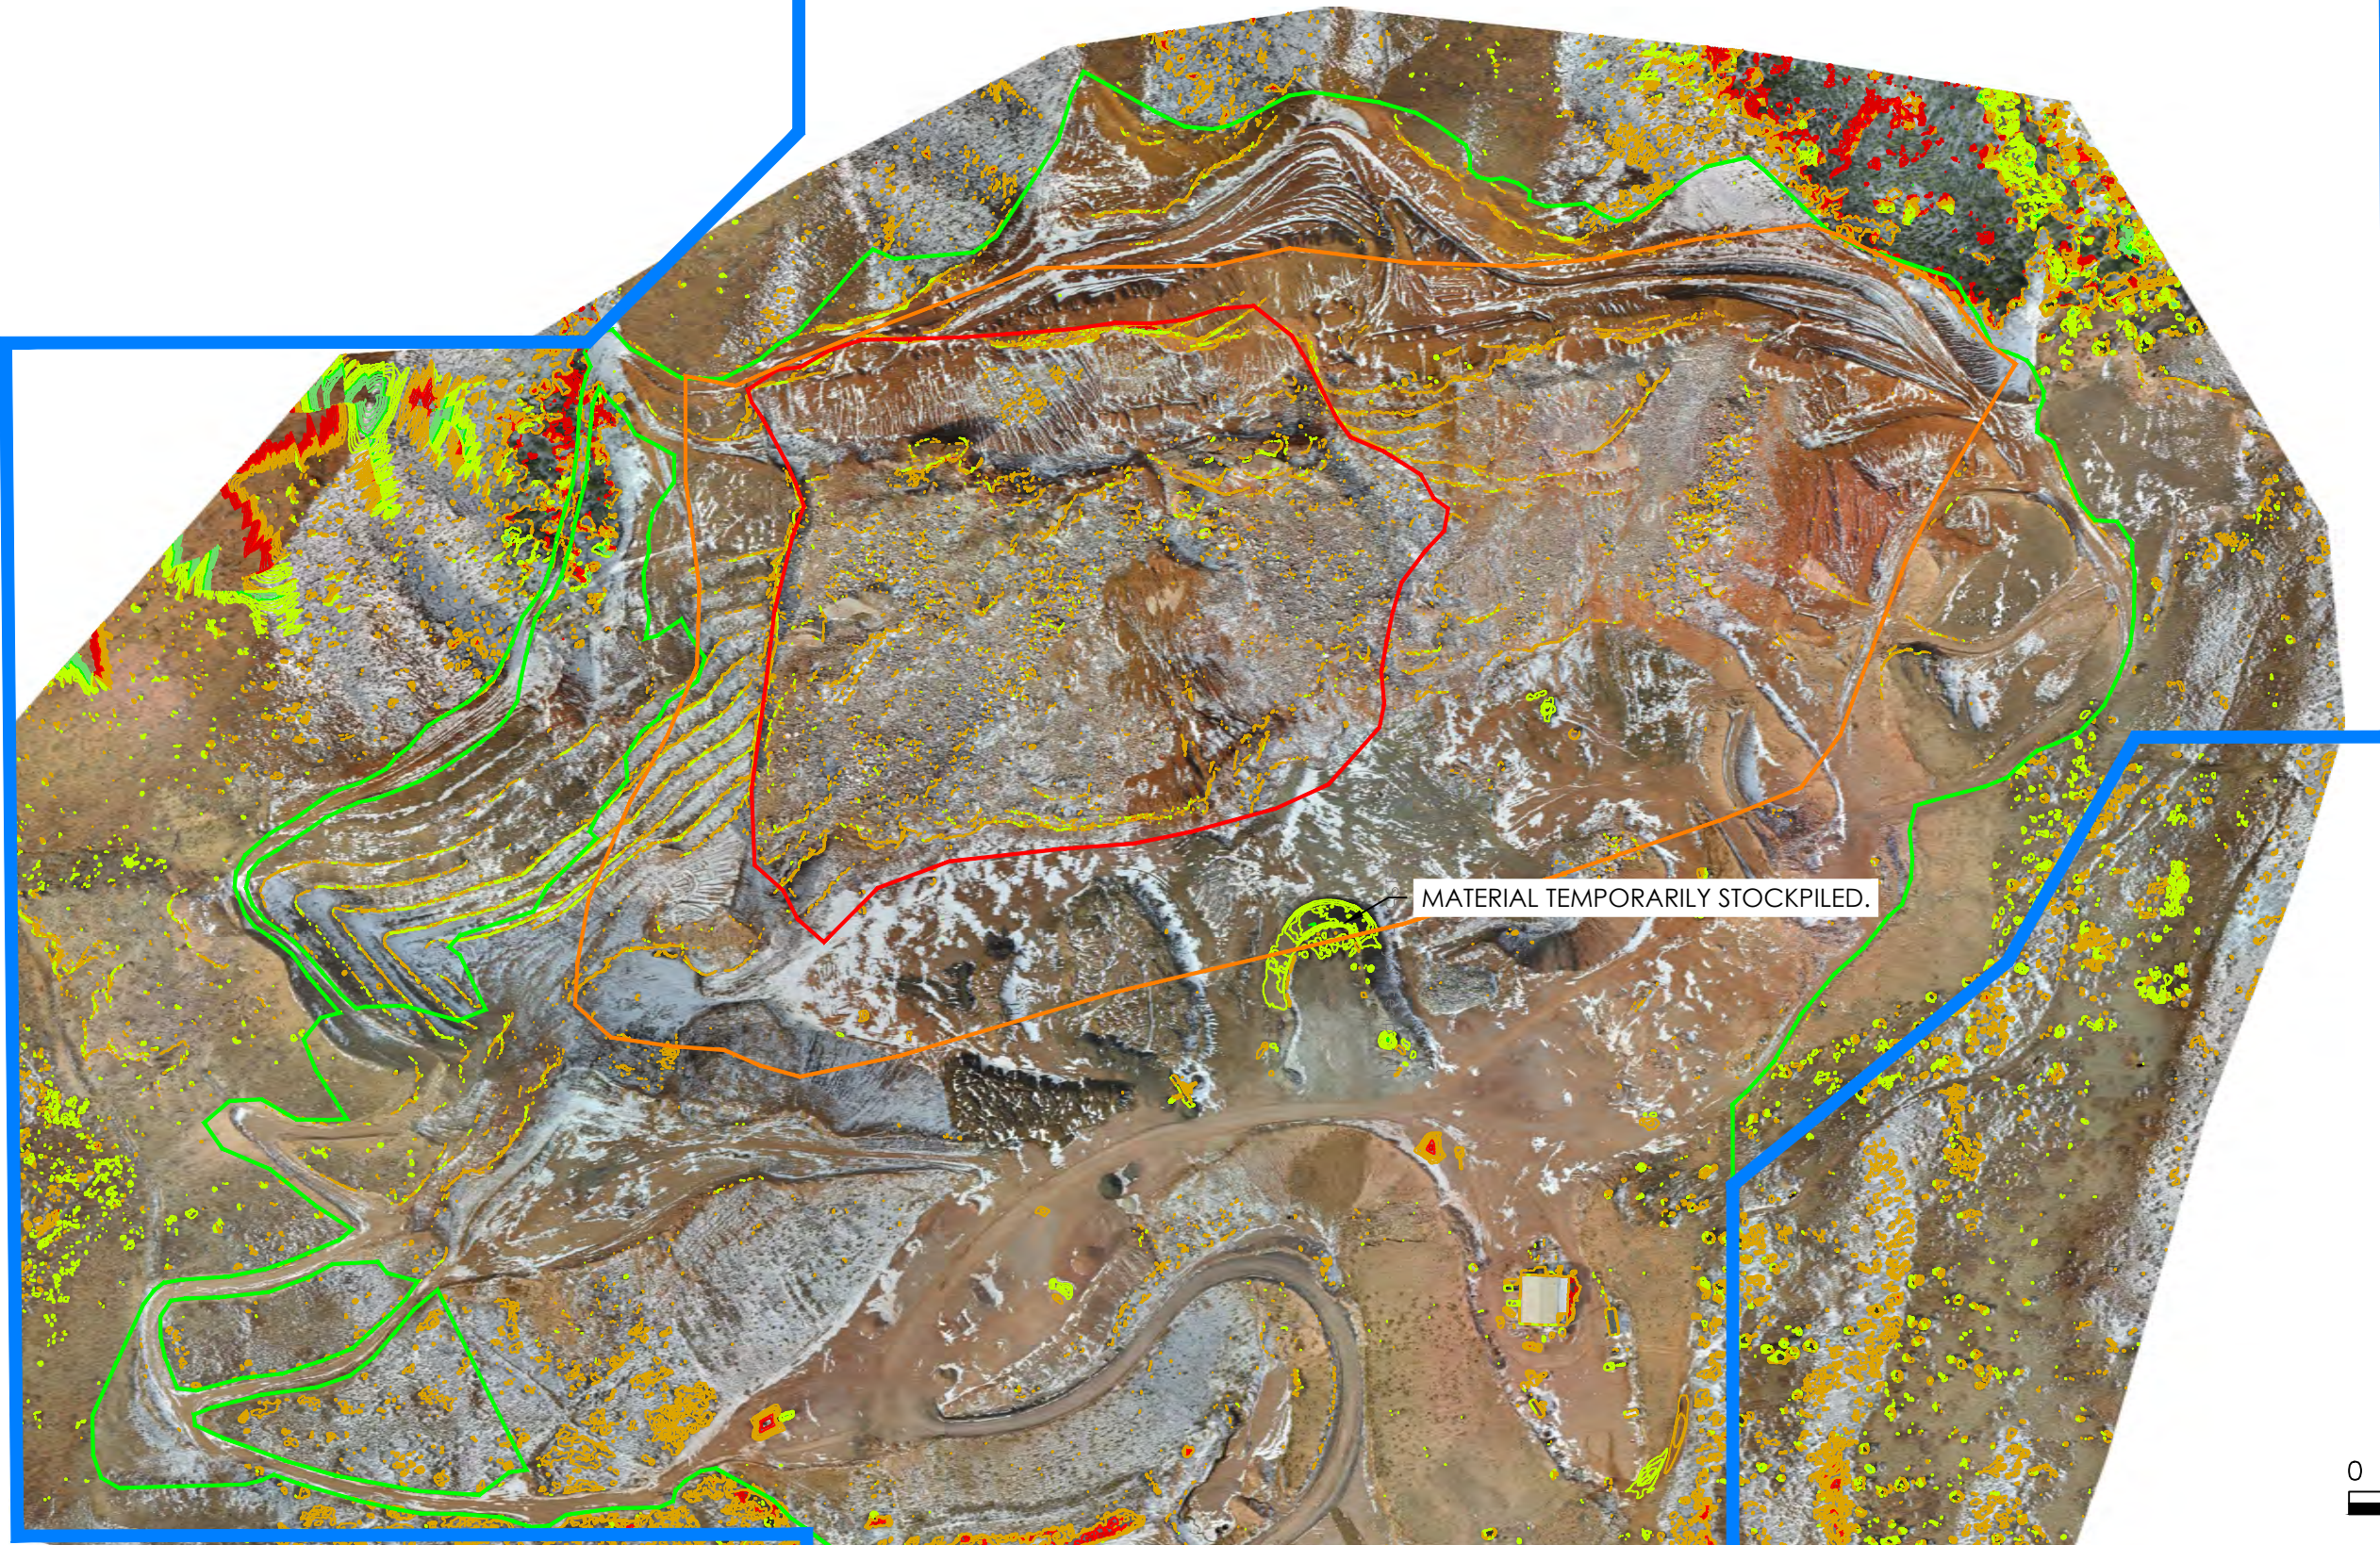
Date
2021.01.31
Figure No.
5

The November topography was also compared to the December topography to identify changes in the site topography. Comparison of the two surveys showed that approximately 2,195 yd³ of fill had been imported and temporarily placed. No slope movements or other changes in topography were identified. The current imagery and topography are included in Figures 1 and 3, and the comparison surface is included as Figure 5 in Appendix C.

As previously reported in the September 2020 monitoring report, there are limitations with the method of comparing drone surveys from different months. The drone data indicate changes in the slopes along each of the reclamation benches, buildings, and areas with trees or shrubs. These areas are stable, and the changes are the result of survey limitations on or near vertical slopes.
