**MINERALS PROGRAM INSPECTION REPORT**  
**PHONE: (303) 866-3567**

<b>MINE NAME:</b> Miller Gravel Pit	<b>MINE/PROSPECTING ID#:</b> M-1982-112	<b>MINERAL:</b> Sand and gravel	<b>COUNTY:</b> Elbert
<b>INSPECTION TYPE:</b> Monitoring	<b>INSPECTOR(S):</b> Amy Eschberger	<b>INSP. DATE:</b> February 3, 2021	<b>INSP. TIME:</b> 10:30
<b>OPERATOR:</b> Schmidt Construction Company	<b>OPERATOR REPRESENTATIVE:</b> Dan Chavez, Greg Olson, Mark Heifner	<b>TYPE OF OPERATION:</b> 112c - Construction Regular Operation	
<b>REASON FOR INSPECTION:</b> Normal I&E Program	<b>BOND CALCULATION TYPE:</b> Partial	<b>BOND AMOUNT:</b> \$146,646.00	
<b>DATE OF COMPLAINT:</b> NA	<b>POST INSP. CONTACTS:</b> None	<b>JOINT INSP. AGENCY:</b> None	
<b>WEATHER:</b> Clear	<b>INSPECTOR'S SIGNATURE:</b>

## M-1982-112 / Miller Gravel Pit / Schmidt Construction Company (112c)

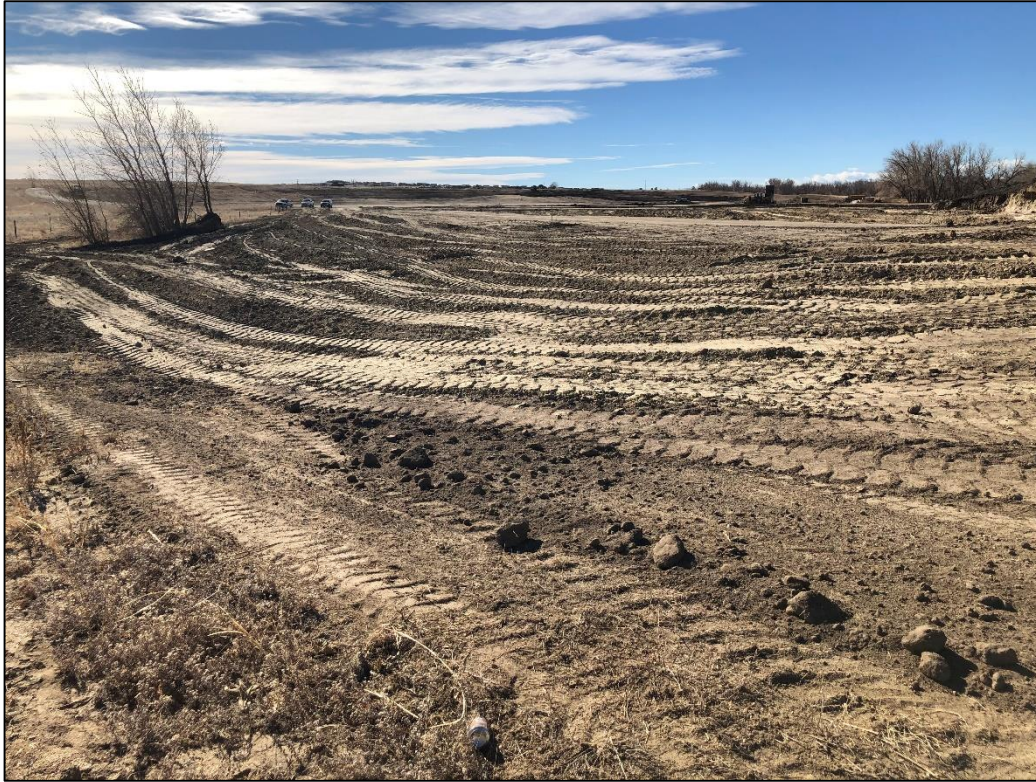
**Photo 1.** View looking south across northeastern portion of permit area, where overburden stockpiles were removed and used for reclamation and the underlying area graded. The operator may add additional fill in this area to create better drainage.

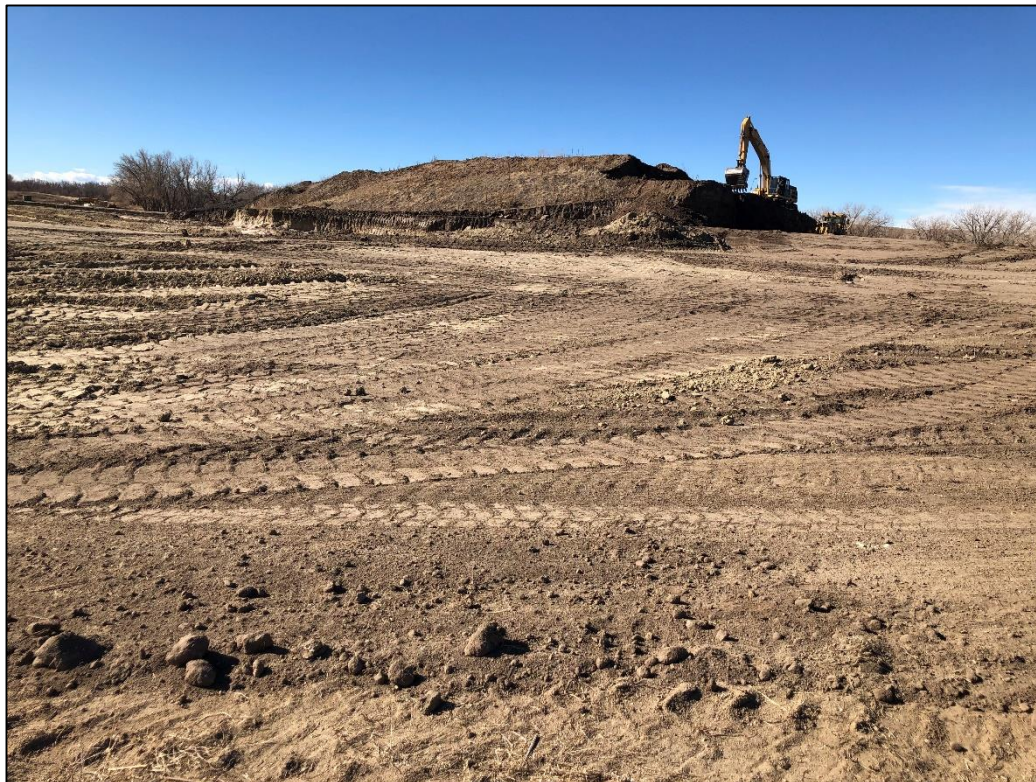
**Photo 2.** View looking west across northern portion of permit area, where overburden stockpiles were removed and used for reclamation and the underlying area graded. Note large topsoil stockpile (in background) which remains in this area.

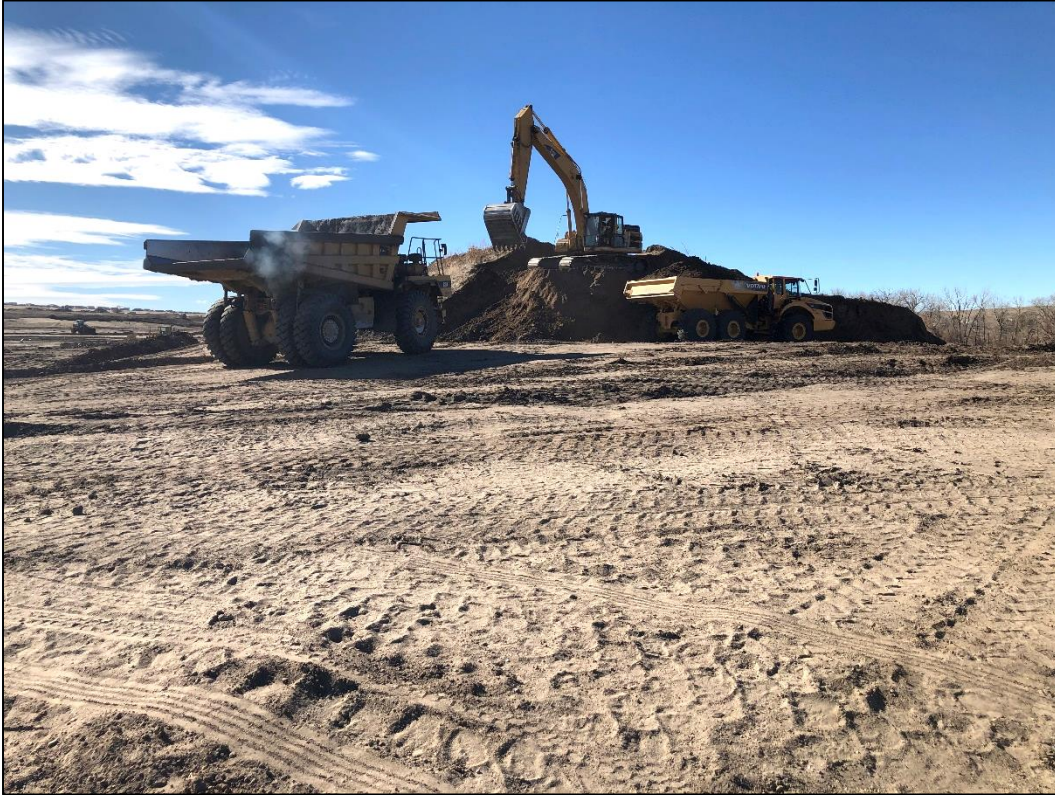
**Photo 3.** View looking southwest at large topsoil stockpile that remains in northern portion of permit area. This material was being placed in the former processing/stockpiling area during the inspection.

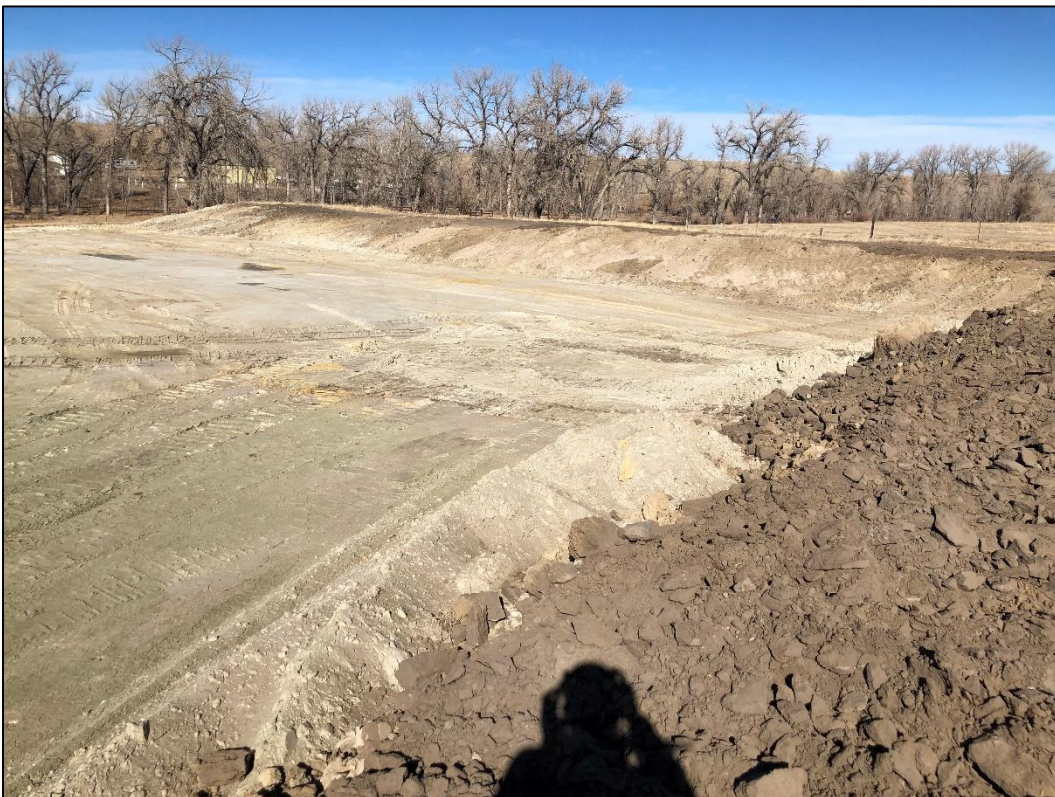
**Photo 4.** View looking northwest across excavated area in northwestern portion of permit area. All slopes in this area will be graded 3H:1V or flatter and the area graded for positive drainage to the west.

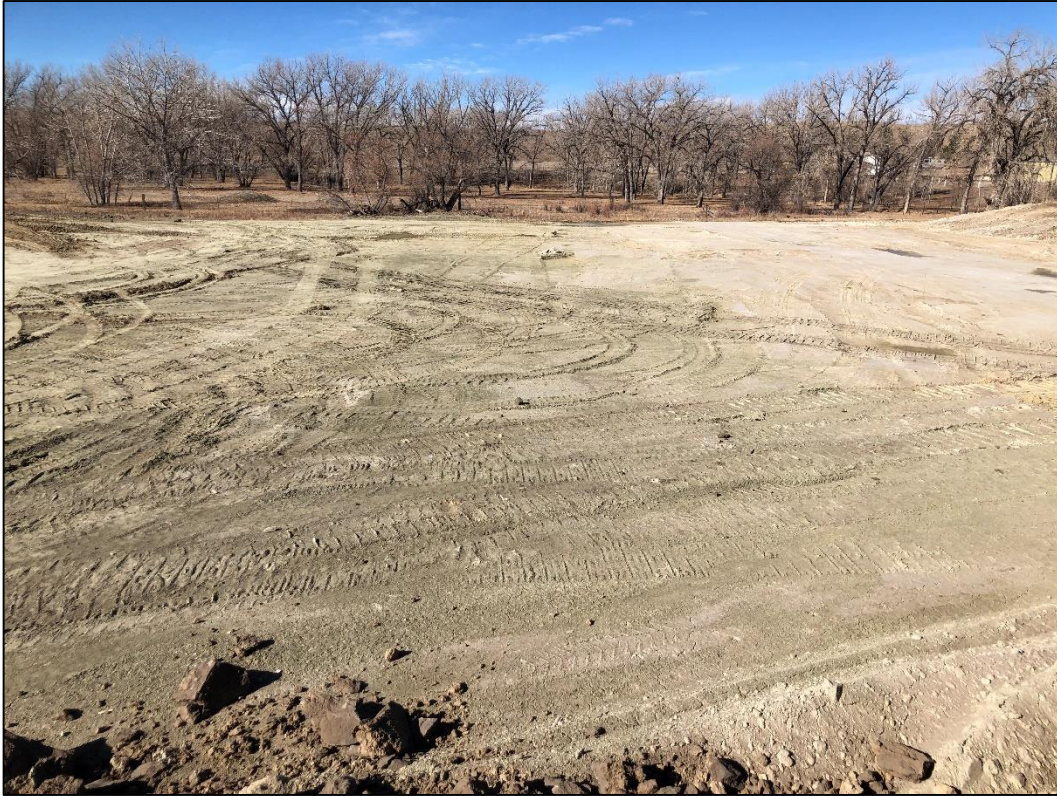
**Photo 5.** View looking west across excavated area in northwestern portion of permit area. All slopes in this area will be graded 3H:1V or flatter and the area graded for positive drainage to the west.

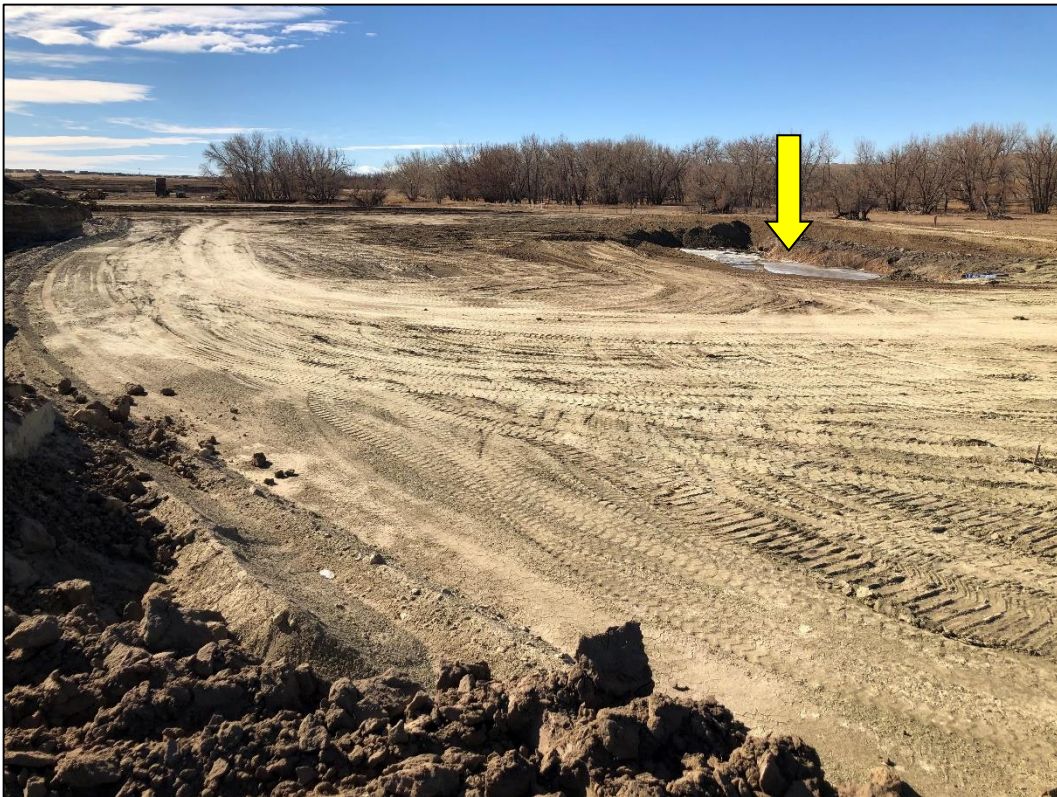
The area around the large topsoil stockpile has been excavated down by approximately 5-8 feet. Once the topsoil stockpile has been removed, the area beneath it can be excavated and the material used as fill to create positive drainage to the west. A small wash pond remains in the area west of the large topsoil stockpile. Based on an aerial image of the site from June 4, 2020 (available in Google Earth), the pond was approximately 0.30 acre in size. However, the operator has recently backfilled a portion of the pond and may backfill it entirely if the landowner decides not to take over the water rights for the exposed groundwater. According to the permit file, the operator has a valid well permit, augmentation decree and water lease agreement with the Town of Elizabeth which more than covers the amount of exposed groundwater at the site.

**Photo 6.** View looking southwest across excavated area in northwestern portion of permit area. All slopes in this area will be graded 3H:1V or flatter and the area graded for positive drainage to the west. Note small wash pond that remains in this area (indicated).

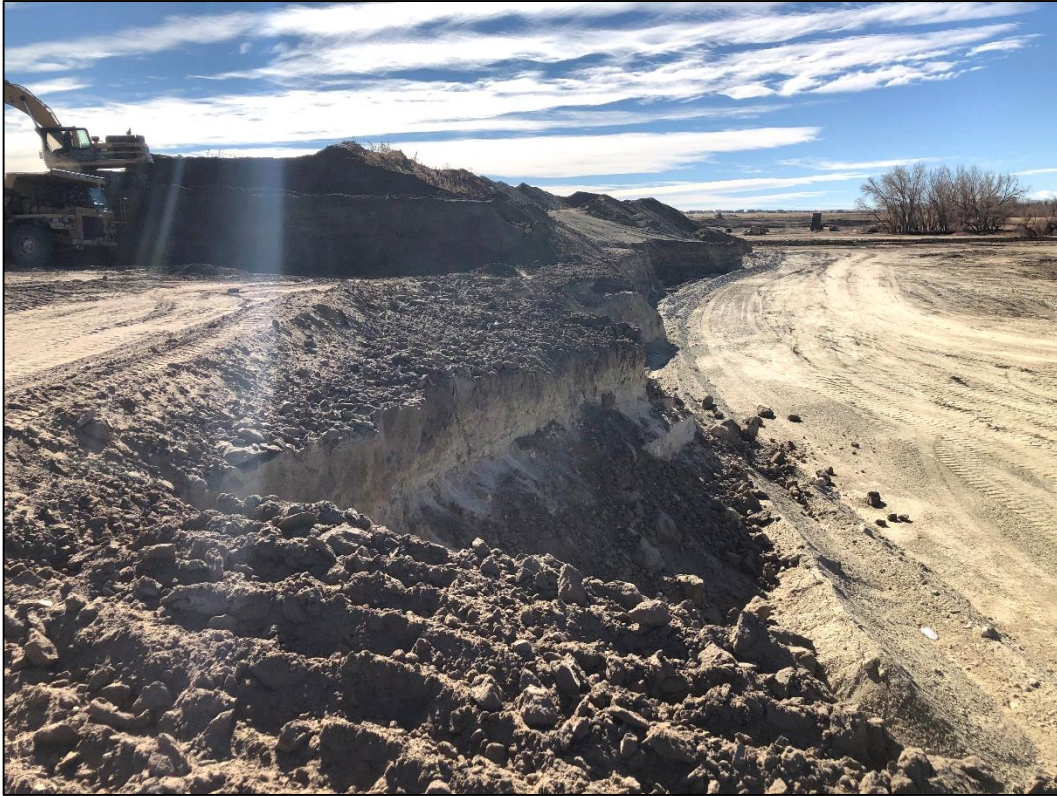
**Photo 7.** View looking south across eastern edge of excavated area in northwestern portion of permit area. Note large topsoil stockpile that remains, at left. All slopes in this area will be graded 3H:1V or flatter and the area graded for positive drainage to the west.

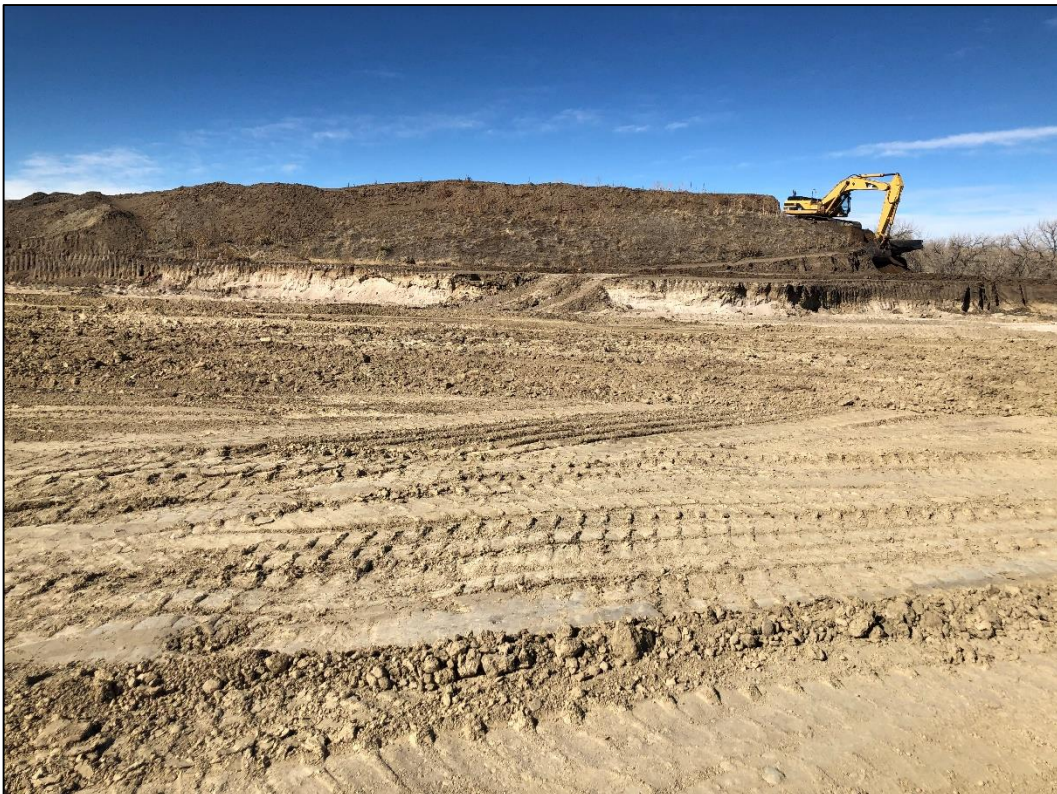
**Photo 8.** View looking northwest across northern portion of permit area, where overburden stockpiles were removed and used for reclamation and the underlying area graded. Note large topsoil stockpile (in background) which remains in this area.

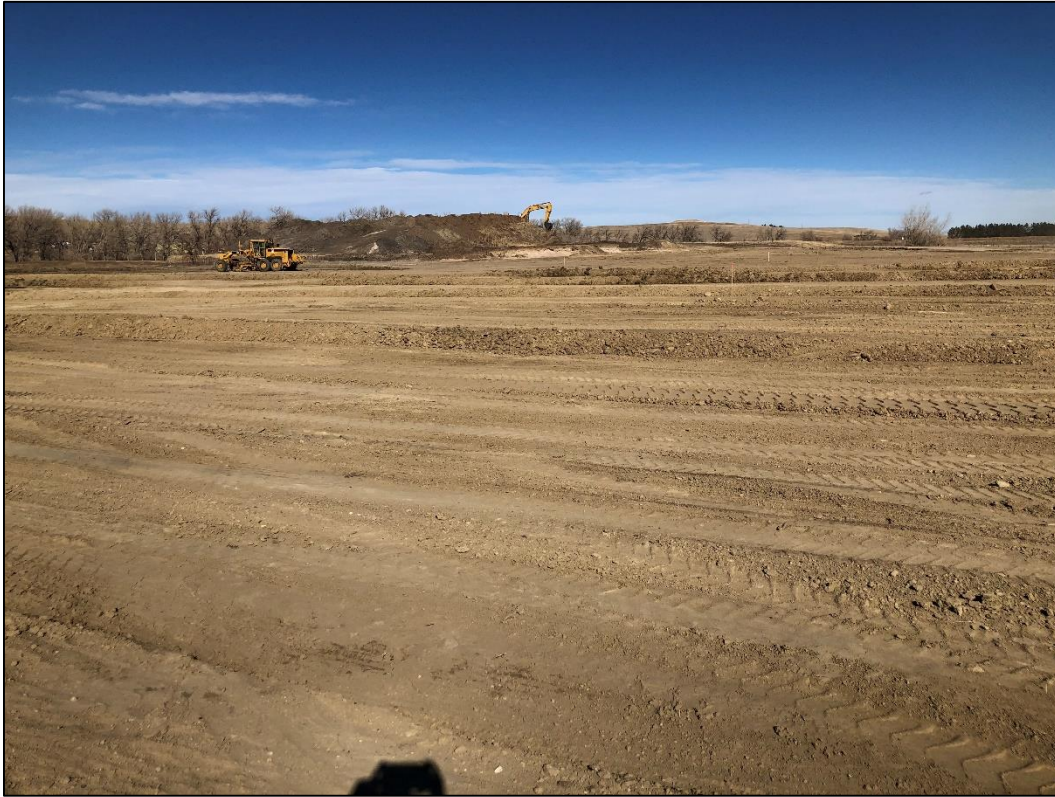
**Photo 9.** View looking north across northern portion of permit area where overburden stockpiles were removed and used for reclamation and the underlying area graded. Continued grading activities were occurring in this area during the inspection.

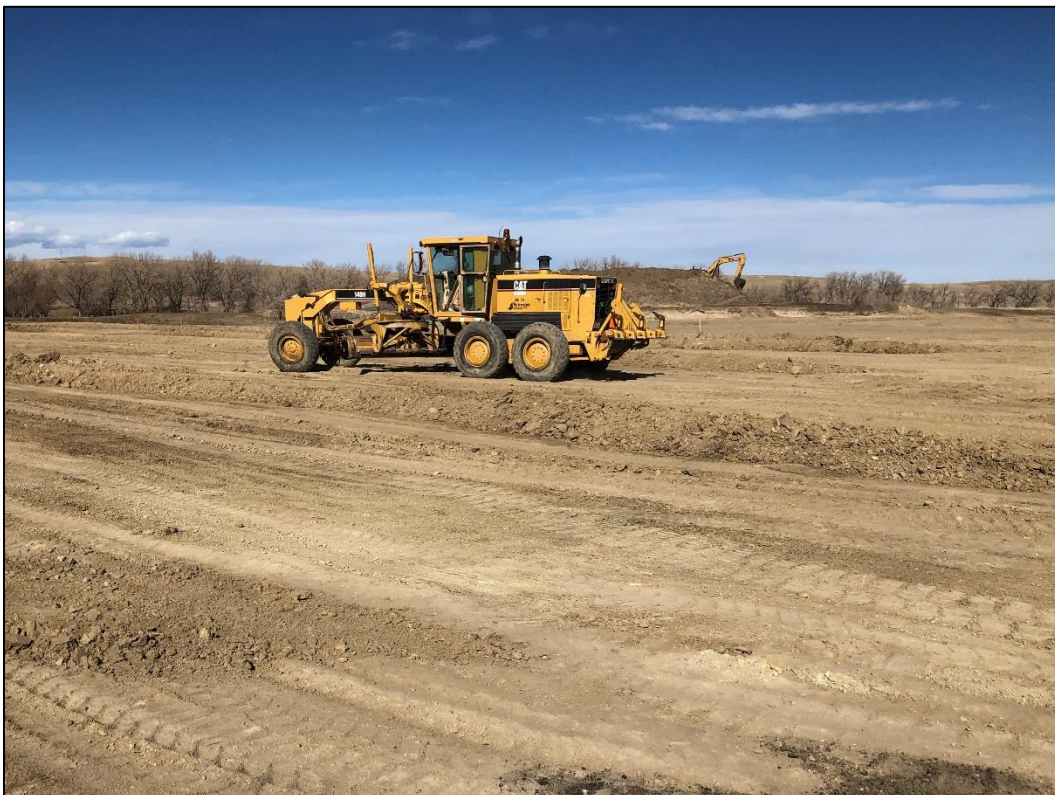
**Photo 10.** View looking northwest across northern portion of permit area where overburden stockpiles were removed and used for reclamation and the underlying area graded. Note continued grading activities occurring in this area during the inspection.

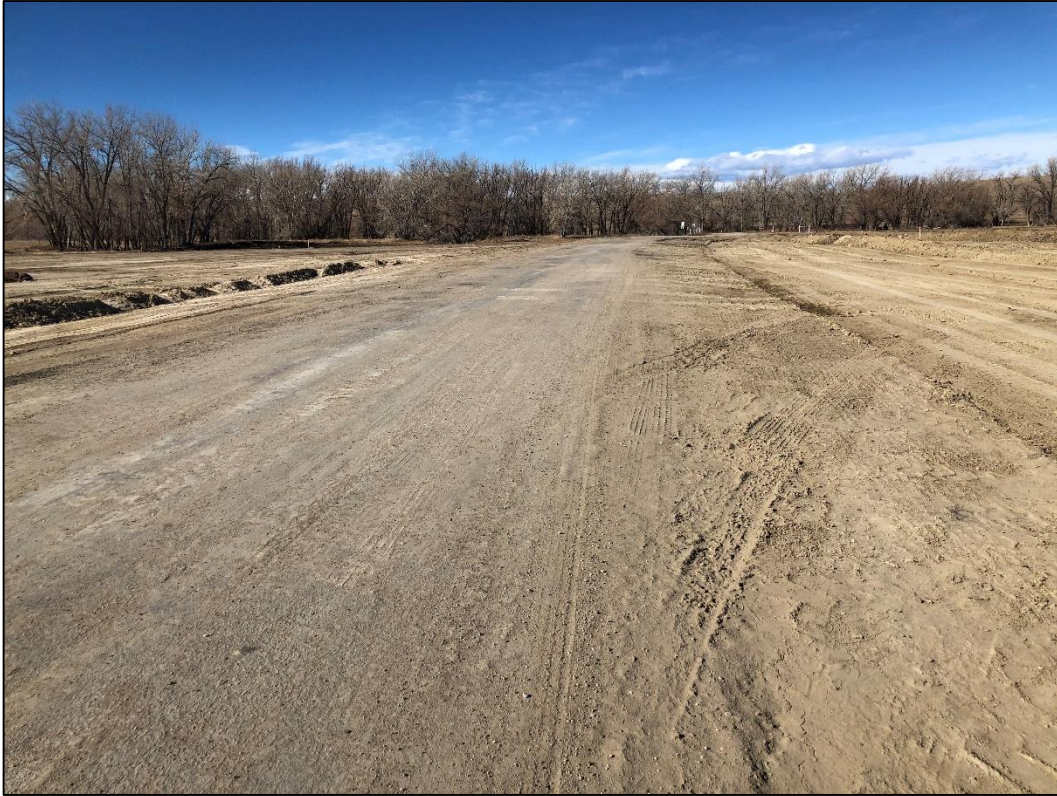
**Photo 11.** View looking west across access road (relocated in 2011) which crosses the permit area, separating the overburden/topsoil stockpiling area to the north (right) from the pit and processing areas to the south (left). This road will remain after reclamation.

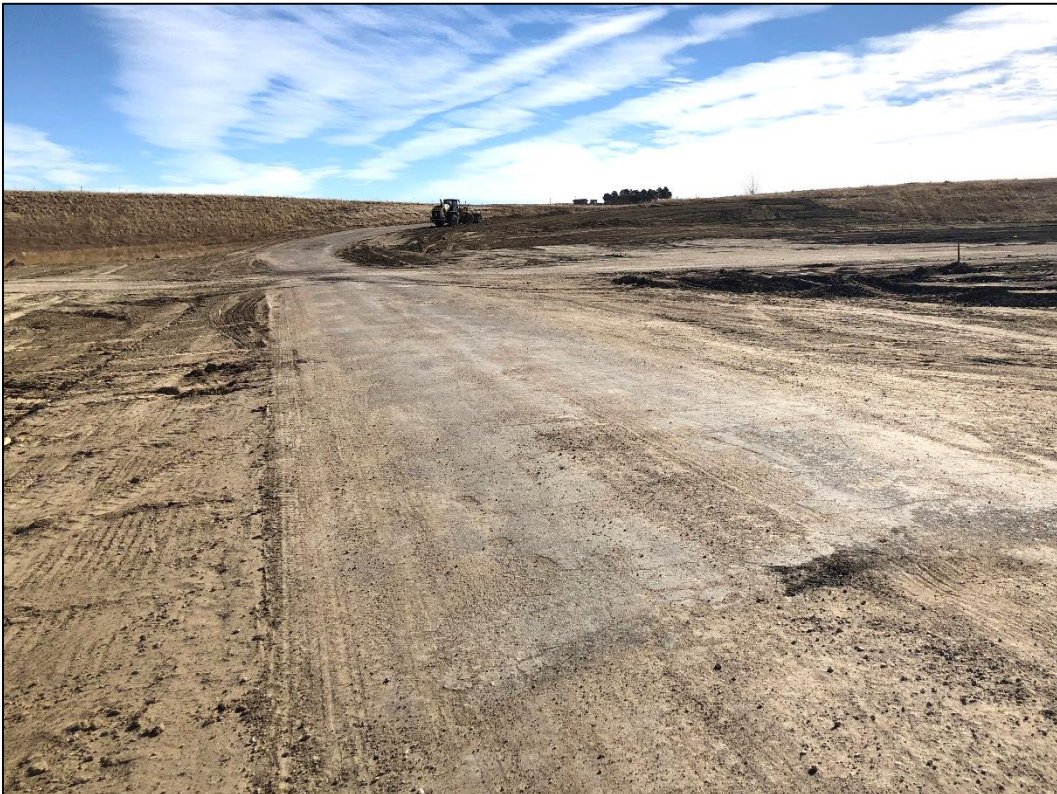
**Photo 12.** View looking east across access road (relocated in 2011) which crosses the permit area, separating the overburden/topsoil stockpiling area to the north (left) from the pit and processing areas to the south (right). This road will remain after reclamation.

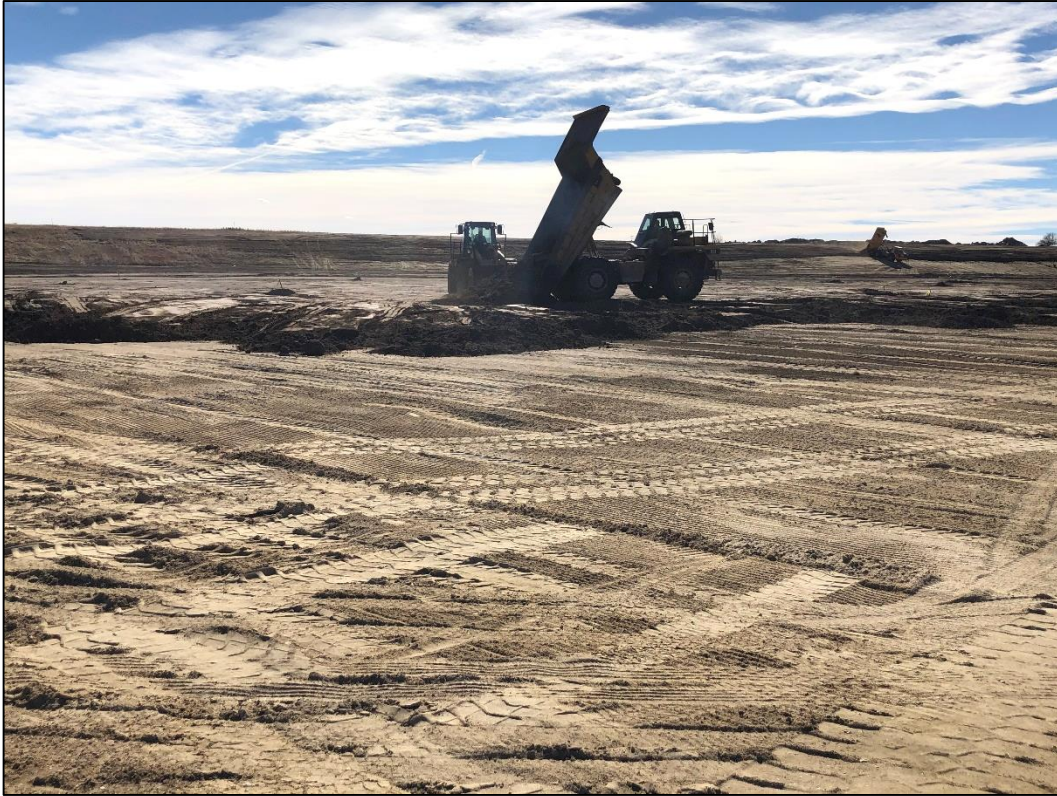
**Photo 13.** View looking south across former processing/stockpiling area where all equipment and stockpiles have been removed. The operator was grading and retopsoiling this area during the inspection.

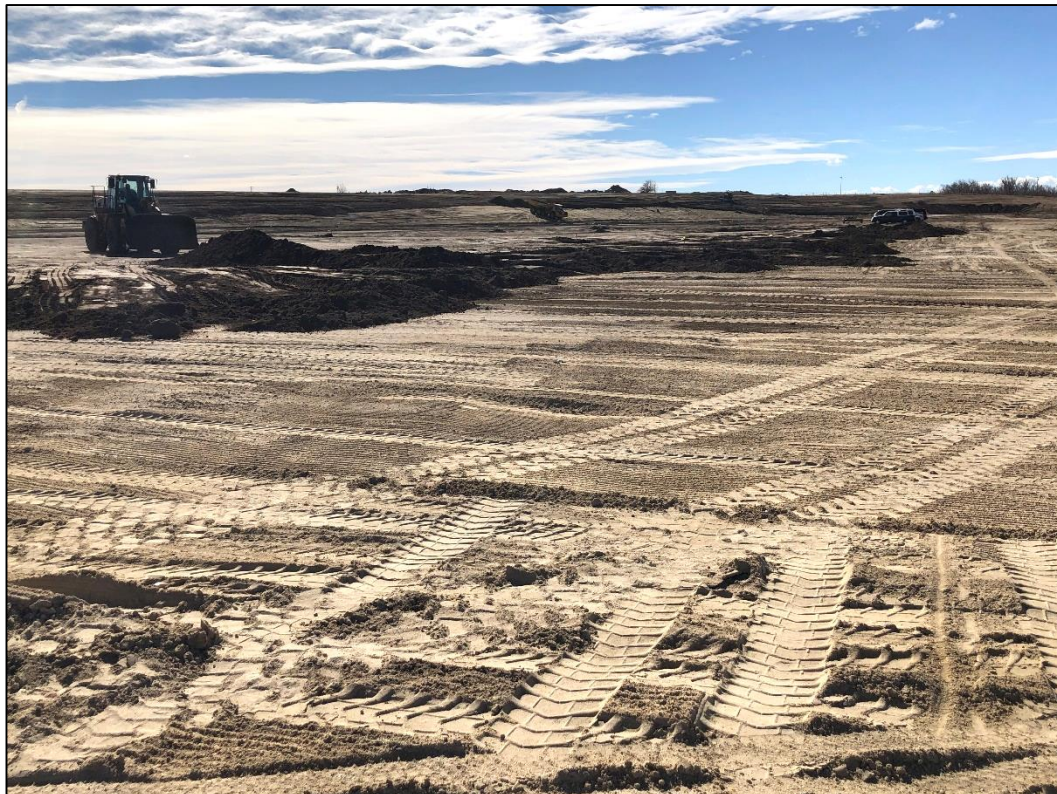
**Photo 14.** View looking south across former processing/stockpiling area where all equipment and stockpiles have been removed. The operator was grading and retopsoiling this area during the inspection.

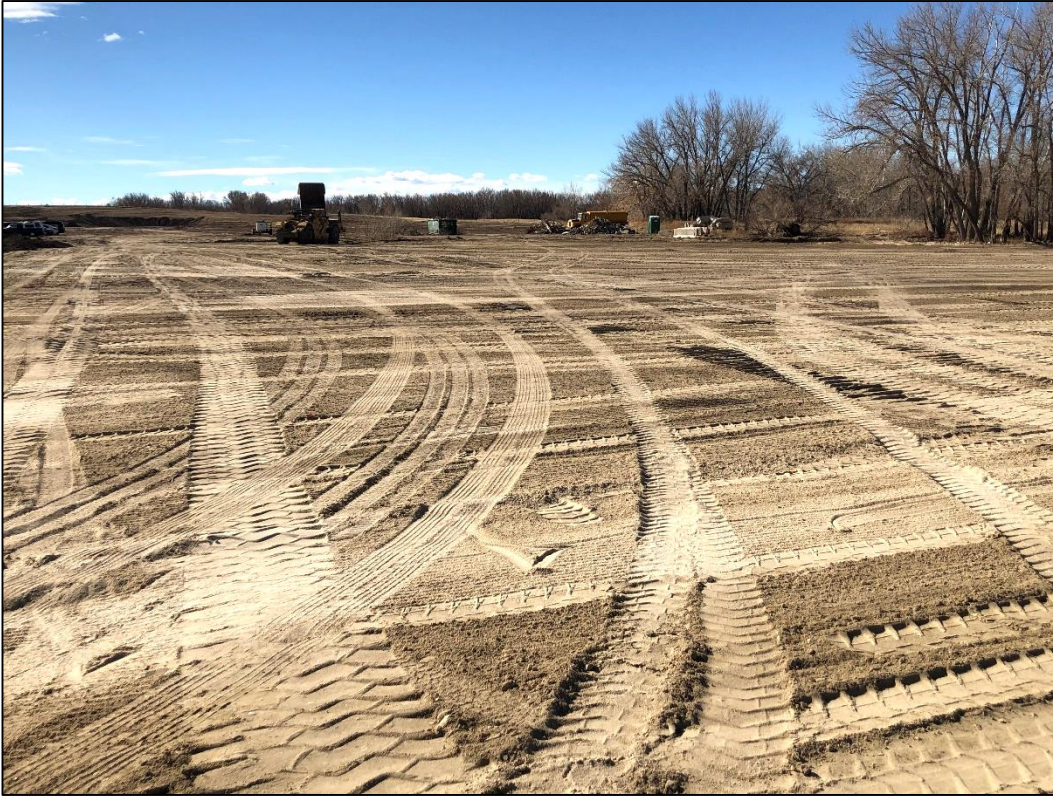
**Photo 15.** View looking southwest across former processing/stockpiling area where all equipment and stockpiles have been removed. The operator was grading and retopsoiling this area during the inspection.

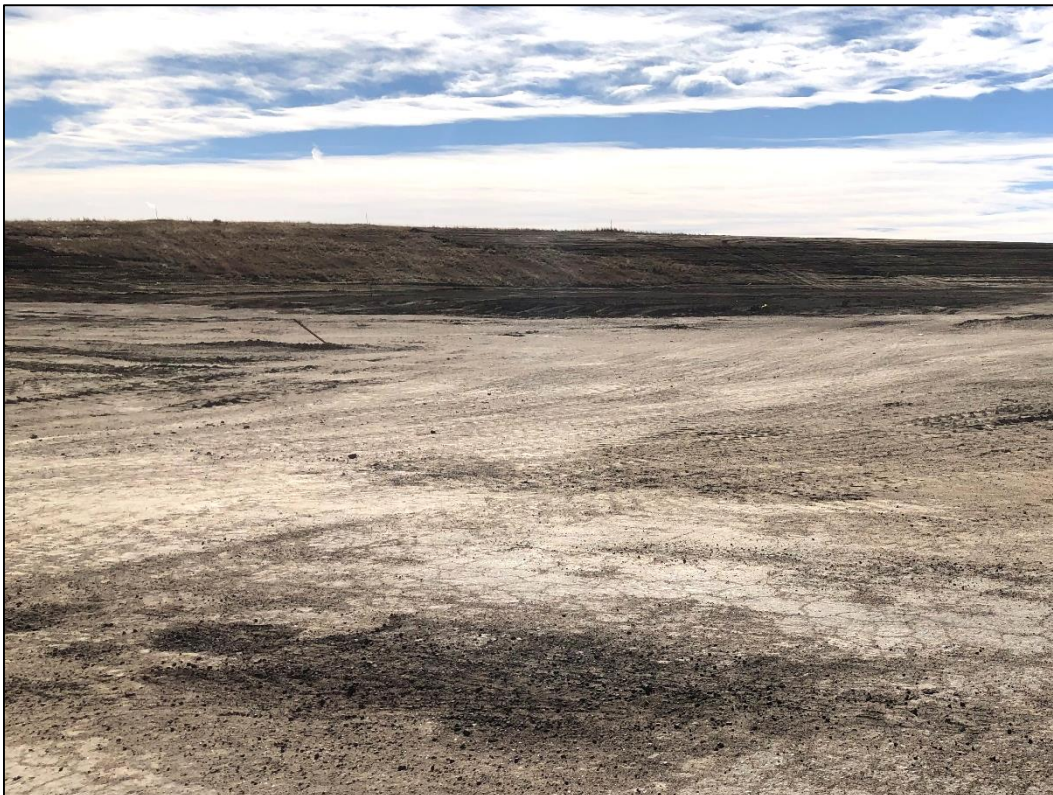
**Photo 16.** View looking southeast across eastern portion of pit where the southern highwall has been graded to 3H:1V or flatter and has good grass growth in some areas. The pit floor will require retopsoiling and revegetation.

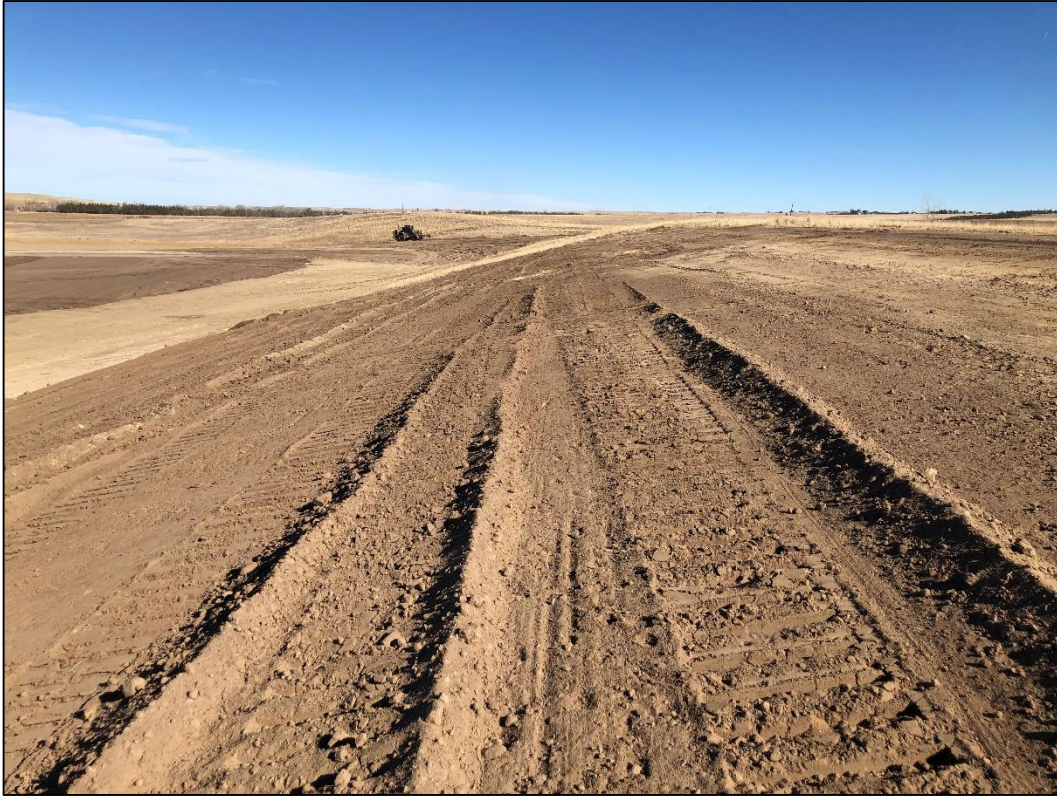
**Photo 17.** View looking northeast across southern highwall which has been backfilled and graded to 3H:1V or flatter.

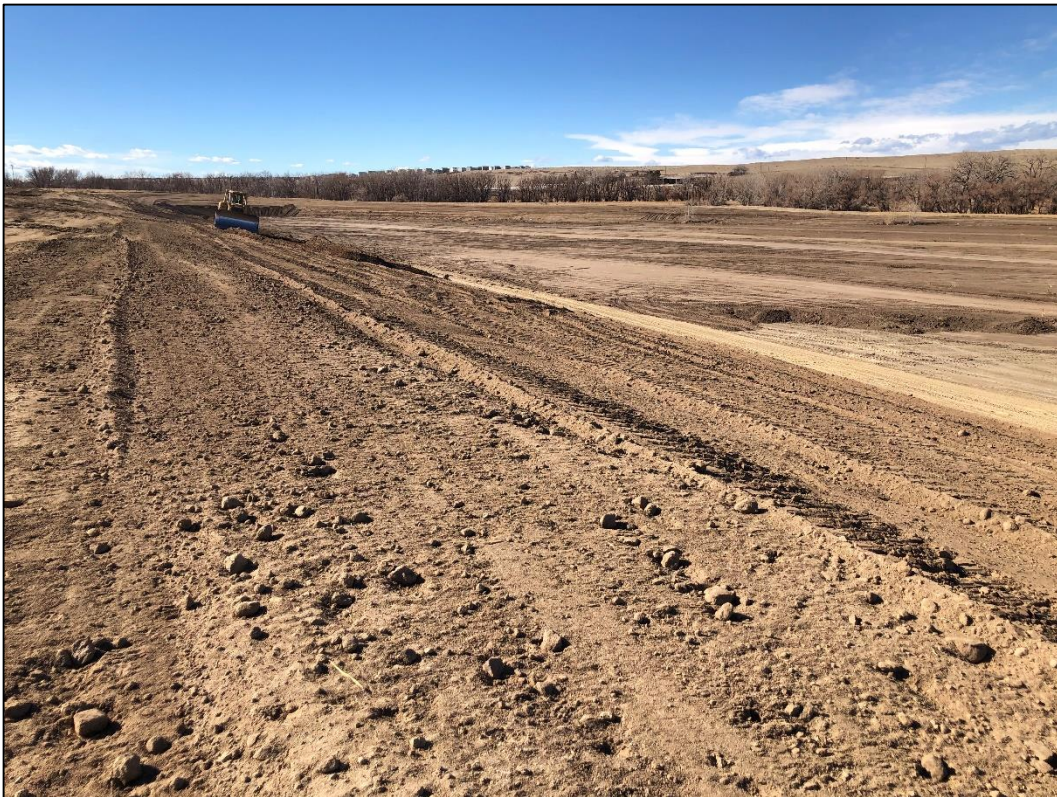
**Photo 18.** View looking southwest across southern highwall which has been backfilled and graded to 3H:1V or flatter.

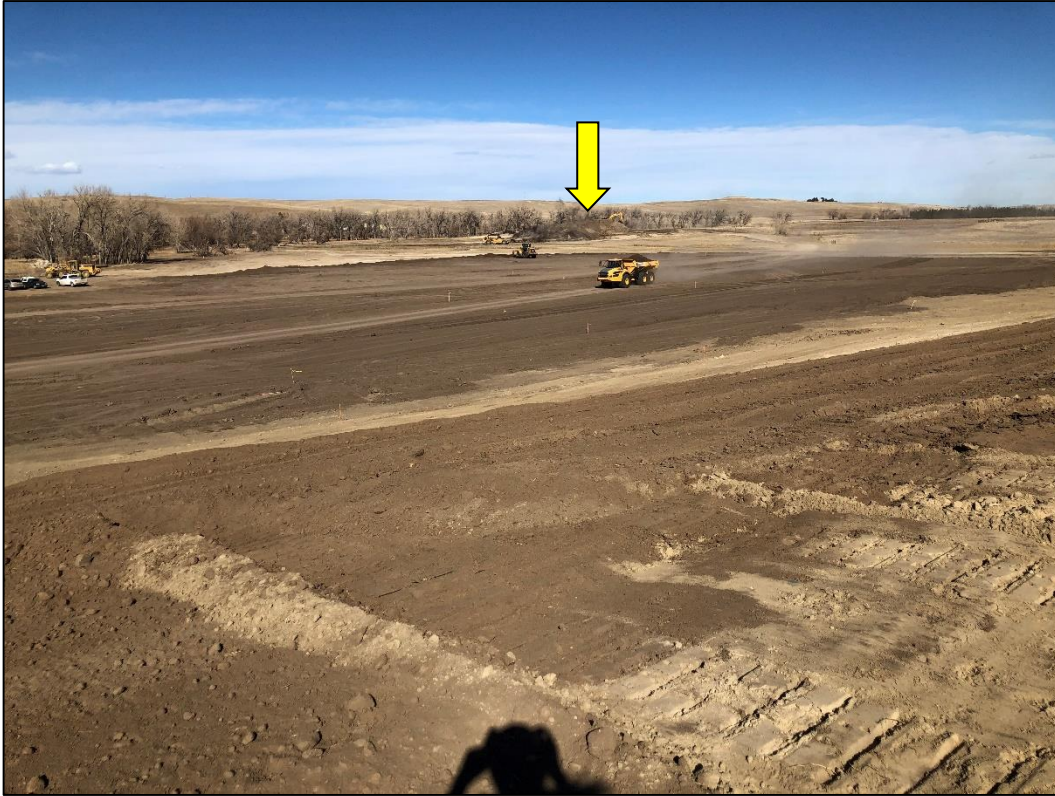
**Photo 19.** View looking north across site from top of southern highwall. For reference, location of remaining topsoil stockpile indicated in background.

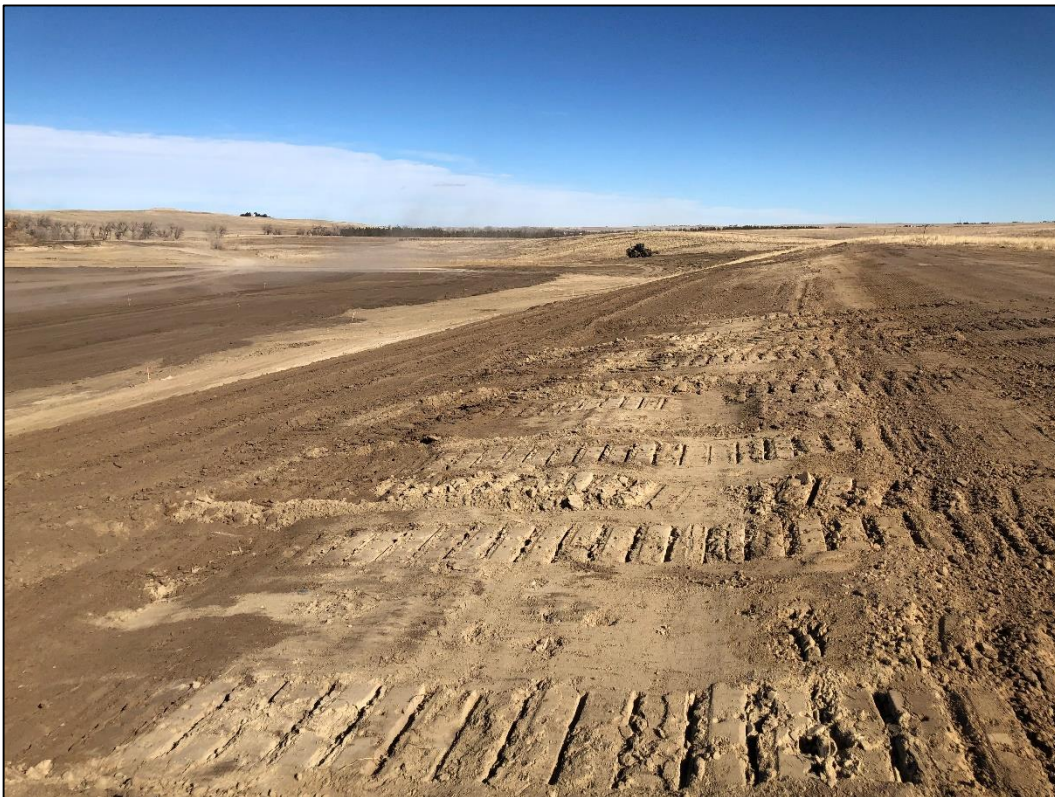
**Photo 20.** View looking northeast across southern highwall which has been backfilled and graded to 3H:1V or flatter.

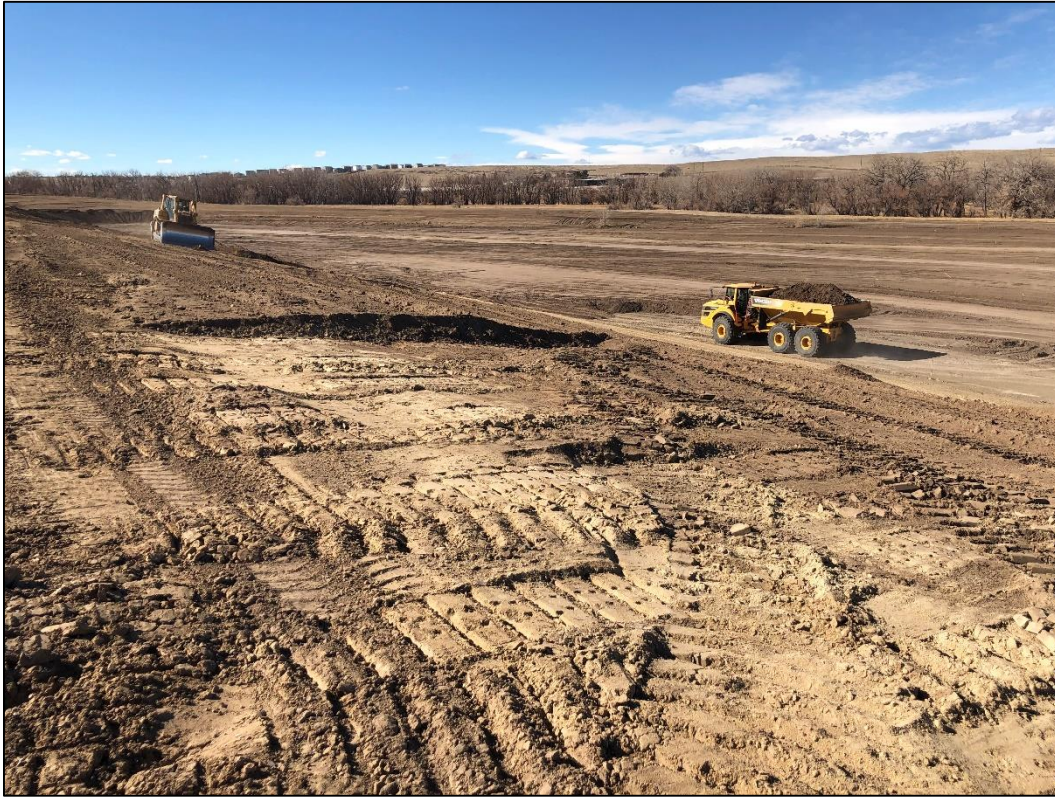
**Photo 21.** View looking southwest across southern highwall which has been backfilled and graded to 3H:1V or flatter. Note truck hauling backfill material to area and dozer grading slope during inspection.

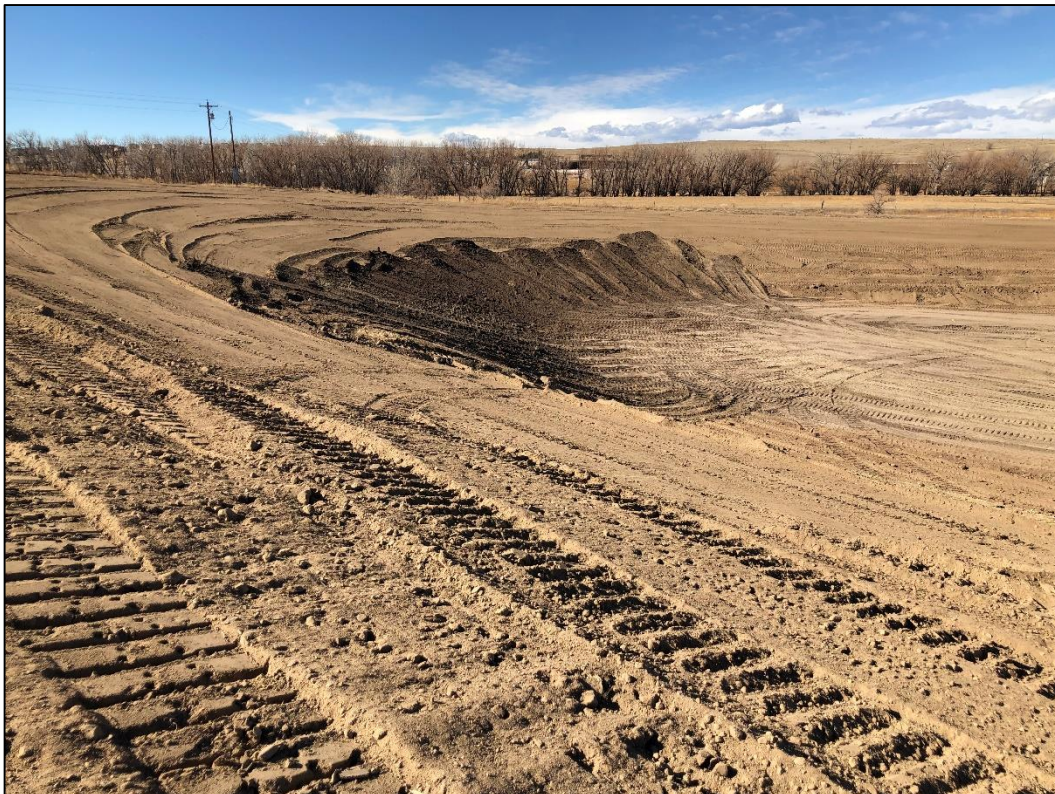
**Photo 22.** View looking southwest at most recently mined southwestern edge of highwall, which will be backfilled and graded to 3H:1V or flatter.

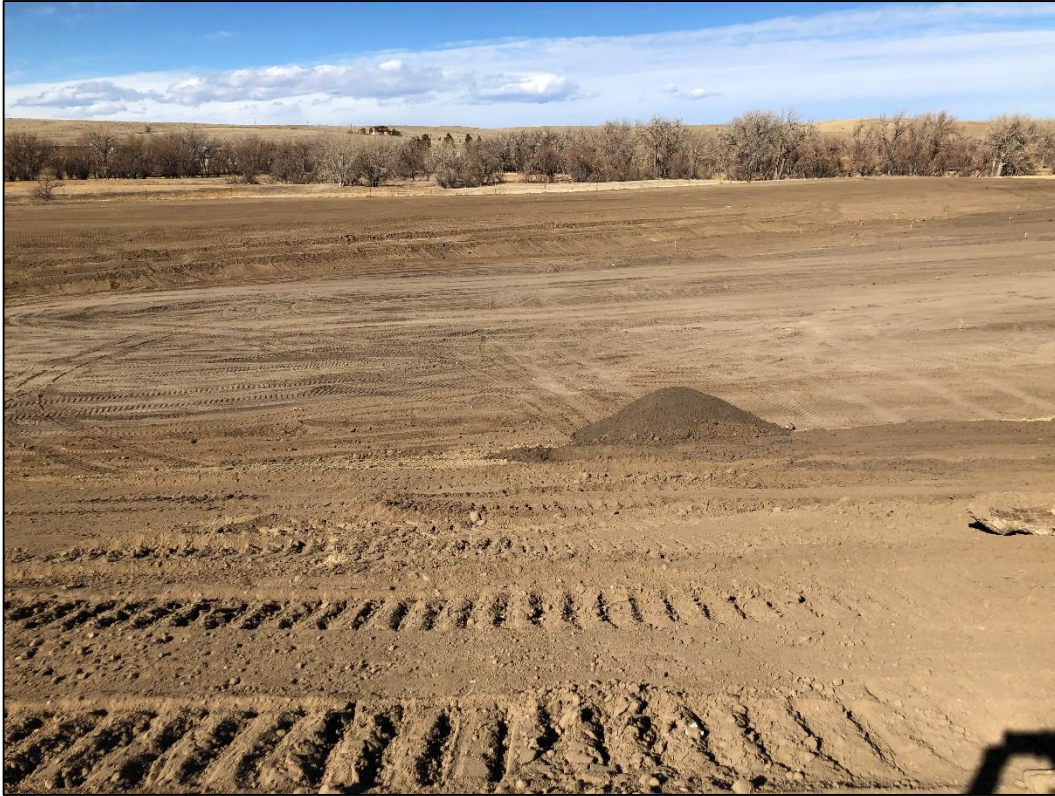
**Photo 23.** View looking west from top of southern highwall across southwestern portion of pit. Note western pit wall (in background) backfilled and graded to 3H:1V or flatter.

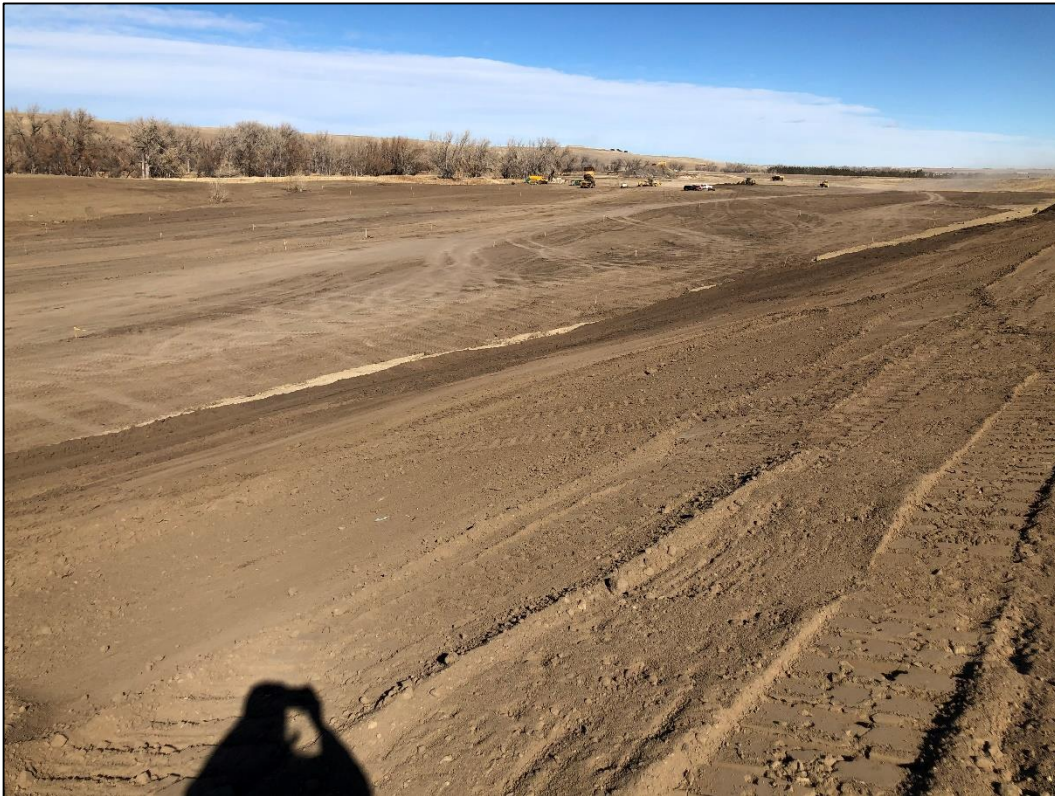
**Photo 24.** View looking north from top of southern highwall across southern portion of pit. Note highwall (in foreground) graded to 3H:1V or flatter.

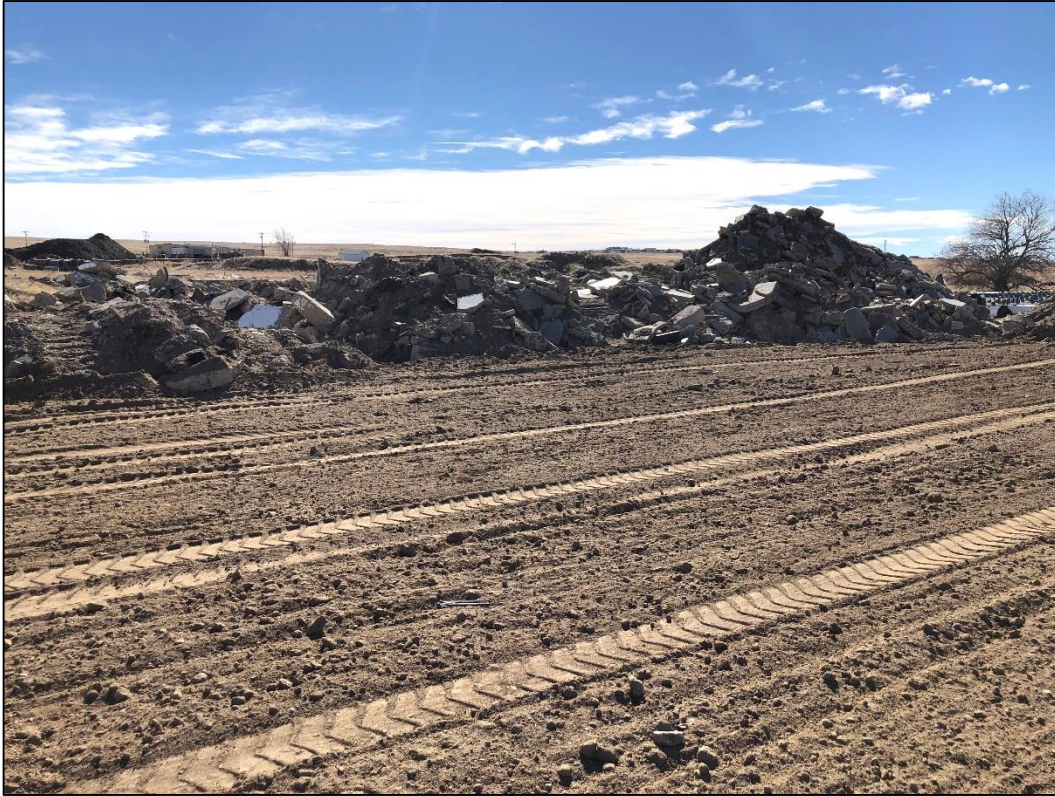
**Photo 25.** View looking southwest at area located south of pit (within permit area) where various pieces of equipment and other materials not related to the mining operation were left by previous landowner. This area is being cleaned up by the new landowner.
