**MINERALS PROGRAM INSPECTION REPORT**  
**PHONE: (303) 866-3567**

<b>MINE NAME:</b> Miller Gravel Pit	<b>MINE/PROSPECTING ID#:</b> M-1982-112	<b>MINERAL:</b> Sand and gravel	<b>COUNTY:</b> Elbert
<b>INSPECTION TYPE:</b> Monitoring	<b>INSPECTOR(S):</b> Amy Eschberger	<b>INSP. DATE:</b> February 3, 2021	<b>INSP. TIME:</b> 10:30
<b>OPERATOR:</b> Schmidt Construction Company	<b>OPERATOR REPRESENTATIVE:</b> Dan Chavez, Greg Olson, Mark Heifner	<b>TYPE OF OPERATION:</b> 112c - Construction Regular Operation	
<b>REASON FOR INSPECTION:</b> Normal I&E Program	<b>BOND CALCULATION TYPE:</b> Partial	<b>BOND AMOUNT:</b> \$146,646.00	
<b>DATE OF COMPLAINT:</b> NA	<b>POST INSP. CONTACTS:</b> None	<b>JOINT INSP. AGENCY:</b> None	
<b>WEATHER:</b> Clear	<b>INSPECTOR'S SIGNATURE:</b>

## M-1982-112 / Miller Gravel Pit / Schmidt Construction Company (112c)

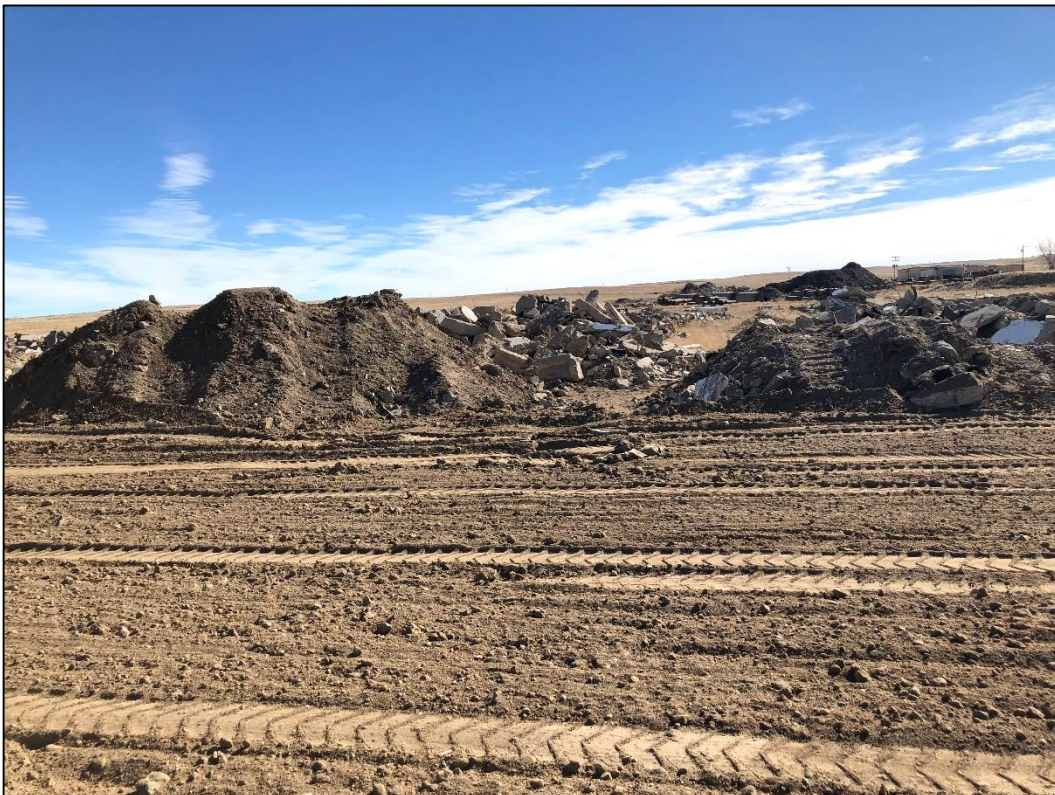
**Photo 26.** View looking south at area located south of pit (within permit area) where various pieces of equipment and other materials not related to the mining operation were left by previous landowner. This area is being cleaned up by the new landowner.

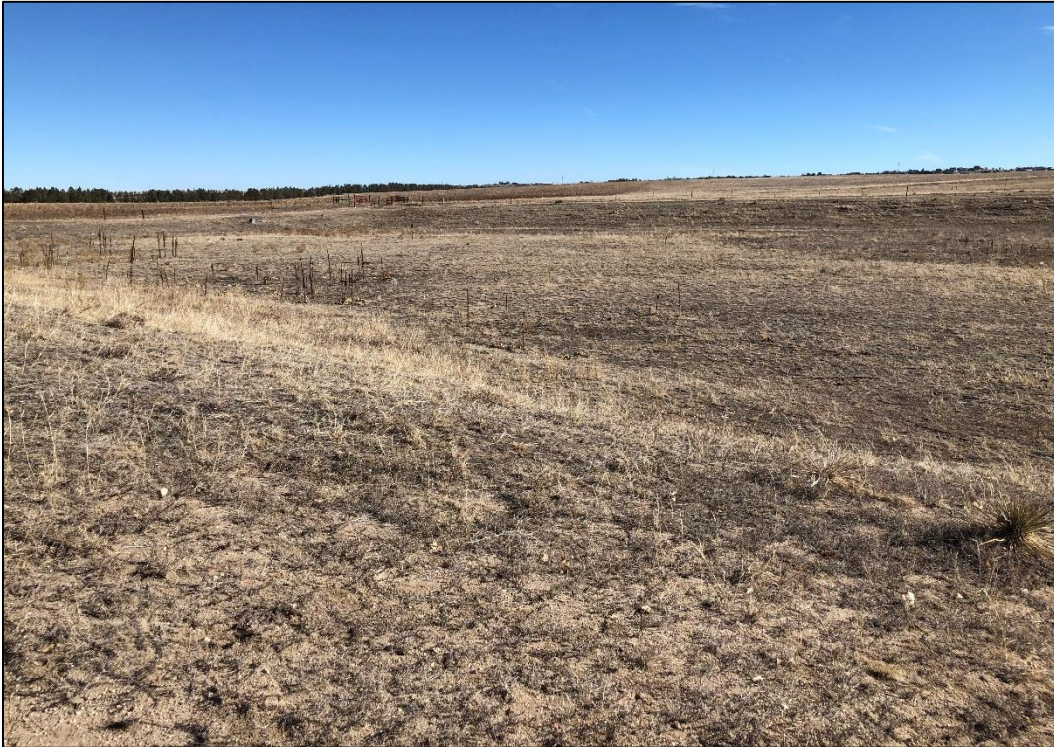
During the inspection, Mr. Mocevic (the landowner) expressed his dissatisfaction with the way the lands located northeast of the permit area had been reclaimed, particularly with regard to the grading. The landowner would like for the operator to place fill material from the mine site into this area and regrade it for positive drainage to the north. This area was reclaimed almost 20 years ago and was part of the land released in 2019 with the Division's approval of AR-1. The landowner was noticed of AR-1 but did not submit comments or objections to the release. On January 25, 2019, the Division inspected the lands requested for release and found them to be undisturbed by the operation or reclaimed in accordance with the approved reclamation plan. Now that these lands have been released from the permit area, the operator is not authorized to redisturb them. Additionally, all available material at the mine site must be used for reclaiming disturbed lands within the permit area. If any excess material remains after all required earthwork has been completed at the mine site, the operator may then provide this material to the landowner. The operator has offered to rework the offsite lands under a separate contract with the landowner, by removing all or a portion of the existing northern berm and using this material to create positive drainage to the north. These activities would not require additional permitting through our Office, as long as the excavated material does not leave the property.

**Photo 27.** View looking northeast across land located northeast of permit area which was released from the permit in 2019 through AR-1. The landowner would like this area to be reworked to create positive drainage. However, the operator is not authorized to redisturb or place reclamation material in this area under the current permit.

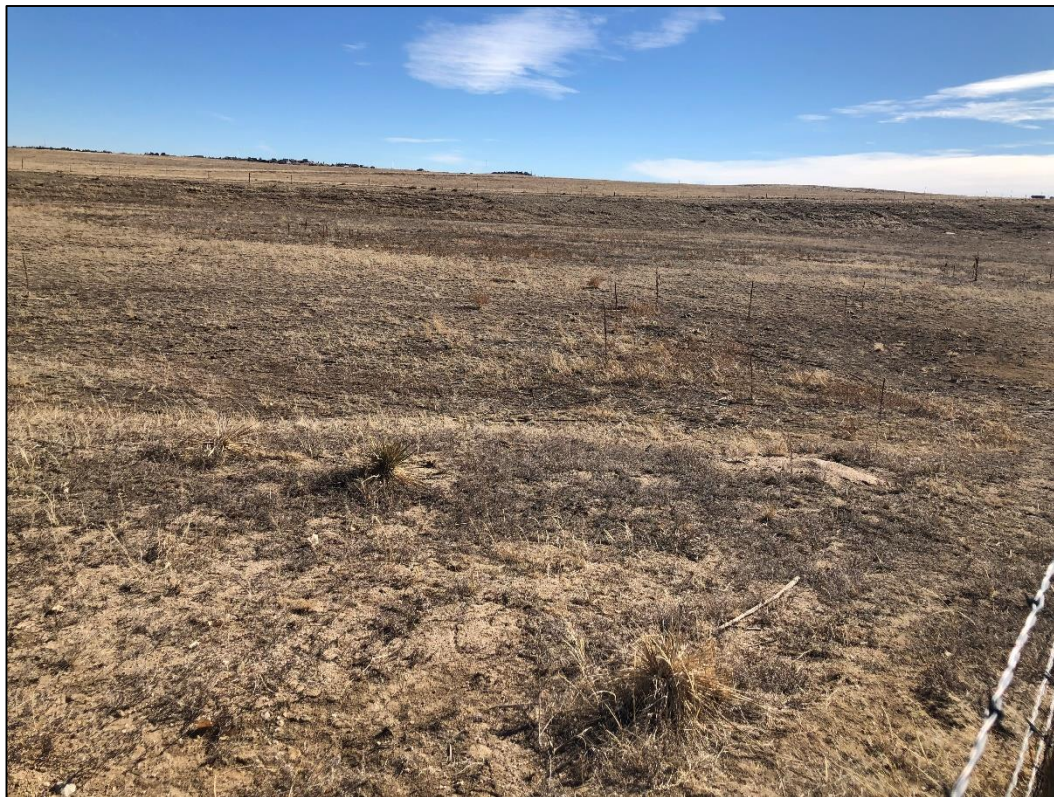
**Photo 28.** View looking east across land located northeast of permit area which was released from the permit in 2019 through AR-1. The landowner would like this area to be reworked to create positive drainage. However, the operator is not authorized to redisturb or place reclamation material in this area under the current permit.
