**RE: Colowyo Coal Mine  
Permit No. C-1981-019  
Fill Monitoring Certifications  
First Quarter 2021**

### **South Taylor Fill Inspection Certification**

**INSPECTION REPORT ~ SOUTH TAYLOR FILL**  
**(Including Both the East Taylor and West Taylor Fill Segments)**

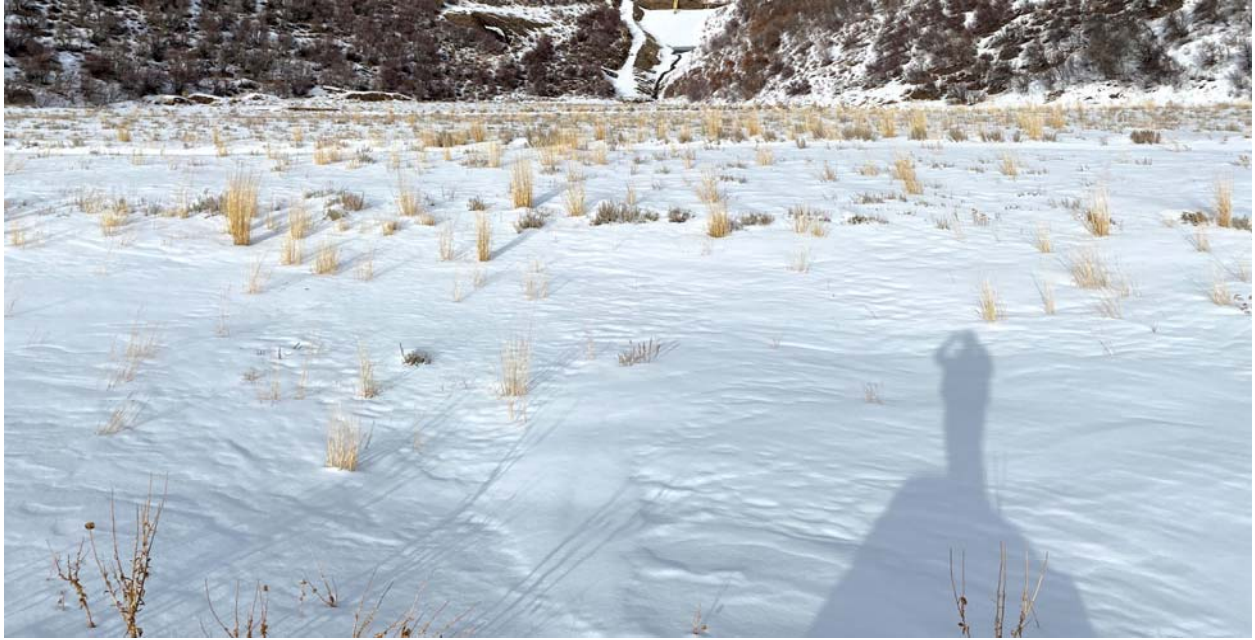
2-01-21 - West Taylor fill looking north from monitoring well location

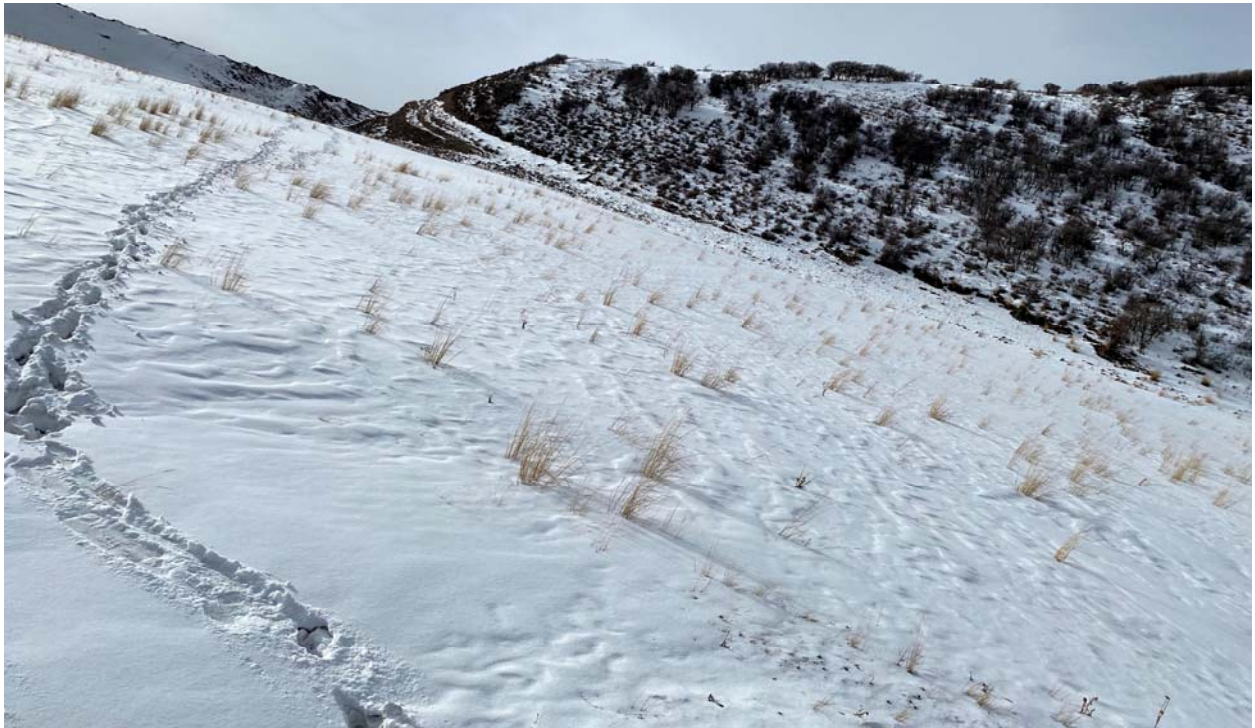
**West Taylor Fill with A-A' and B-B' Underdrain Area** The East Tributary of the West Taylor fill has rip-rap installed up to the 7840' elevation. The West Tributary of the West Taylor fill has rip-rap installed up to the 7820' elevation.

2-01-21 - West Taylor Fill West Flank from monitoring well location

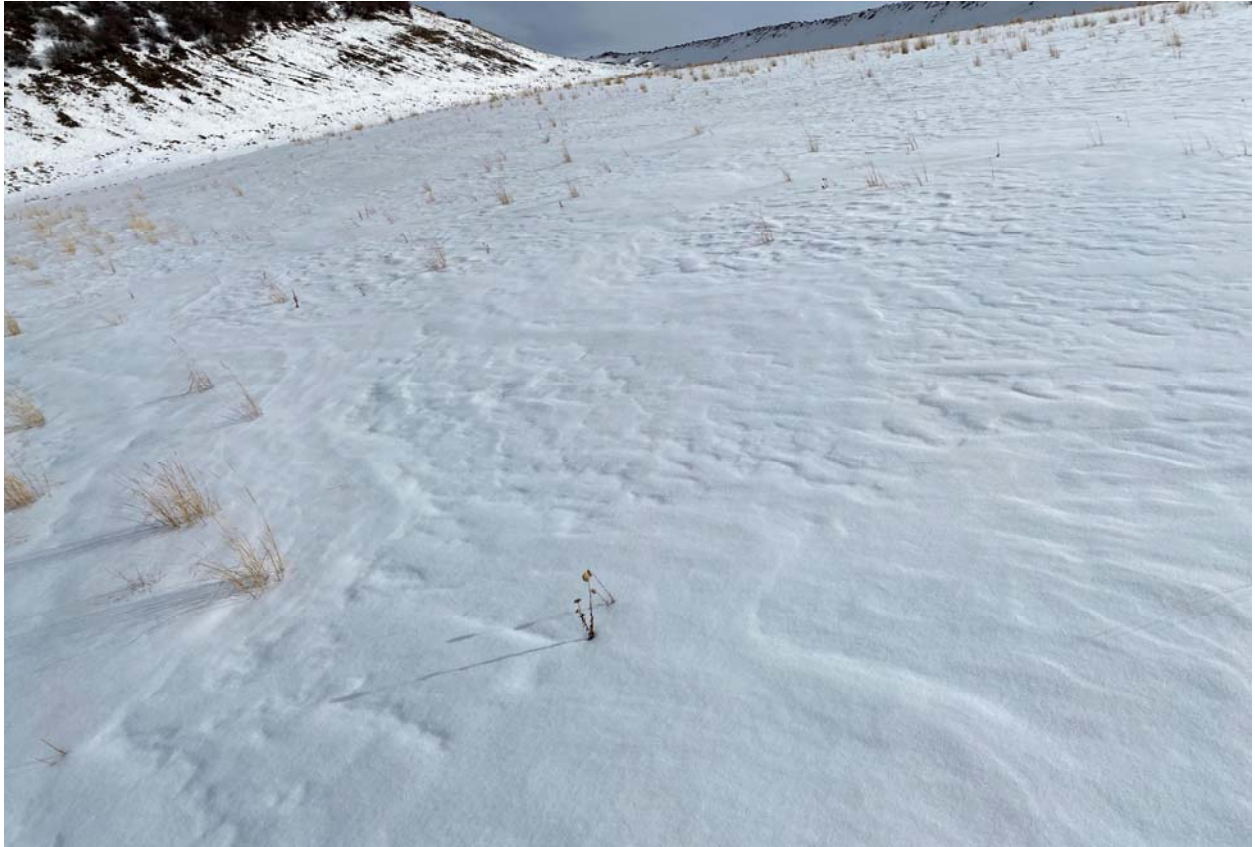
2-01-21 - West Taylor Fill East Flank from monitoring well location

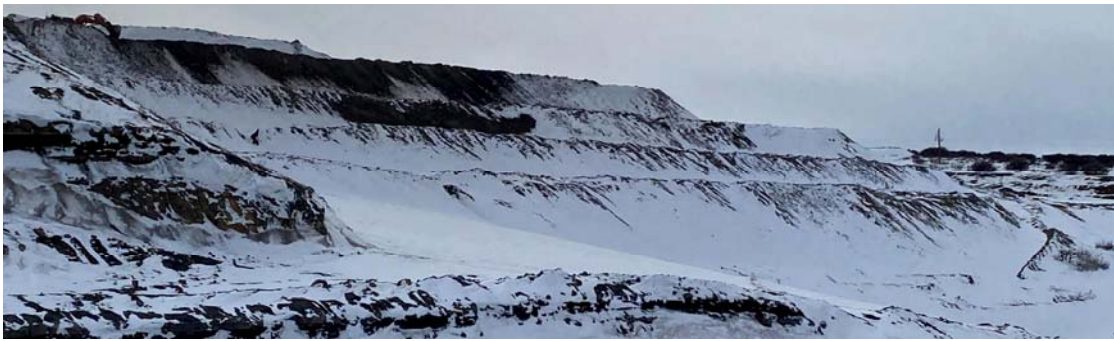
**East Taylor Fill with C-C' Underdrain Area:** Reclamation activity including truck/excavator removal of material from the top of the fill area as well as dozer's cleaning various benches as the top surface is lowered has taken place within the East Taylor fill during this quarter.

No structural weakness, signs of instability, or other hazards were noted at the time of inspection.

2-01-21 - East Taylor Fill looking southwest from the West Pit reclamation
