MINERALS PROGRAM INSPECTION REPORT

MINE NAME: Freund Pit	MINE/PROSPECTING ID#: M-1985-003	MINERAL: Sand and gravel	COUNTY: Elbert
INSPECTION TYPE: Monitoring	INSPECTOR(S): Amy Eschberger	INSP. DATE: February 3, 2021	INSP. TIME: 13:00
OPERATOR: Running Creek Ranch	OPERATOR REPRESENTATIVE: Joseph Freund, Jr.	TYPE OF OPERATION: 112c - Construction Regular Operation	
REASON FOR INSPECTION: Normal I&E Program	BOND CALCULATION TYPE: Complete Bond	BOND AMOUNT: \$11,902.00	
DATE OF COMPLAINT: NA	POST INSP. CONTACTS: None	JOINT INSP. AGENCY: None	
WEATHER: Clear	INSPECTOR'S SIGNATURE:

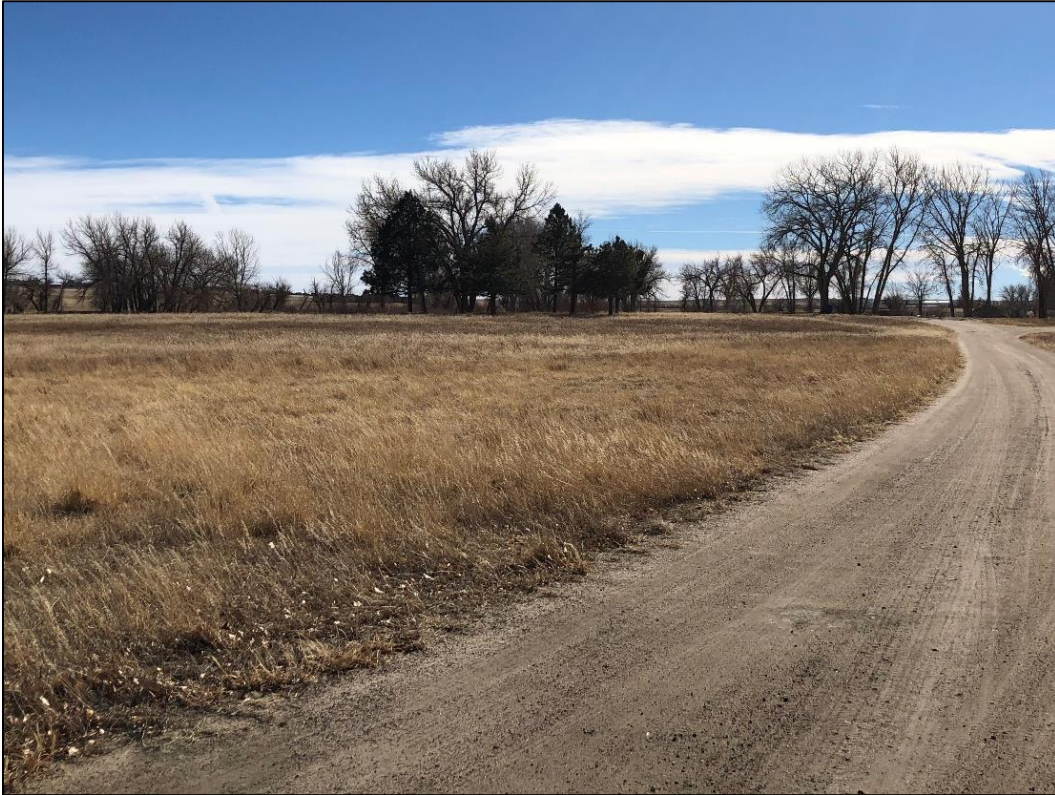
Photo 1. View looking southeast from access road across northern portion of permit area never disturbed by mining operation.

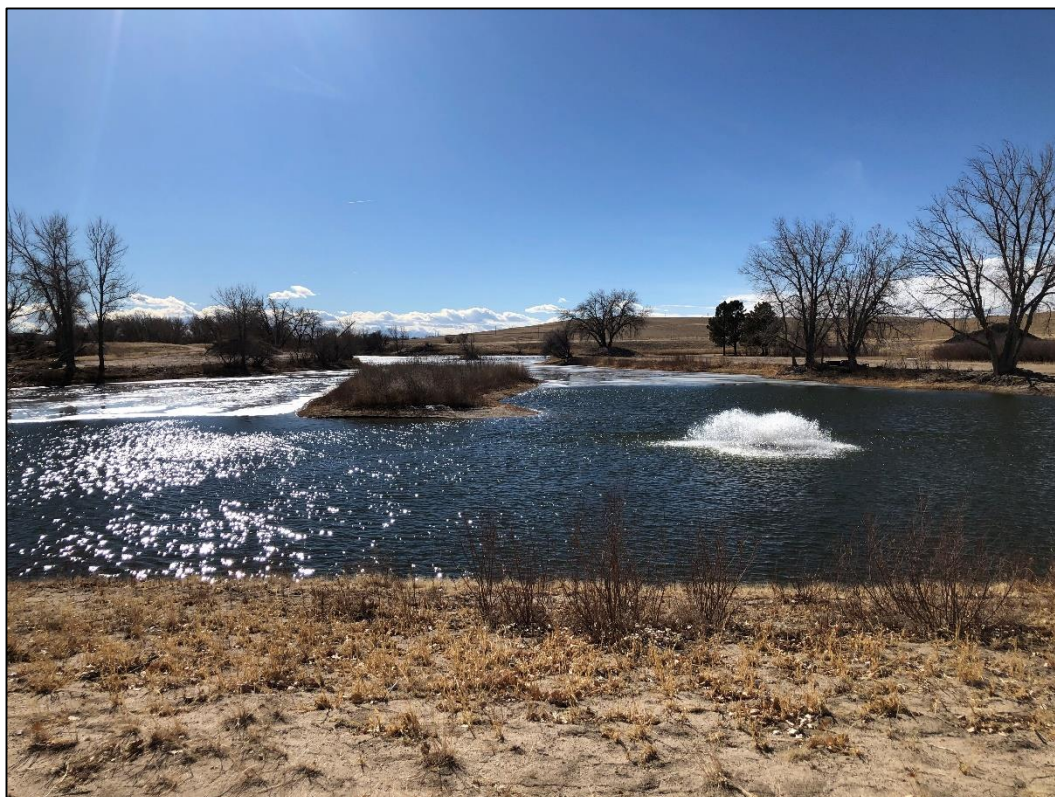
Photo 2. View looking southwest across northern portion of pond from its northern edge. Note island in background.

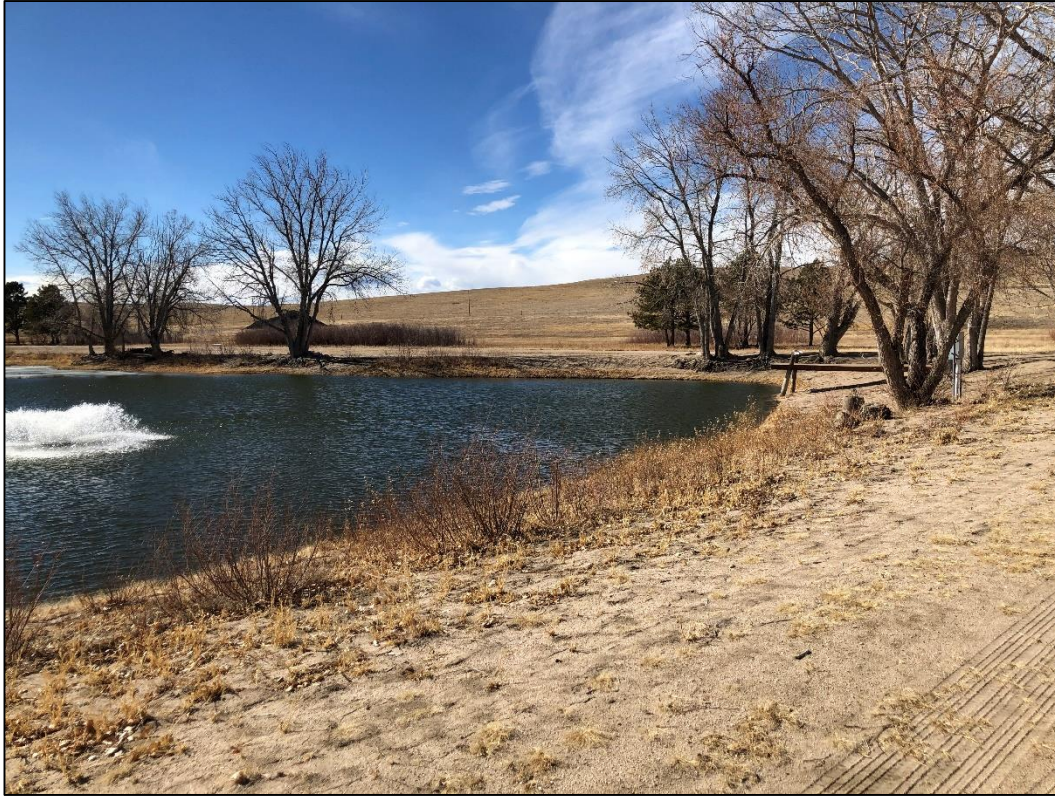
Photo 3. View looking northwest across northern shoreline of pond, graded 3H:1V or flatter and stable with some vegetative cover consisting of grasses and trees (willows and cottonwoods).

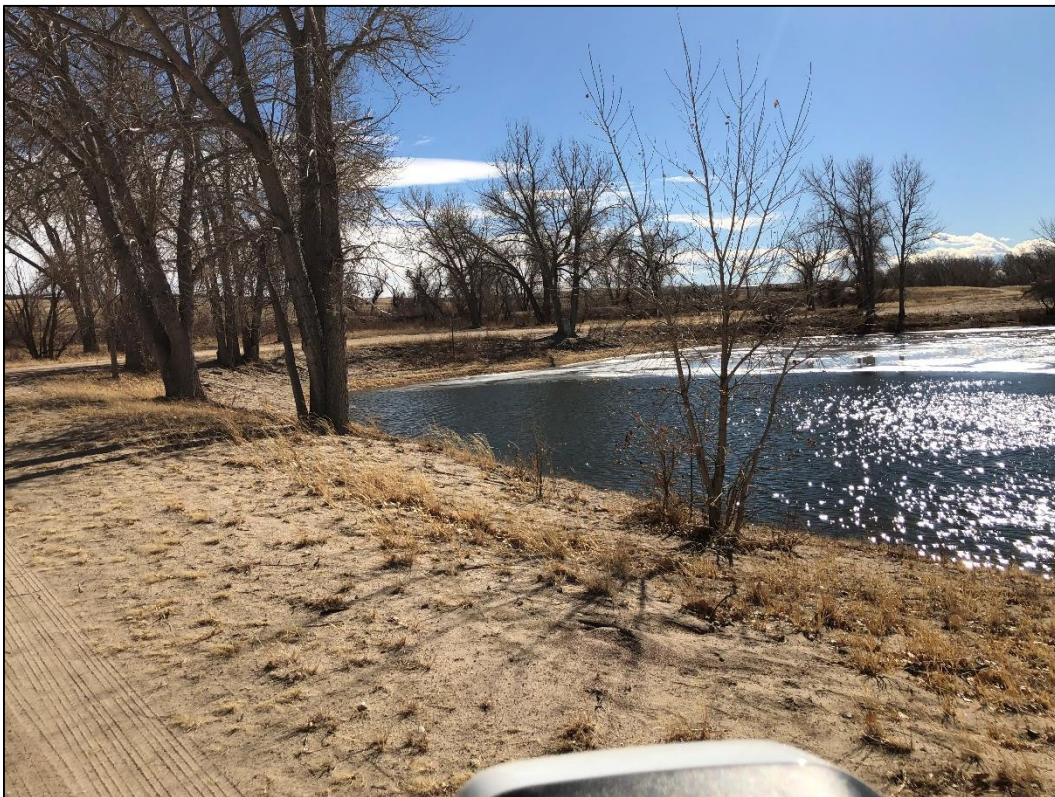
Photo 4. View looking southeast across northern shoreline of pond, graded 3H:1V or flatter and stable with some vegetative cover consisting of grasses and trees (willows and cottonwoods).

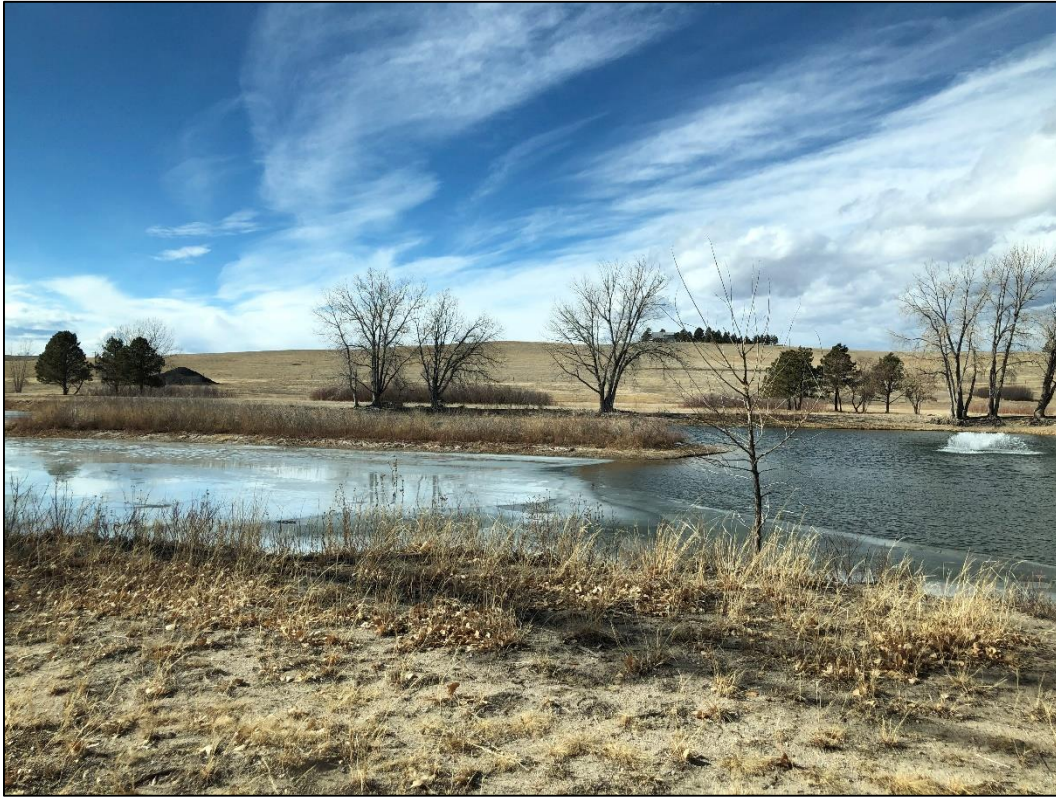
Photo 5. View looking west across northern portion of pond from its eastern edge. Note pond banks stabilized with grasses and trees (willows and cottonwoods). Pond island visible in background, left.

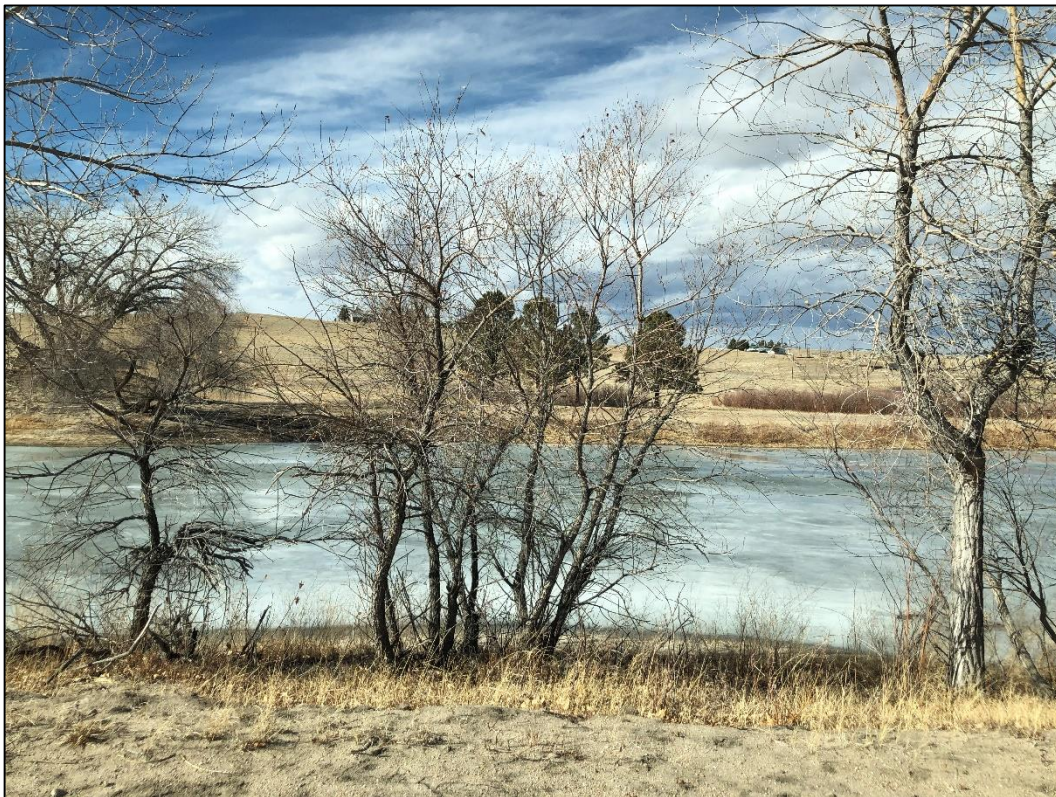
Photo 6. View looking west across pond from its eastern edge. Note pond banks stabilized with grasses and trees (willows and cottonwoods).

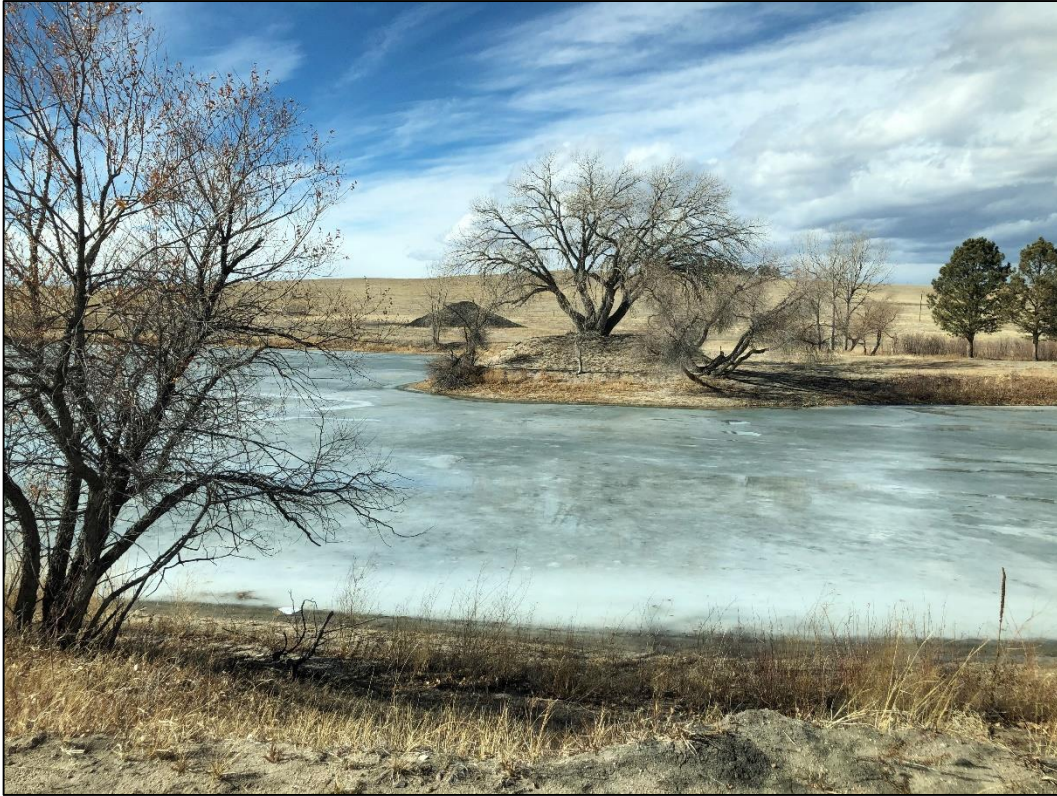
Photo 7. View looking west across pond from its eastern edge. Note pond banks stabilized with grasses and trees (willows and cottonwoods).

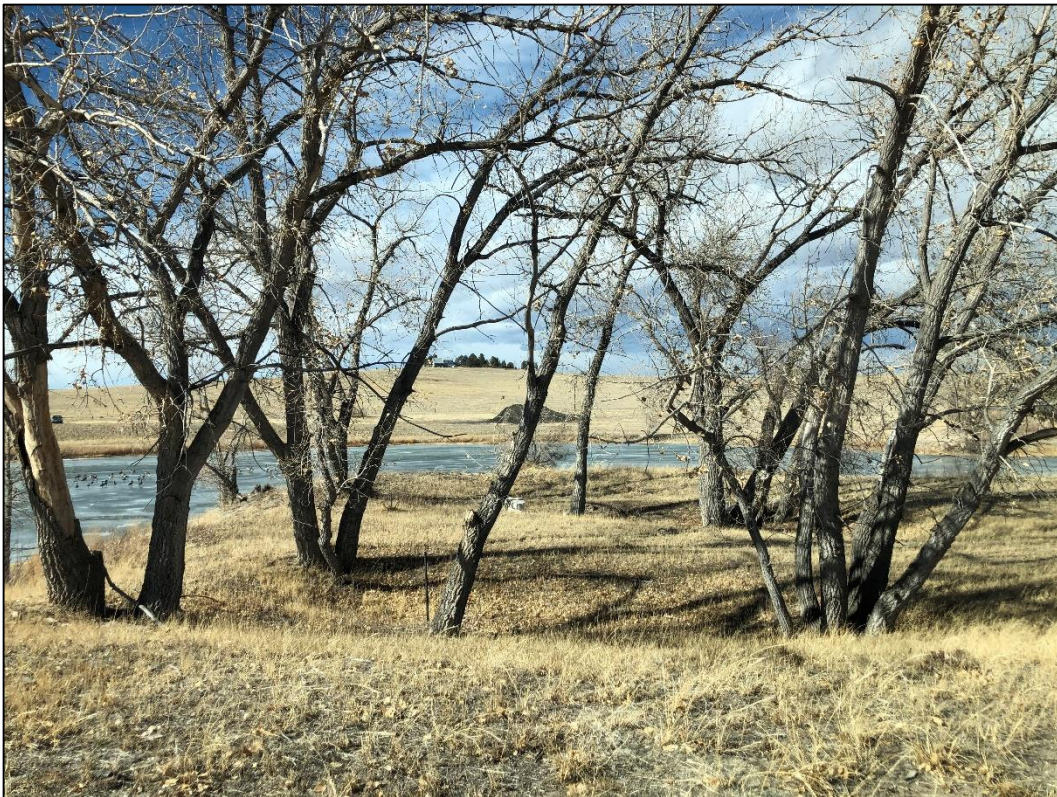
Photo 8. View looking west across area east of pond with good vegetative cover consisting of grasses and cottonwood trees.

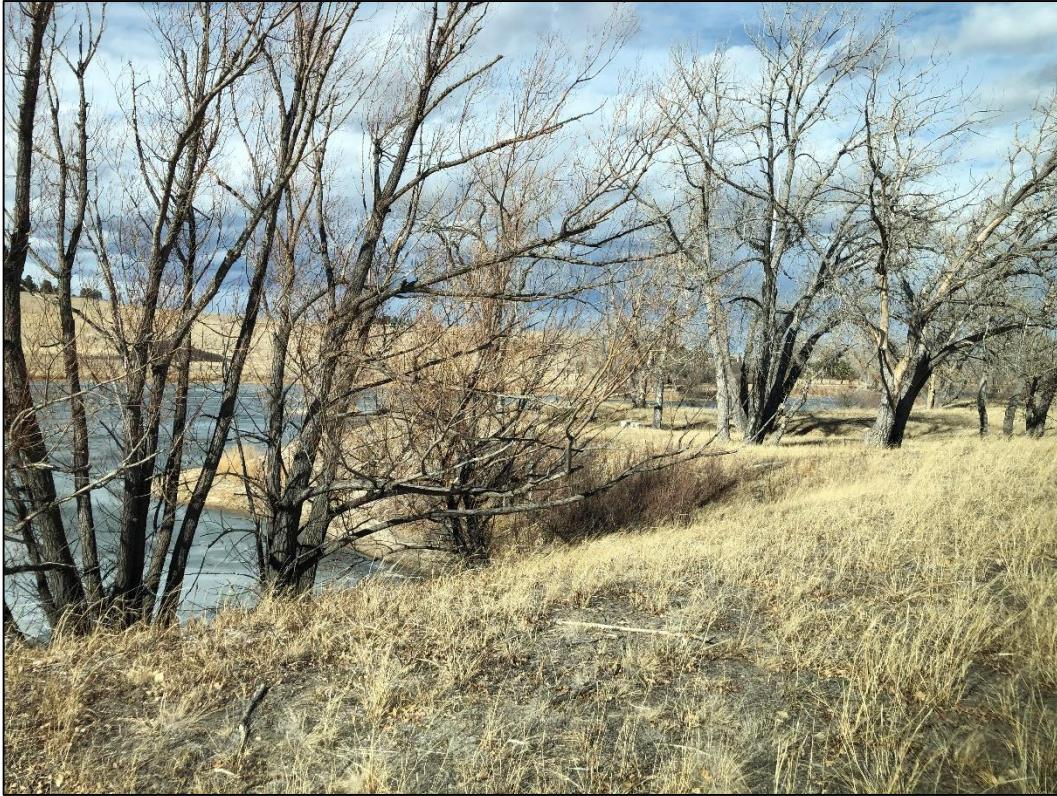
Photo 9. View looking northeast across eastern pond shoreline, graded steeper than 3H:1V but stable with good vegetative cover consisting of grasses and trees (willows and cottonwoods).

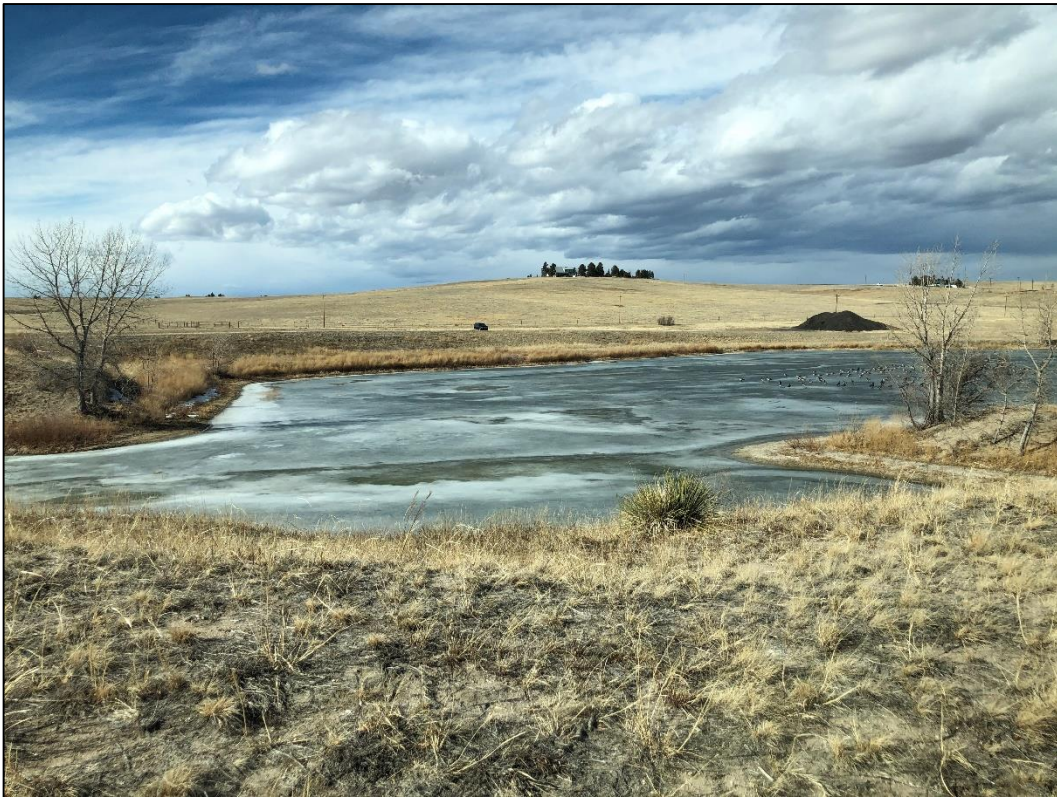
Photo 10. View looking west across pond from its eastern edge. Note shorelines graded 3H:1V or flatter and stable with good vegetative cover consisting of grasses and trees (willows and cottonwoods).

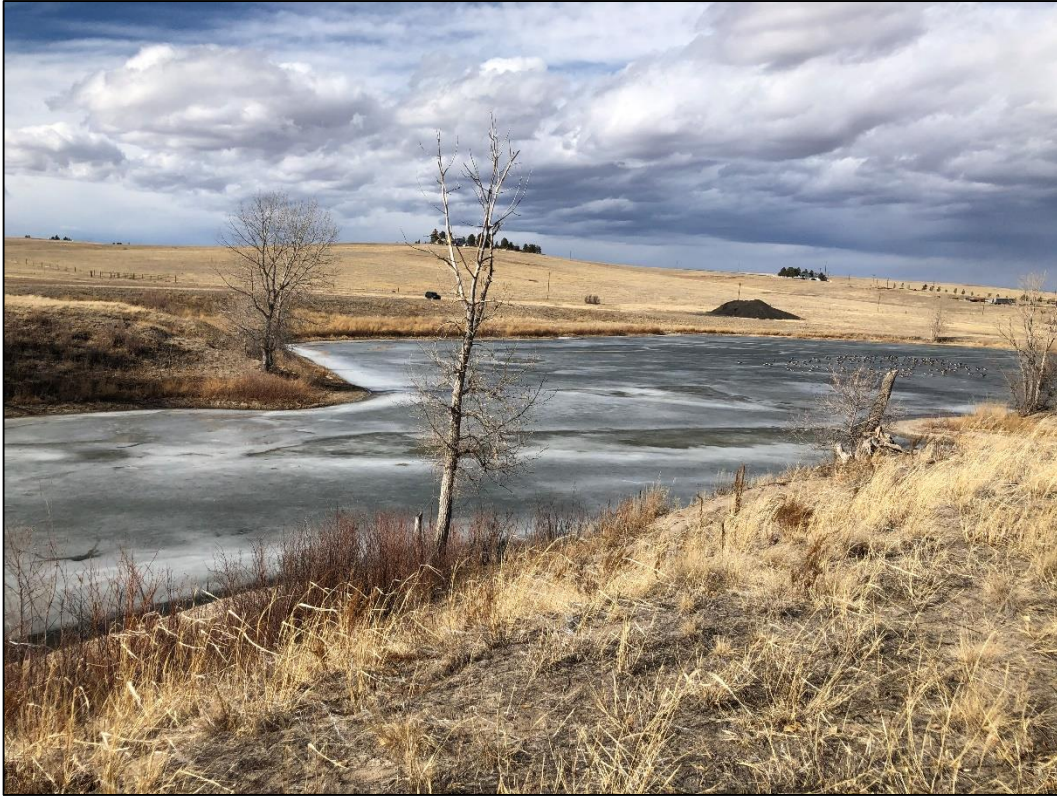
Photo 11. View looking northwest across pond from its eastern edge. Note shorelines stable with good vegetative cover consisting of grasses and trees (willows and cottonwoods).

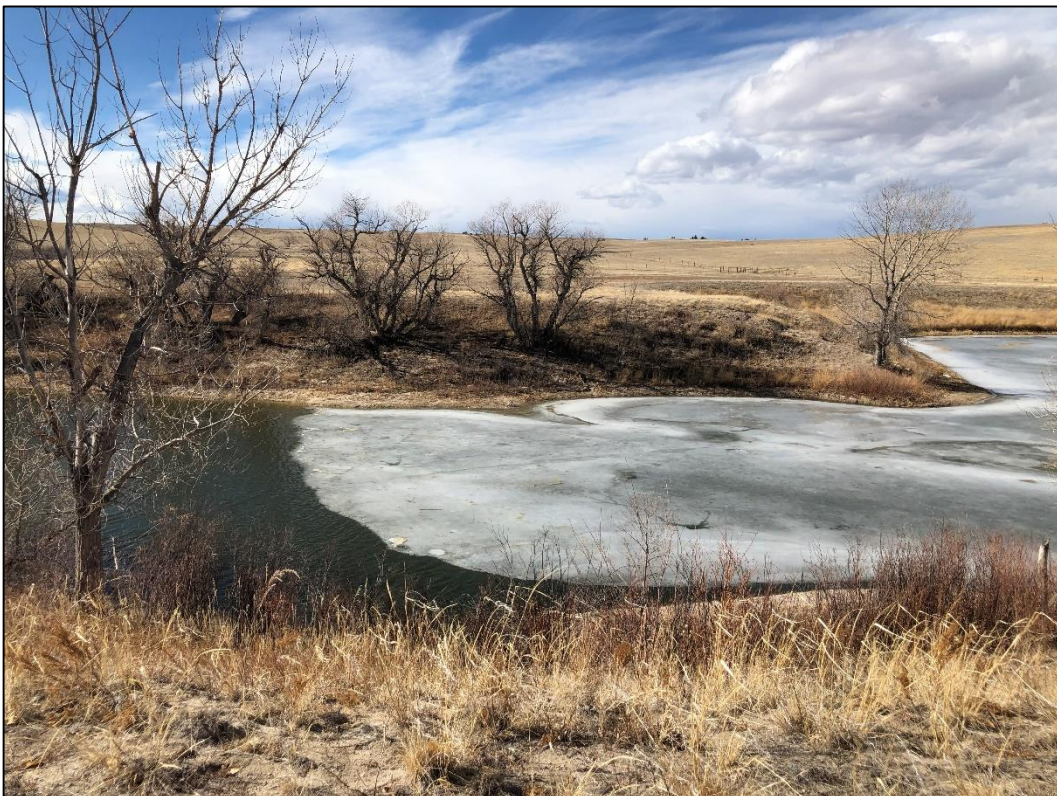
Photo 12. View looking west across pond from its eastern edge. Note shorelines stable with good vegetative cover consisting of grasses and trees (willows and cottonwoods).

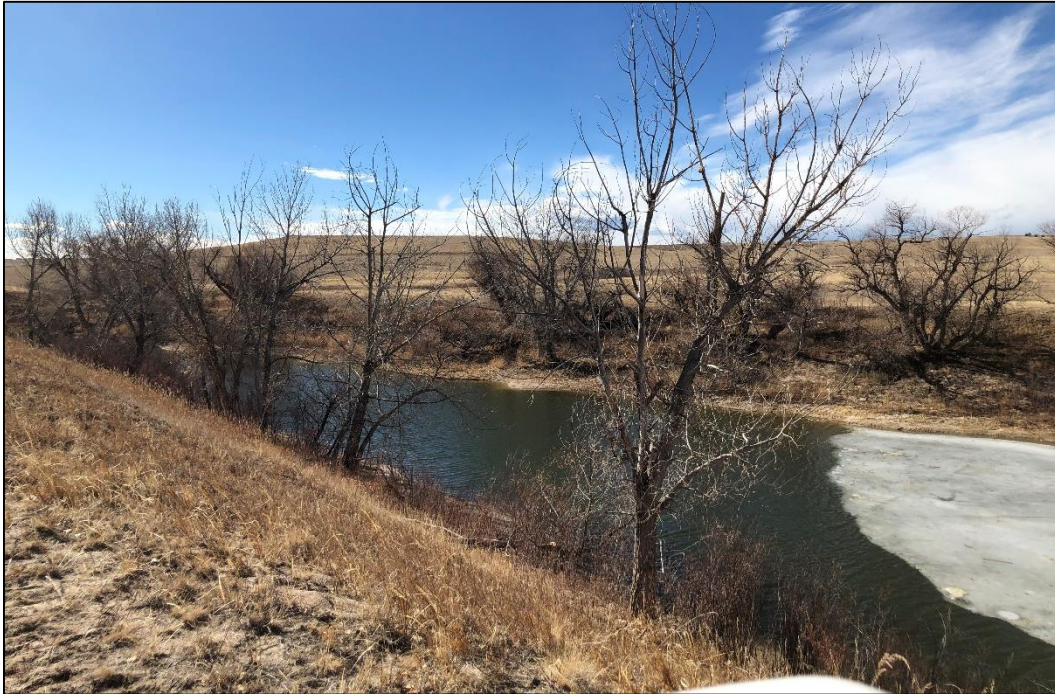
Photo 13. View looking southwest across southern portion of pond from its eastern edge. This portion of eastern pond bank (in foreground) is higher and steeper than rest of pond. Note pond banks stable with good vegetative cover consisting of grasses and trees (willows and cottonwoods).

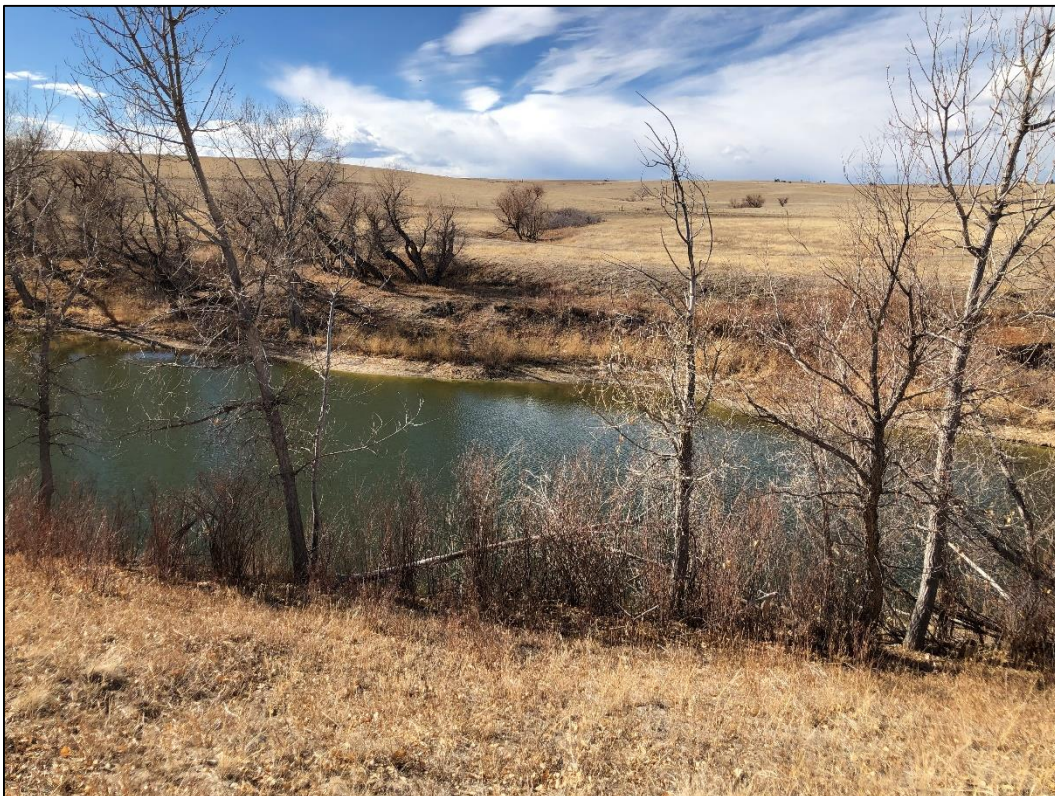
Photo 14. View looking west across southern portion of pond from its eastern edge. This portion of eastern pond bank (in foreground) is higher and steeper than rest of pond. Note pond banks stable with good vegetative cover consisting of grasses and trees (willows and cottonwoods).

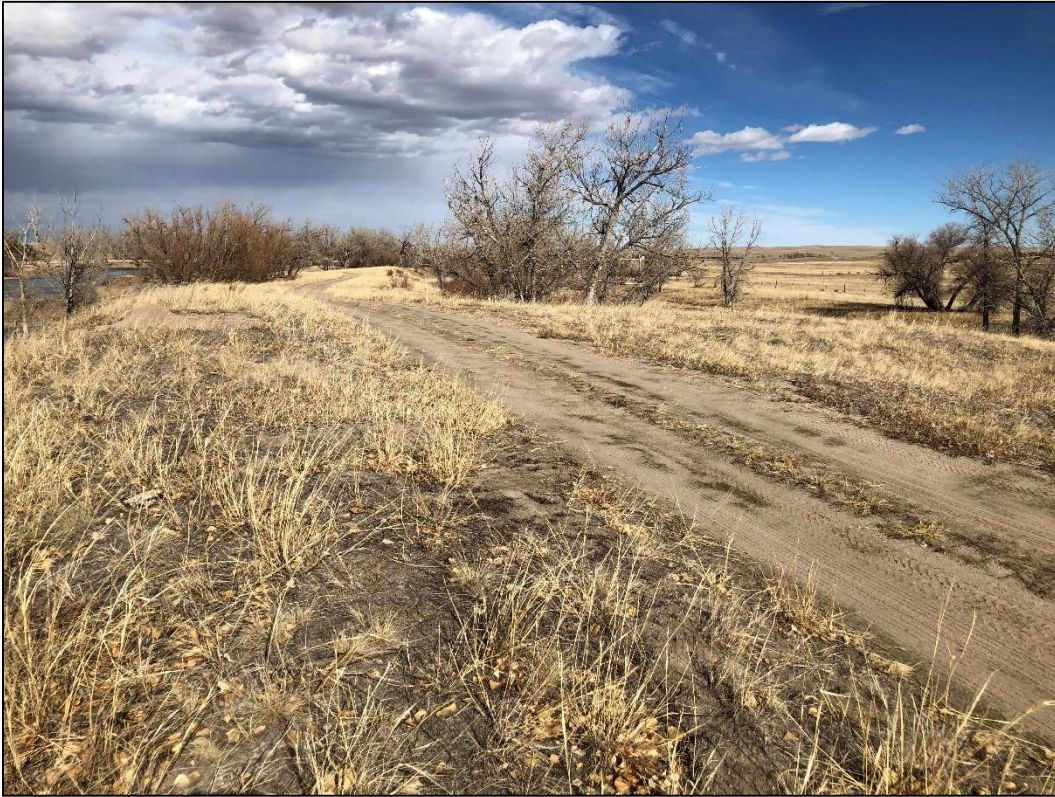
Photo 15. View looking northeast at dirt road that circles perimeter of pond, which will remain after reclamation.

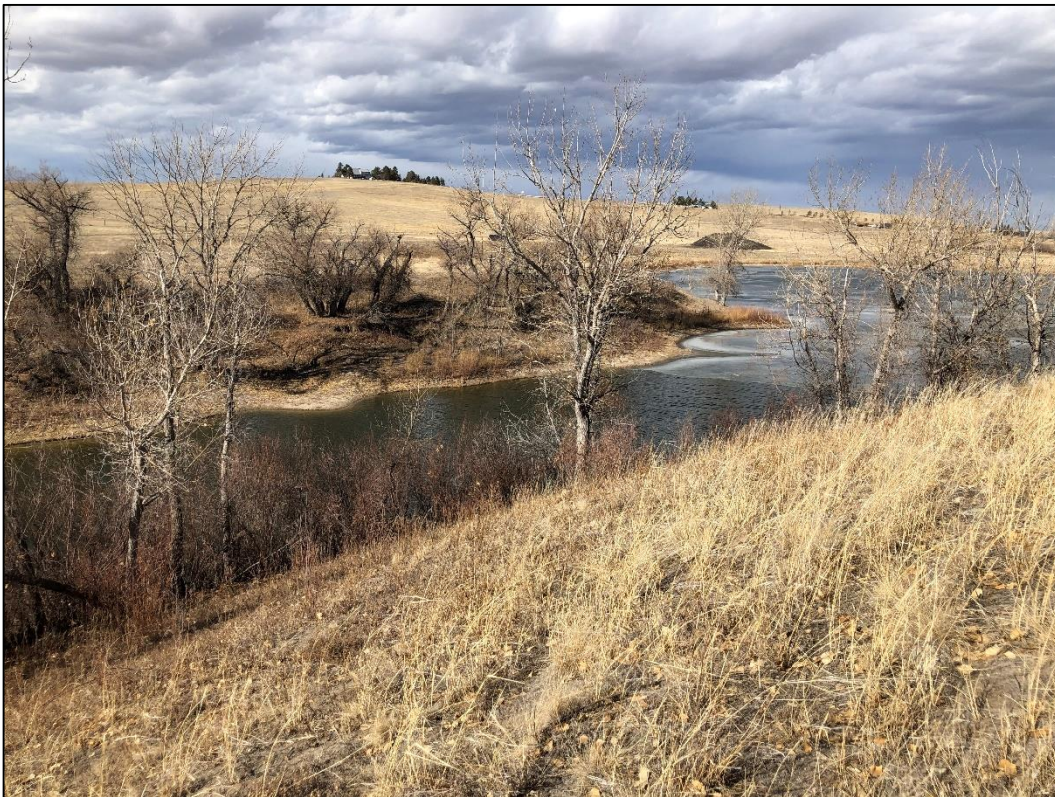
Photo 16. View looking north across southern portion of pond from its eastern edge. This portion of eastern pond bank (in foreground) is higher and steeper than rest of pond. Note pond banks stable with good vegetative cover consisting of grasses and trees (willows and cottonwoods).

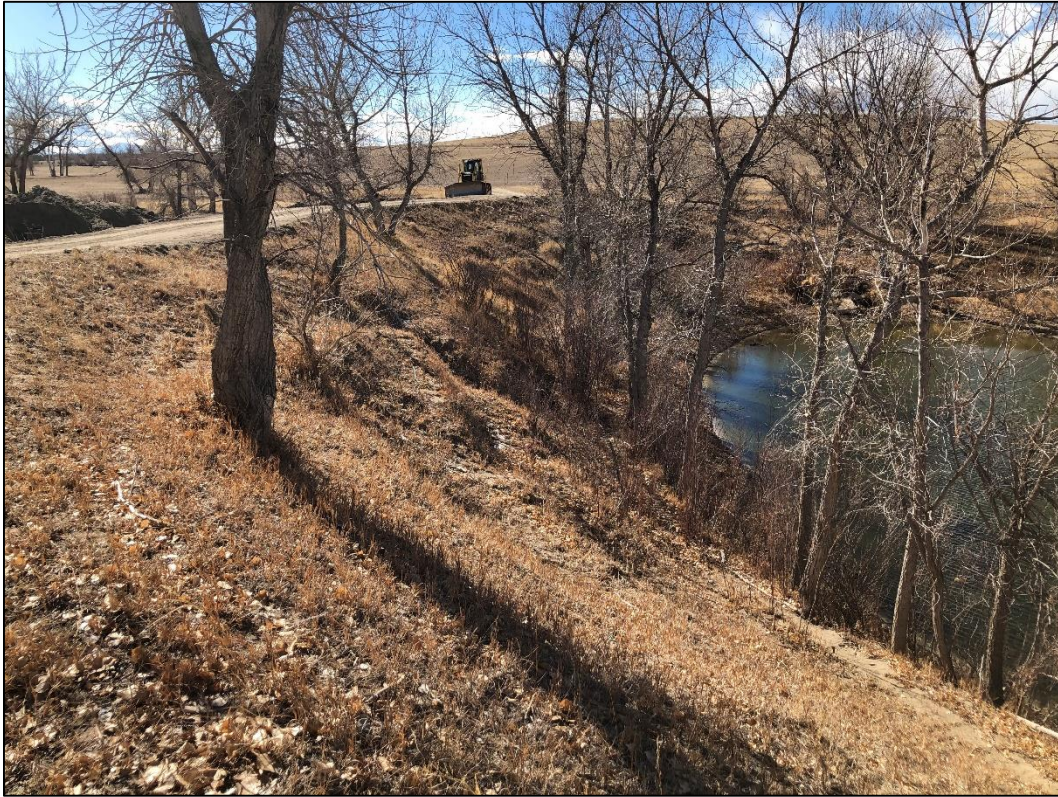
Photo 17. View looking southwest across southeastern pond shoreline. This portion of pond bank (in foreground) is higher and steeper than rest of pond. Note pond banks stable with good vegetative cover consisting of grasses and trees (willows and cottonwoods).

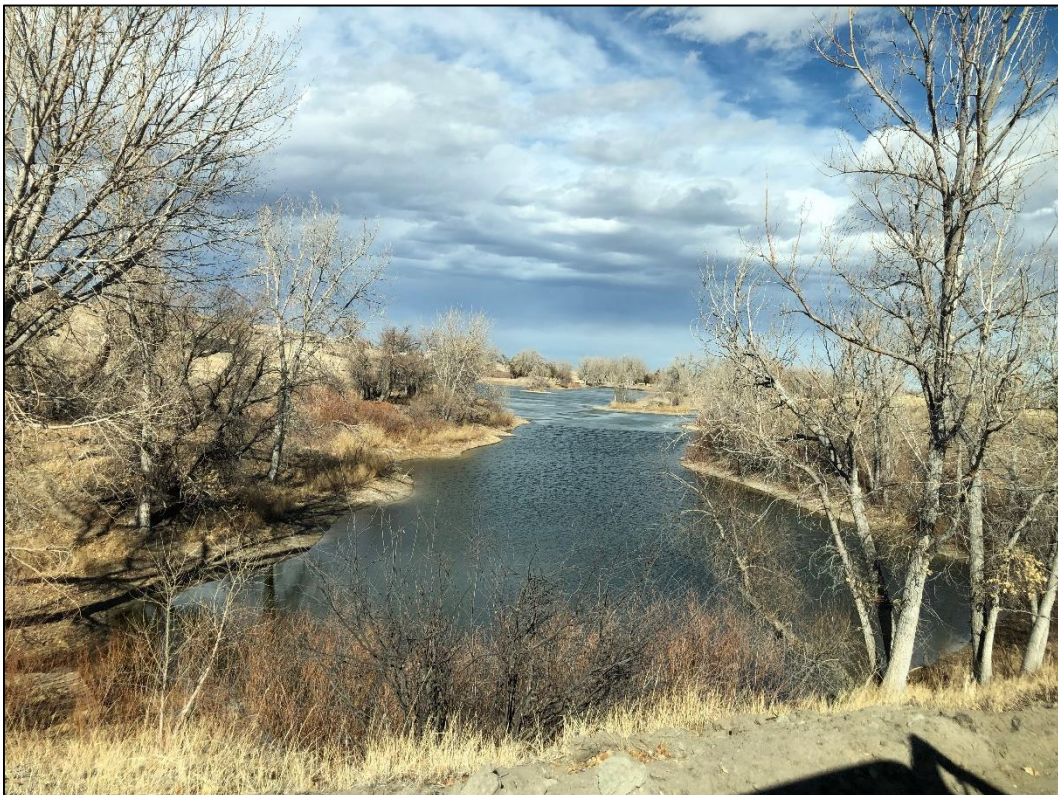
Photo 18. View looking northeast across pond from its southern edge. Note pond banks stable with good vegetative cover consisting of grasses and trees (willows and cottonwoods).

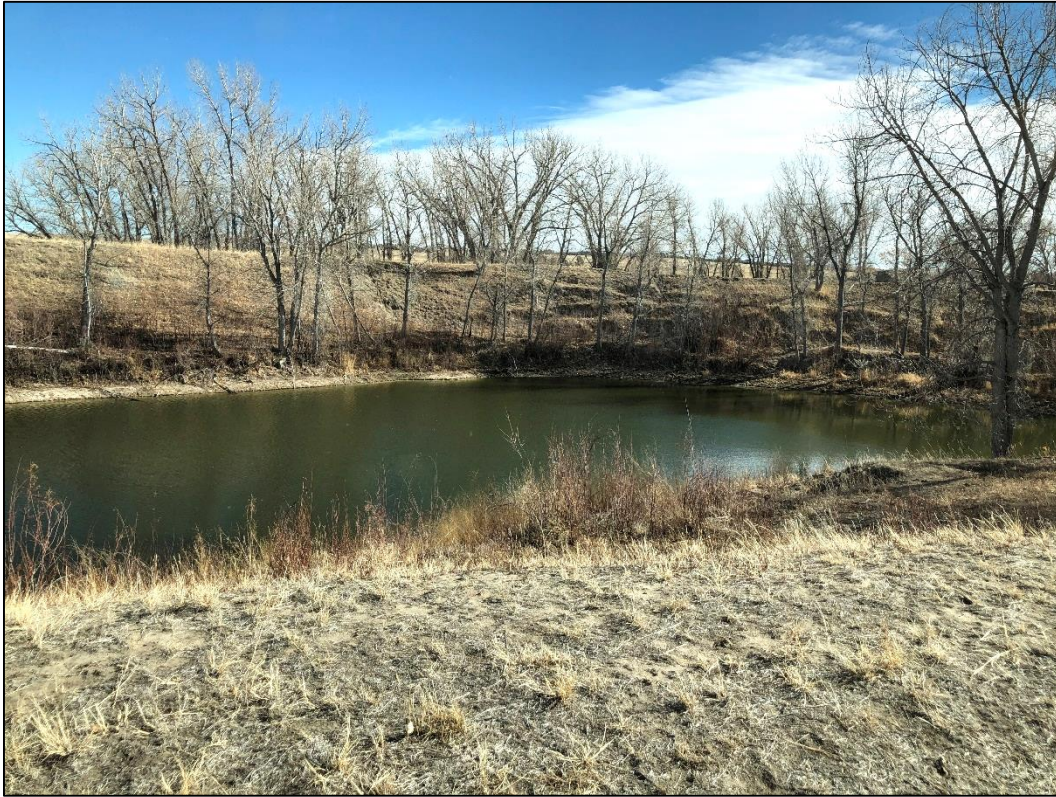
Photo 19. View looking southeast across southern portion of pond. Note pond banks (in background) are higher and steeper in this area than rest of pond, but stable with good vegetative cover consisting of grasses and trees (willows and cottonwoods).

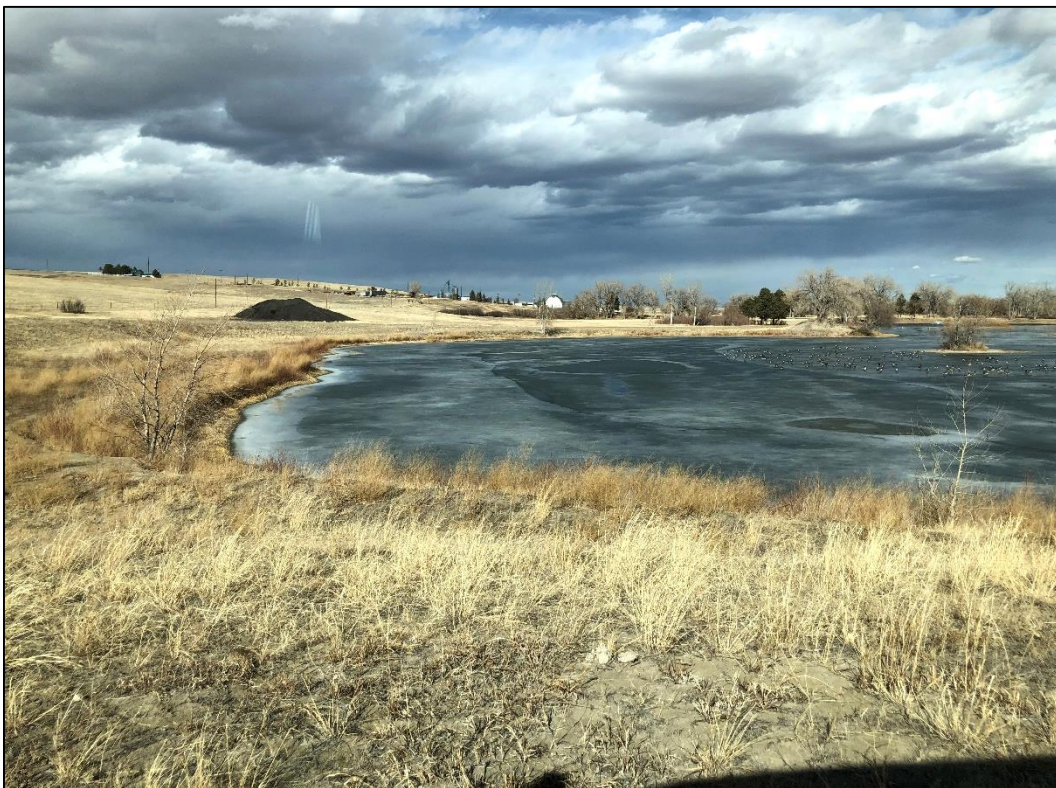
Photo 20. View looking north across western pond shoreline, graded 3H:1V or flatter and stable with good vegetative cover consisting of grasses and some trees.

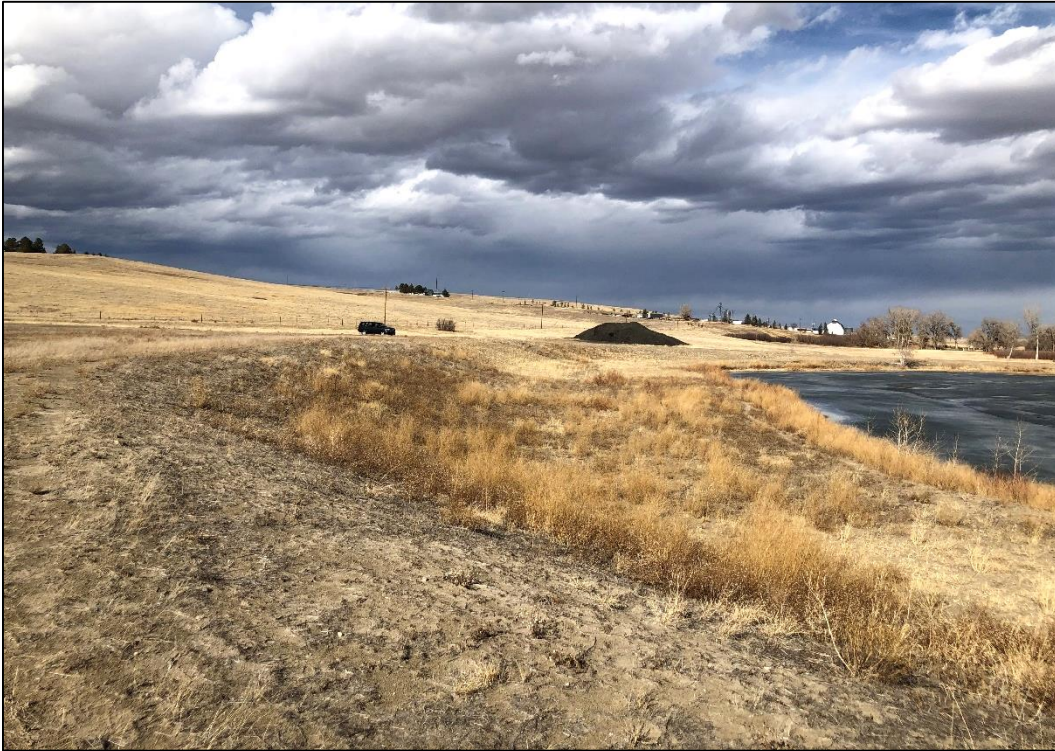
Photo 21. View looking north across excavation area west of pond with slopes graded 3H:1V or flatter and topsoil replaced. Portions of this area (particularly along crest of slope) may require reseeding for reclamation.

As mentioned above, the current pond is approximately 10 acres in size, which is in compliance with the operator's approved augmentation plan. The water level in the pond was low during the inspection, with depths of only 3-4 feet according to the operator. The majority of the pond shorelines are graded to 3H:1V or flatter in accordance with the approved reclamation plan, and stable with a good establishment of grasses and trees (mainly willows and cottonwoods). Much of the western shoreline is graded flatter than 3H:1V. However, there are some portions of the eastern and southern pond shorelines which have slopes steeper than 3H:1V. These steeper shorelines appeared to be stable with good vegetative growth and no erosion features observed. Because much of the eastern pond shoreline was created prior to the site being permitted, as long as the operation did not redisturb this shoreline in any way, and it remains stable, no additional work will be required along this shoreline for reclamation. However, the steeper portions of the southern shoreline may require some additional grading to meet the 3H:1V requirements. The operator mentioned plans to use cut and fill methods to flatten out the steeper portions of the southern shoreline in the near future. Because the southern end of the pond has higher banks than the rest of the pond, approximately 8-10 feet high versus near flat to 3 feet high in other areas, there is plenty of material to work with in this area. However, given the closeness of the southern pond shoreline to the permit boundary, the Division recommends the operator be very careful not to create offsite disturbance while completing this project. Once the regrading project is completed, the newly disturbed areas will need to be seeded for reclamation.

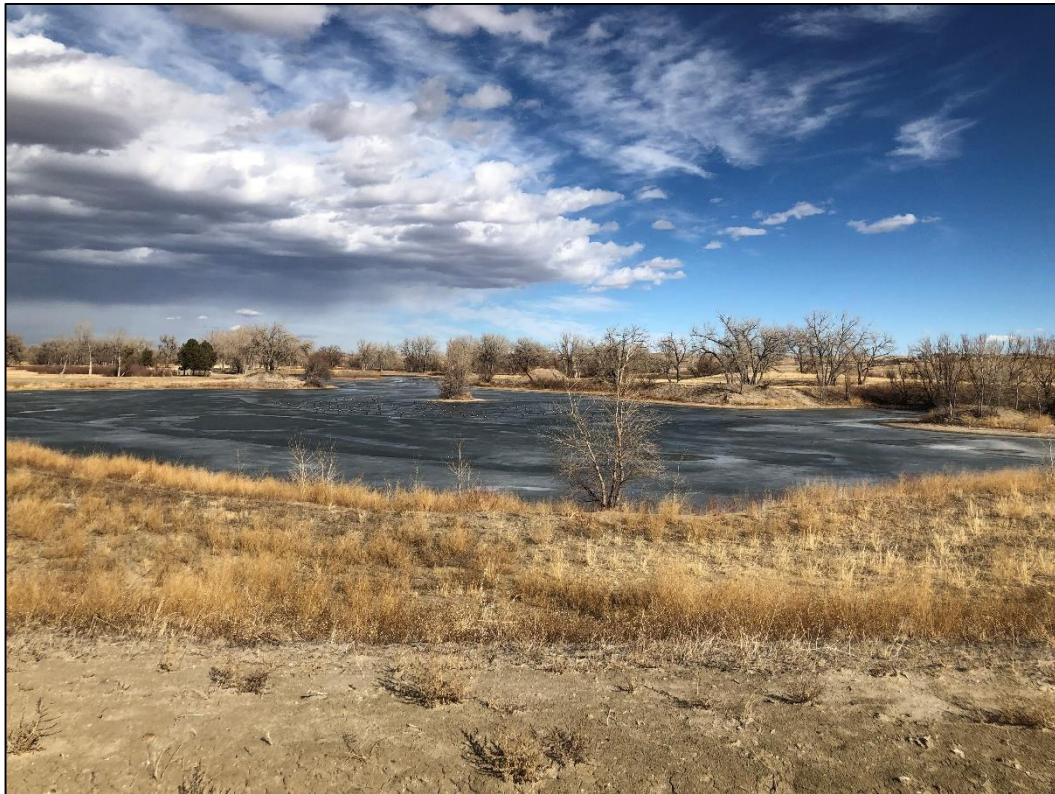
Photo 22. View looking east across excavation area west of pond with slopes graded 3H:1V or flatter and topsoil replaced. Portions of this area (particularly along crest of slope) may require reseeding for reclamation.

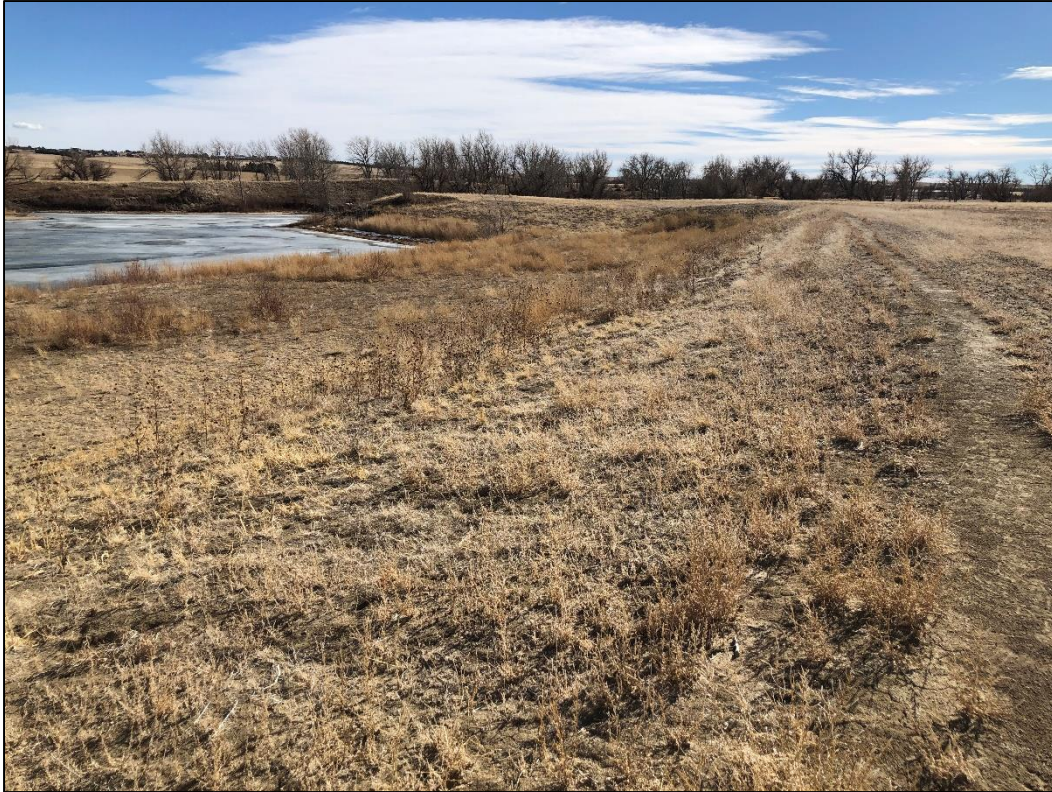
Photo 23. View looking south across excavation area west of pond with slopes graded 3H:1V or flatter and topsoil replaced. Portions of this area (particularly along crest of slope) may require reseeding for reclamation.

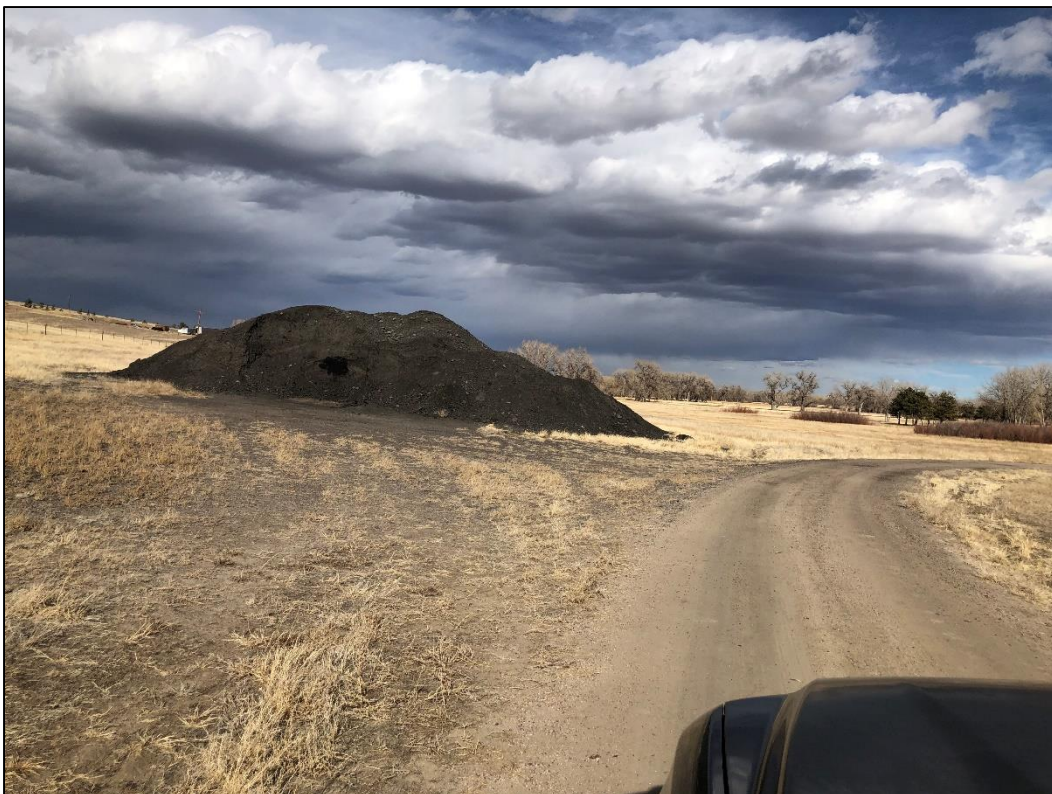
material in the pond. The operator submitted a response on October 31, 2007 which explained the material is used strictly for road maintenance on the ranch and would not be used as reclamation backfill material. At the time, the operator estimated the asphalt stockpile to be approximately 3,000 CY in volume. The Division estimates the current stockpile to be no more than 1,200 CY.

Photo 24. View looking northwest at stockpile of milled asphalt stored in area west of pond. This material is used strictly for road maintenance on the operator's ranch and will not be used as reclamation backfill material on the mine site.

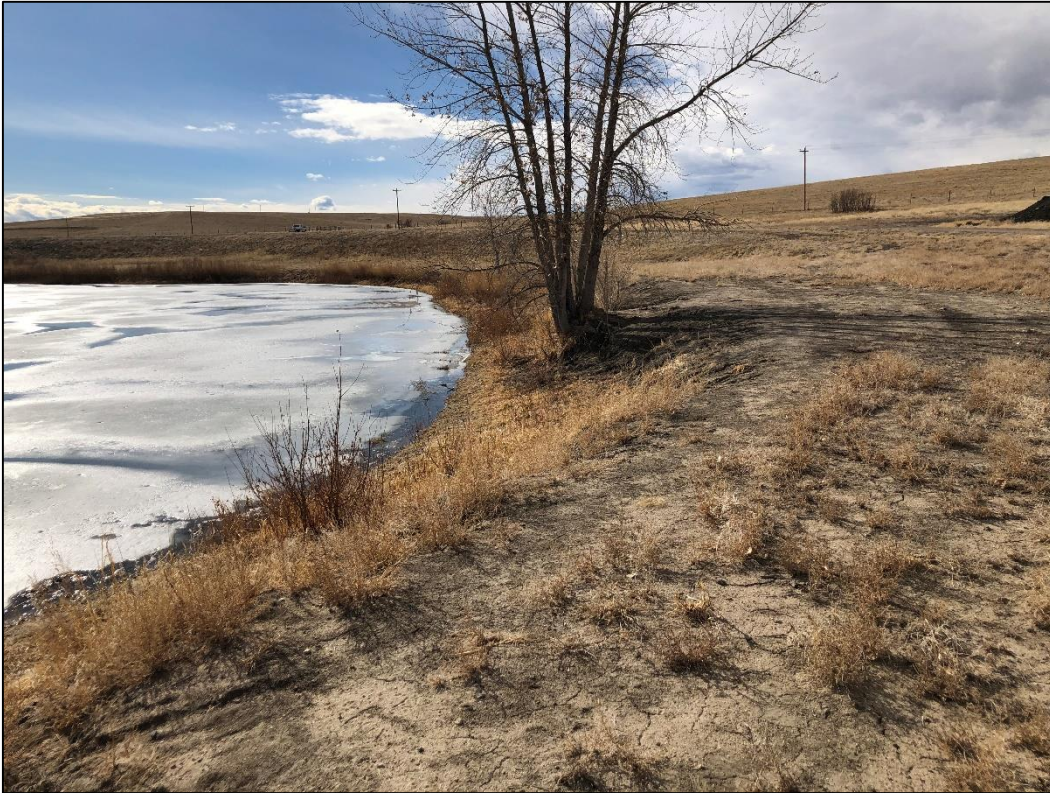
Photo 25. View looking southwest across western pond shoreline graded 3H:1V or flatter and stable with vegetative cover consisting of grasses and trees (willows and cottonwoods).
