MINERALS PROGRAM INSPECTION REPORT

MINE NAME: Freund Pit	MINE/PROSPECTING ID#: M-1985-003	MINERAL: Sand and gravel	COUNTY: Elbert
INSPECTION TYPE: Monitoring	INSPECTOR(S): Amy Eschberger	INSP. DATE: February 3, 2021	INSP. TIME: 13:00
OPERATOR: Running Creek Ranch	OPERATOR REPRESENTATIVE: Joseph Freund, Jr.	TYPE OF OPERATION: 112c - Construction Regular Operation	
REASON FOR INSPECTION: Normal I&E Program	BOND CALCULATION TYPE: Complete Bond	BOND AMOUNT: \$11,902.00	
DATE OF COMPLAINT: NA	POST INSP. CONTACTS: None	JOINT INSP. AGENCY: None	
WEATHER: Clear	INSPECTOR'S SIGNATURE:

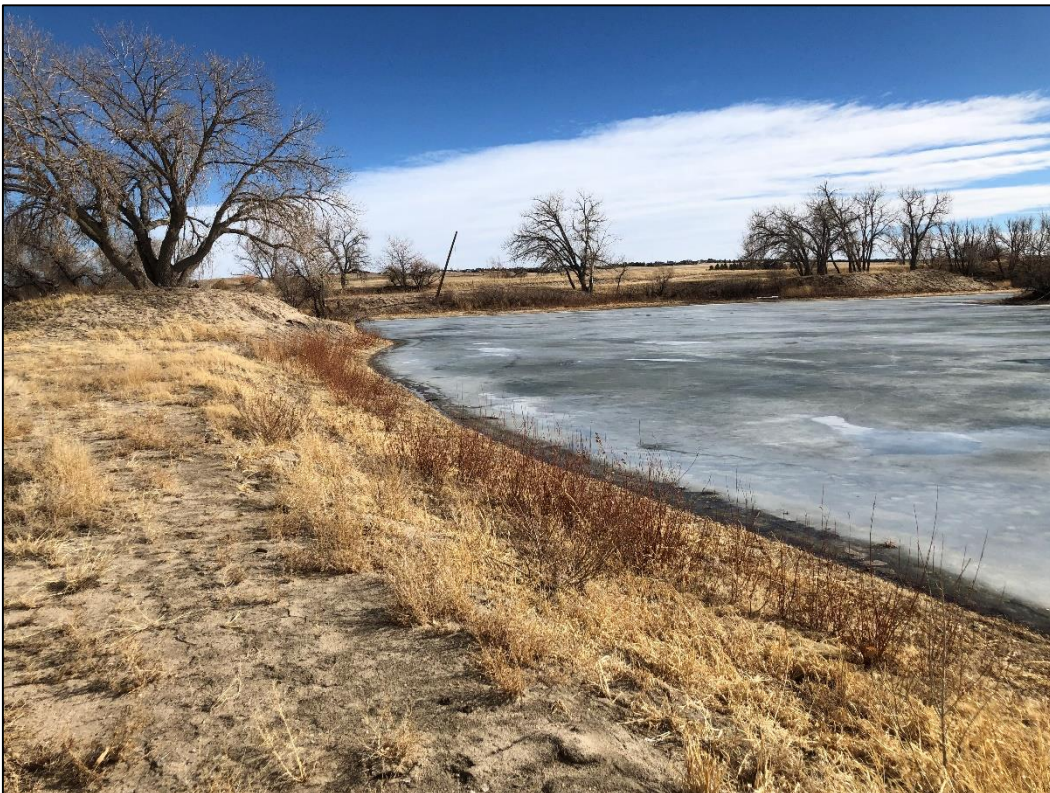
Photo 26. View looking northeast across western pond shoreline graded 3H:1V or flatter and stable with vegetative cover consisting of grasses and trees (willows and cottonwoods).

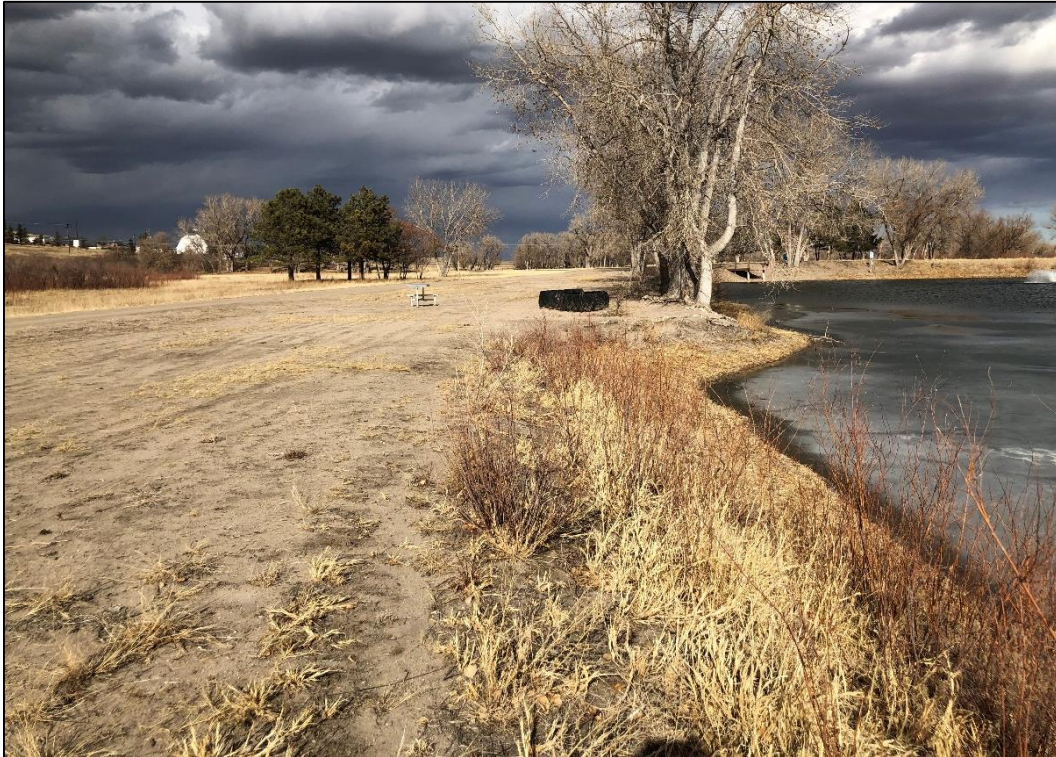
Photo 27. View looking northwest across western pond shoreline graded 3H:1V or flatter and stable with vegetative cover consisting of grasses and trees (willows and cottonwoods). Note area west (left) of pond with sparse vegetative cover which will require reseeding for reclamation (unless operator submits Technical Revision to change revegetation plan for this area).

During the inspection, there was discussion about leaving some areas adjacent to the pond as sandy areas for recreational use. The sandy area west of the pond appears to already be used for this purpose. If the operator wishes to revise the approved reclamation plan to leave areas around the pond unvegetated for recreational use, this change must be proposed through a Technical Revision (see enclosed form). This revision must include a revised reclamation plan map for the site showing how all affected lands will be reclaimed. The operator should be advised, any areas proposed for swimming will require pond shorelines to be graded to 5H:1V or flatter in accordance with Rule 3.1.5(7).

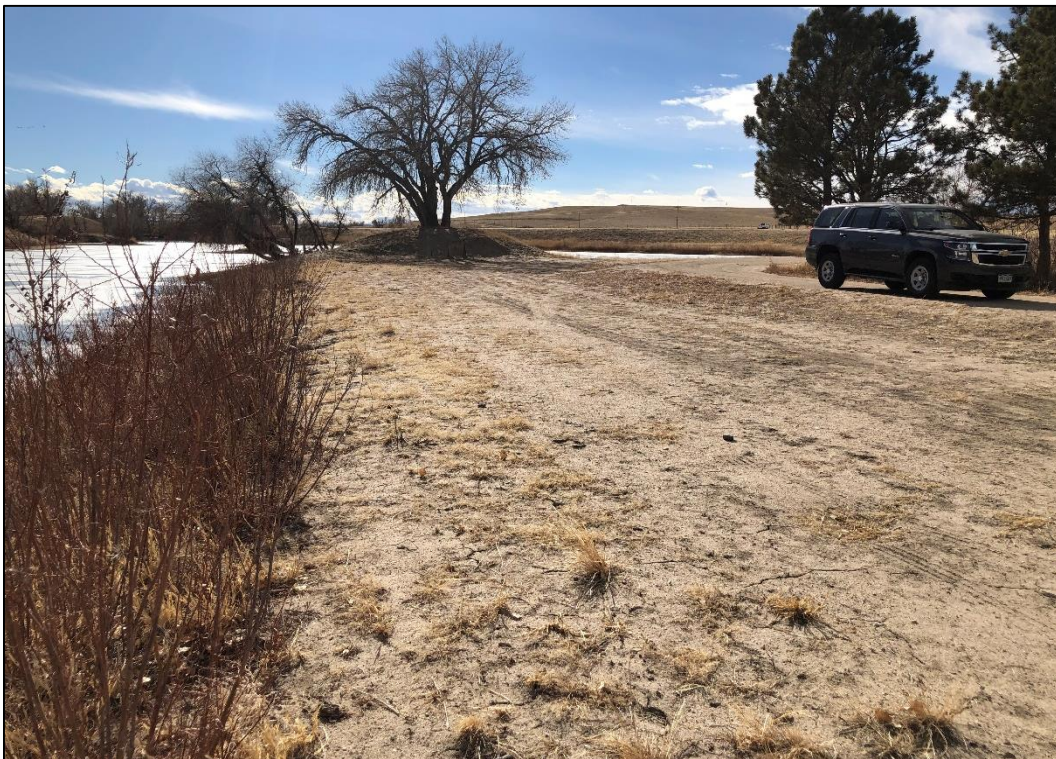
Photo 28. View looking southwest across western pond shoreline graded 3H:1V or flatter and stable with vegetative cover consisting of grasses and trees (willows and cottonwoods). Note area west (right) of pond with sparse vegetative cover which will require reseeding for reclamation (unless operator submits Technical Revision to change revegetation plan for this area).

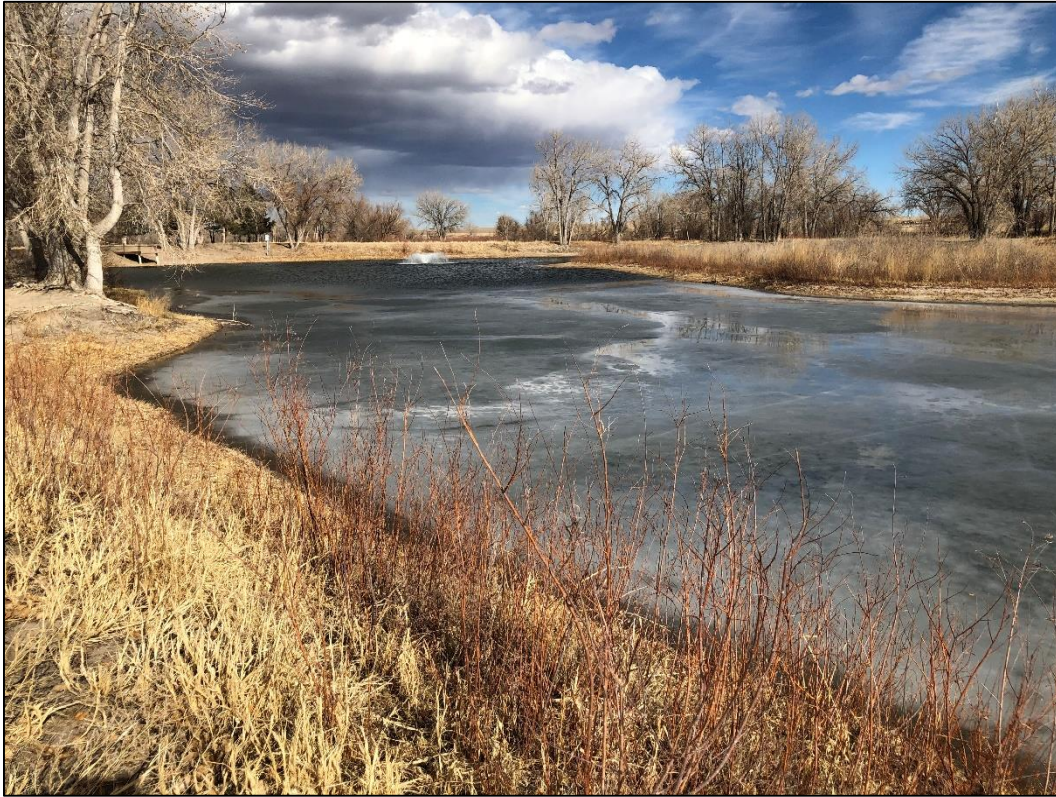
Photo 29. View looking southwest across northern portion of pond. Note shorelines graded 3H:1V or flatter and stable with vegetative cover consisting of grasses and trees (willows and cottonwoods).

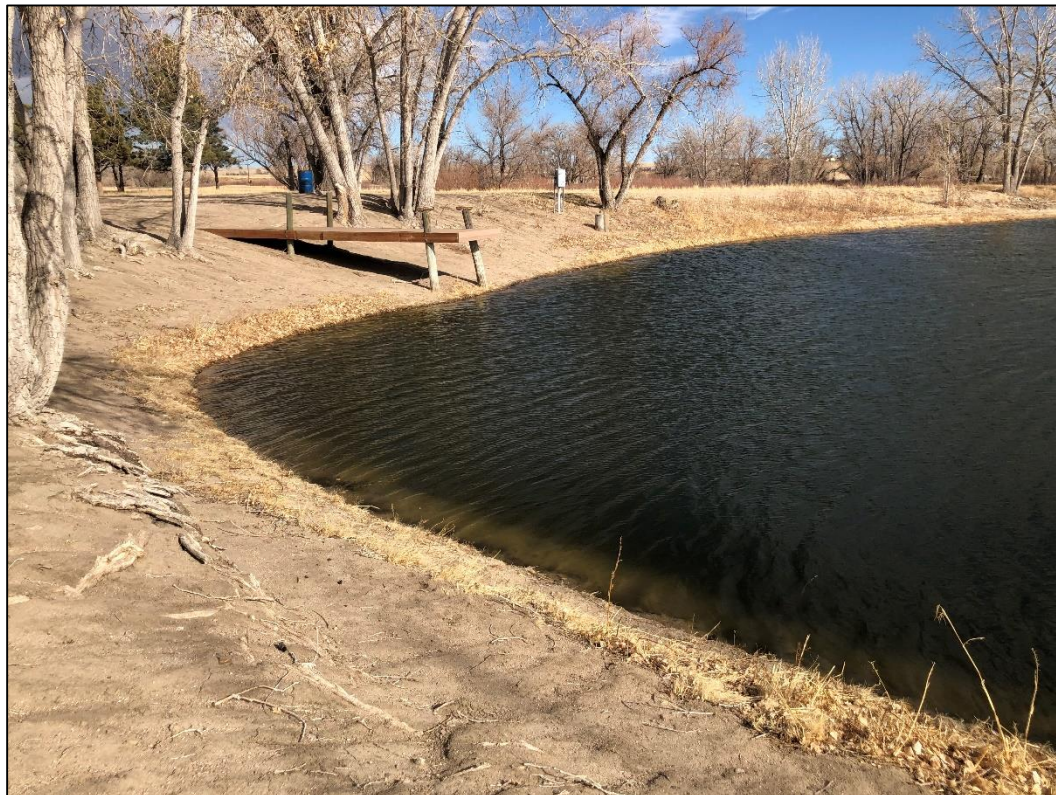
Photo 30. View looking northeast across northern pond shoreline graded 3H:1V or flatter. This area will require reseeding for reclamation (unless operator submits Technical Revision to change revegetation plan for this area).

According to the operator, mining activities are most likely completed at the site. The operator currently has no plans to expand the pond, and no material stockpiles remain on site. If the operator has no plans to continue mining activities, then per Rule 3.1.3, final reclamation of the site must be completed within 5 years of the date that mining activities ceased. Because the operator just recently hauled off the remaining material stockpiled in the staging area, the reclamation deadline will be set at 5 years from the date of this inspection, by February of 2026. To complete reclamation of the site, the operator will need to ensure all pond shorelines (created or redisturbed by the operation after permitting in 1985) are graded to 3H:1V or flatter, and all disturbed land including pond shorelines down to the anticipated high water line and areas around the pond (estimated to be approximately 6.5 acres total) are revegetated with the approved seed mixture.
