**MINERALS PROGRAM INSPECTION REPORT**  
**PHONE: (303) 866-3567**

<b>MINE NAME:</b> High Mesa Gravel Pit	<b>MINE/PROSPECTING ID#:</b> M-2000-067	<b>MINERAL:</b> Sand and gravel	<b>COUNTY:</b> Delta
<b>INSPECTION TYPE:</b> Surety Release Inspection	<b>INSPECTOR(S):</b> Stephanie Mitchell	<b>INSP. DATE:</b> February 2, 2021	<b>INSP. TIME:</b> 12:00
<b>OPERATOR:</b> Beavers Construction Co./High Mesa Gravel	<b>OPERATOR REPRESENTATIVE:</b> George Bouroussa	<b>TYPE OF OPERATION:</b> 112c - Construction Regular Operation	
<b>REASON FOR INSPECTION:</b> Surety Release Requested	<b>BOND CALCULATION TYPE:</b>	<b>BOND AMOUNT:</b> \$65,790.00	
<b>DATE OF COMPLAINT:</b> NA	<b>POST INSP. CONTACTS:</b> None	<b>JOINT INSP. AGENCY:</b> None	
<b>WEATHER:</b> Clear	<b>INSPECTOR'S SIGNATURE:</b>

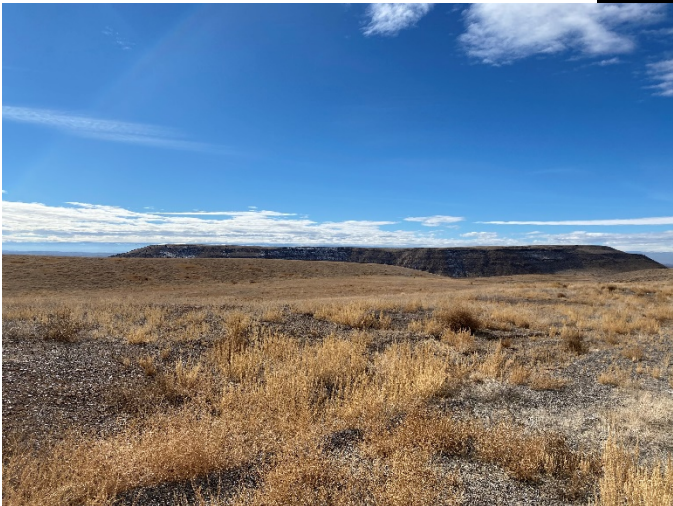
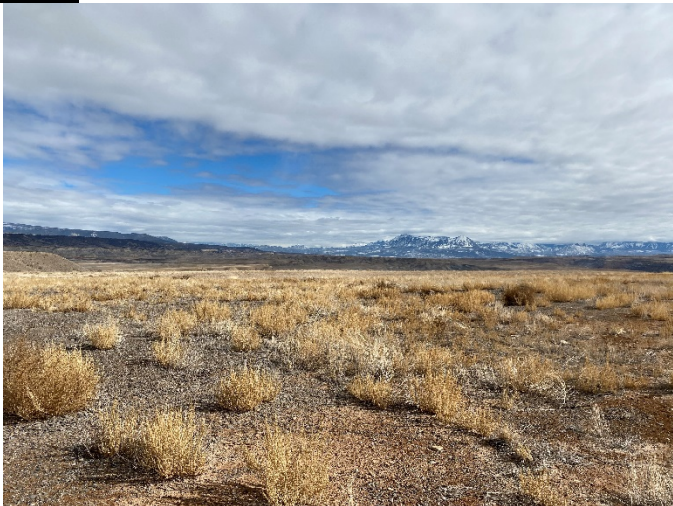
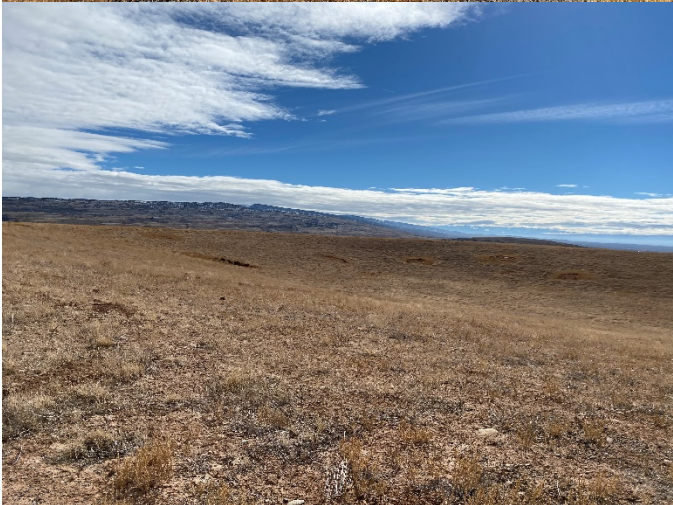
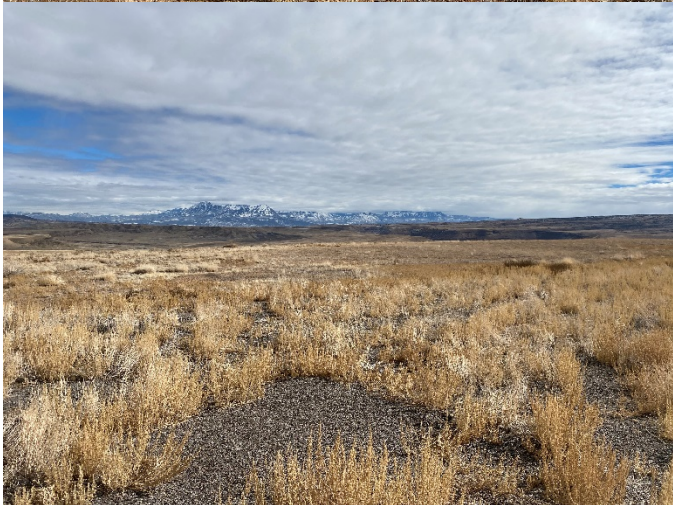
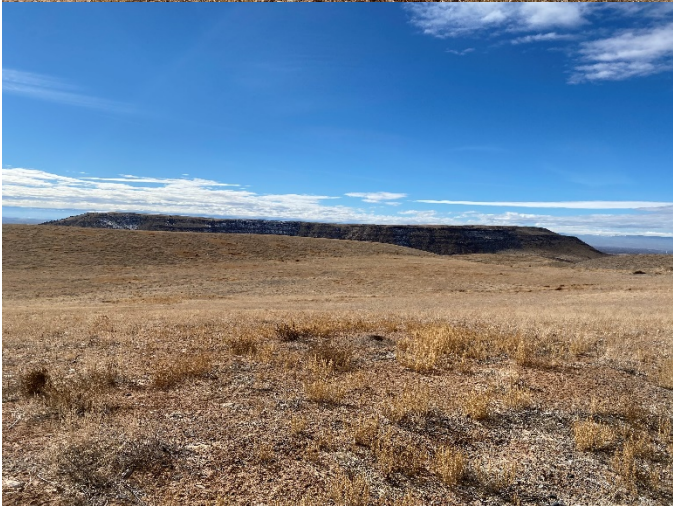
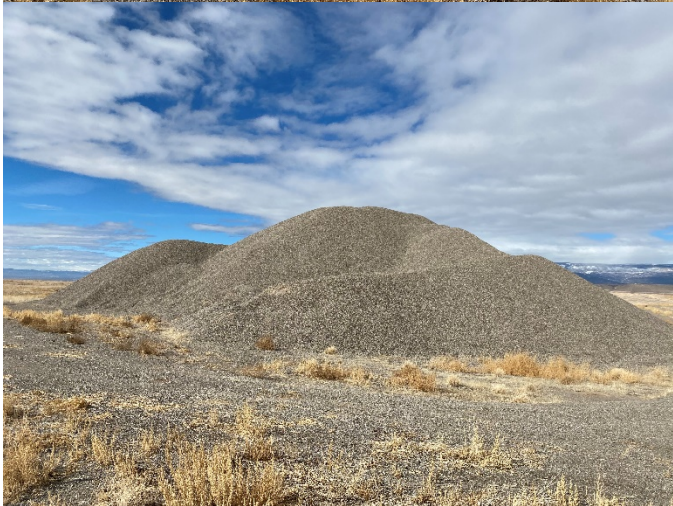
The purpose of the inspection was to observe the reclamation success and determine if the November 27, 2020 request for full release of the reclamation permit was approvable. Based on the conditions observed during the inspection the 56.02 Acres requested to be released has been granted. The site was graded exceptionally well and the reclaimed slopes tie into the adjacent undisturbed slopes in a very natural looking way. All reclaimed slopes appear to be no steeper than the required 3H:1V.

Vegetation appeared to be well established with the approved seed mix.

There was no erosional issues observed.

A processed gravel stockpile is to remain on site for residential roads as approved in a recent amendment.
