KEENESBURG REPORT

PERMIT INFORMATION

Permit Number: C-1981-028 Mine Name: Keenesburg Strip Mine Operator: Coors Energy Company Operator Address: Mr. Ben Moline PO Box 4030 Golden, CO 80402	County: Weld Operation Type: Surface Permit Status: Permanent Cessation Ownership: Private Operator Representative Present: None		
Operator Representative Signature: (Field Issuance Only)

Inspection Start Date: February 23, 2021 Inspection Start Time: 09:30 Inspection End Date: February 23, 2021 Inspection End Time: 11:00			Inspection Type: Coal Partial Inspection Inspection Reason: Normal I&E Program Weather: Clear	
Joint Inspection Agency: Join		Joint	oint Inspection Contacts:	
None				
Post Inspection Agency: P		Post	Post Inspection Contacts:	
None				
Inspector(s):	Inspector's Signature: Signature Dat		ature Date:	
Robert Zuber, P.E.	Phot D. The			
			2/2	23/2021

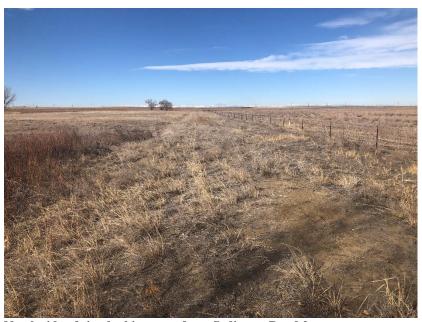
The eastern portion of the northern boundary of the site (including the ditch to Sediment Pond 2) was observed, and no signs of pollutant loading from the mine site, or any other problems, were seen.

North side of site, looking west from Sediment Pond ${\bf 2}$

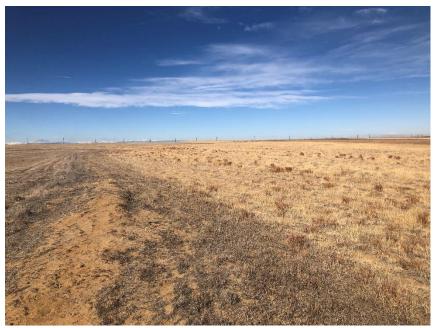
- * The older reclamation near the southwest corner of the current permit area (Areas 29 and 30)
- * Area 25 west of the Dugout Pond
- * Area 33 along the southern permit boundary
- * The areas that were reclaimed in 2019 and 2020, including roads, the Long Term Spoil Area, and the footprints of old soil piles
- * Area 34 at the southeast part of the site.
- * The relatively steep slope between the Dugout Pond and the area where topsand was stored (south of facilities).

Area 33 (right side of photo)

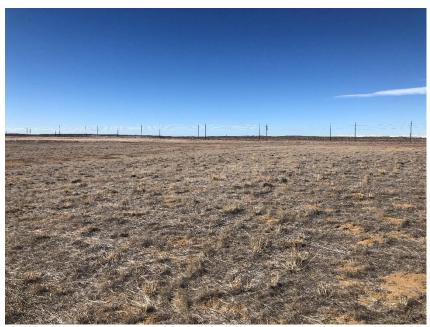
Southwest corner of permit area (Area 29)

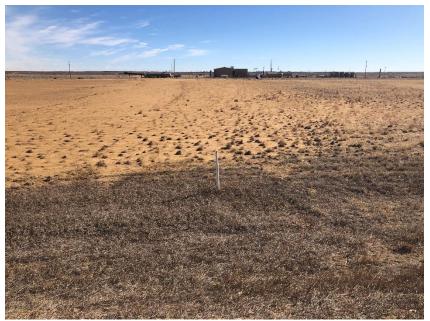
Area 34 to right and reclaimed topsoil area to left (marker is northwest corner of Area 34)

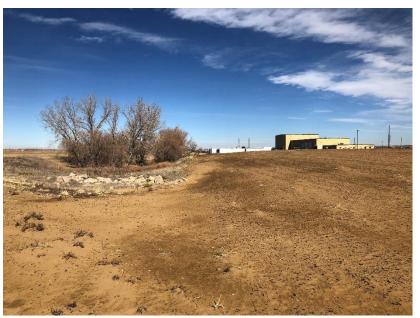
Dugout Pond to left and reclaimed topsoil area to right
