## 15.0 GEOTECHNICAL STABILITY (SEC 6.5)

M1990-057  
GEOTECHNICAL STABILITY  
Page 15-2

### **GEOTECHNICAL STABILITY OBSERVATION HOLE CHARACTERIZATION**

PERMEABILITY STUDY  
TAILING POND AREA  
LEADVILLE MINING & MILLING CORPORATION MILL  
NEAR  
LEADVILLE, COLORADO

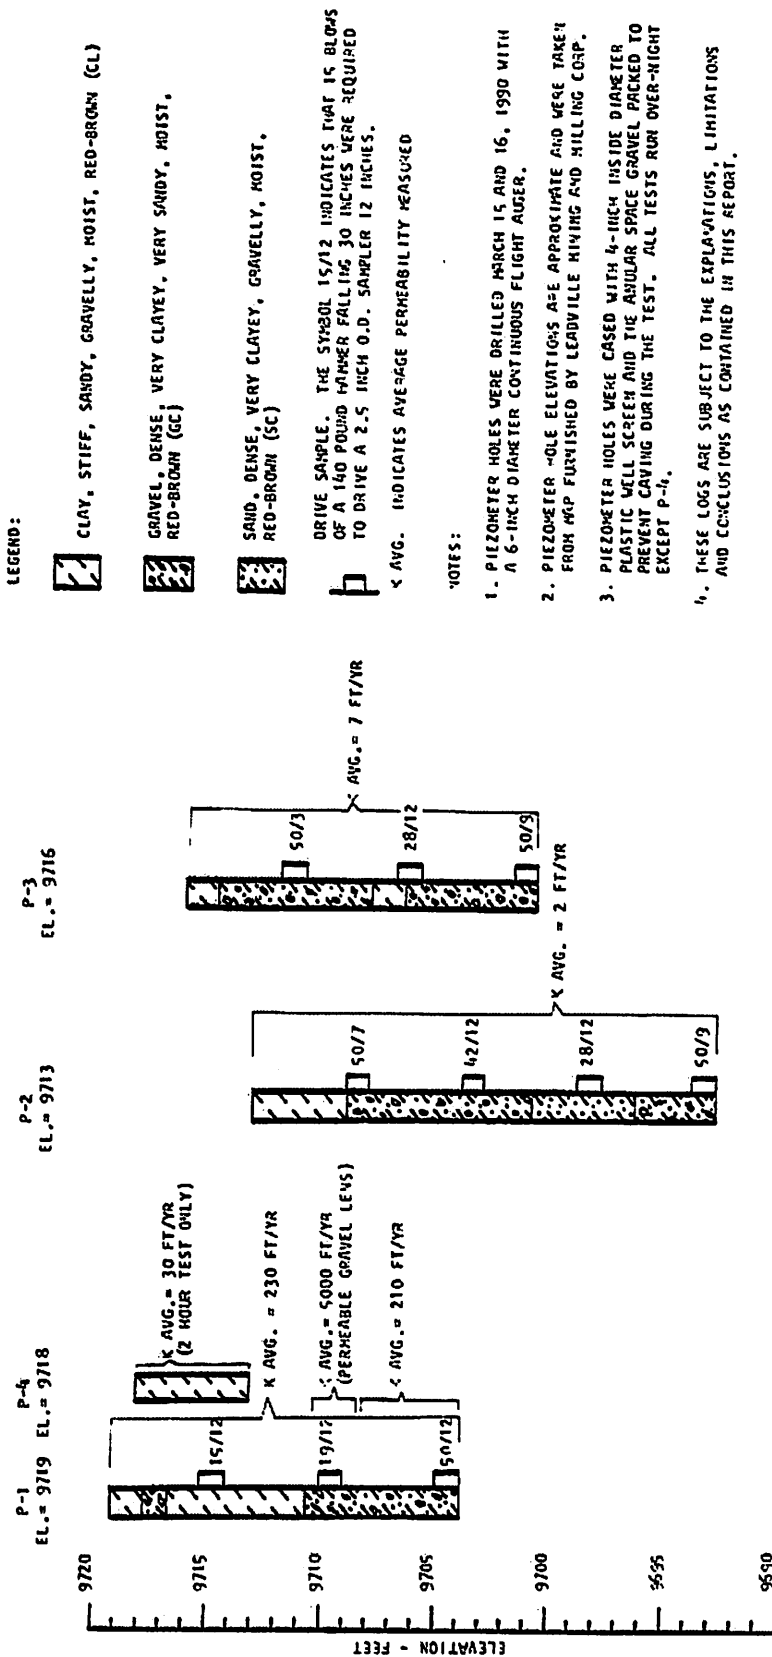
## SUMMARY LOGS OF PIEZOMETER HOLES

The tailing disposal area soils generally have low permeabilities. Our tests measured average permeabilities between 2 ft/yr and 230 ft/yr. The higher permeability was in P-1 which was located at the uphill edge of the disposal area. We saw in the existing trench and measured a more permeable (5000 ft/yr) lens in P-1 at about 8 feet. This lens in P-1 was about 1.5 feet thick.

We have concluded the clays overlying the gravel lens and the clayey gravels and clayey sands are comparatively impervious. For comparison, some sandy compacted clays have permeabilities of the order of 1 ft/yr. We suggest excavation which might reduce the natural clay cover over the gravel lens be omitted or minimized to the minimum to leave the natural clay surface layer uninterrupted or nearly uninterrupted. The pond bottom should be stripped and compacted before filling with tailings to decrease the permeability of the ground immediately under the tailings.

Should the gravel lens be exposed we recommend such exposures be blocked with 3 feet of the shallow clays densely compacted in thin lifts.

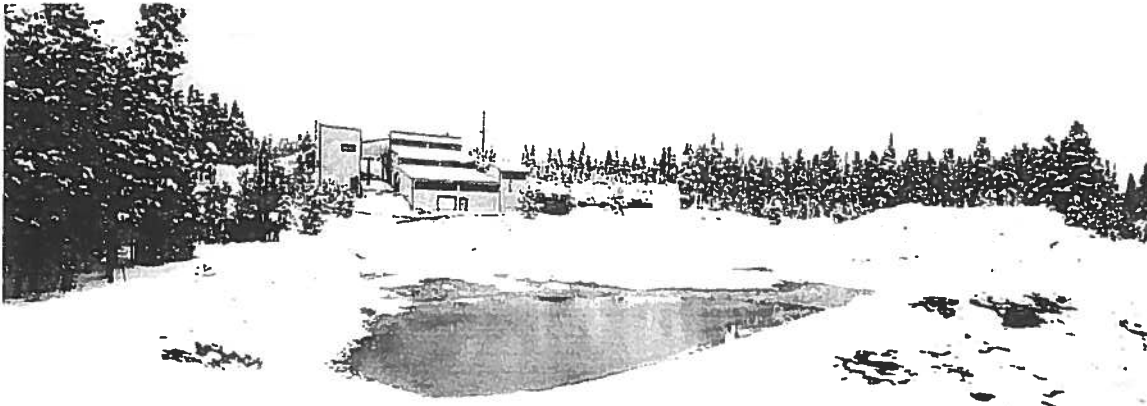
Picture 1. Union Mill and Tailings Pond. Drilling rig on TH-1. Stockpile on right.

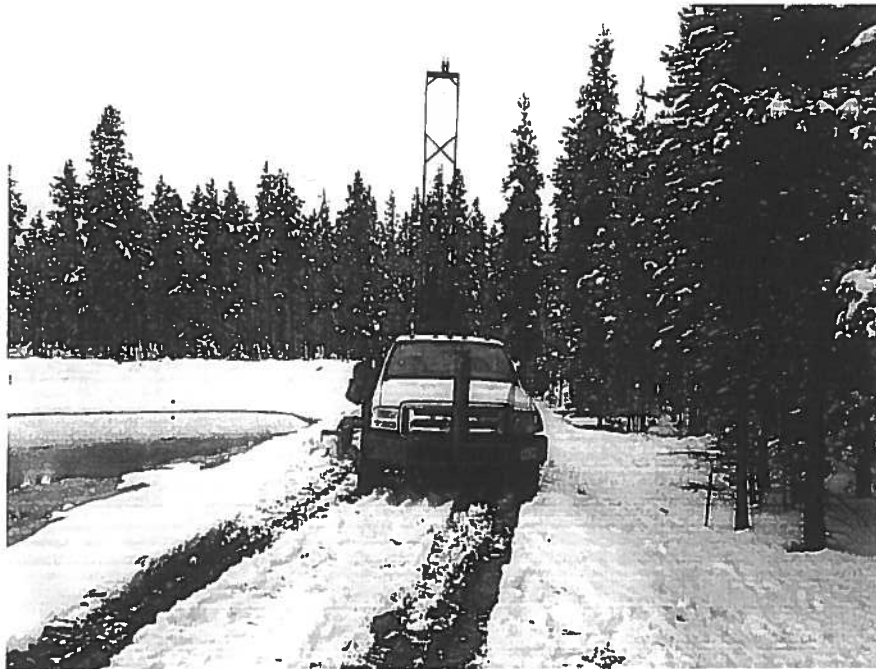
Picture 2. Drilling rig on TH-2 on the embankment

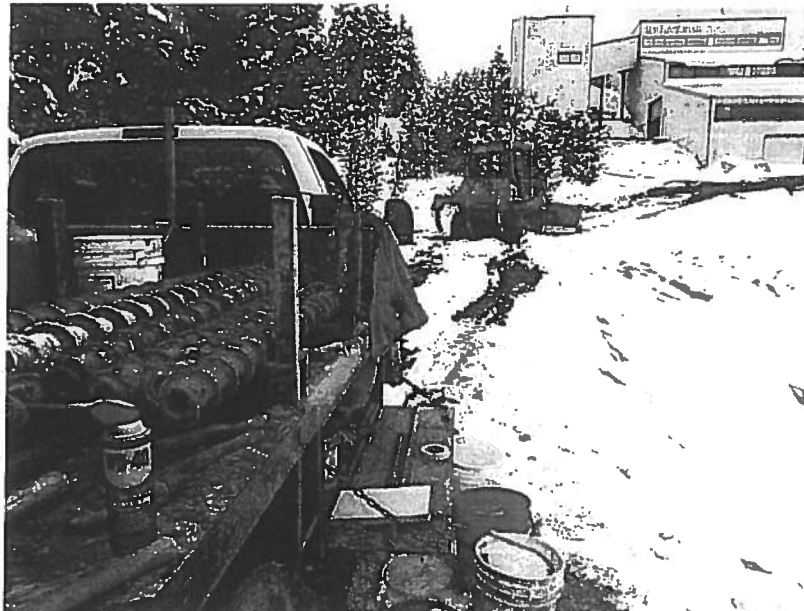
Picture 3. Bulldozer used to access TH locations. Bulldozer at approximate site of TH-1

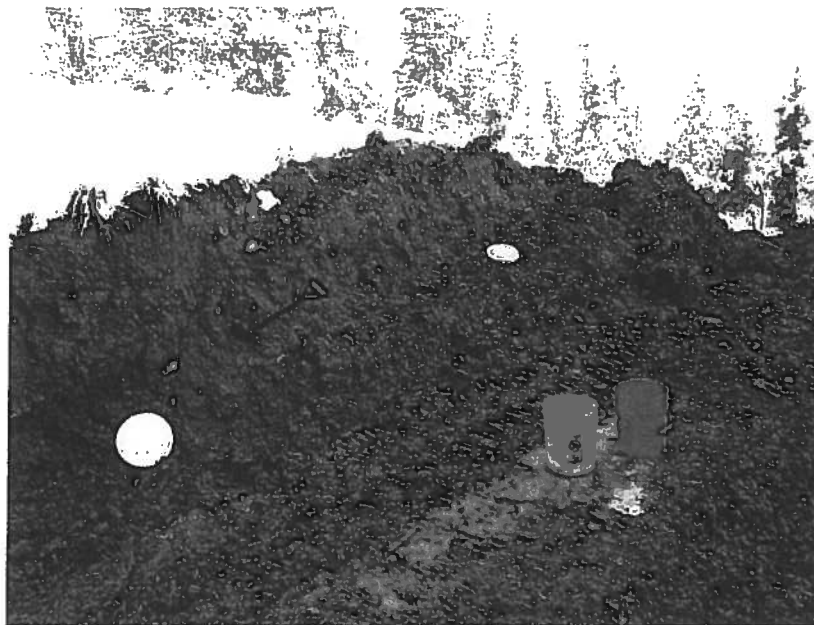
Picture 4. Stockpile
