MINERALS PROGRAM INSPECTION REPORT
PHONE: (303) 866-3567

MINE NAME: West Farm Pit	MINE/PROSPECTING ID#: M-2008-078	MINERAL: Gravel and sand	COUNTY: Prowers
INSPECTION TYPE: Preoperation Inspection	INSPECTOR(S): Brock Bowles	INSP. DATE: February 19, 2021	INSP. TIME: 08:00
OPERATOR: Prowers Aggregate Operators, LLC	OPERATOR REPRESENTATIVE: JC York	TYPE OF OPERATION: 112c - Construction Regular Operation	
REASON FOR INSPECTION: Preoperation Inspection	BOND CALCULATION TYPE: None	BOND AMOUNT: \$1,881,294.00	
DATE OF COMPLAINT: NA	POST INSP. CONTACTS: None	JOINT INSP. AGENCY: None	
WEATHER: Clear	INSPECTOR'S SIGNATURE:

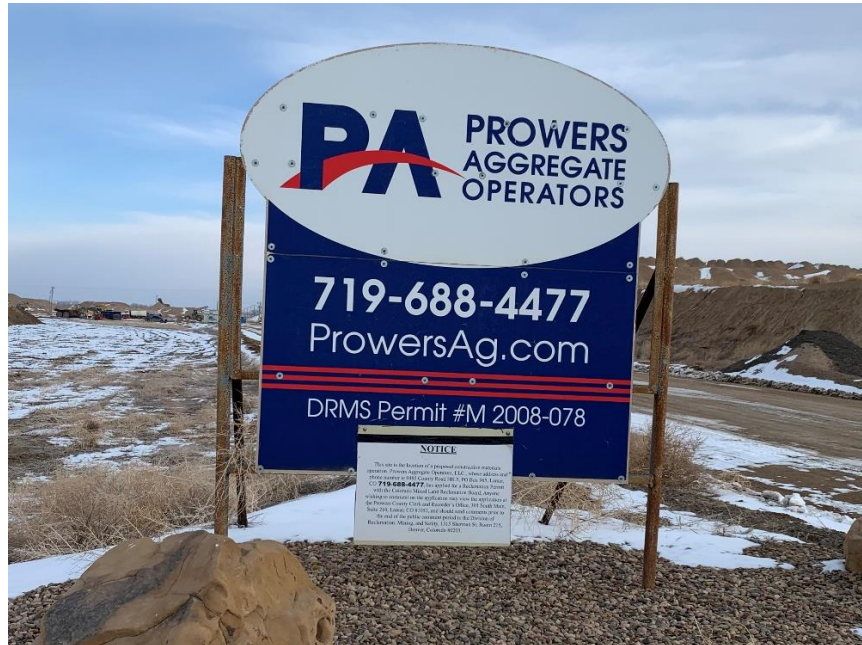
The mine entrance sign (Rule 3.1.12) and public notice required by Rule 1.6.2(1)(b) were posted at the entrance and visible from County Road HH.5 (photo 1).

Photo 1 – Mine entrance and public notice signs

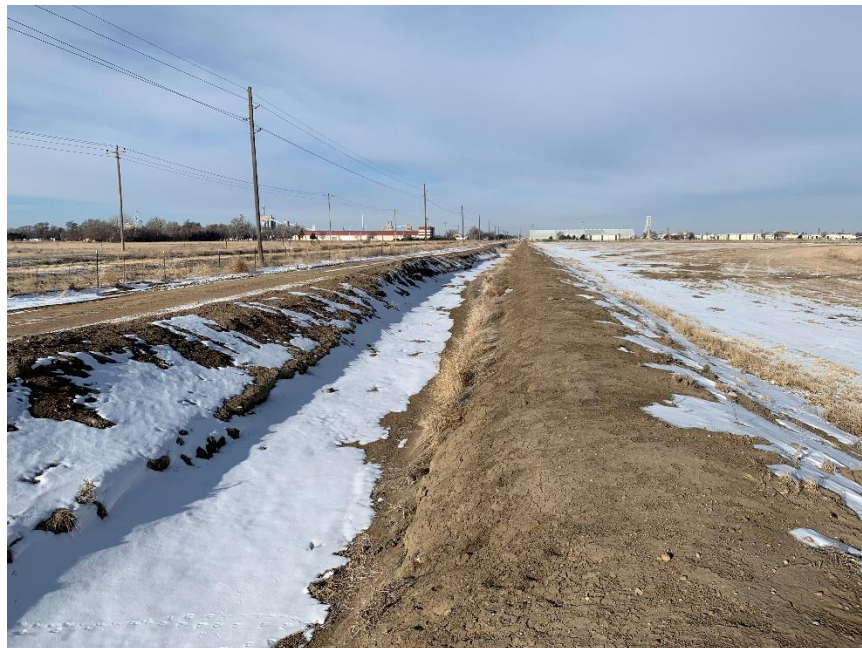
Phase 3 area – This area is the western most phase that will be mined. The land is currently used for agriculture and it contains 2 irrigation pivots, an irrigation pond and a supply ditch. The ditch runs along the southern border within the proposed permit boundary (photo 2). The southern permit boundary is the property line delineated by a fence. Ground water monitoring wells (photo 3) were installed around Phase 3 in January 2021 to collect baseline data. The current location of the SE Colorado Power buried electric line was marked with marker flags.

Photo 2 – Irrigation ditch along southern boundary of Phase 3, facing west

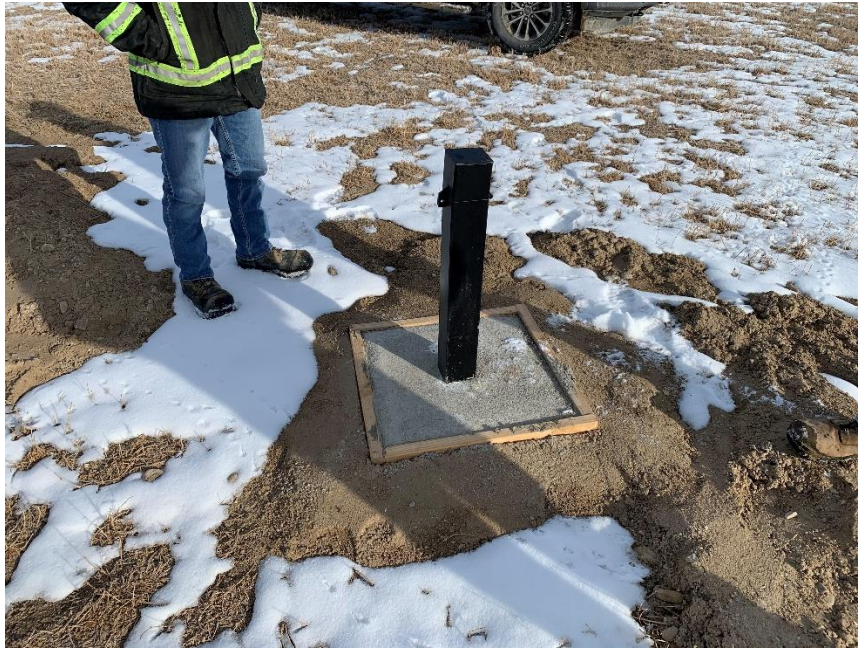
Photo 3 – Typical ground water monitoring well, north side of Phase 3

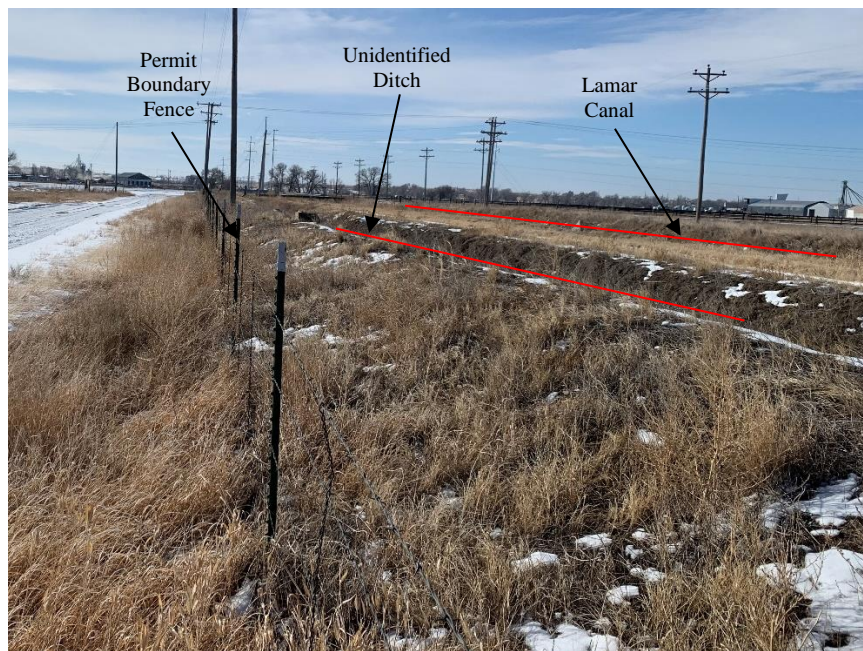
Photo 4 – Phase 8 western boundary facing south

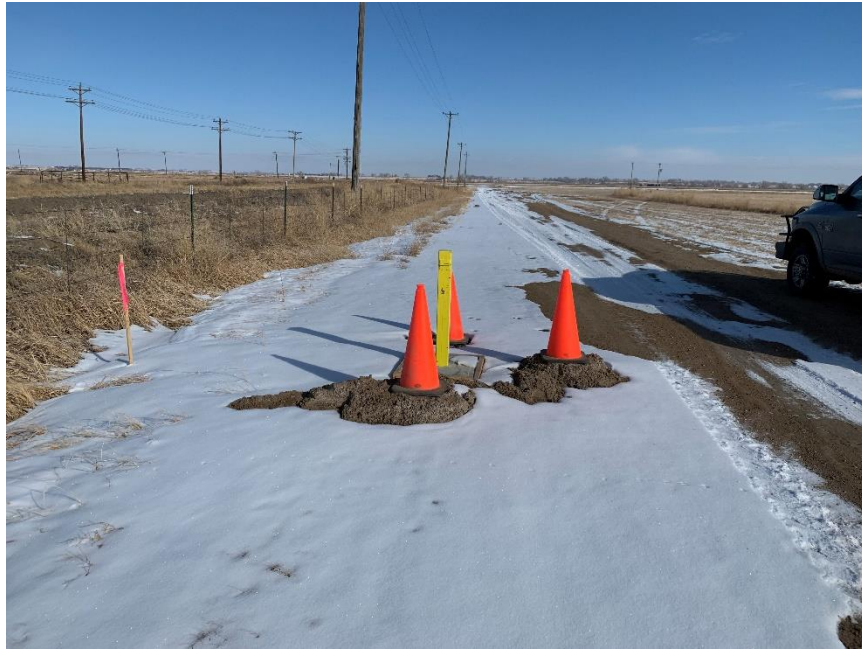
Phase 8 area – This area is located between CR HH .8 and CR HH .5, and between the Lamar Canal and the highway realignment parcel. The current land use is agricultural and there is 1 irrigation pivot. Phase 8 will be mined after Phase 3 to minimize potential conflict with the CDOT highway construction project. The highway project has not begun and a timeline is not known at this time. A ditch on the southern boundary was not identified on the maps. This ditch needs to be labeled on the maps and the owner of the ditch needs to be identified. A second ditch was noted on the western boundary between the Lamar Canal and permit boundary (photo 4). This ditch needs to be labeled on the maps and the owner needs to be identified. Ground water monitoring wells were installed on the southern and western boundaries (photo 5). The permit boundary is the western fenceline.

Photo 5 – Groundwater monitoring well on western boundary of Phase 8, facing north

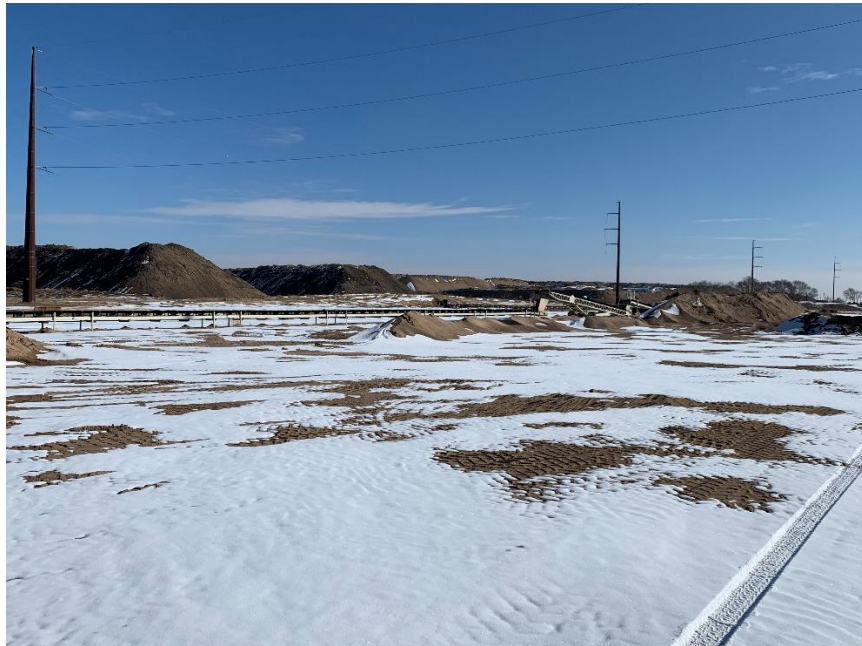
Parcel B (loadout area) – The permit boundary markers were in place on the western border. The southern boundary is along the railroad track and no markers were in this area because of load out operations. The eastern corner marker by the tracks was in place. This area contained a portable conveyor belt system and stockpiles of product ready for shipment (photo 6).

Photo 6 – Parcel B train loadout staging area, facing northeast

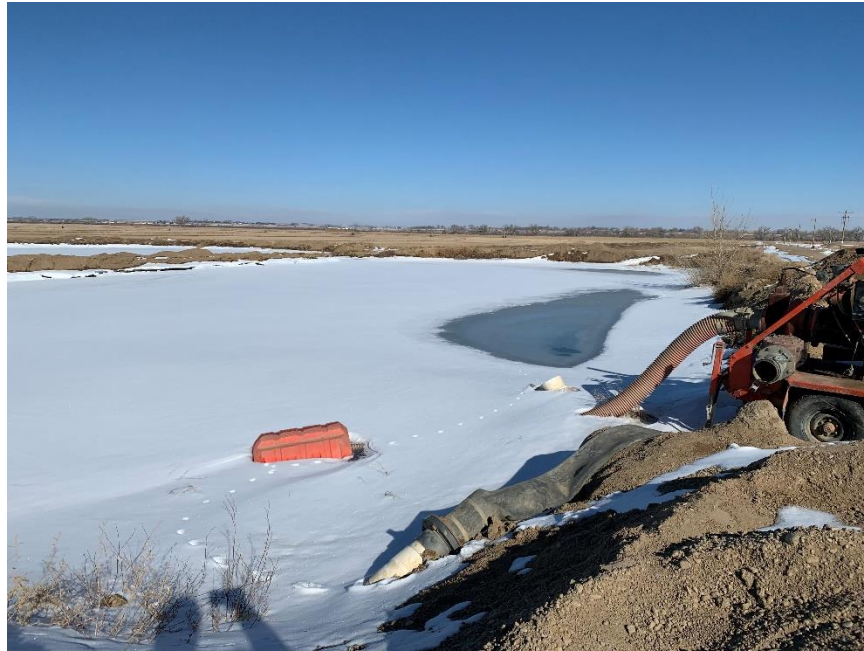
Phase 2 area – The 2 wash plants were located in the western side of this area. Neither plant was in operation due to the prolonged freezing weather conditions. The wash plant sediment ponds west of Phase 2 contained water and

were frozen (photo 7). The crusher and screen plants were in operation. Conveyors were moving material from the bottom of the pit to the screen plant (photo 8). An excavator and a series of articulating trucks were moving overburden from the east end of the pit to the overburden stockpile in Phase 9. The perimeters of the pit were mined to approximately 3h:1v slopes.

Photo 7 – Sediment ponds west of Phase 2

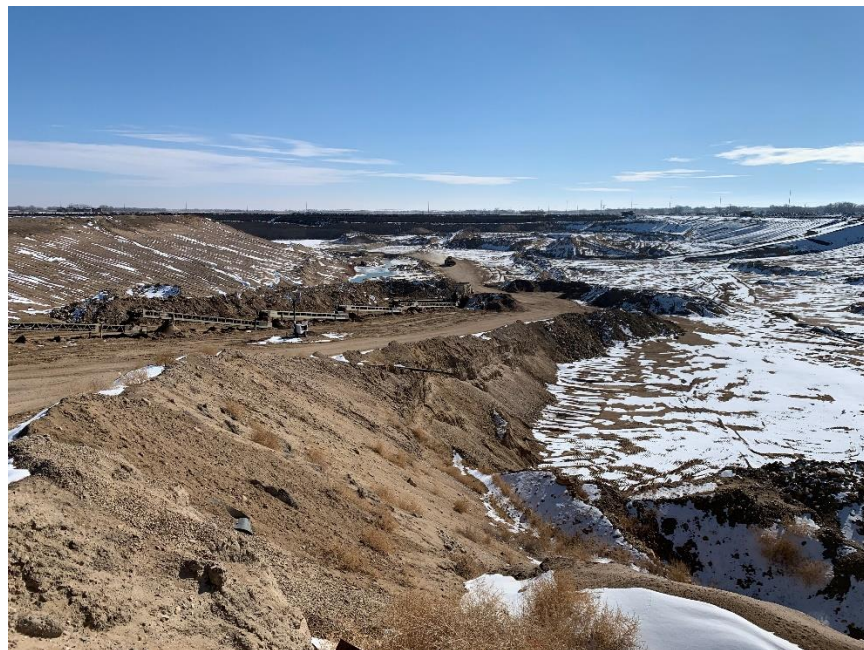
Photo 8 – Phase 2 pit looking east

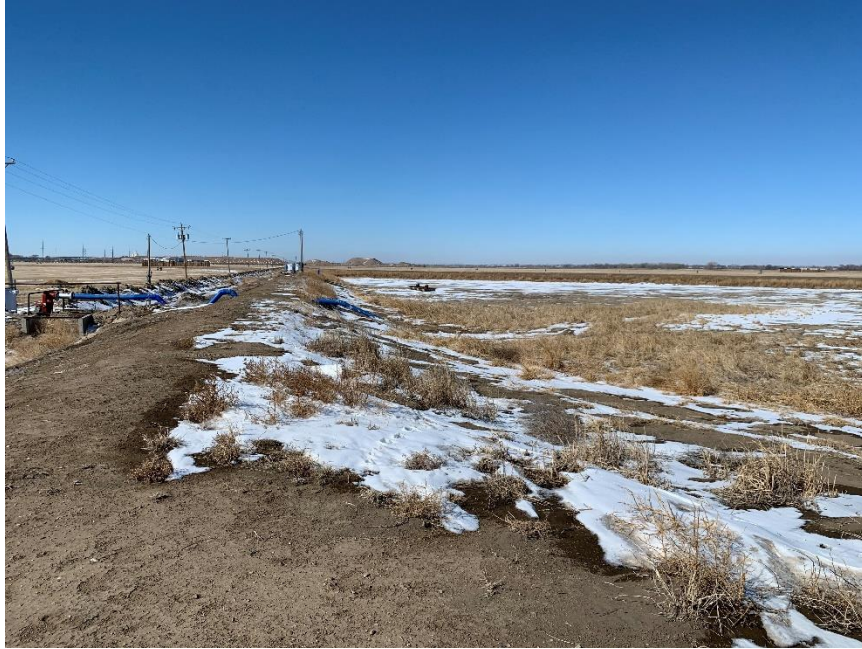
Phase 4 area- This area is currently used for agriculture and contains 2 irrigation pivots and an irrigation pond. The water supply ditch that supplies water to the irrigation pivots is located 85 feet south of this mining area and will remain as part of the post mining land use. The triangle shaped irrigation pond will be mined through (photo 9).

Photo 9- Irrigation ditch on left, Phase 4 and triangle pond on right, facing west

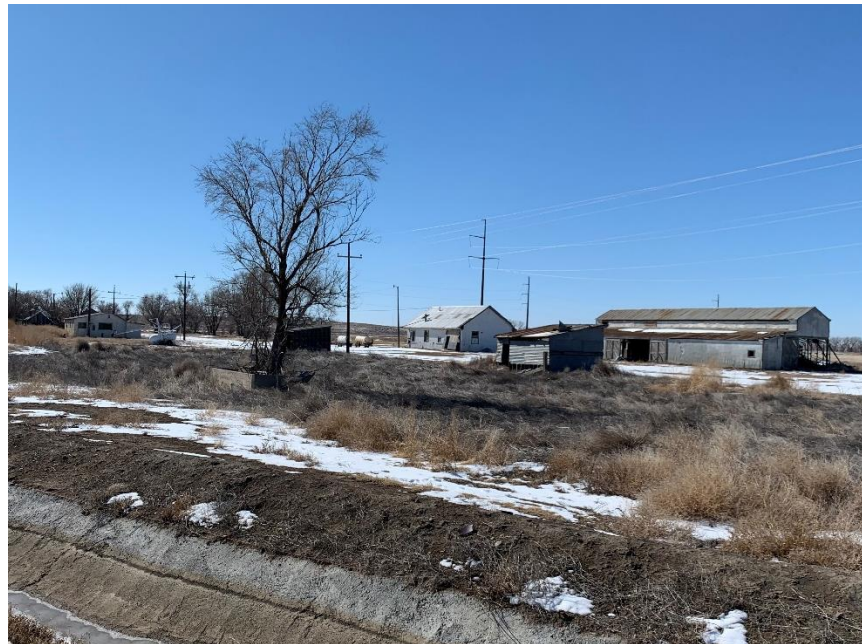
Phase 7 area- This area is currently used for agriculture and contains 3 irrigation pivots. The access road runs between Phases 7 and 4. There are overhead power lines and a gas line under the road. According to Mr. York, the gas line is abandoned. The gas line will be addressed through the adequacy process. The structures on the east side of Phase 7 all appear to be abandoned (photo 10). The ownership of these structures will be verified through the adequacy process.

Photo 10- Structures located between Phases 5 and 7

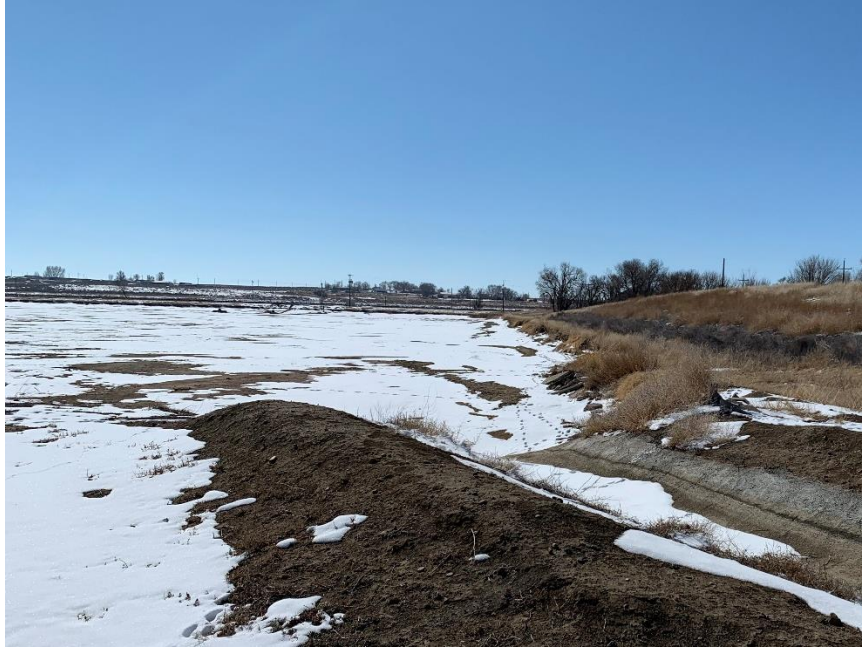
Phase 5 area- This area is currently used for agriculture and contains 1 irrigation pivot, irrigation ditch, and an irrigation pond. The water supply ditch enters this phase from the west and terminates at the pond (photo 11). The west side of this mining area will be set back 75 feet from the large overhead power lines that run north and south according to Map 6 of 6. During the field inspection it was noted that a smaller set of power lines run between the large power lines and the Phase 5 slurry wall. It needs to be verified that this 75' setback is sufficient for the smaller set of powerlines. The slope stability analysis did not address the west bank of the Phase 5 area.

Photo 11- Irrigation ditch ends at irrigation pond in Phase 5

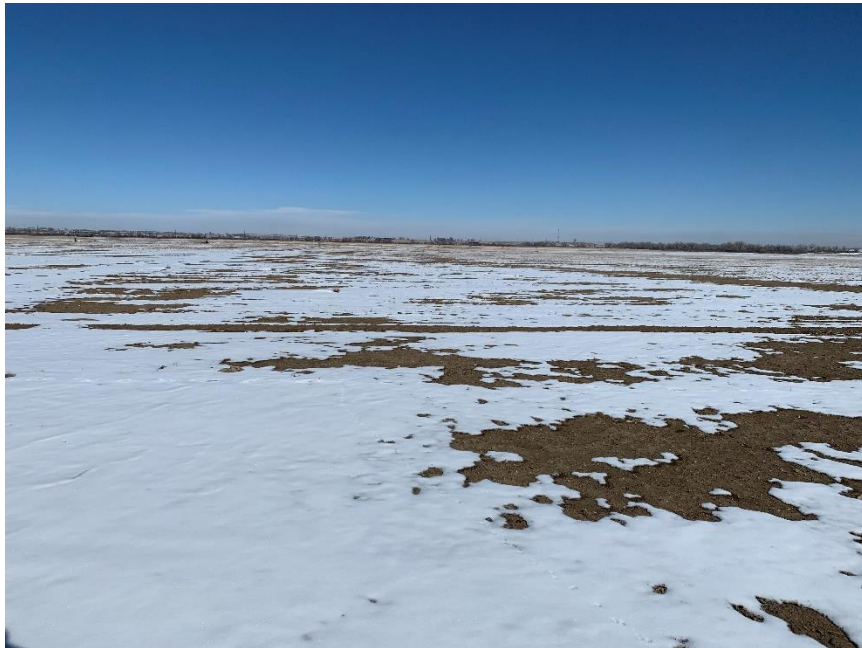
Phase 6 area – This area is the eastern most proposed mining area. It is currently used for agriculture and contains 2 irrigation pivots (photo 12). A large irrigation canal runs along the southern border of Phases 5 and 6 (photo 13). The mining setback from the canal is 75' for both phases. The canal lies outside the permit boundary.

Photo 12 – Phase 6 area, facing north

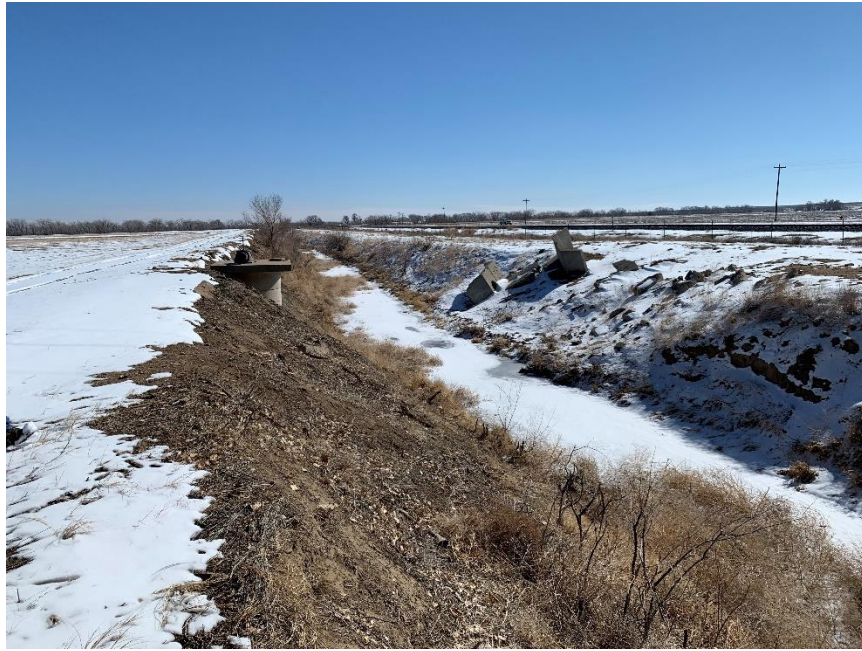
Photo 13 – Irrigation canal south of Phases 5 and 6 permit boundaries, facing east
