**COLORADO****Division of Reclamation,
Mining and Safety**

PERMIT INFORMATION

| Permit Number: C-1981-041 Mine Name: Roadside Portals Operator: Snowcap Coal Company, Inc Operator Address: Ms Tonya Hammond P.O. Box 1430 Palisade, CO 81526 | County: Mesa Operation Type: Underground Permit Status: Active Ownership: Private |

| Inspection Start Date: March 2, 2021 Inspection Start Time: 12:00 Inspection End Date: March 2, 2021 Inspection End Time: 12:05 | | Inspection Type: Aerial Inspection Inspection Reason: Normal I&E Program Weather: Clear | |

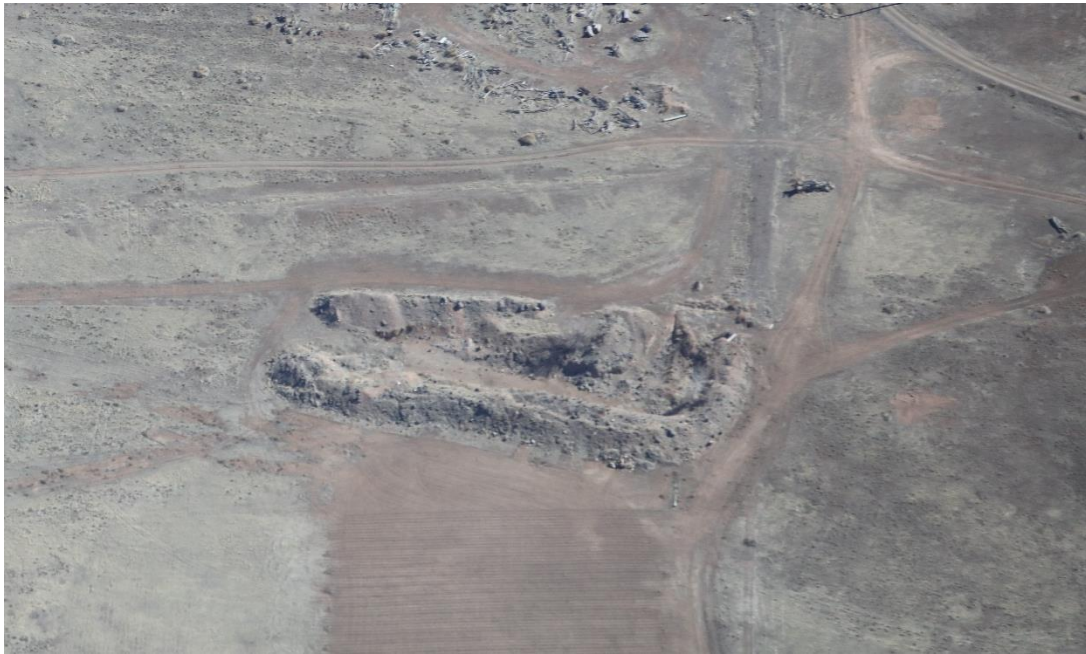
During the inspection the Carey pit was observed to be dry (Photo 1). There were no indications of recent water application to the pit. Trenches on top of the Tract 70 Mesa were observed to be dry (Photo 2). There were no signs of recent water application within the area. The landowner's field just south of the Tract 70 Mesa was not applying water at the time of the inspection (Photo 3). The field had no indications that water had been recently applied to it. The reclaimed portals area did not appear to have any seepage, slumping or other indications of instability. There was no water observed flowing out from the French drain (Photo 4).

Photo 1: The Carey Pit located to the south of the TR-69 repair area.

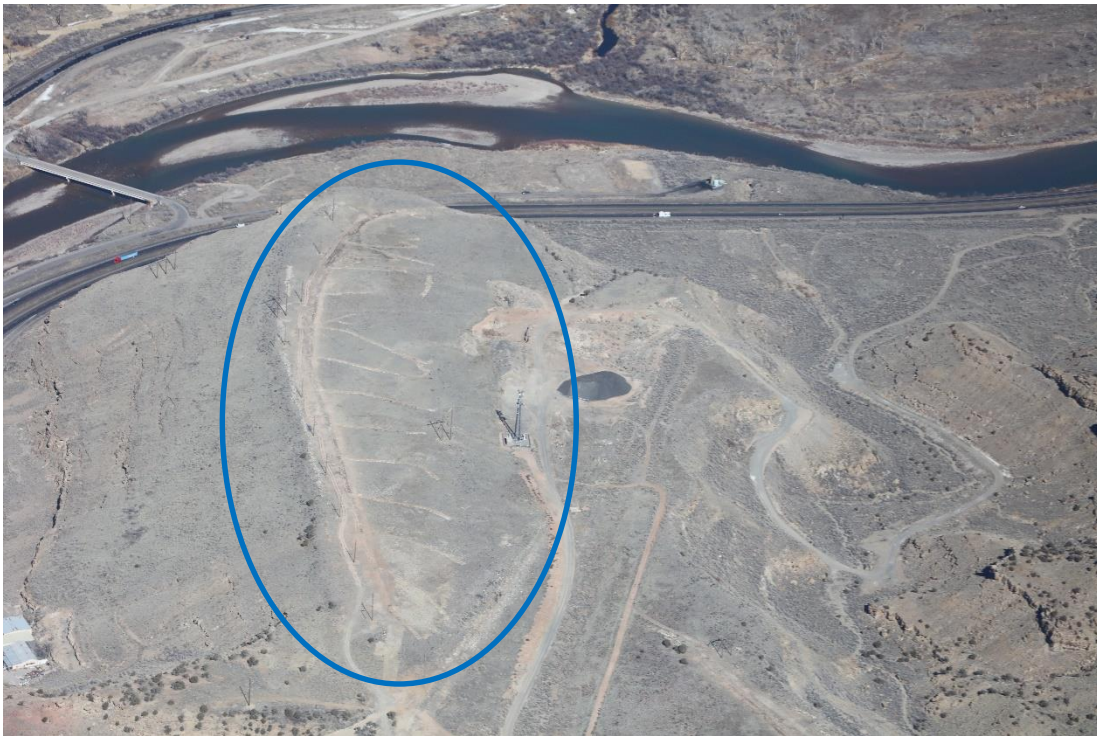
Photo 2: The trenches located on Tract 70 are outlined by the blue oval in the photo.

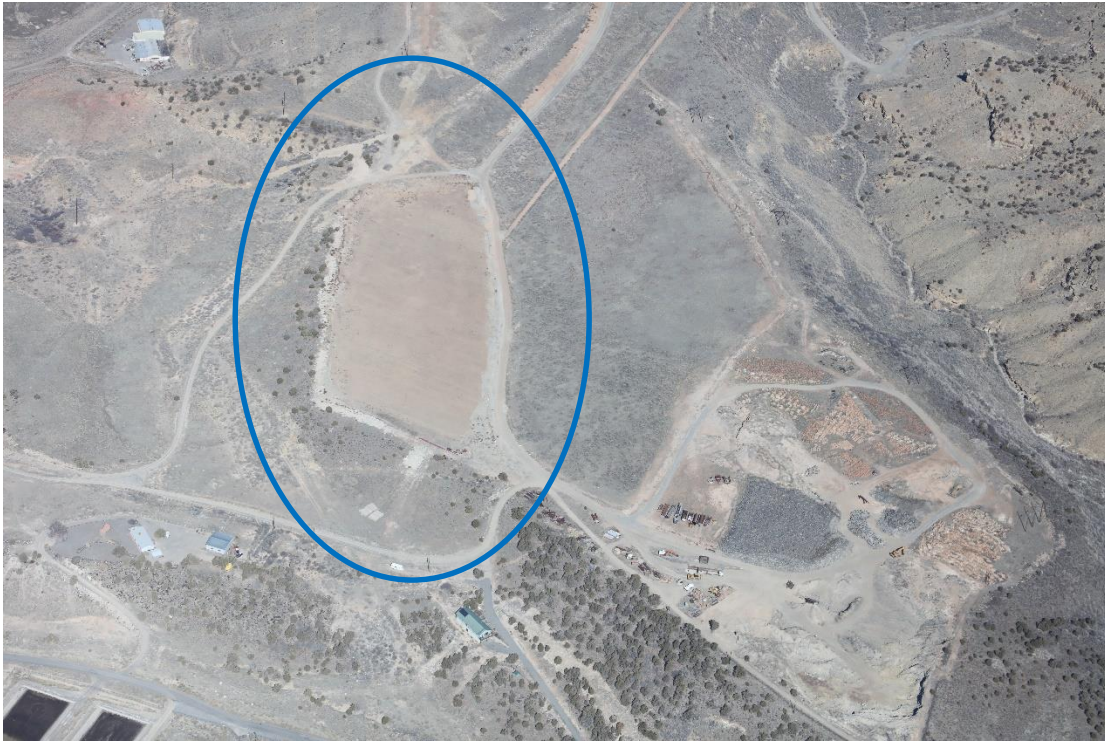
Photo 3: The landowner's field is outlined by the blue oval in the photo.

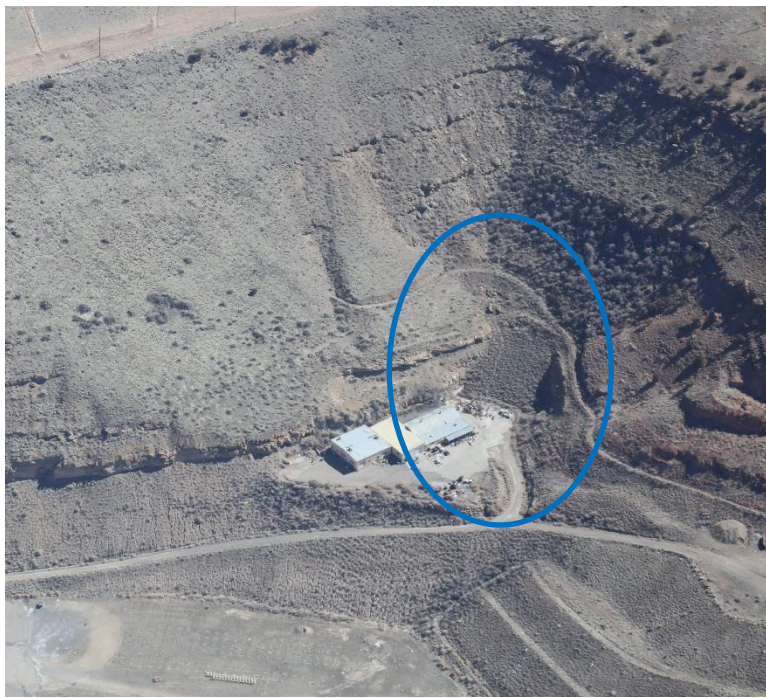
Photo 4: The reclaimed portals are outlined by the blue oval in the photo.

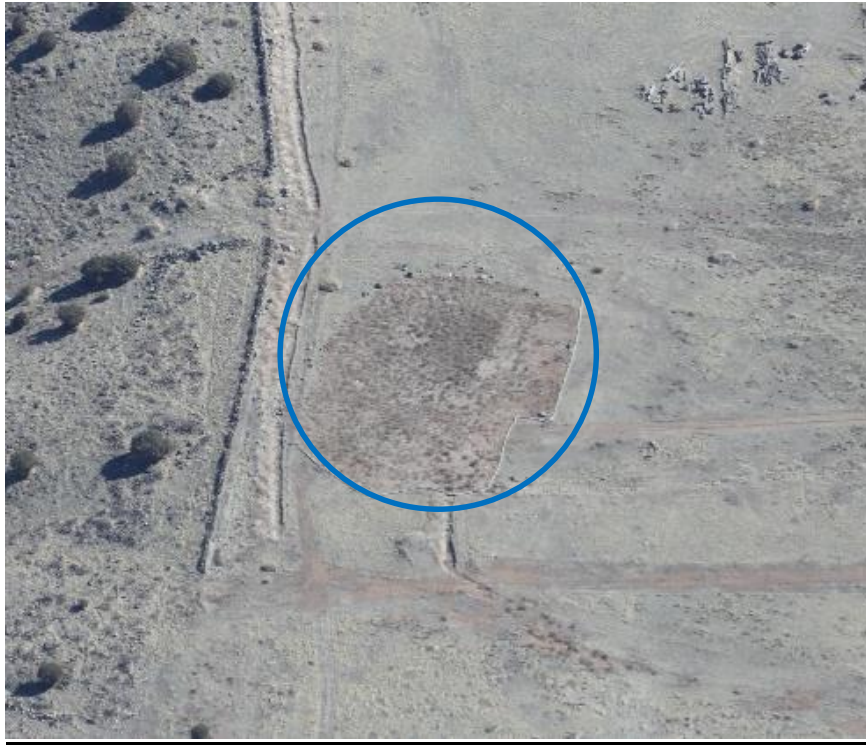
The remaining permitted surface area associated with reclaimed disturbance is the land reclaimed in late 2019. The land was reclaimed following the work conducted for TR-69. The site is approximately 0.4 acres in size. The site was vegetated and stable during the inspection. There were no indications of erosional features or settling of the surface (Photo 5).

Photo 5: The reclaimed disturbance associated with TR-69 is outlined by the blue circle in the photo.
