MINERALS PROGRAM INSPECTION REPORT
PHONE: (303) 866-3567

MINE NAME: Roman's Pit	MINE/PROSPECTING ID#: M-2021-004	MINERAL: Gravel	COUNTY: Conejos
INSPECTION TYPE: Preoperation Inspection	INSPECTOR(S): Lucas West	INSP. DATE: February 24, 2021	INSP. TIME: 15:30
OPERATOR: Rio Grande Bentonite, Inc.	OPERATOR REPRESENTATIVE: Larry and Lawrence Mondragon	TYPE OF OPERATION: 110c - Construction Limited Impact	
REASON FOR INSPECTION: Preoperation Inspection	BOND CALCULATION TYPE: Complete Bond	BOND AMOUNT: No Bond Held	
DATE OF COMPLAINT: NA	POST INSP. CONTACTS: None	JOINT INSP. AGENCY: None	
WEATHER: Clear	INSPECTOR'S SIGNATURE:

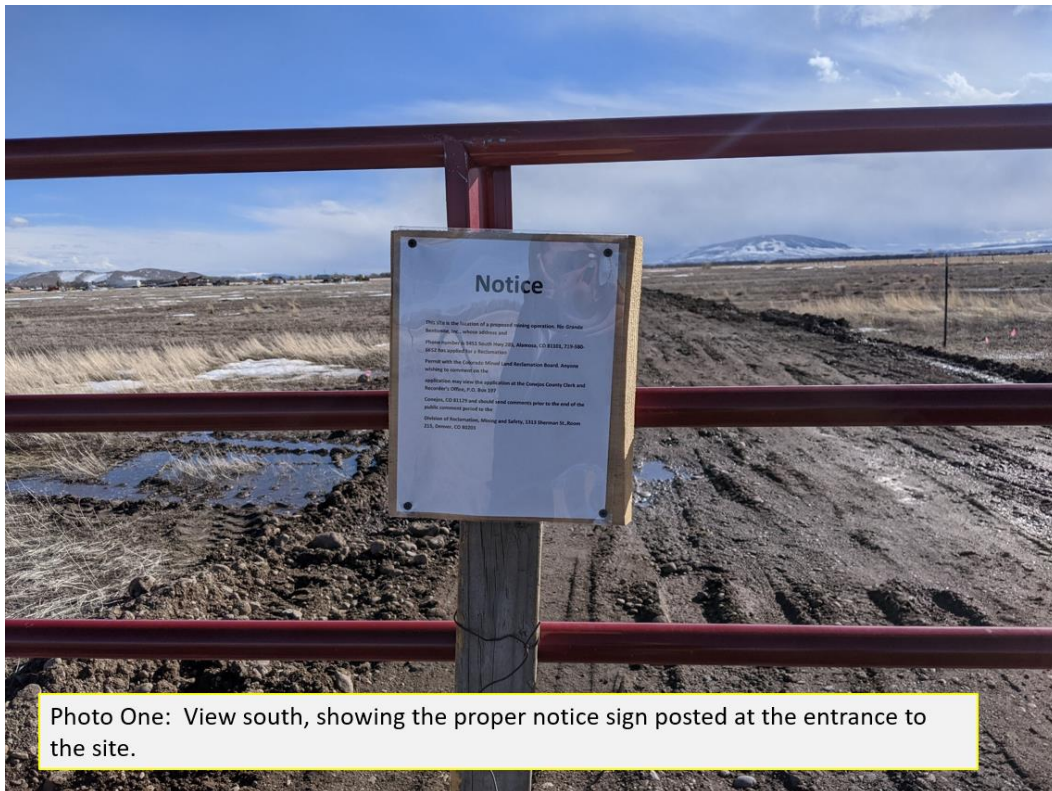
The proper site identification signage was posted at the entrance to the site as seen in Photo One. A majority of the permitted acreage is undisturbed and un-utilized pasture land that is vegetated with low growing grass species and various weeds. Examples of the pasture like area can be seen in Photos Two and Three. No mining related disturbance exists on site, a small preexisting access road leads back to a depression located towards the south end of the property. The access road will also be utilized by the mining operations and will remain post reclamation. The depression located on the property is a pre-law gravel pit dug by Conejos County. The permit boundary intersects the existing depression in the northeast corner and will serve as the starting point for mining operations. The point of intersection can be seen in Photo Four. Mining will proceed in the northeast direction resulting in an 8.68 acre depression, including slopes that will serve as a lay down yard for the operator. The side slopes will be mined and reclaimed to a 3H:1V slopes with no revegetation proposed due to the lack of existing topsoil and the stability of the native material.

Photo One: View south, showing the proper notice sign posted at the entrance to the site.

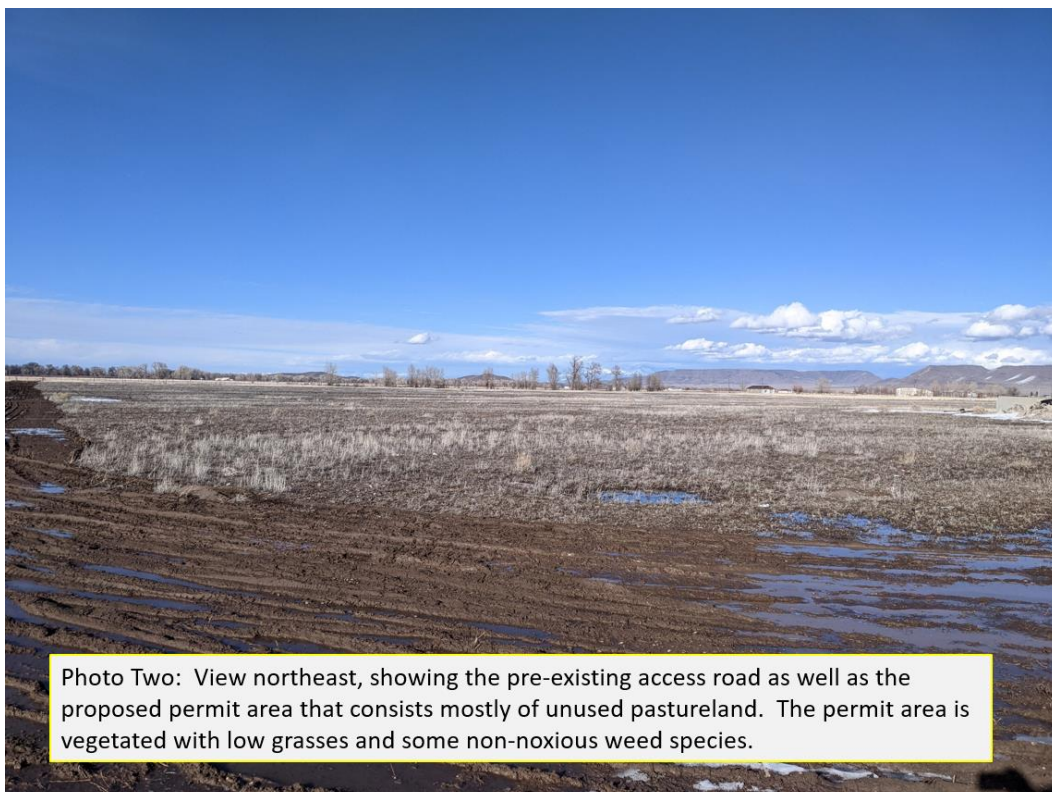
Photo Two: View northeast, showing the pre-existing access road as well as the proposed permit area that consists mostly of unused pastureland. The permit area is vegetated with low grasses and some non-noxious weed species.

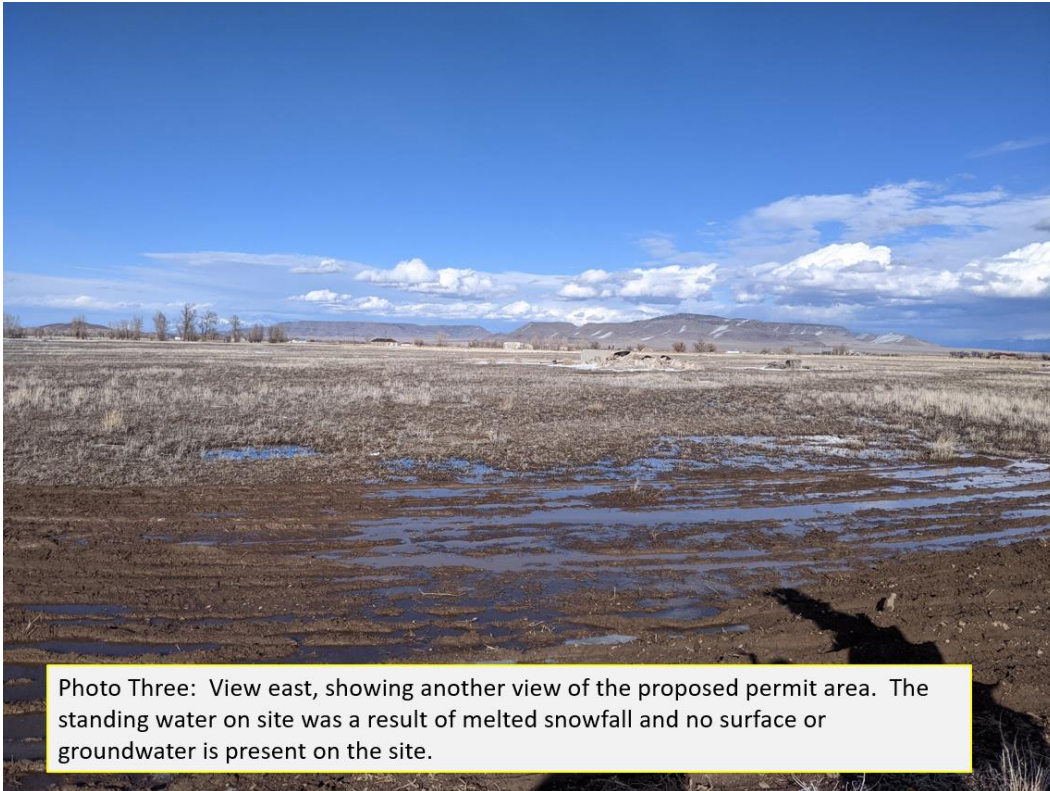
Photo Three: View east, showing another view of the proposed permit area. The standing water on site was a result of melted snowfall and no surface or groundwater is present on the site.

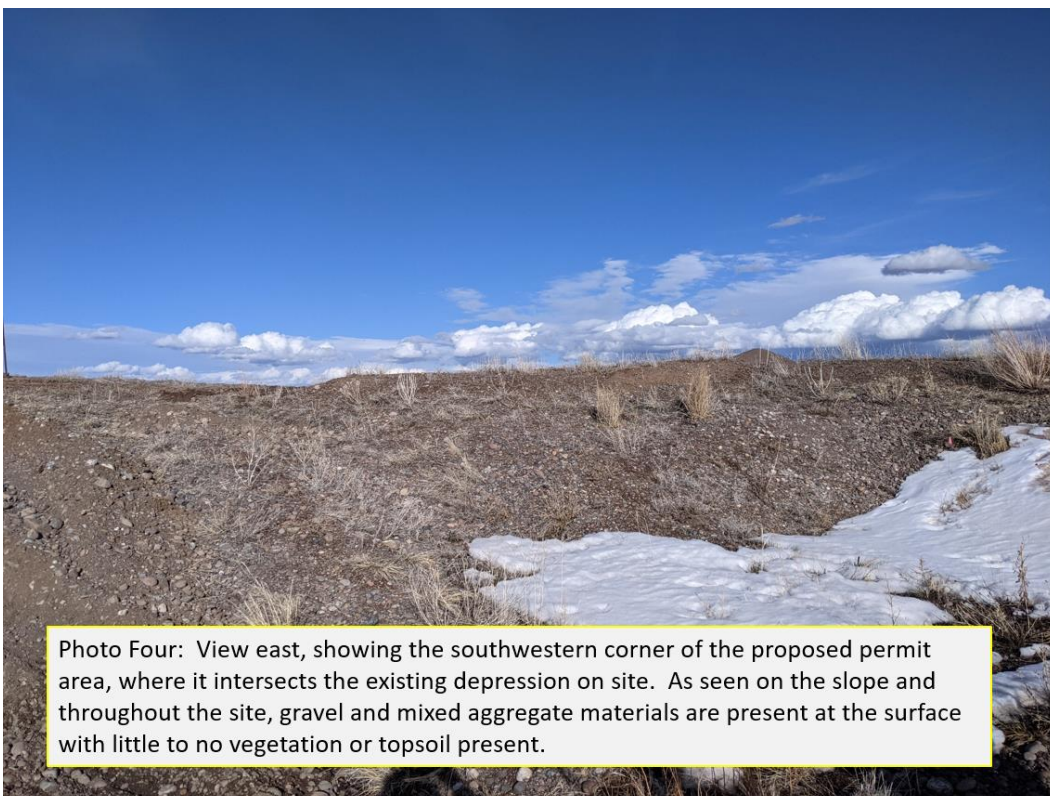
Photo Four: View east, showing the southwestern corner of the proposed permit area, where it intersects the existing depression on site. As seen on the slope and throughout the site, gravel and mixed aggregate materials are present at the surface with little to no vegetation or topsoil present.
