**MINERALS PROGRAM INSPECTION REPORT**  
**PHONE: (303) 866-3567**

<b>MINE NAME:</b> Raindance Reservoir #2	<b>MINE/PROSPECTING ID#:</b> M-2021-012	<b>MINERAL:</b> Borrow material for	<b>COUNTY:</b> Weld
<b>INSPECTION TYPE:</b> Illegal(Unpermitted Operation)	<b>INSPECTOR(S):</b> Peter Hays	<b>INSP. DATE:</b> March 1, 2021	<b>INSP. TIME:</b> 13:00
<b>OPERATOR:</b> Vima Partners, LLC	<b>OPERATOR REPRESENTATIVE:</b> Cody Wooldridge	<b>TYPE OF OPERATION:</b> ILL - Illegal	
<b>REASON FOR INSPECTION:</b> Citizen Complaint	<b>BOND CALCULATION TYPE:</b> None	<b>BOND AMOUNT:</b> No Bond Held	
<b>DATE OF COMPLAINT:</b> NA	<b>POST INSP. CONTACTS:</b> None	<b>JOINT INSP. AGENCY:</b> None	
<b>WEATHER:</b> Clear	<b>INSPECTOR'S SIGNATURE:</b>

# Raindance Reservoir #2

March 1, 2021 Inspection Map  
M-2021-012

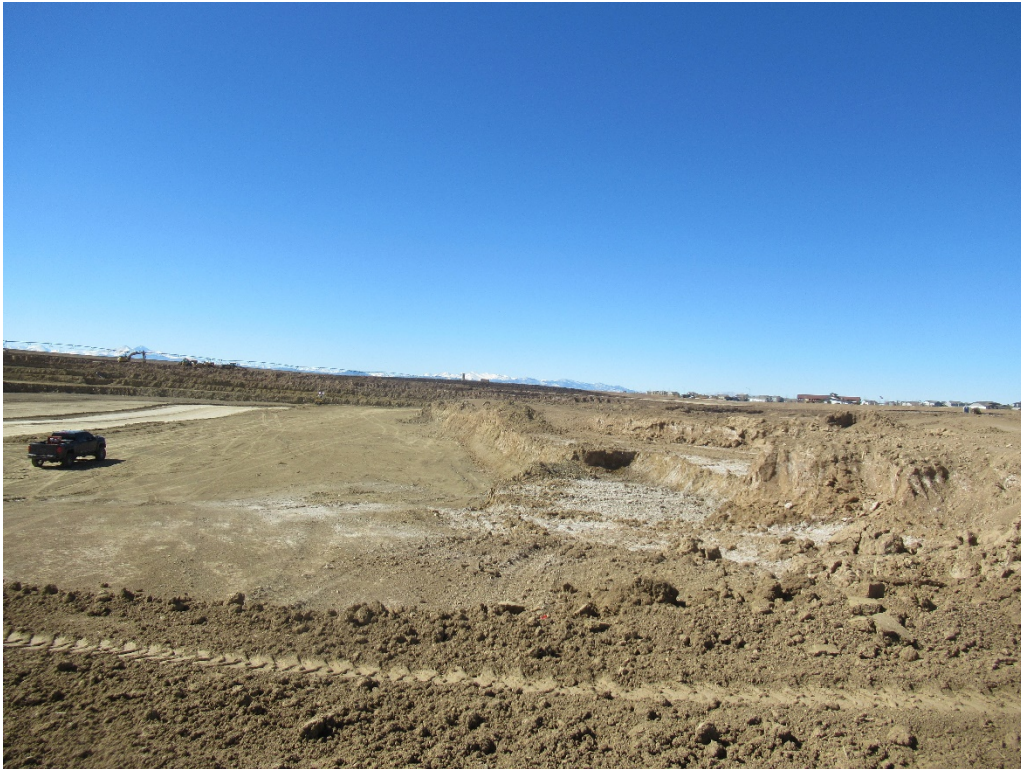
The operation was actively excavating and hauling material from the site during the inspection. The Operator stated the deepest excavation was currently at 26 feet below the original grade and excavation would continue to a final depth of 45 feet below grade. Groundwater was not exposed at the time of the inspection, however the exposure of groundwater is anticipated as stated in the completed questionnaire. The excavation area will be clay lined to create a reservoir with 4H:1V perimeter slopes. The reservoir will be used as a stormwater detention pond for the Raindance residential development located on the north side of WCR 62 and for agricultural water storage. The Operator provided the Division with a copy of the Town of Windsor approved overall grading plan for the Raindance Reservoir #2 site during the inspection. The Division estimated the size of the current disturbance area at 18.5 acres based on the inspection map. On March 2, 2021, the Operator submitted copies of grading permit applications with Weld County to the Division. Based on these grading permit applications, the Operator is proposing not only the excavation from the reservoir but also a large stockpile area. The reservoir area is sixty-seven (67) acres and the stockpile area is forty (40) acres according to the Weld County applications. The Division will require both for these areas and any access routes or roads constructed for the operation included in the DRMS permit area.

View of active excavation area from the northeast corner looking west

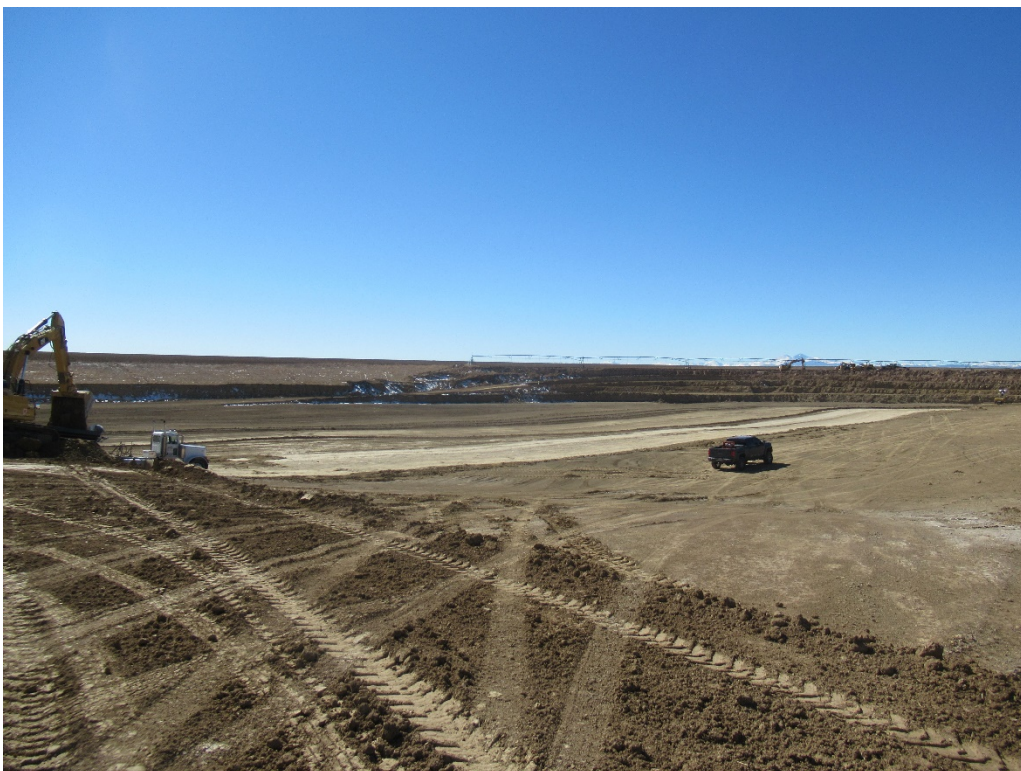
View of active excavation area from the northeast corner looking southwest

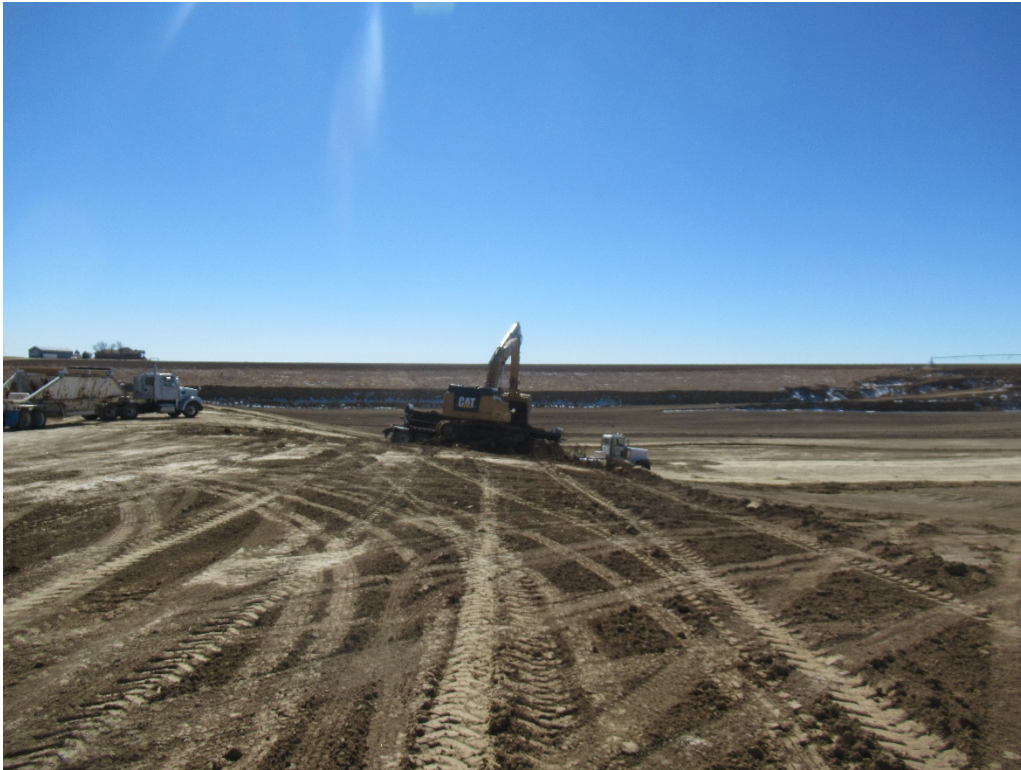
View of active excavation area from the northeast corner looking south

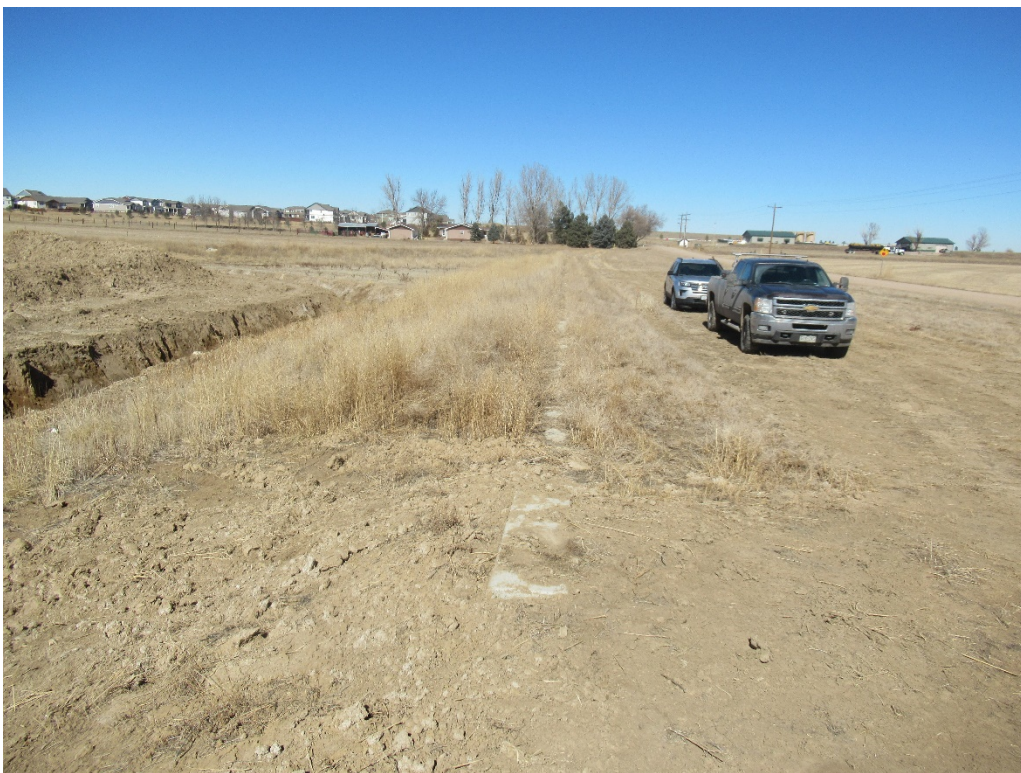
View of the concrete outfall structure located west of WCR 15

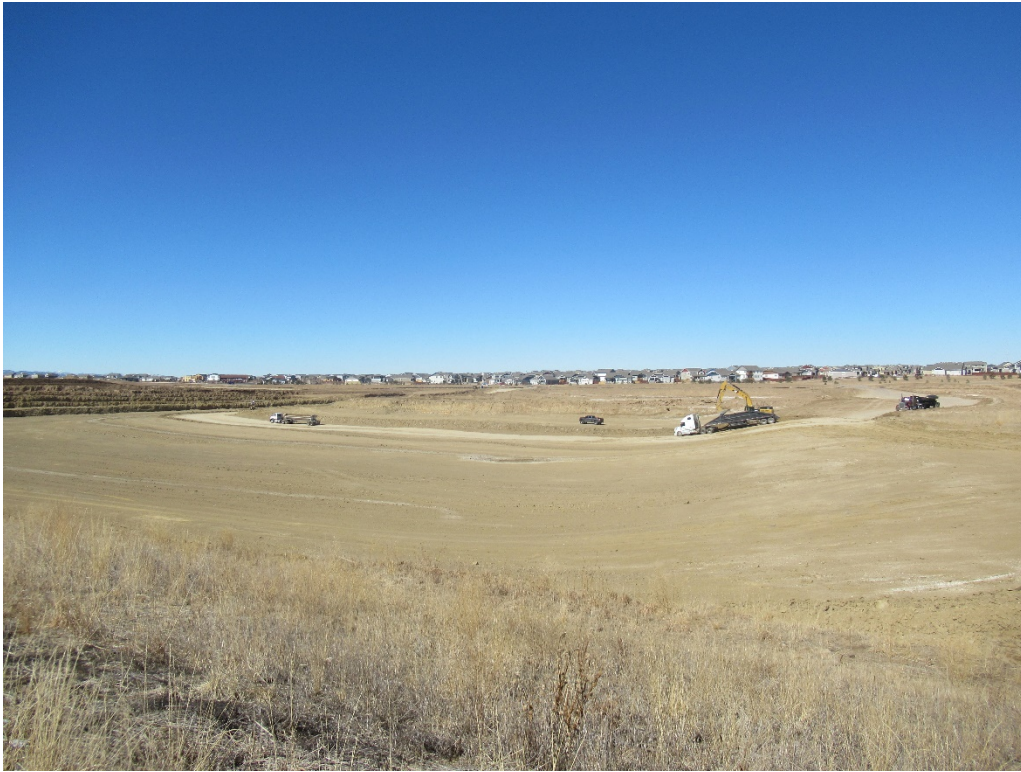
View of the site from the southeast corner looking northwest

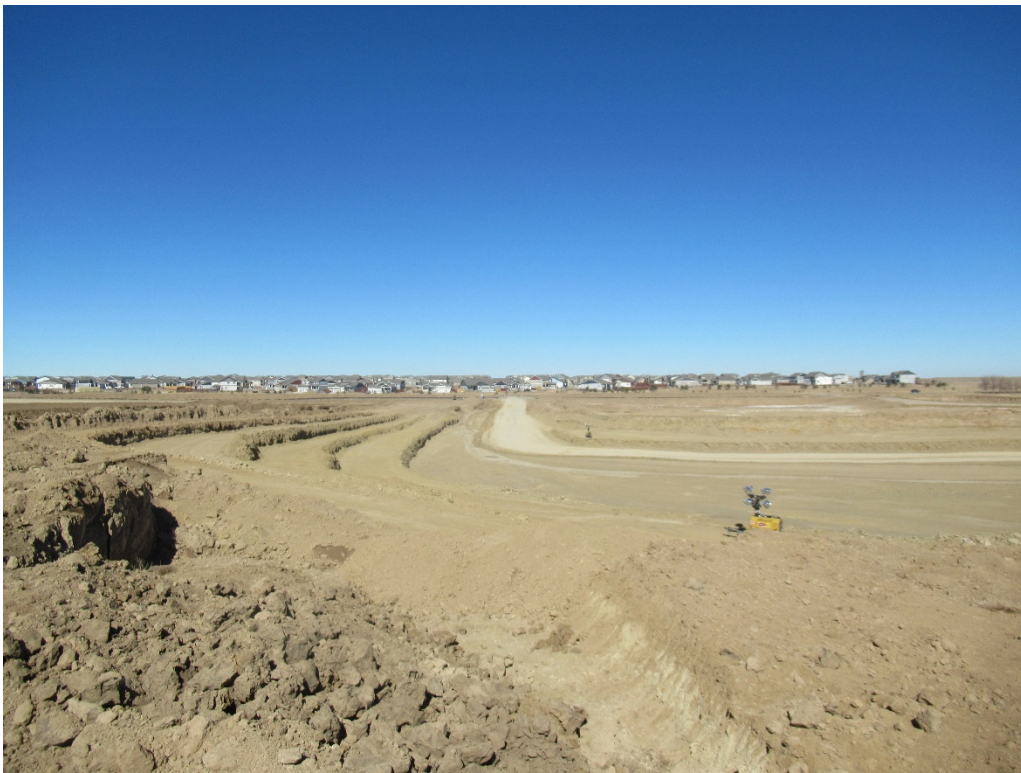
View of the site from the southwest corner looking north

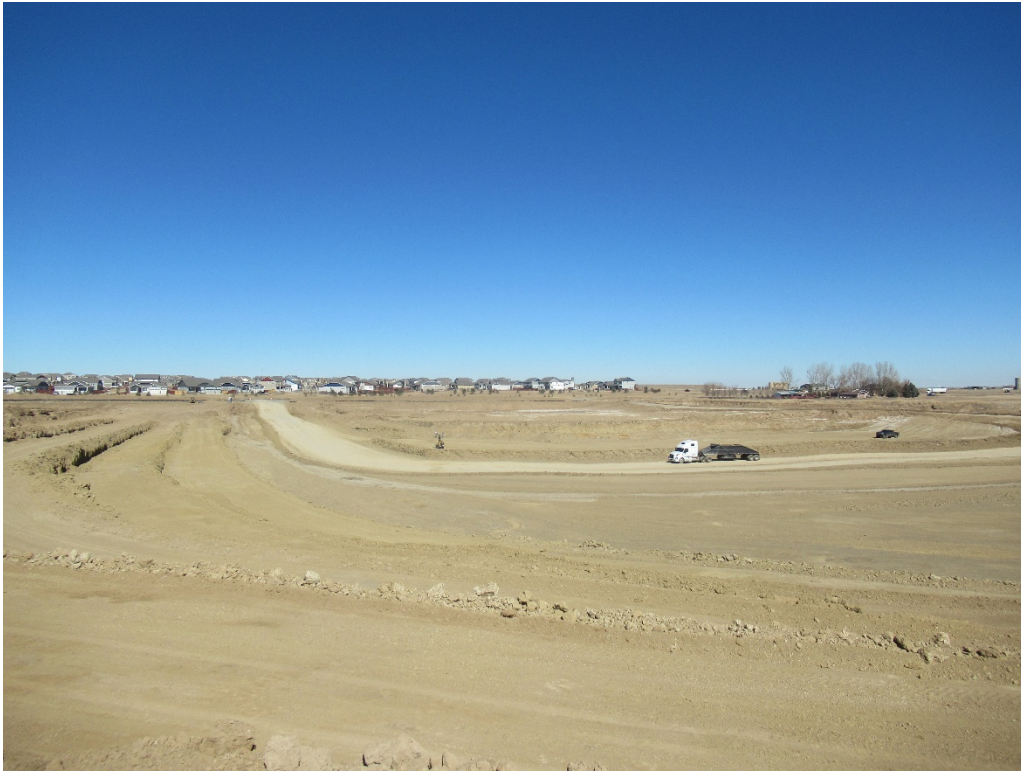
View of the site from the southwest corner looking northeast

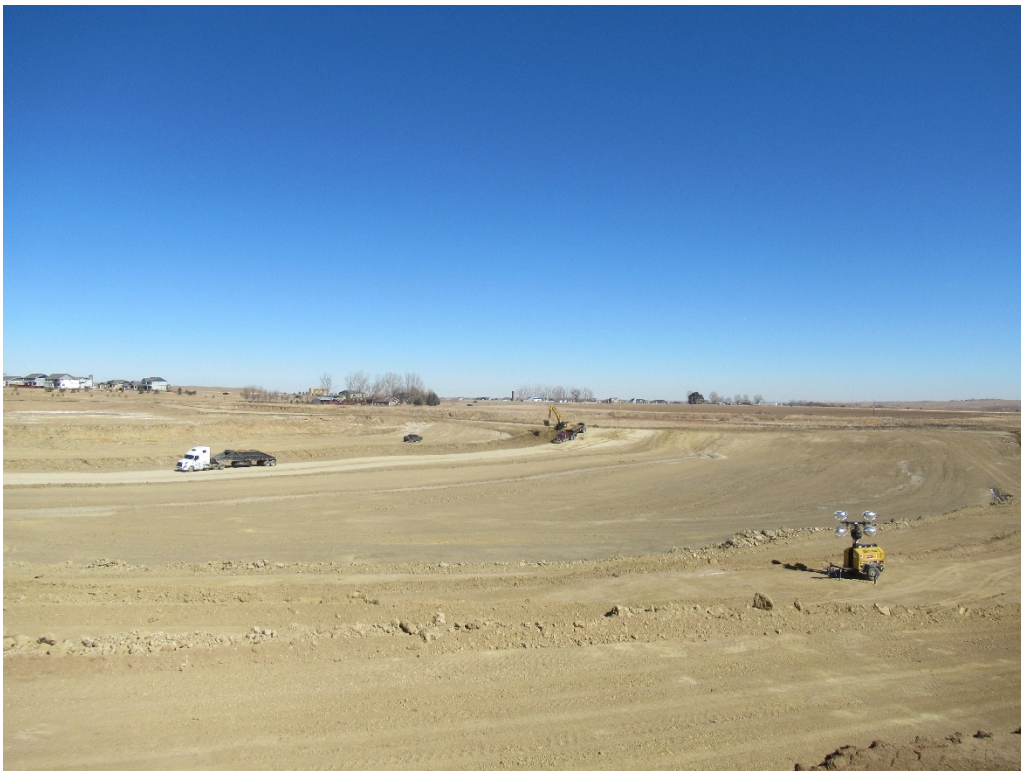
View of the site from the southwest corner looking northeast

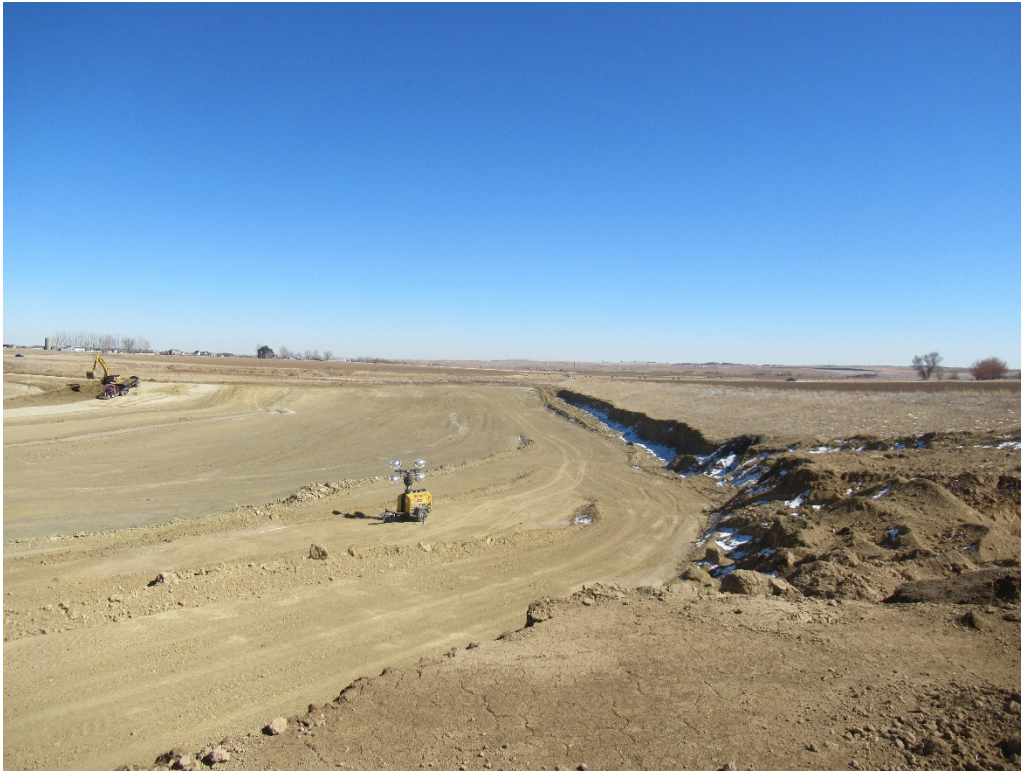
View of the site from the southwest corner looking east
