PERMIT INFORMATION

Permit Number: C-1982-056 Mine Name: Foidel Creek Mine Operator: Twentymile Coal, LLC Operator Address: Ms Miranda Kawcak 29515 Routt County Road No. 27 Oak Creek, CO 80467	County: Routt Operation Type: Underground Permit Status: Active Ownership: Private
	Operator Representative Present: None
Operator Representative Signature: (Field Issuance Only)

Inspection Start Date: March 2, 2021 Inspection Start Time: 12:15 Inspection End Date: March 2, 2021 Inspection End Time: 12:30		Inspection Type: Aerial Inspection Inspection Reason: Normal I&E Program Weather: Clear	
Joint Inspection Agency: None		Joint Inspection Contacts:	
Post Inspection Agency: None		Post Inspection Contacts:	
Inspector(s): Tabetha Lynch Brock Bowles	Inspector's Signature:

This was an aerial inspection of the Foidel Creek Mine; DRMS Permit No. C-1982-056, operated by Twentymile Coal, LLC. (TC). The photos were taken by Brock Bowles on 3/2 and the inspection report was written by Tabettha Lynch with the Colorado Division of Reclamation, Mining, and Safety (Division). The weather was clear and the site was snow covered during the inspection.

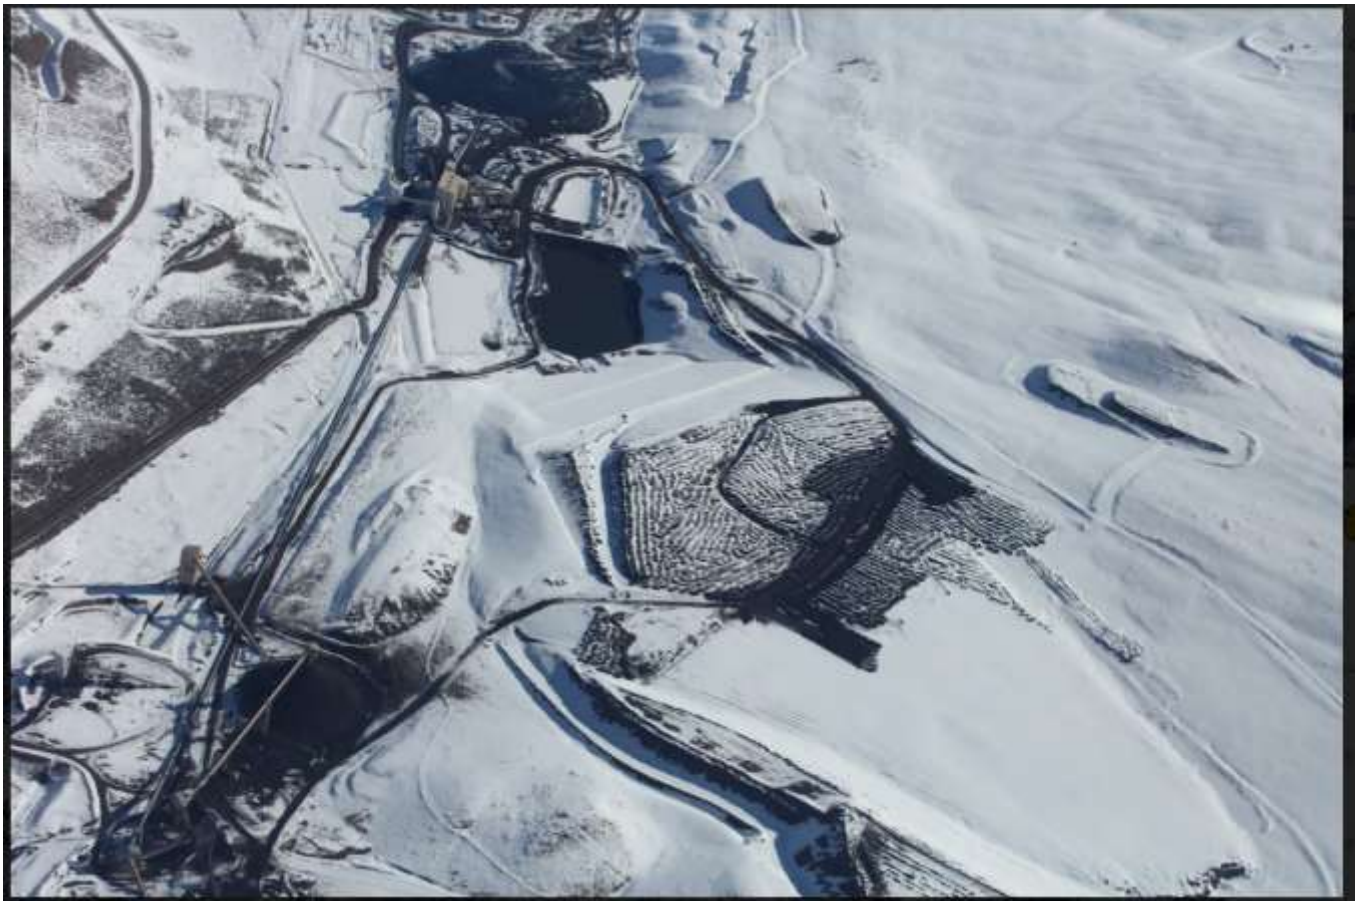
Mine facilities area is pictured below, looking east. Ponds appear to be mostly covered with the exception of the pit pond. Waste pile appears active, stable, and on the third lift. Topsoil piles appear stable, snow covered, and undisturbed. Roads appear to be plowed in facilities area.

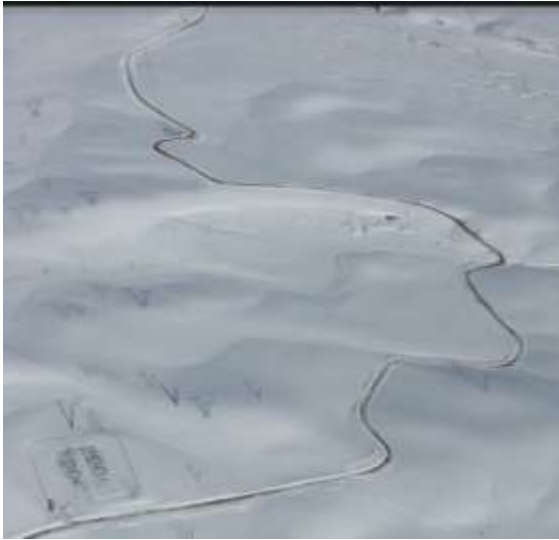
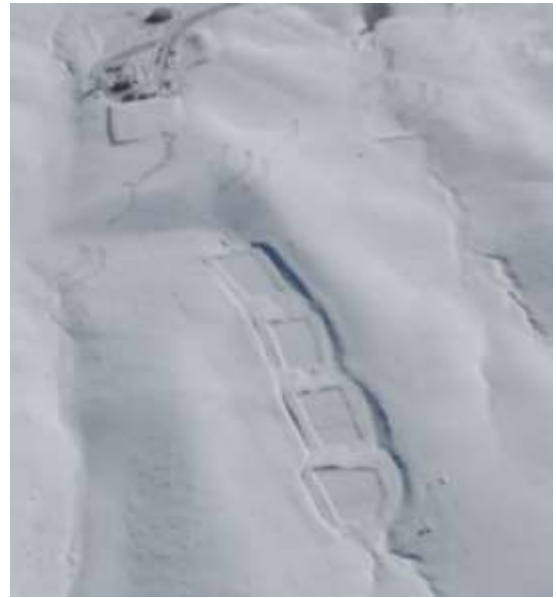
Above is the road the 6 Main North and the passive treatment ponds near the 6MN reservoir and pad. Road appears to be plowed, no issues are noted. Topsoil piles along the road appear undisturbed. Passive treatment ponds are snow covered and appear inactive.

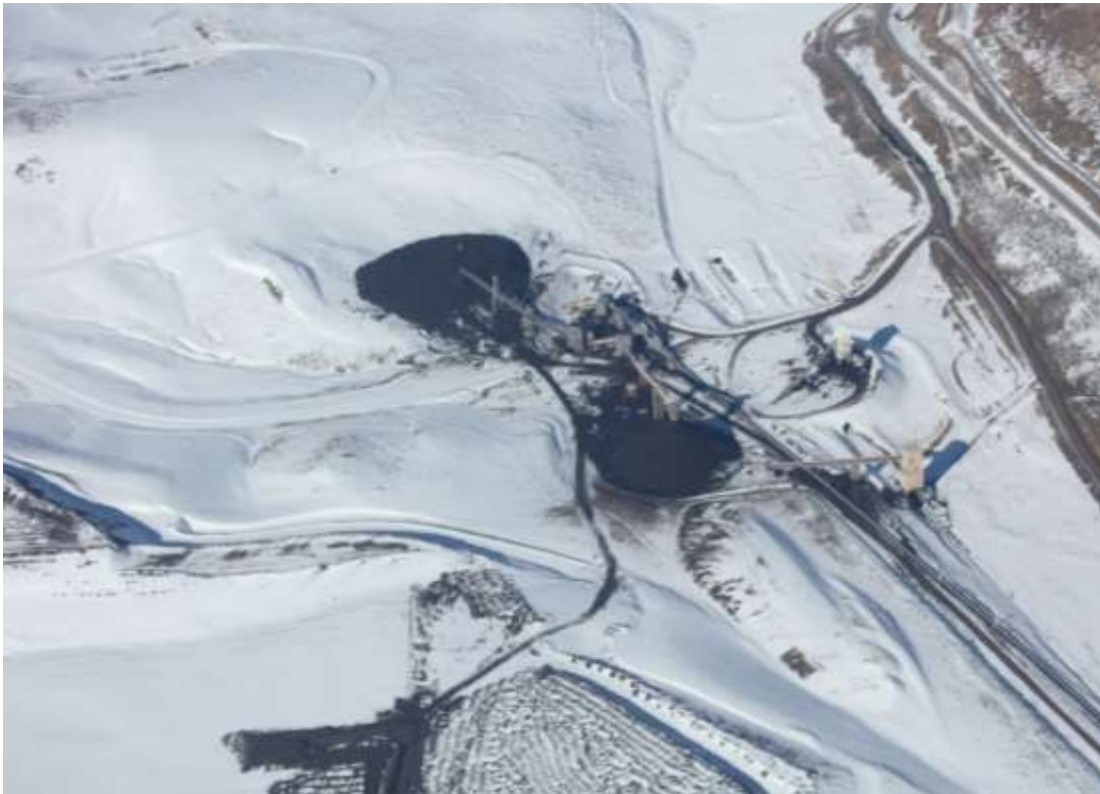
West end of facilities area and waste pile is pictured above. Topsoil piles in this area appear stable and undisturbed. Ponds are mostly snow covered. Roads appear well maintained. No issues were noted as a result of this inspection.
