RE: 2020 Annual Report, Henderson Mine and Mill, Permit No M-1977-342

HENDERSON MILL
MLRB Permit No. M-77-342
Annual Reclamation Report
March 3, 2021

HENDERSON MINE
MLRB Permit No. M-77-342
Annual Reclamation Report
March 3, 2021

Subject: Annual (Year 2020) Tailings Storage Facility Evaluation, Henderson Tailings Storage Facility, Henderson Mill, Colorado

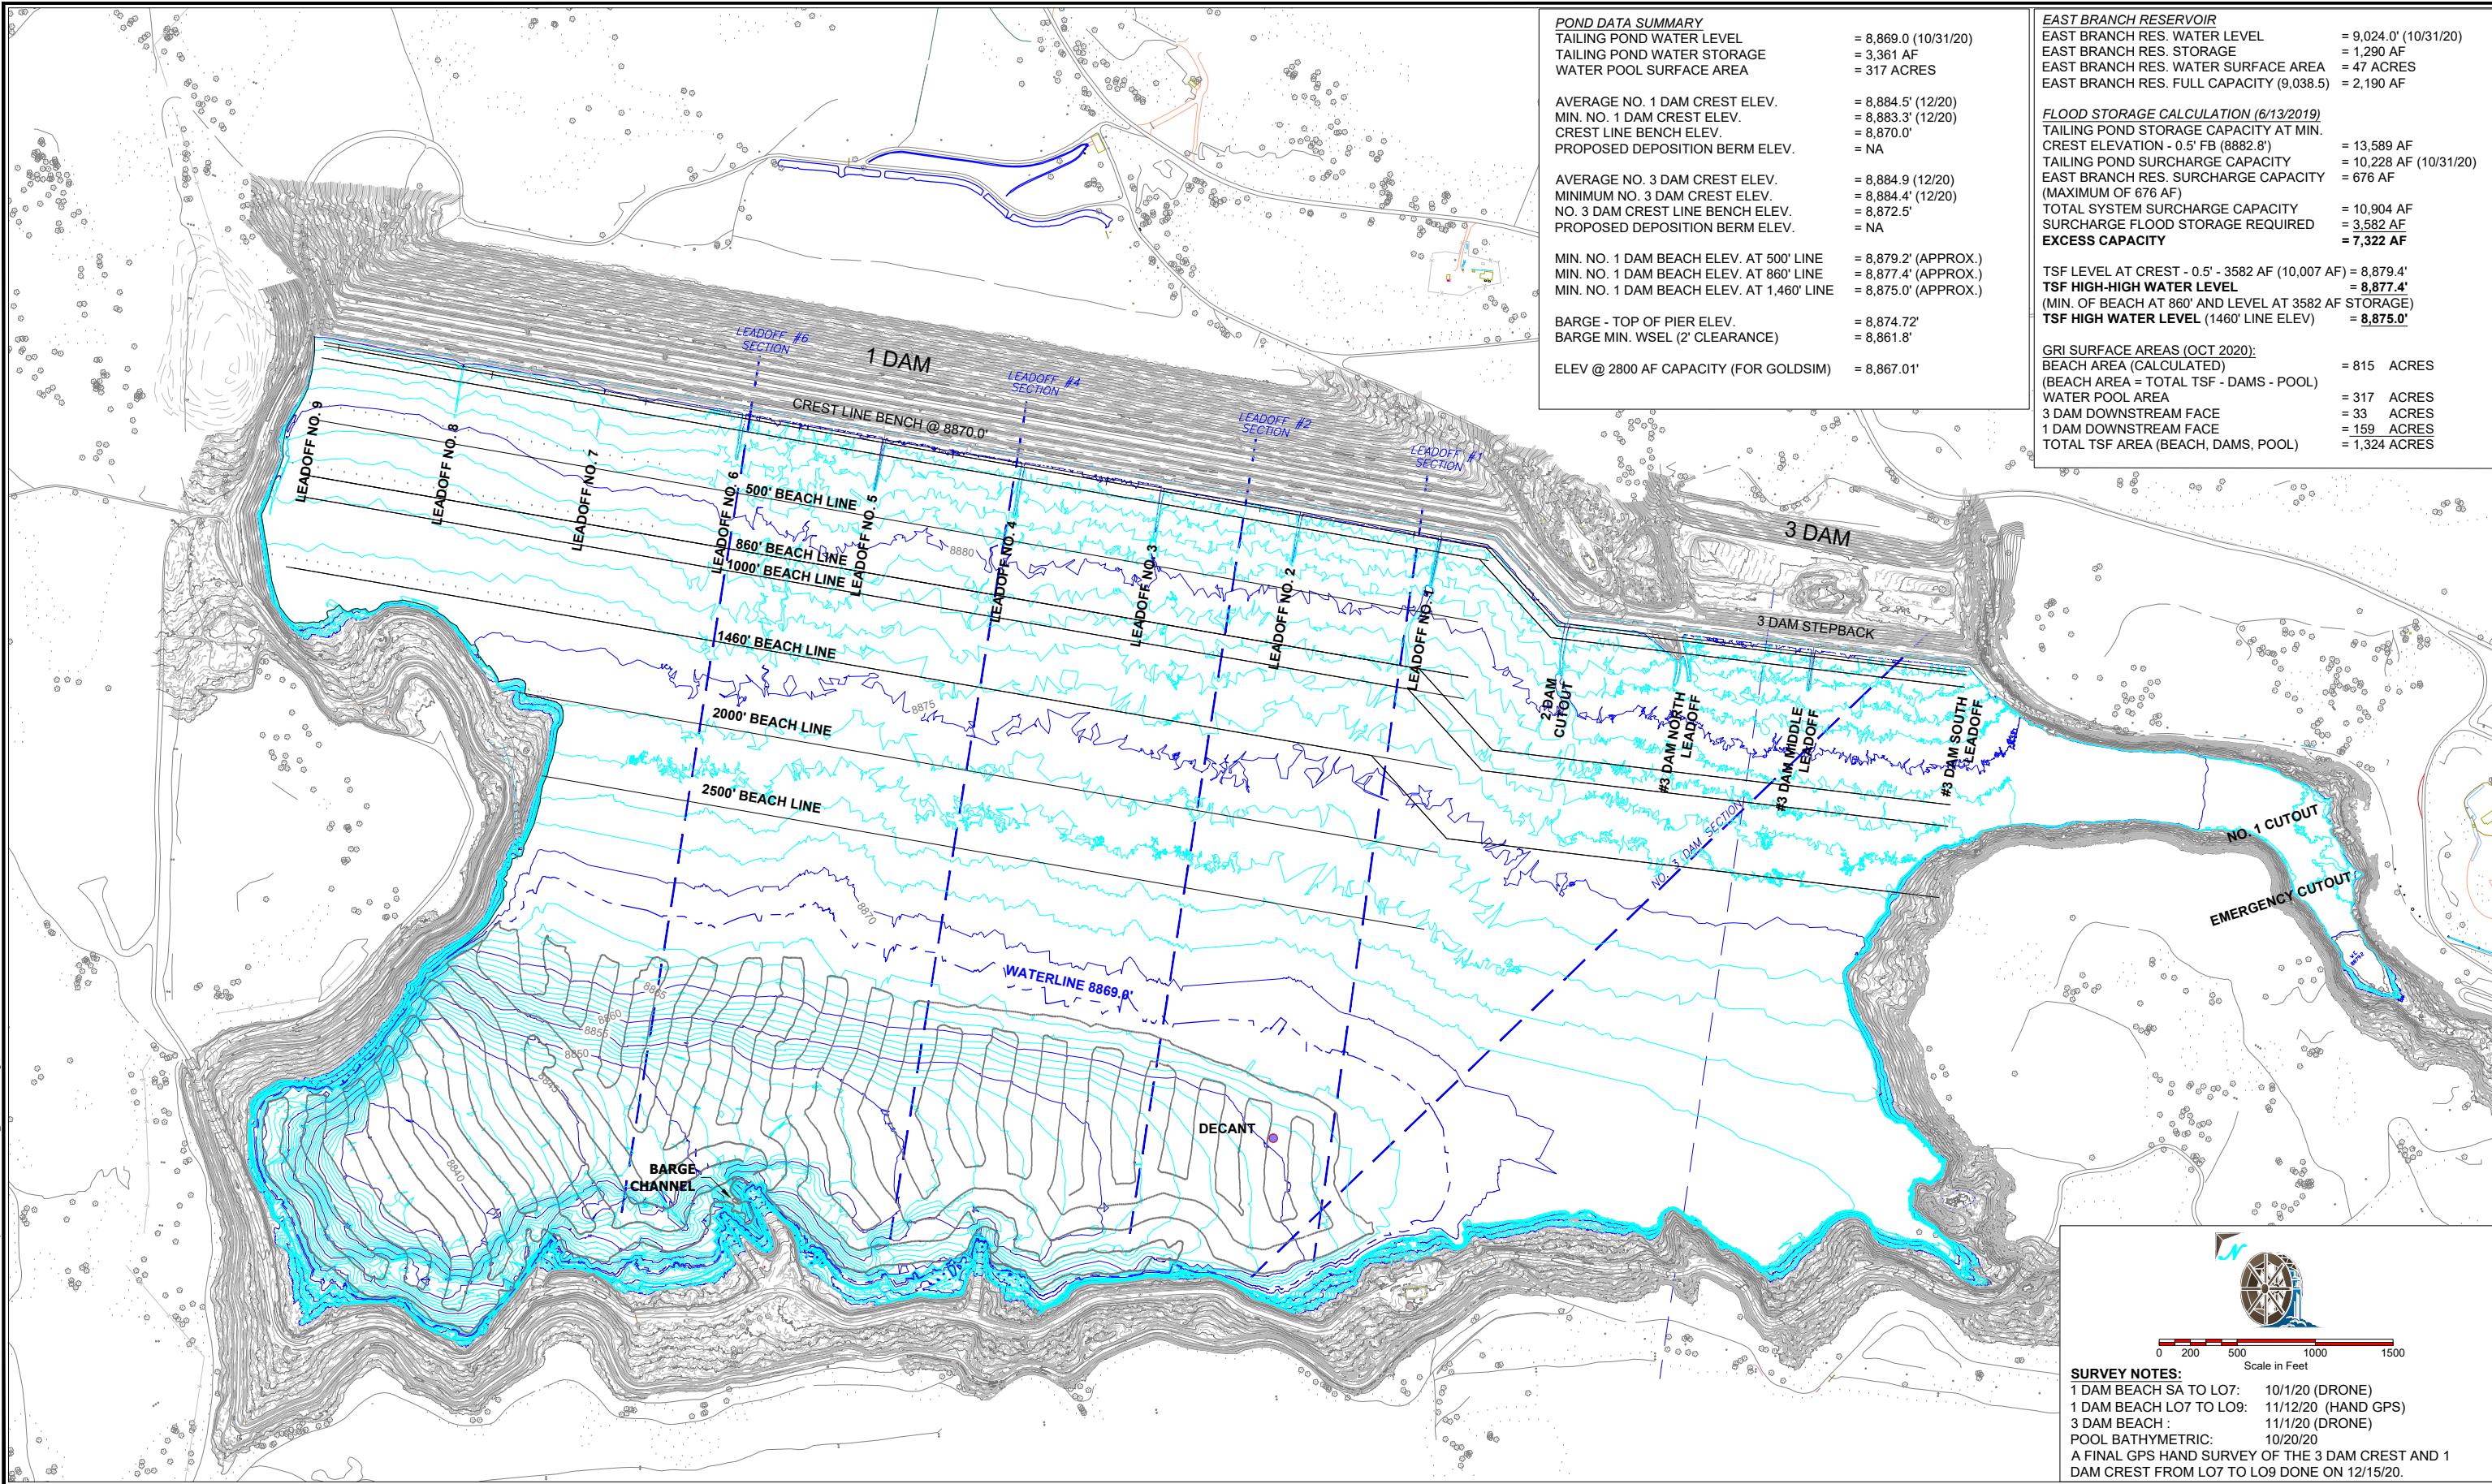
HENDERSON MILL TAILINGS STORAGE FACILITY		Climax Molybdenum Henderson Mill Parshall, CO		
BEACH AND POND SURVEY		SAA	12/20	SCALE AS NOTED
FALL 2020 SURVEY		CHECKED BY SMM	12/20	DRAWING NO.
DATES: SEE SURVEY NOTES		ACCEPTED BY ...		FIGURE 1

One of the primary uses of the survey data is to evaluate the flood storage capacity conditions in the water system. As summarized on Figure 1, at the approximate time of the fall survey there was a total system surcharge storage capacity of about **10,904 acre-feet** in the system. This capacity includes both the TSF and East Branch Reservoir and is based on 0.5 feet of residual freeboard below the minimum dam crest elevation of 8,883.3' and a October 31st water level of 8,869.0 feet. The flood storage requirement for the system is **3,582 acre-feet**. This requirement is based on hydrologic modeling of the probable maximum precipitation (PMP) event. The available flood storage capacity in the system at

the time of the survey significantly exceeds the storage requirement. However, this excess capacity will decrease throughout the coming year as additional inflows to the system occur and a portion of the storage space is filled with deposited tailing.
