**MINERALS PROGRAM INSPECTION REPORT**  
**PHONE: (303) 866-3567**

<b>MINE NAME:</b> Hofacker Property Borrow	<b>MINE/PROSPECTING ID#:</b> M-2021-013	<b>MINERAL:</b> Unknown commodity	<b>COUNTY:</b> Larimer
<b>INSPECTION TYPE:</b> Preoperation Inspection	<b>INSPECTOR(S):</b> Timothy Cazier, P.E.	<b>INSP. DATE:</b> March 5, 2021	<b>INSP. TIME:</b> 08:20
<b>OPERATOR:</b> Ames Construction, Inc.	<b>OPERATOR REPRESENTATIVE:</b> Damien Chavarria & Steve Lange	<b>TYPE OF OPERATION:</b> 111 - Construction by Government Agency	
<b>REASON FOR INSPECTION:</b> Preoperation Inspection	<b>BOND CALCULATION TYPE:</b> None	<b>BOND AMOUNT:</b> \$22,500.00	
<b>DATE OF COMPLAINT:</b> NA	<b>POST INSP. CONTACTS:</b> None	<b>JOINT INSP. AGENCY:</b> None	
<b>WEATHER:</b> Clear	<b>INSPECTOR'S SIGNATURE:</b>

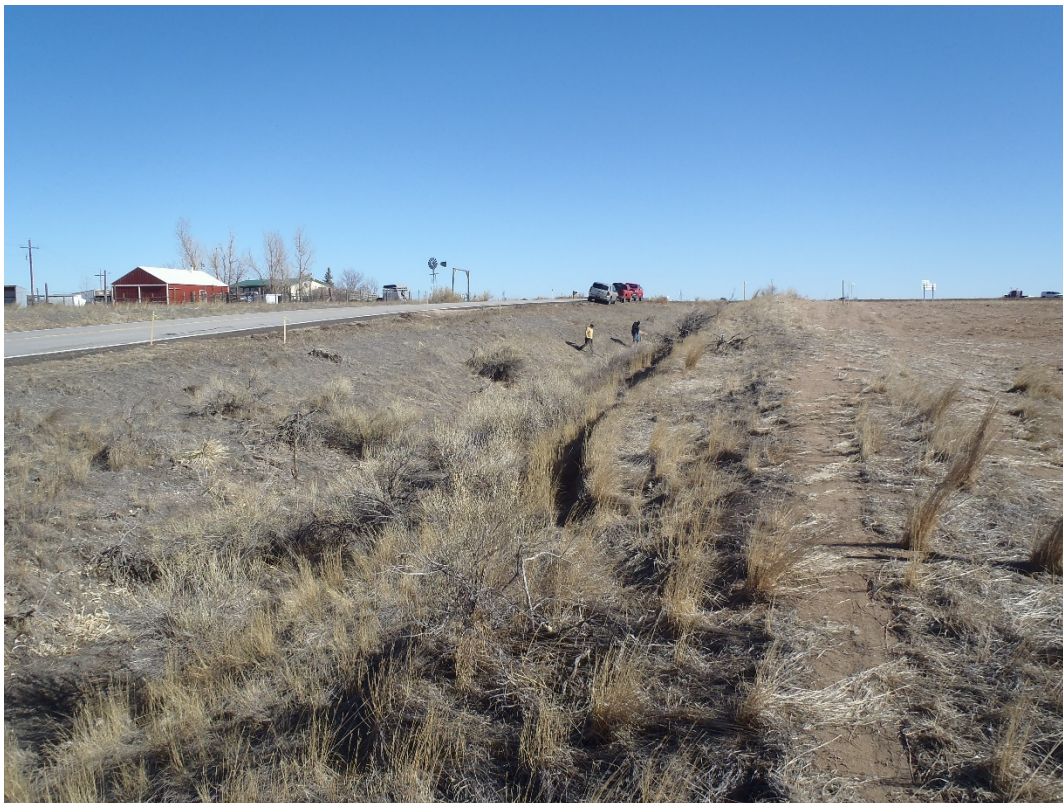
**Hydrologic Balance:** Based on submitted grading plans, no stormwater or groundwater is expected to be captured in the pit. There is a drainage ditch (see **Photos 1 and 2**) on the west side of the pit paralleling CR 5J. Mr. Lange stated Ames would place two 24-inch CMPs in the ditch to allow stormwater to pass through the entrance and exit roads to the pit.

Photo 1. Drainage ditch west of site along CR 5J (looking NE from below proposed south site entrance).

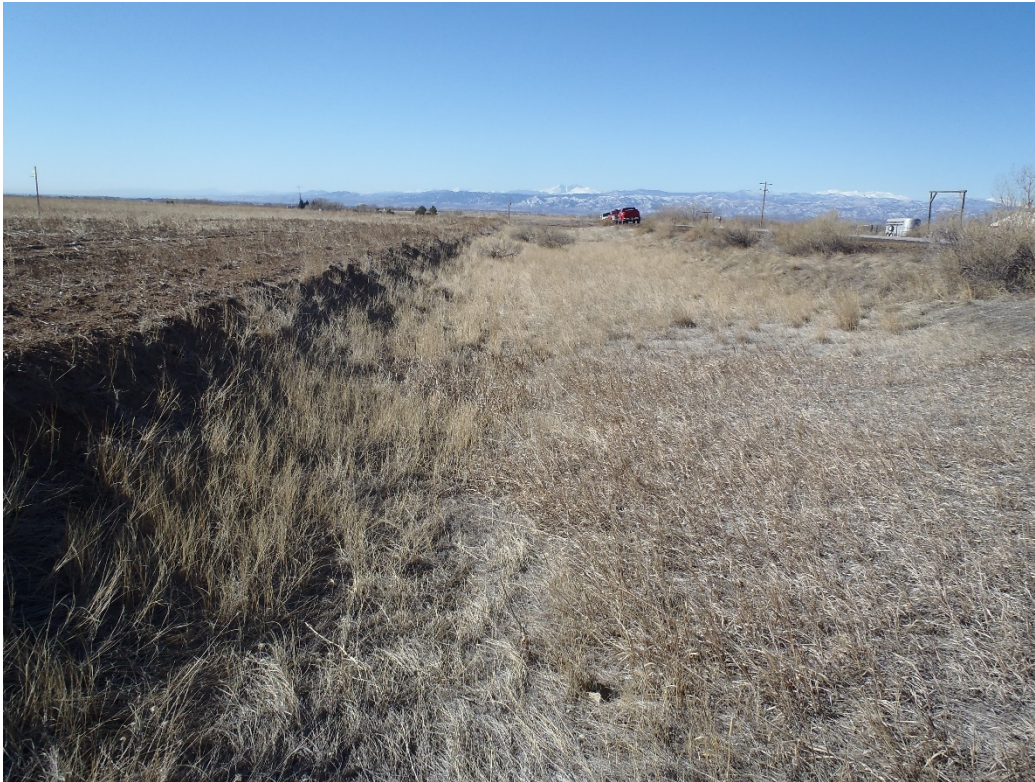
Photo 2. Drainage ditch west of site along CR 5J (looking SW from proposed north site entrance).

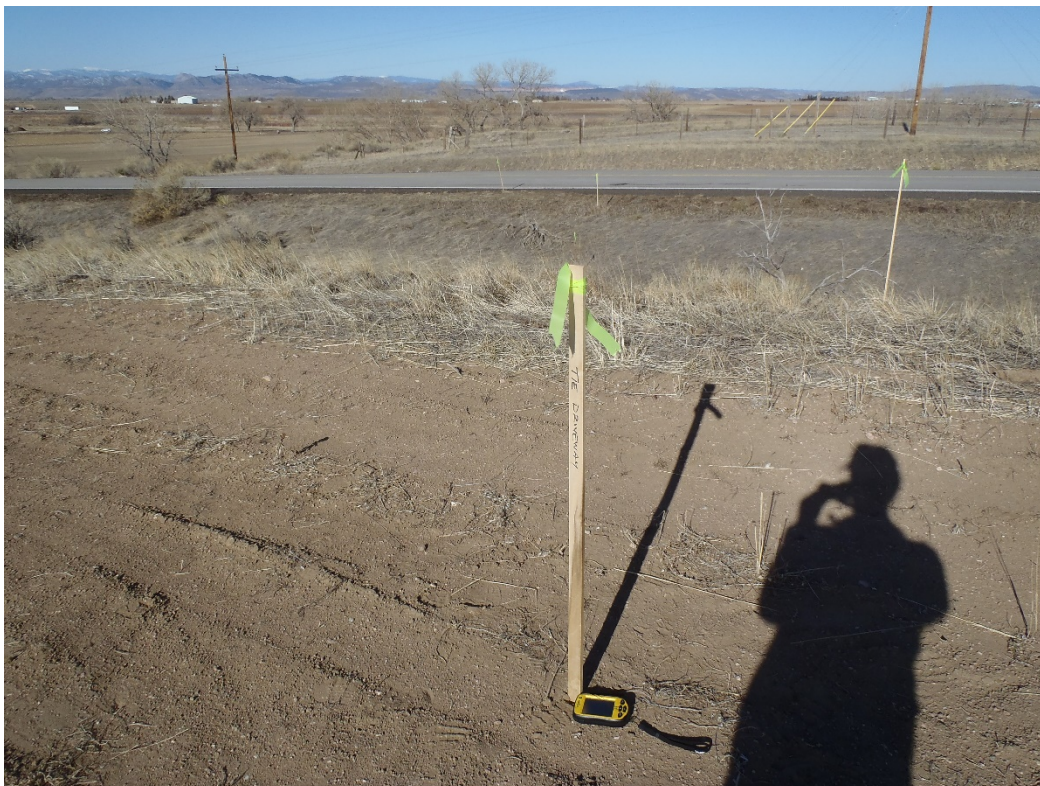
**Gen. Compliance with Mine Plan:** The application proposes a maximum disturbance area of 8.7 acres. Based on GPS data collected from survey stake locations (see **Photo 3**) using a Trimble handheld Juno 3B GPS unit during the inspection, there is 8.75 acres within the survey boundary (see attached **Post Inspection Map**). Given the accuracy of handheld GPS units, the difference of 0.05 acres, amounting to 0.5% in area confirms the 8.7 acres proposed by the Applicant.

Photo 3. Typical permit boundary survey stake (note GPS at stake base).

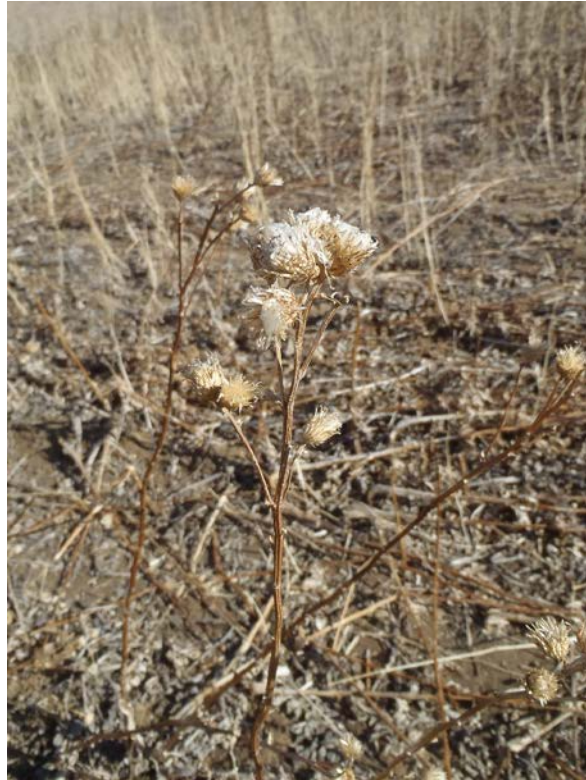
**Revegetation:** A small amount of what appeared to be knapweed (see **Photo 4**) was observed on the south end of the site. This is a noxious weed List B species. As the applicant has not initiated mining operations, this was not cited as a problem. However, should the application be approved, the Operator should submit via technical revision and implement a weed control program.

Photo 4. Knapweed (Likely diffuse), observed near south side of site.

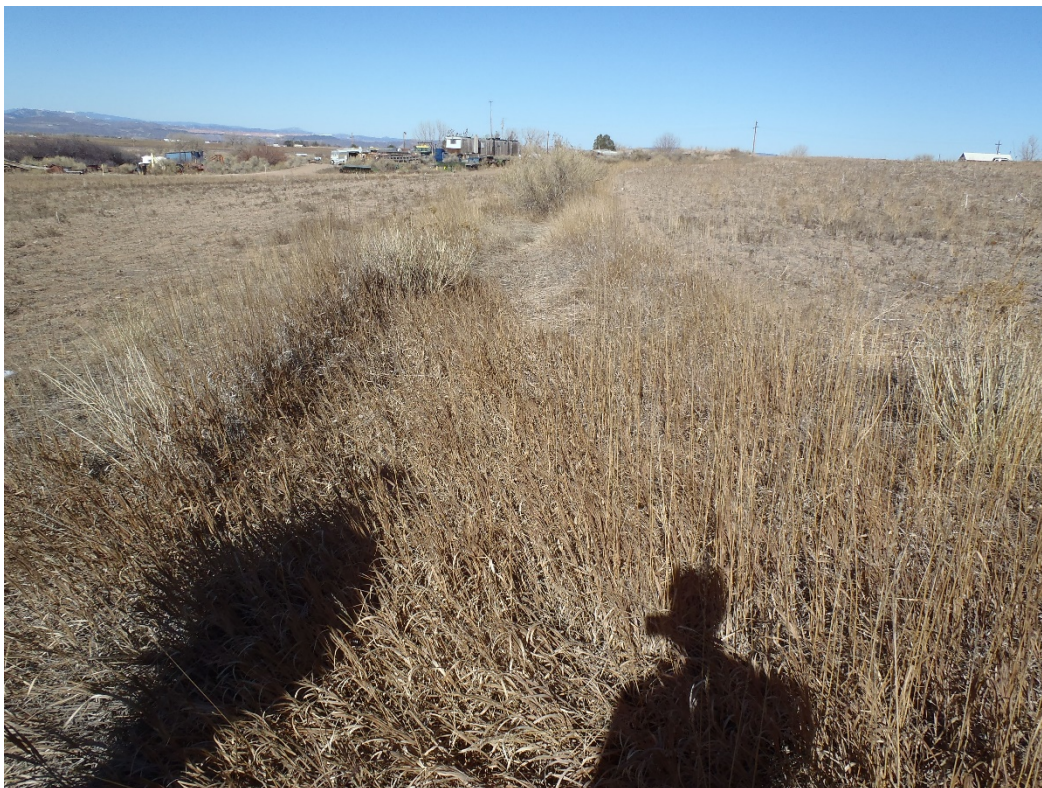
**Sediment Control:** The land owner has constructed an erosion control ditch (see **Photo 5**) about 230 feet from the south side of the proposed permit boundary (see attached **Post Inspection Map**). This will be mined through and will not be replaced. Site representatives stated they would use silt fence to protect the irrigation ditch (see **Photo 6**) belonging to North Poudre Irrigation Co. on the south end from site sediment.

Photo 5. Existing erosion control ditch (looking NW from east side of site).

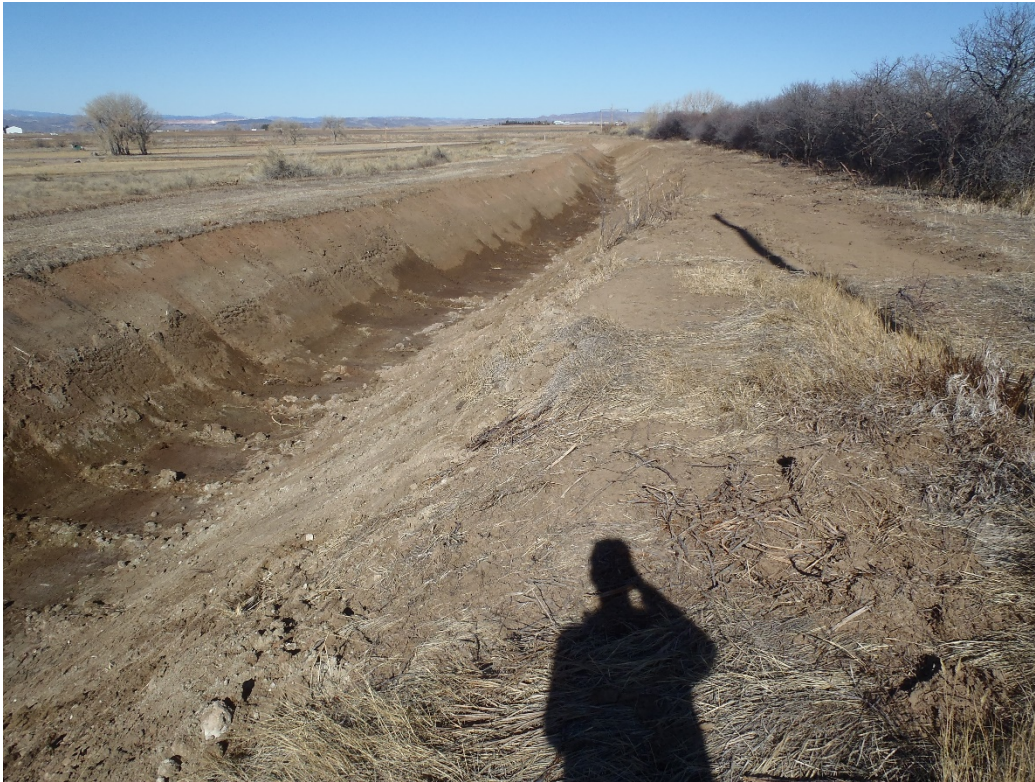
Photo 6. Irrigation ditch (looking NW from SE corner of site).

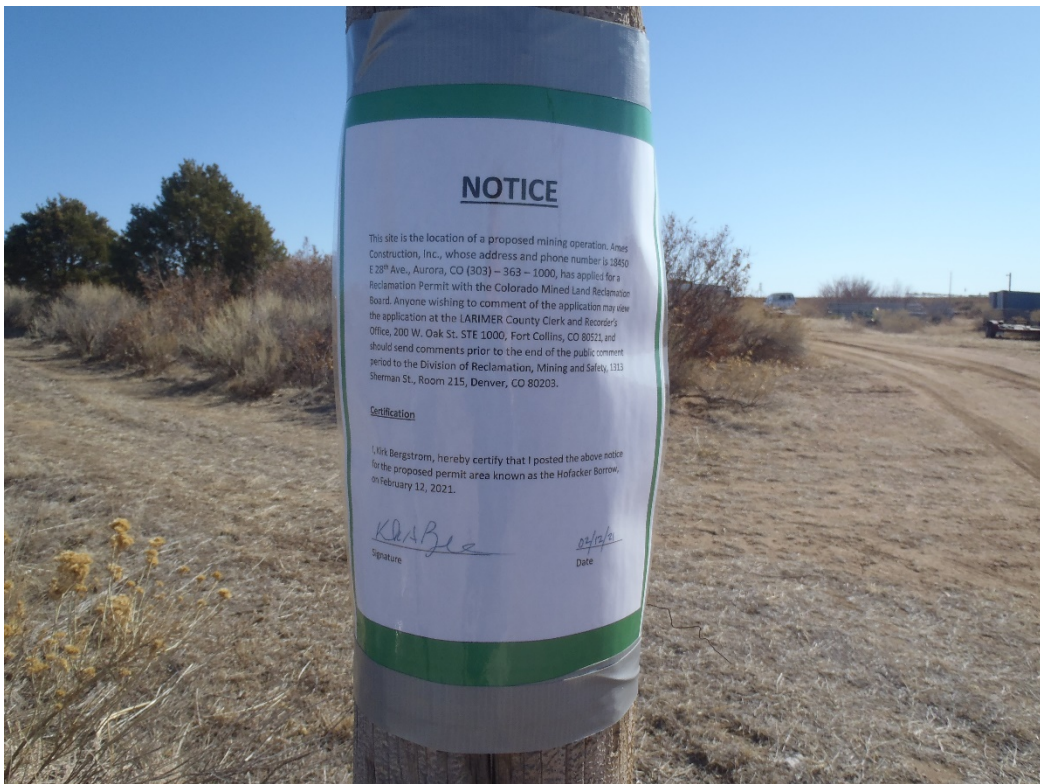
**Signs and Markers:** The notice was properly posted (see **Photo 7**) and survey stakes were observed to delineate the permit boundary (see **Photo 8**).

Photo 7. Required public notice (on post at entrance to Hofacker residence).

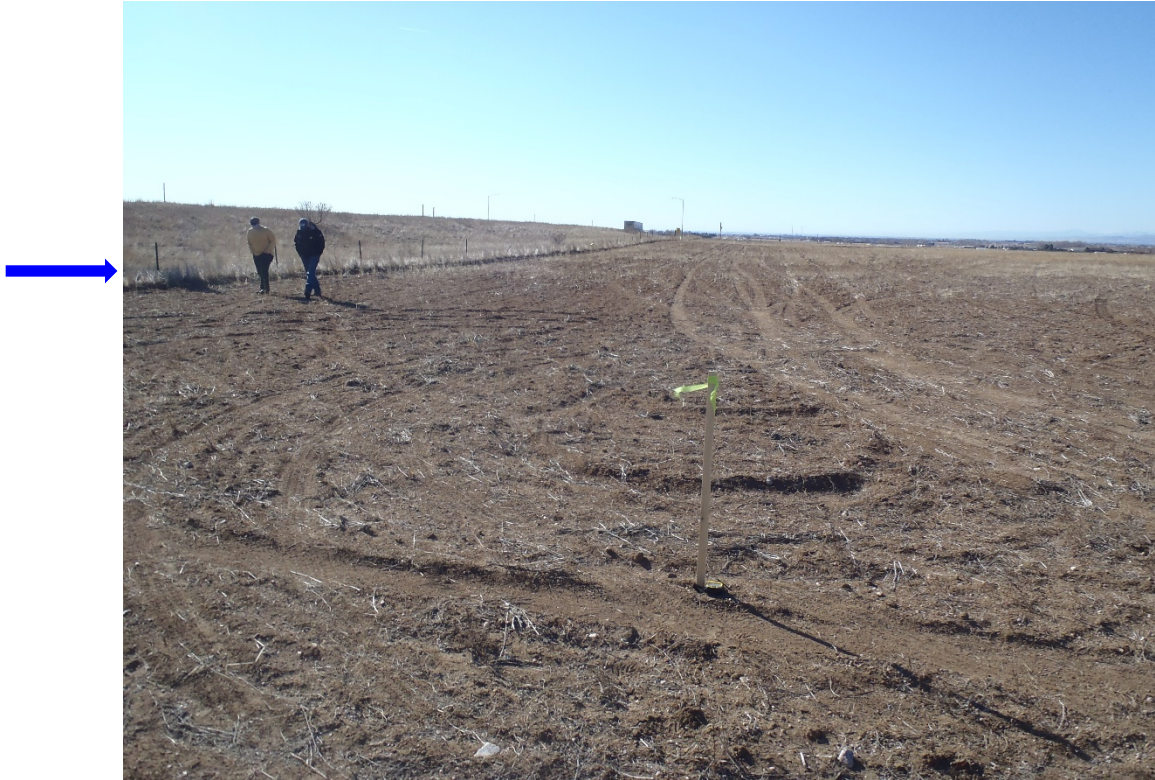
Photo 8. Survey stake at NE corner (note CDOT right of way fence on left).

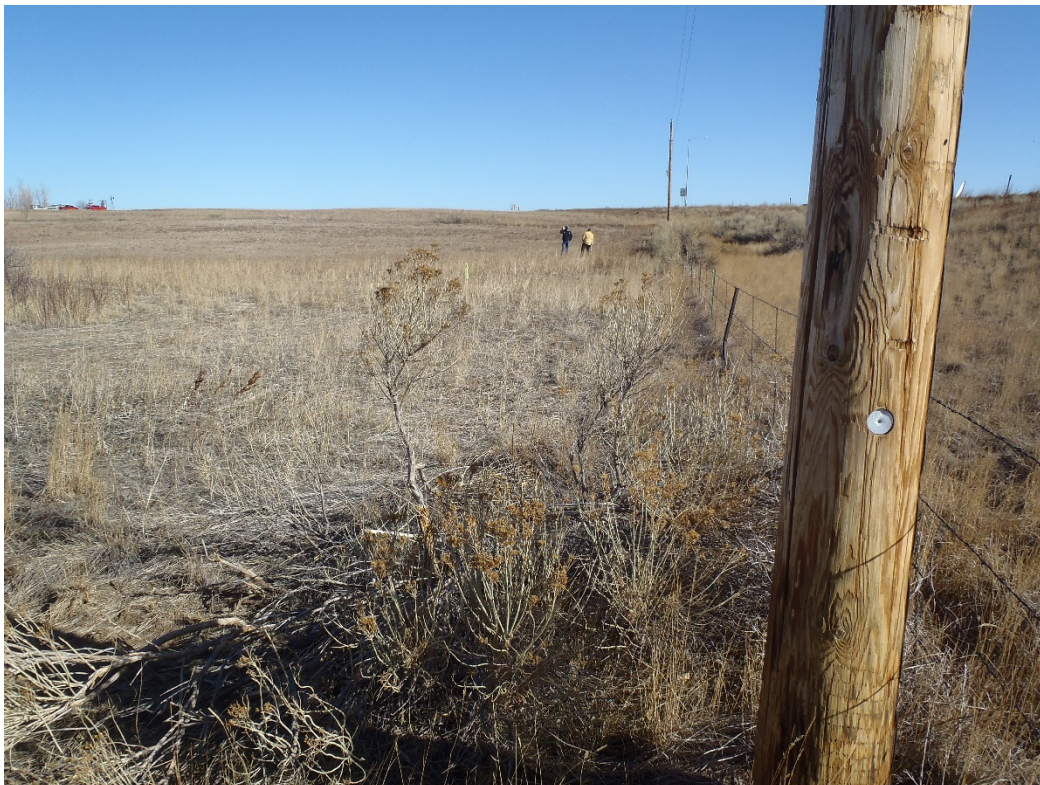
Photo 9. CDOT ROW fence and powerline on SE side of site (looking NNE).

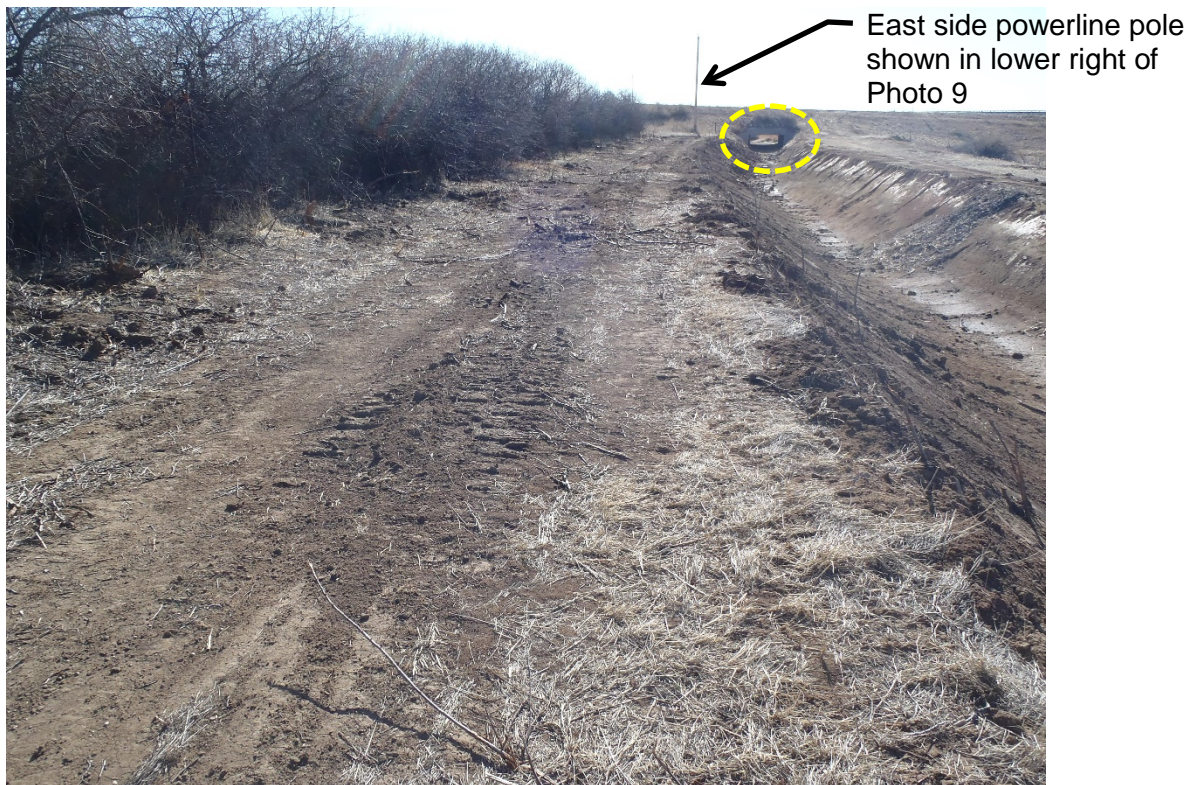
Photo 10. Irrigation ditch (looking SE from SW corner of site, box culvert circled).

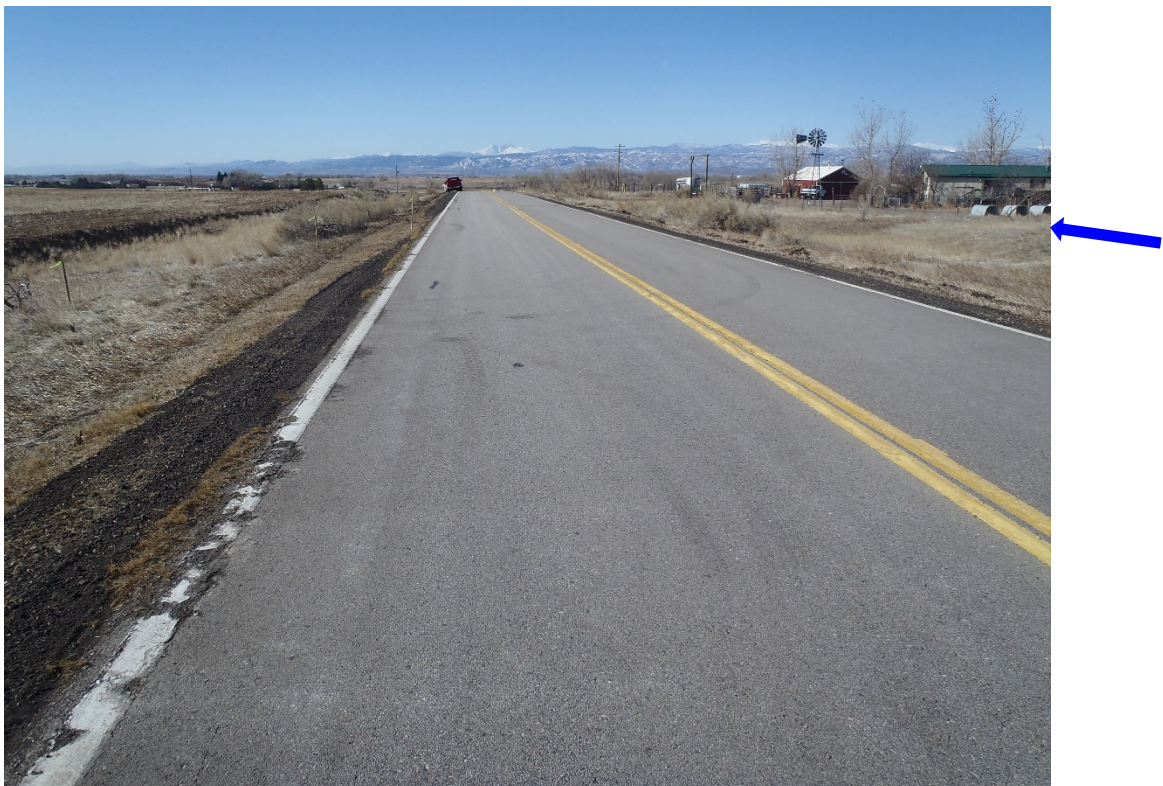
With the exception of Mr. Hofacker's buildings, all of these structures are identified on the attached **Post Inspection Map**; and with the exception of the streetlamp and the Maxwell fence, all were identified either prior to, or during the inspection. The Maxwell fence and I-25 streetlamp were not included in the March 1, 2021 Preliminary Adequacy Review letter, but will also need structure damage compensation agreements.

Photo 11. County Road 5J & Maxwell fence on right (looking SW from north site entrance).
