**COLORADO**  
Division of Reclamation,  
Mining and Safety  
Department of Natural Resources

<b>Permit Number:</b> C-1981-018 <b>Mine Name:</b> Deserado Mine <b>Operator:</b> Blue Mountain Energy, Inc. <b>Operator Address:</b> Mr. Kurtis Blunt 3607 County Road 65 Rangely, CO, 81648	<b>County:</b> Moffat, Rio Blanco <b>Operation Type:</b> Underground <b>Permit Status:</b> Active <b>Ownership:</b> Private
	<b>Operator Representative Present:</b>  NA
<b>Operator Representative Signature:</b> (Field Issuance Only)

<b>Inspection Start Date:</b> March 2, 2021 <b>Inspection Start Time:</b> 13:00 <b>Inspection End Date:</b> March 2, 2021 <b>Inspection End Time:</b> 13:05	<b>Inspection Type:</b> Aerial Inspection <b>Inspection Reason:</b> Normal I&E Program <b>Weather:</b> Clear
<b>Joint Inspection Agency:</b>  None	<b>Joint Inspection Contacts:</b>  None
<b>Post Inspection Agency:</b>  None	<b>Post Inspection Contacts:</b>  None
<b>Inspector(s):</b>  Clayton Wein  Brock Bowles	<b>Inspector's Signature:</b>

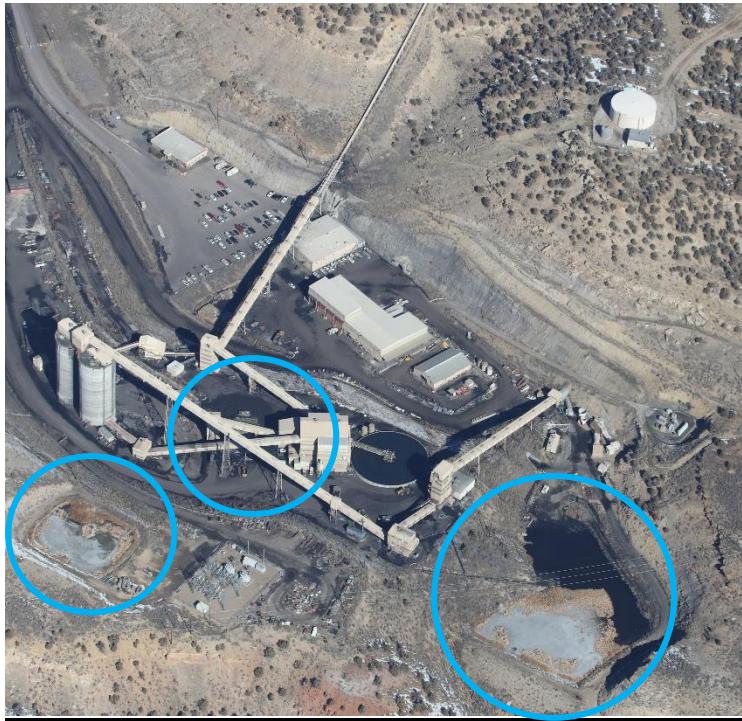
Three ponds are located within the main facilities area; the DP-1 Pond, the PP-1 Pond and the PP-2 Pond (Photo 1). The DP-1 Pond was impounding water during the inspection. The pond was partially covered with ice near the outlet. The embankment was stable with vegetation. There were no indications of erosion observed. The view of PP-1 was obstructed by the Prep Plant. The portion that could be seen appeared to be frozen. The PP-2 pond was Holding water but frozen over. The embankment was vegetated and stable. No erosional concerns were identified.

**Photo 1:** The main facilities area. Ponds DP-1, PP-1 and PP-2 are outlined in blue circles.

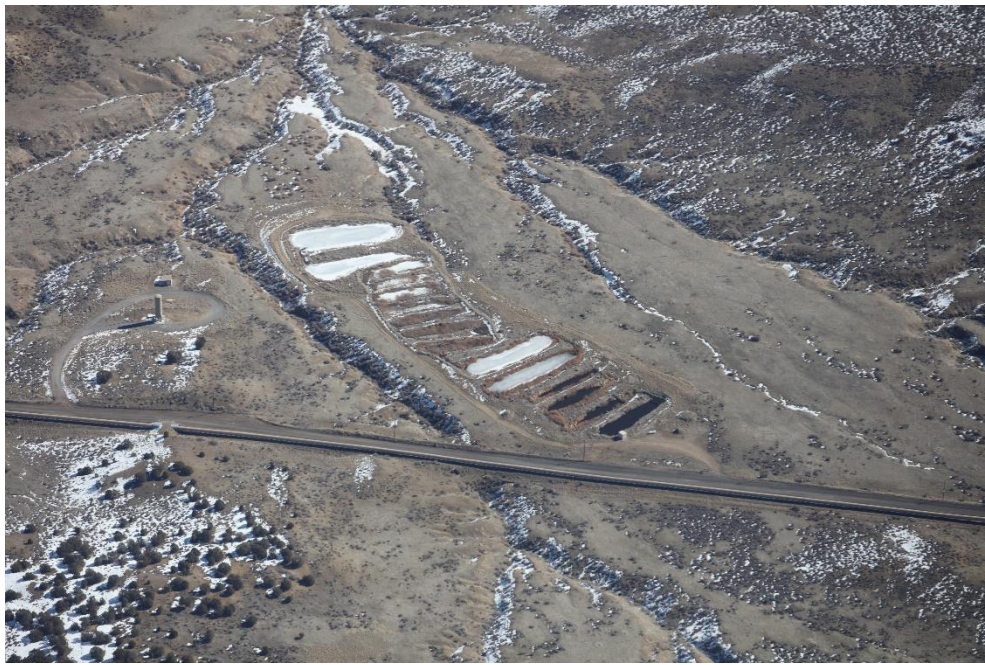
The RP-A refuse area has one pond located at it. The RP-A Pond had a small amount of snow in it (Photo 2). The pond appeared mostly dry and no discharge was occurring. The embankment was stable with vegetative cover. There were no erosional features observed.

The B Seam Dewatering System No. 1 was holding water in all of its cells (Photo 2). Only the first four cells were unfrozen during the inspection. The embankments for the cells were vegetated and stable. There were no indications of erosion at the site.

**Photo 2:** The B Seam Dewatering System No. 1.

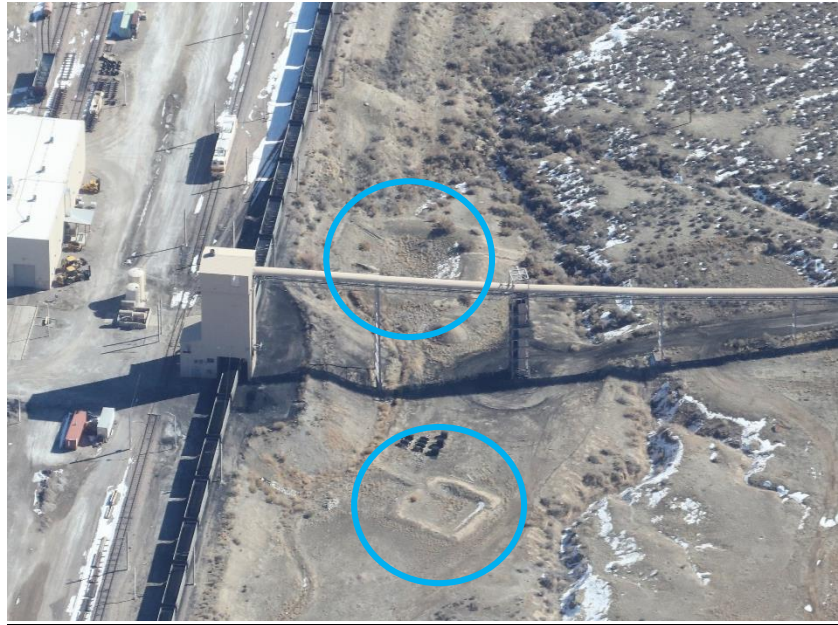
The RS-1 Sump and RR-1 Pond on the south side of the rail loadout were dry (Photo 3). The ponds' embankments were covered with vegetation and stable. No erosional features were identified.

**Photo 3:** The RS-1 sump and RR-1 pond are outlined in blue circles in the photo above.

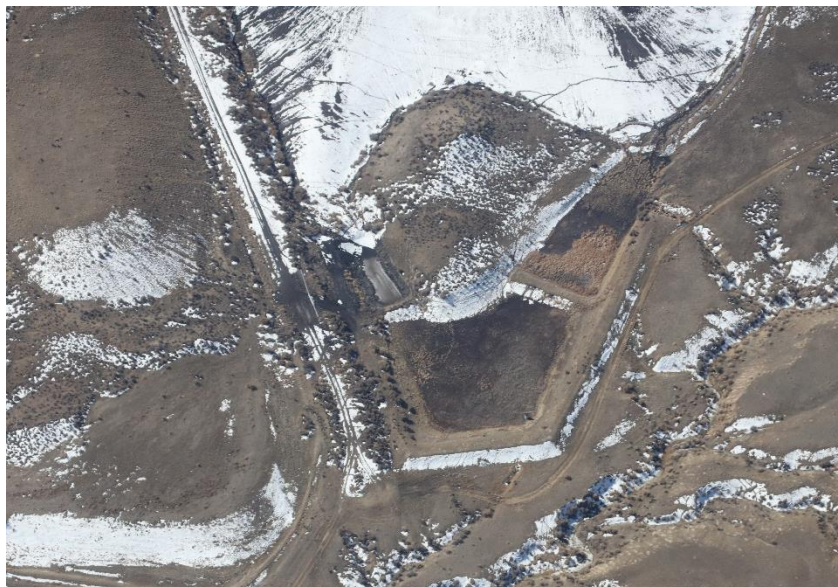
The RP-2/3 Pond was dry in its west and main cells (Photo 4). The east cell was holding a small amount of frozen water. The embankments for the cells were stable and vegetated. There were no erosional features identified. The RP-4 Pond was also dry at the time of the inspection. The embankment was covered with vegetation and stable. No erosional concerns were observed. The RP-5 Pond was dry. The embankment was stable with vegetative cover. There were no erosional features observed.

**Photo 4:** The RP-2/3/ pond.

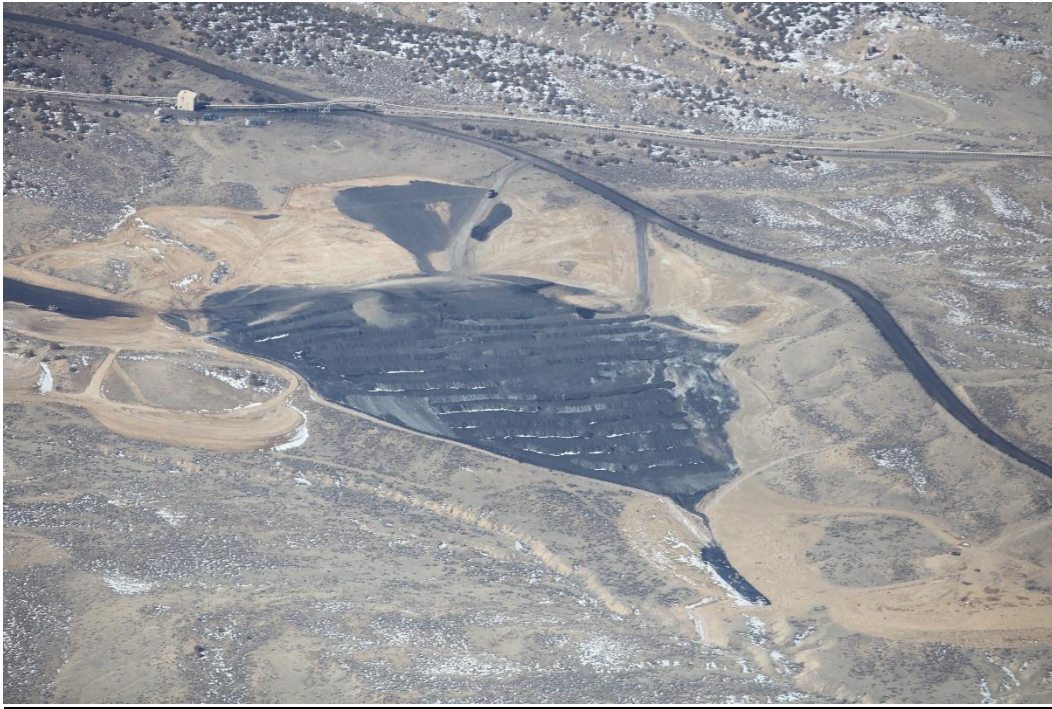
The RP-A refuse area had material stockpiled on top of it (Photo 5). This disposal pile is relatively new and the material placed on the pile is helping create the base of the pile. Refuse stockpiled in this location will need to dry before it can be spread and compacted. The Disposal area was in good repair and there were no indications of erosion. The associated subsoil and topsoil piles were stable with no erosional concerns.

**Photo 5:** The RP-A refuse disposal area. The photo was taken looking west.

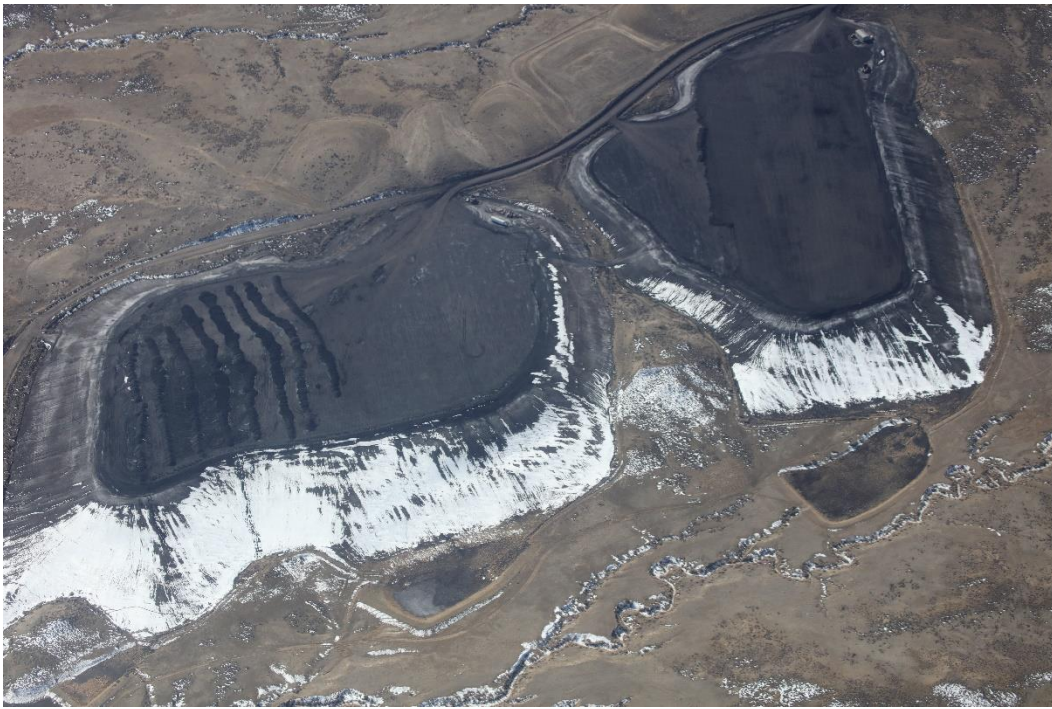
Stockpiling of refuse material was also occurring on the RP-2/3/4 pile (Photo 6). The pile had refuse stockpiled in windrows on about half of its top. The pile was stable and there were no indications of sloughing or instability. No erosional concerns were identified. The slopes of the pile were partly covered in snow.

The RP-5a refuse pile was observed to be stable (Photo 6). There were no indications of instability or excessive erosion. Large rills are on the slopes of both the RP-2/3/4 and 5a piles. The slopes are included on the spring maintenance list for 2021. The rills on the slopes of the refuse piles have not affected the stability of the piles.

**Photo 6:** The RP-2/3/4 refuse pile is on the left side of the photo and the RP-5a /refuse pile is on the right side of the photo.

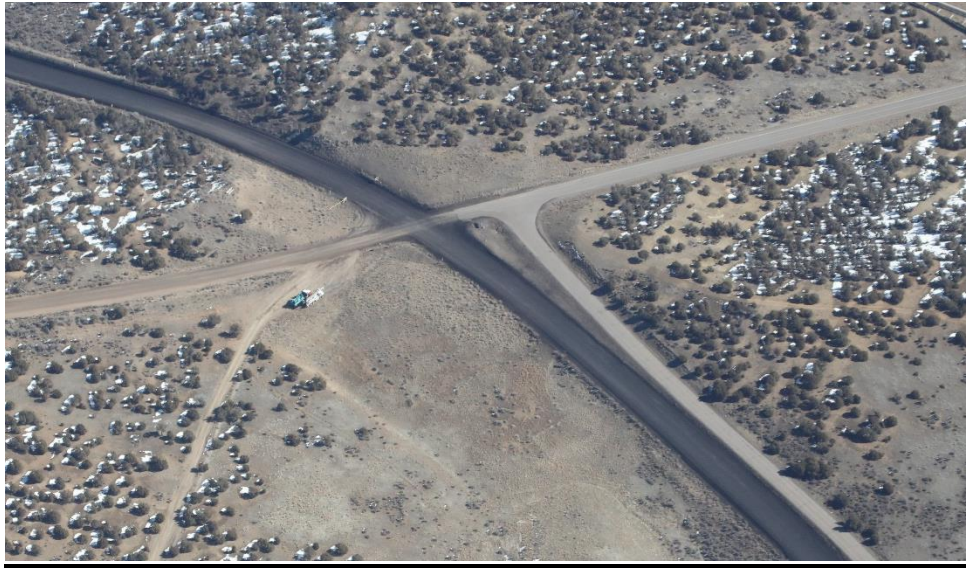
Access road throughout the mine site were observed to be in good condition. There were no roads with erosional issues or concerns of instability. The haul road was in good repair. There were no erosional features identified. The intersection of County Road 65 and the haul road was stable with no erosional issues (Photo 7).

**Photo 7:** The County Road 65 and haul road intersection.
