Pikeview January Monitoring report

Reference: January 2021 Geotechnical Monitoring Summary Pikeview Quarry

Client/Project
CONTINENTAL MATERIALS
CORP.
PIKEVIEW QUARRY SLOPE
MONITORING

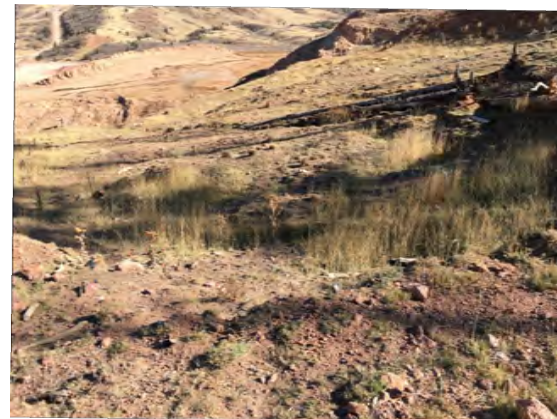
- Healed Cracks: A crack was observed on the slope adjacent to the slide where cracking had previously been observed. This crack runs parallel to the slide and appears to be “healed” and did not indicate any recent movement. (Note 6)

6. AREA ABOVE THE SLIDE

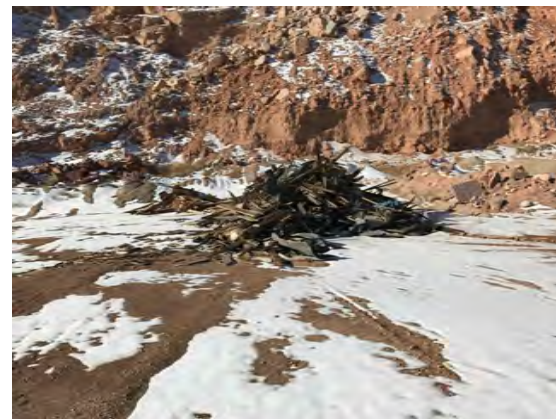
5. DEMOLITION DEBRIS PLACED AT TOE OF SLIDE

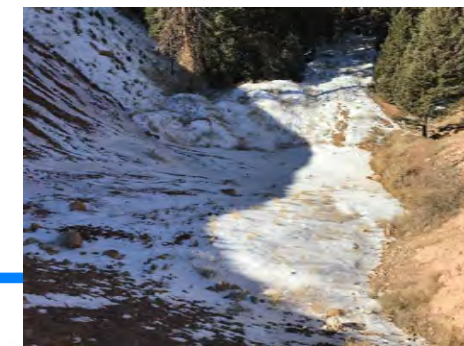
- Culverts: A 6-ft culvert was observed to be blocked on the upstream end. There is evidence that water is collecting at the inlet during rain events and likely seeping through the loose material and through the culvert. (Note 1).

1. AREA UPSTREAM OF BLOCKED CULVERT

Attached is the January monitoring report for your review. Also, the blocked culvert has been cleared, and we will discuss that in the February report.

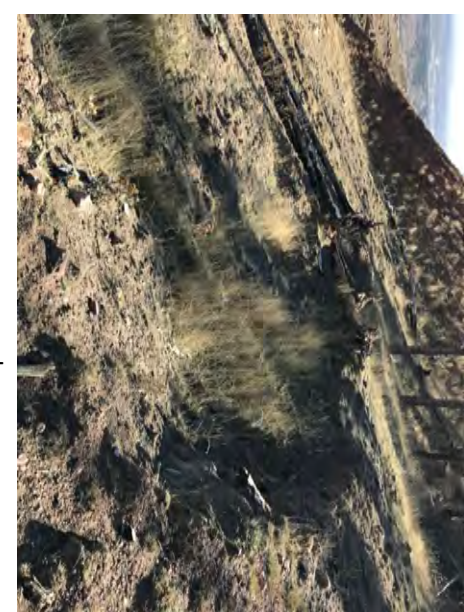
- Several new prisms were in the process of being placed during the site visit and will appear on the next report.
- Gullies: Gullies have formed on the slopes above the slide area as well as in the burn areas above the quarry. (Note 2)

2. EROSION GULLEY

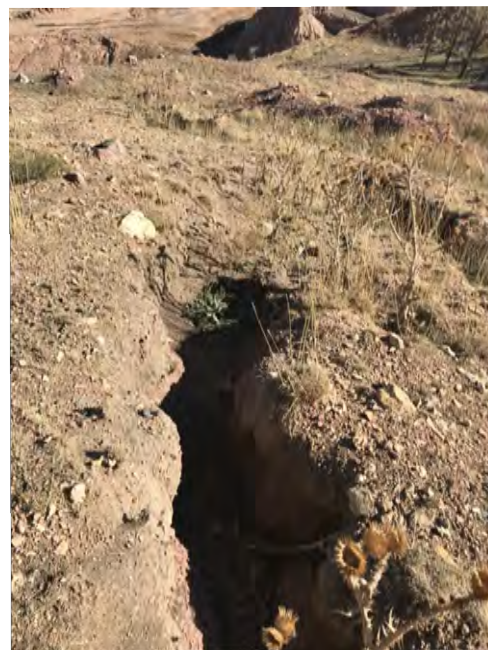
- Pooled Water: The grading at the top of the first ridge causes a small amount (0.03 ac) of water to pool.
- Open Cracks: An open crack was observed during this visit. This feature is in an area where cracking is expected to occur as a result of ongoing slope settlement and relaxation. The edges of the crack have eroded suggesting it is not a new feature. (Note 7)

7. OPEN CRACK PARALLEL TO SLIDE

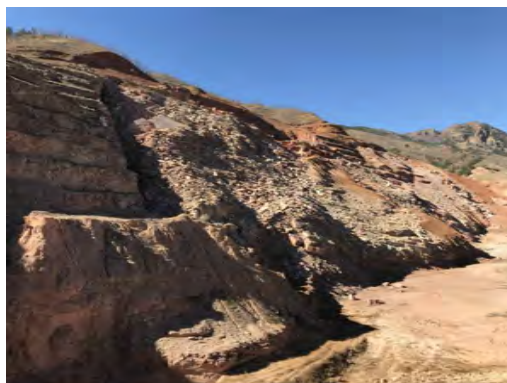
8. VIEW UP SOUTH ESCARPMENT

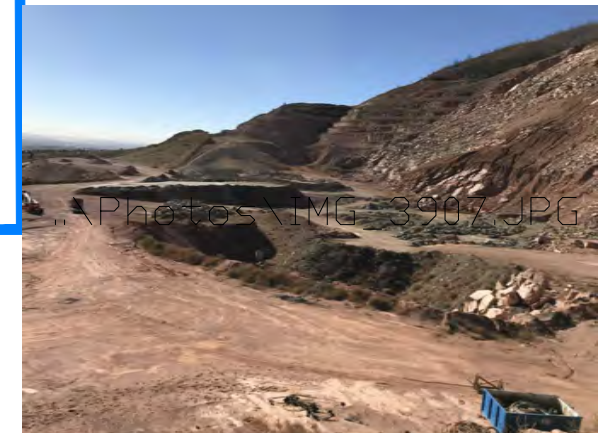
- Fill: Material is being imported and temporarily placed on the “production floor”. During the visit, different types of material including mulch and general fill were being deposited here for future placement. Based on the drone survey, approximately 2,195 cubic yards of temporary fill were imported during the month of December. (Note 3)

3. DEBRIS AND RUBBLE FILL AREA

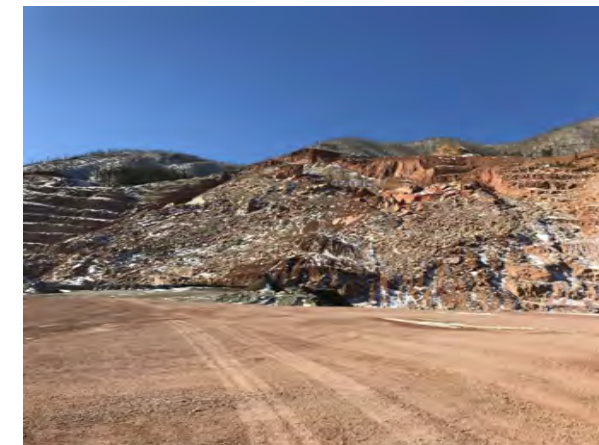
4. FILL DEPOSITED AT TOE OF SLIDE AREA

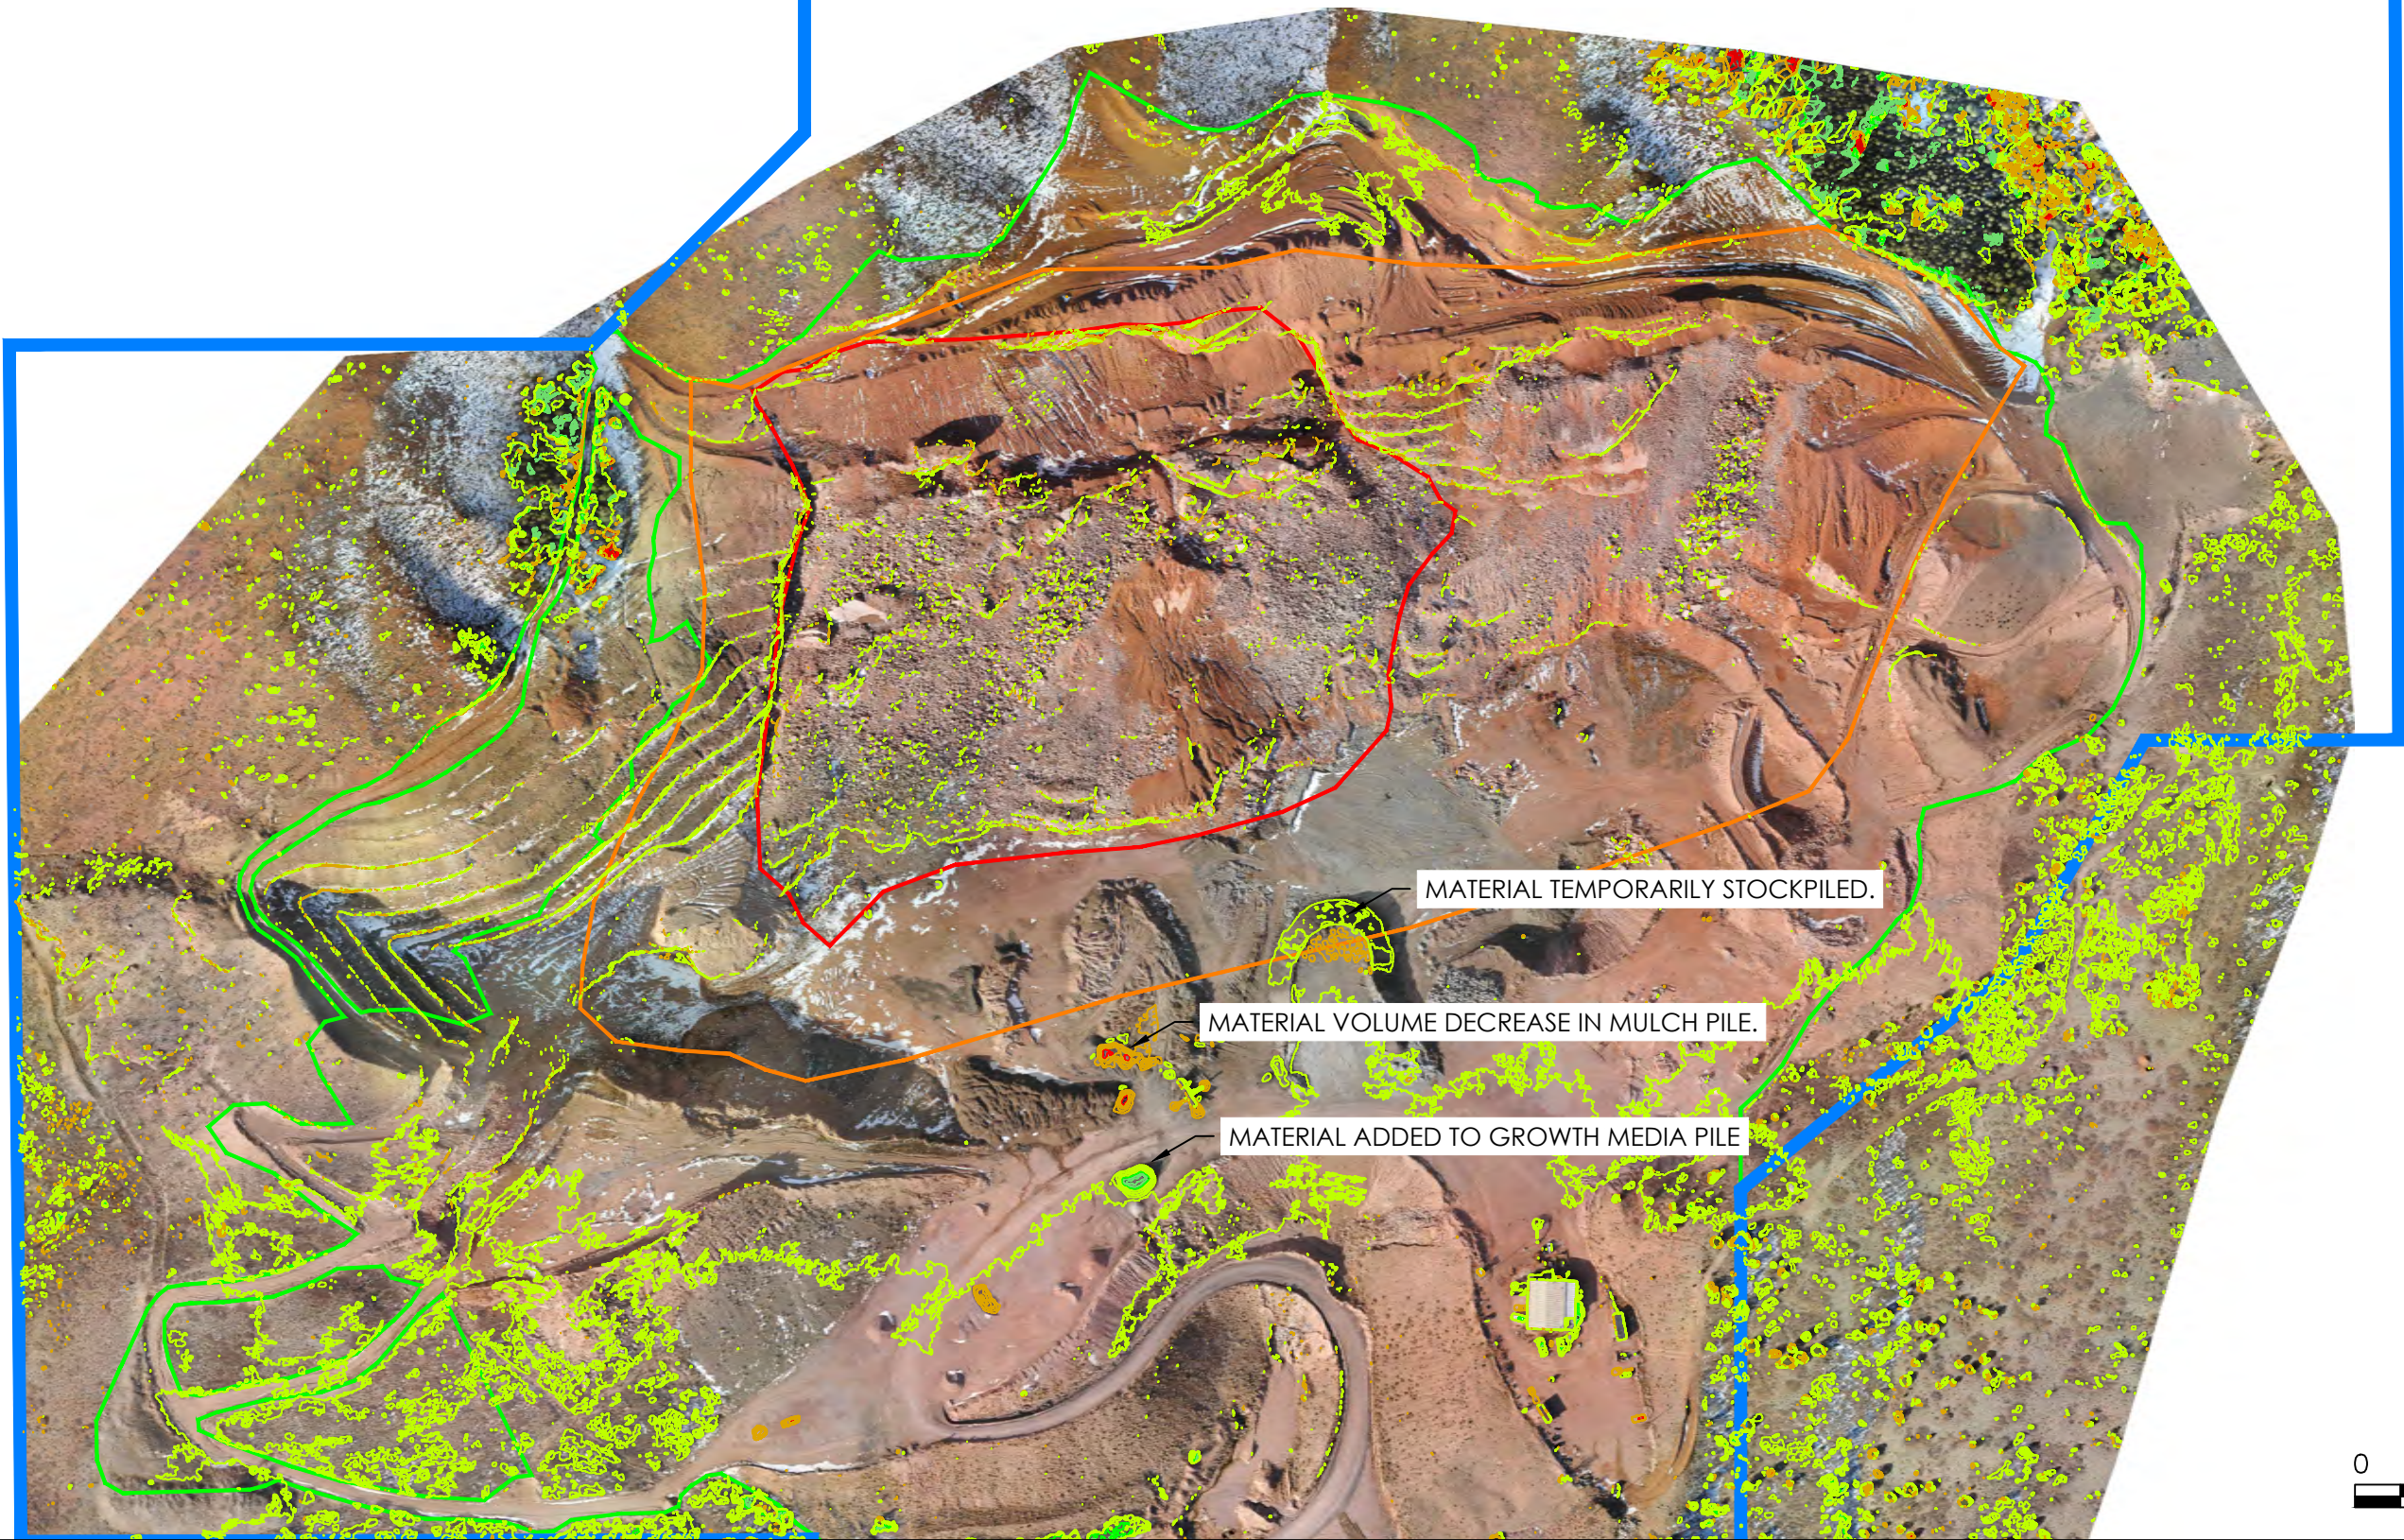
Revision #	Date 2021.02.28
Drawn By PK	Figure No. 5

The December topography was also compared to the January topography to identify changes in the site topography. Comparison of the two surveys showed that approximately 1,084 yd³ of fill had been imported and temporarily placed. No slope movements or other changes in topography were identified. The current imagery and topography are included in Figures 1 and 3, and the comparison surface is included as Figure 5 in Appendix C.

As previously reported in the September 2020 monitoring report, there are limitations with the method of comparing drone surveys from different months. The drone data indicate changes in the slopes along each of the reclamation benches, buildings, and areas with trees or shrubs. These areas are stable, and the changes are the result of survey limitations on or near vertical slopes.
