MINERALS PROGRAM INSPECTION REPORT
PHONE: (303) 866-3567

MINE NAME: Climax Mine	MINE/PROSPECTING ID#: M-1977-493	MINERAL: Molybdenum	COUNTY: Lake, Summit
INSPECTION TYPE: Aerial Inspection	INSPECTOR(S): Dustin Czapla	INSP. DATE: March 2, 2021	INSP. TIME: 12:00
OPERATOR: Climax Molybdenum Company	OPERATOR REPRESENTATIVE: None	TYPE OF OPERATION: 112d-3 - Designated Mining Operation	
REASON FOR INSPECTION: Normal I&E Program	BOND CALCULATION TYPE:	BOND AMOUNT: \$91,011,850.00	
DATE OF COMPLAINT: NA	POST INSP. CONTACTS: None	JOINT INSP. AGENCY: None	
WEATHER: Clear	INSPECTOR'S SIGNATURE:

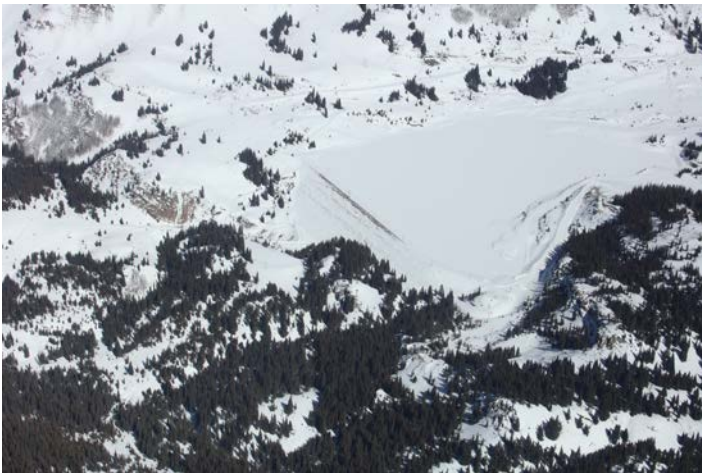
4 Dam and Eagle Park Reservoir

The Mayflower TSF and 5 Dam, Tenmile TSF and 3 Dam, Robinson TSF and 1 and 2 Dams, Robinson Lake, Eagle Park Reservoir and 4 Dam were observed. The area was under thick snow cover. No staining or discoloration were noted at any of the TSF dams. No abnormal conditions were noted. TSF's appear to be functioning within the established design criteria.

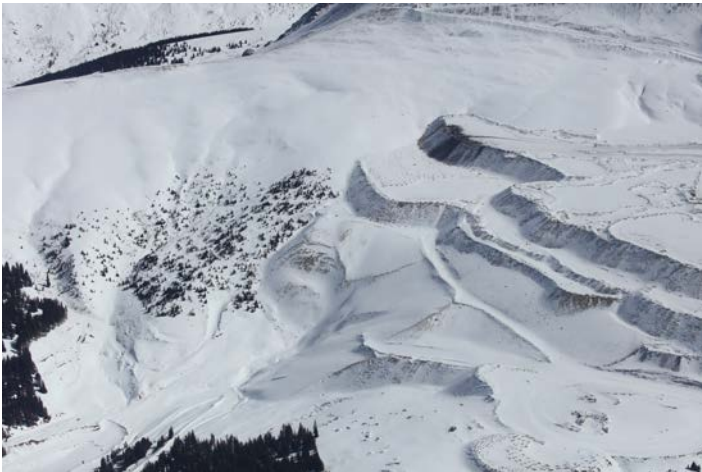
The McNulty and North 40 OSF's were observed. Deposition was not observed during this inspection, but evidence of recent deposition is seen at the McNulty OSF. The current OSF operating plan was drafted by Golder Associates in December 2016. The plan was submitted to the Division as part of TR-25. In the Plan Golder states that snow accumulations of up to 2-3 feet on OSF faces do not significantly impact operation of large OSFs, however larger accumulations greater than 3 feet can become trapped as a continuous layer and form a weak layer or saturate finer grained layers as melting occurs. Therefore Golder recommended that waste rock only be deposited on slopes with less than 3 feet of snow accumulation. Climax appears to be in compliance with Golder recommendations for OSF operations. No problems were noted with the OSF's.

McNulty OSF showing recent deposition at top of dump
