MINERALS PROGRAM INSPECTION REPORT
PHONE: (303) 866-3567

MINE NAME: Triangle One Pit	MINE/PROSPECTING ID#: M-1980-228	MINERAL: Sand and gravel	COUNTY: Archuleta
INSPECTION TYPE: Surety Release Inspection	INSPECTOR(S): Lucas West	INSP. DATE: February 24, 2021	INSP. TIME: 11:07
OPERATOR: Oldcastle SW Group, Inc. dba Four Corners M	OPERATOR REPRESENTATIVE: Matt Carnahan	TYPE OF OPERATION: 112c - Construction Regular Operation	
REASON FOR INSPECTION: Surety Release Requested	BOND CALCULATION TYPE: None	BOND AMOUNT: \$19,504.00	
DATE OF COMPLAINT: NA	POST INSP. CONTACTS: None	JOINT INSP. AGENCY: None	
WEATHER: Clear	INSPECTOR'S SIGNATURE:

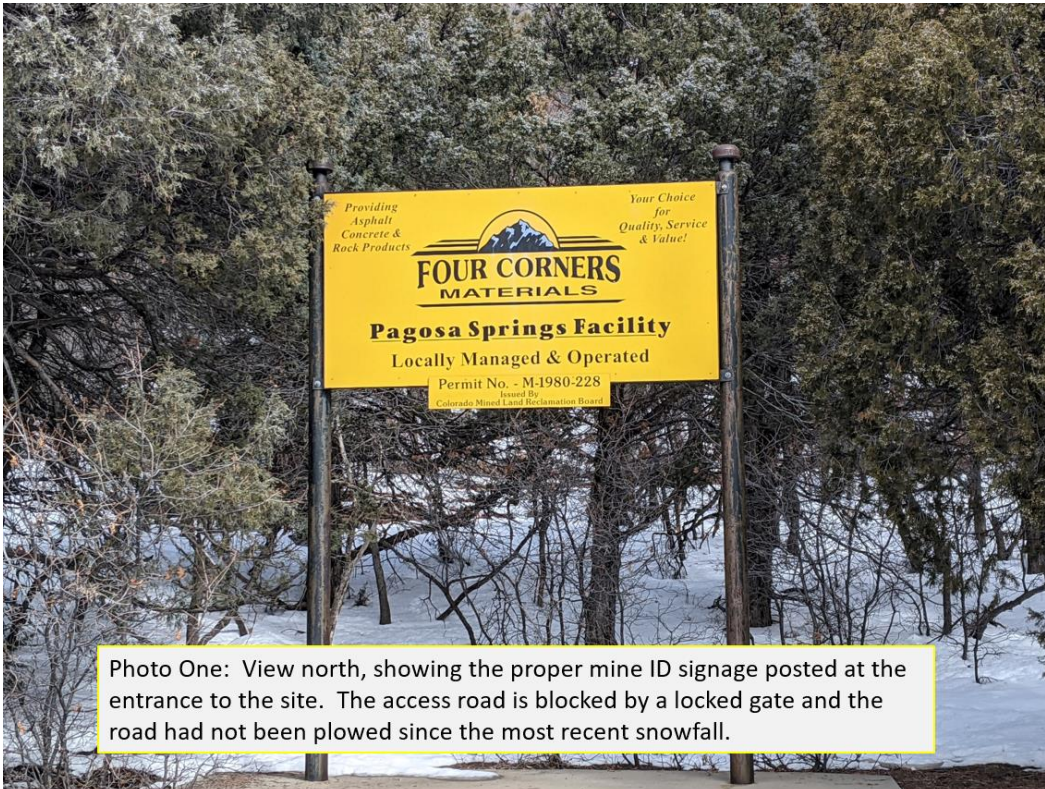
Proper mine identification signage is posted at the entrance to the site, shown in Photo One. The permit boundaries were clearly marked with signs and berms around the perimeter of the site. The site was not active during the time of the inspection. Photo Two shows the processing facilities in good condition. Materials used in processing are imported and most of the reserves have been used. Photo Three shows an example of the remaining stockpiles on site. All stockpiles appear to be stable and are in good condition. All fuel storage tanks located on site are kept within proper secondary containment devices and verified that they are empty. Storm water control devices were observed, and appear to be functioning as designed. The sediment ponds located on site are in good condition and are stabilized with vegetation. The pit floor exhibits positive drainage and no erosional issues were noted during the time of the inspection. These items, including but not limited to the shop building, support buildings, stockpiles, fuel storage tanks and storm water control devices are approved to remain on site post reclamation. The features are in support of the approved post mining land use of Industrial / Commercial and are in compliance with the approved reclamation plan.

Photo One: View north, showing the proper mine ID signage posted at the entrance to the site. The access road is blocked by a locked gate and the road had not been plowed since the most recent snowfall.

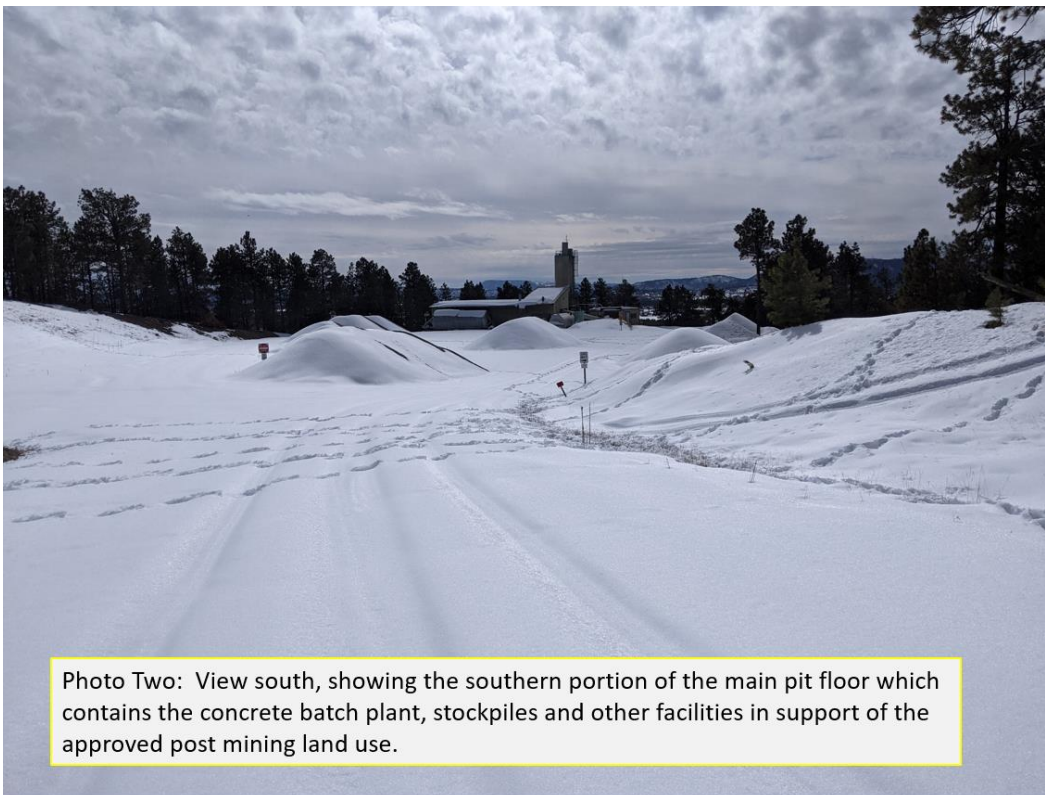
Photo Two: View south, showing the southern portion of the main pit floor which contains the concrete batch plant, stockpiles and other facilities in support of the approved post mining land use.

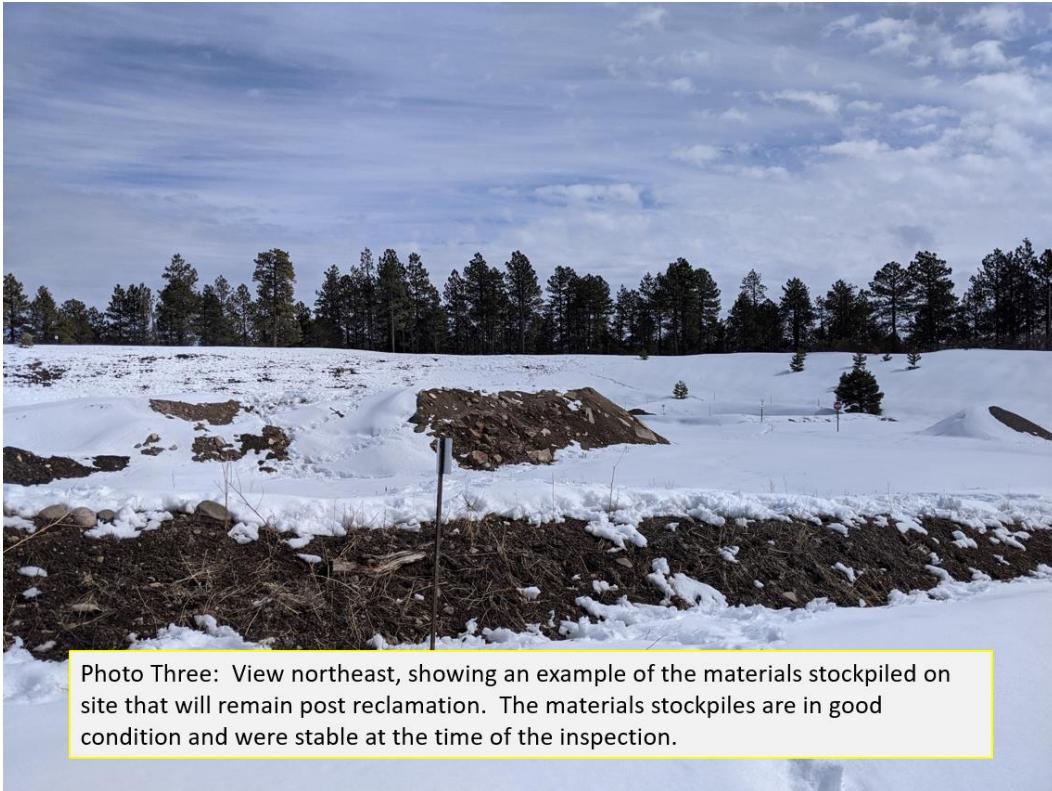
Photo Three: View northeast, showing an example of the materials stockpiled on site that will remain post reclamation. The materials stockpiles are in good condition and were stable at the time of the inspection.

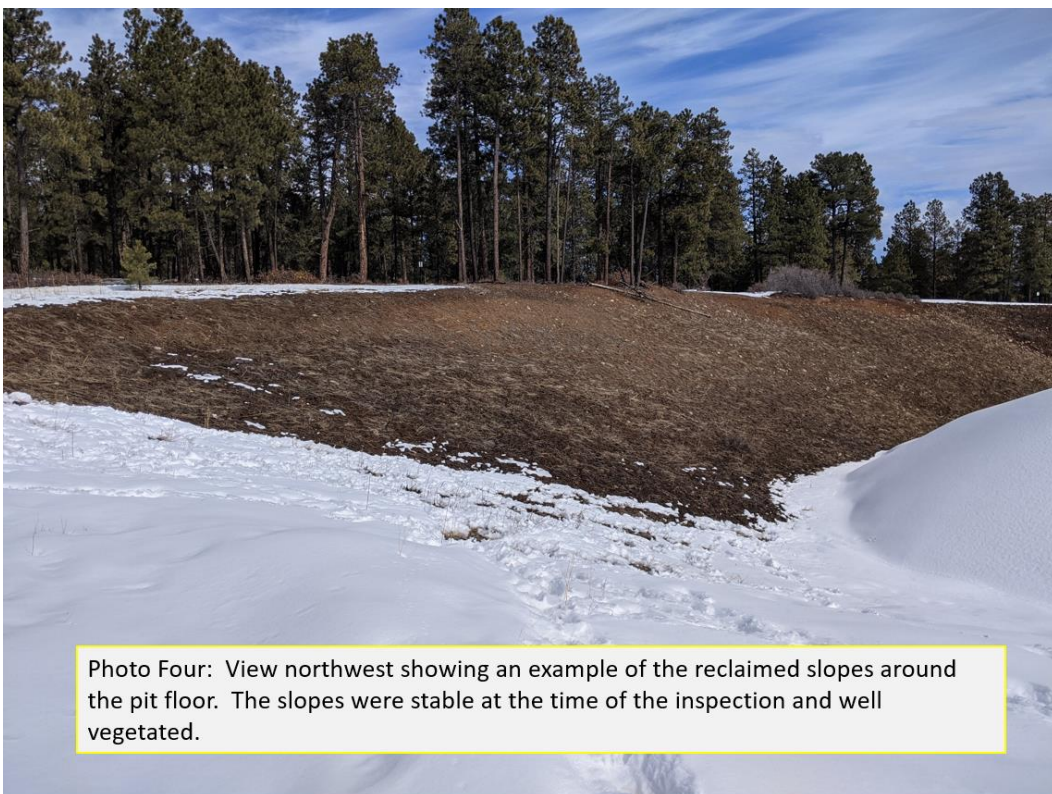
All slopes around the perimeter of the site appear to be stable and are approximately 3H: 1V or shallower. Despite the snow cover on most of the site, areas of the side slopes were free from snow to confirm observations made during previous inspections. The slopes are well vegetated a variety of grass and shrub species in accordance with the approved reclamation plan. The vegetative cover is dense, diverse and appears to be capable of self-regeneration. An example of the vegetative cover can be seen in Photo Four. No evidence of settling, slumping or erosional features were noted during the inspection and no state listed noxious weeds were observed. The overall footprint of the site is in excellent condition and free from trash and debris.

Photo Four: View northwest showing an example of the reclaimed slopes around the pit floor. The slopes were stable at the time of the inspection and well vegetated.
