## MINERALS PROGRAM INSPECTION REPORT

<b>MINE NAME:</b> Weaver Quarry	<b>MINE/PROSPECTING ID#:</b> M-1986-085	<b>MINERAL:</b> Sandstone (silica, stone, quartzite)	<b>COUNTY:</b> Larimer
<b>INSPECTION TYPE:</b> Monitoring	<b>INSPECTOR(S):</b> Amy Eschberger	<b>INSP. DATE:</b> March 11, 2021	<b>INSP. TIME:</b> 10:15
<b>OPERATOR:</b> Loukonen Bros. Stone Company	<b>OPERATOR REPRESENTATIVE:</b> Michael Loukonen	<b>TYPE OF OPERATION:</b> 110c - Construction Limited Impact

## M-1986-085 / Weaver Quarry / Loukonen Bros. Stone Company (110c)

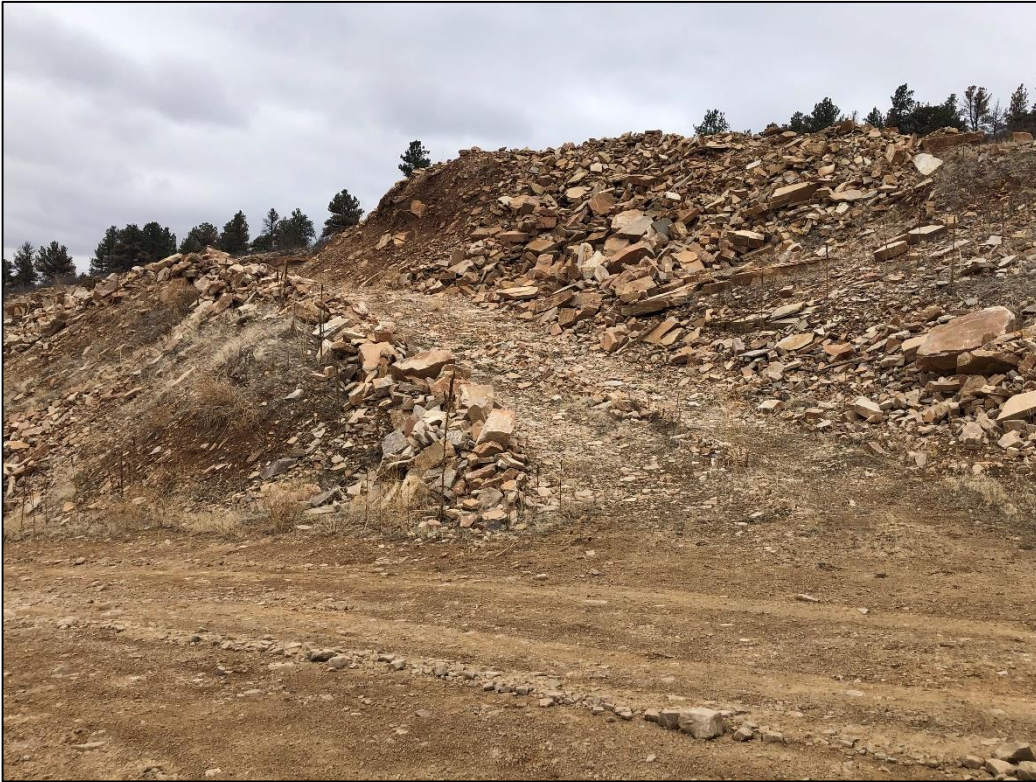
**Photo 1.** View looking west at waste rock piled near center of quarry disturbance area.

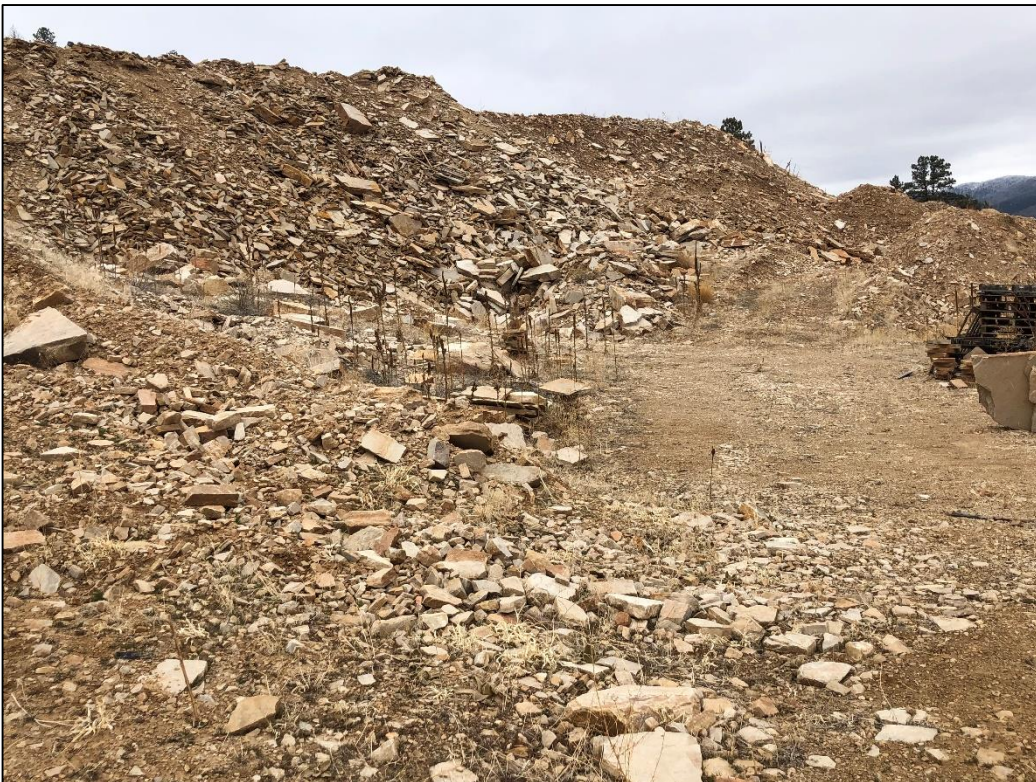
**Photo 2.** View looking northwest at waste rock piled near northwestern edge of quarry disturbance area.

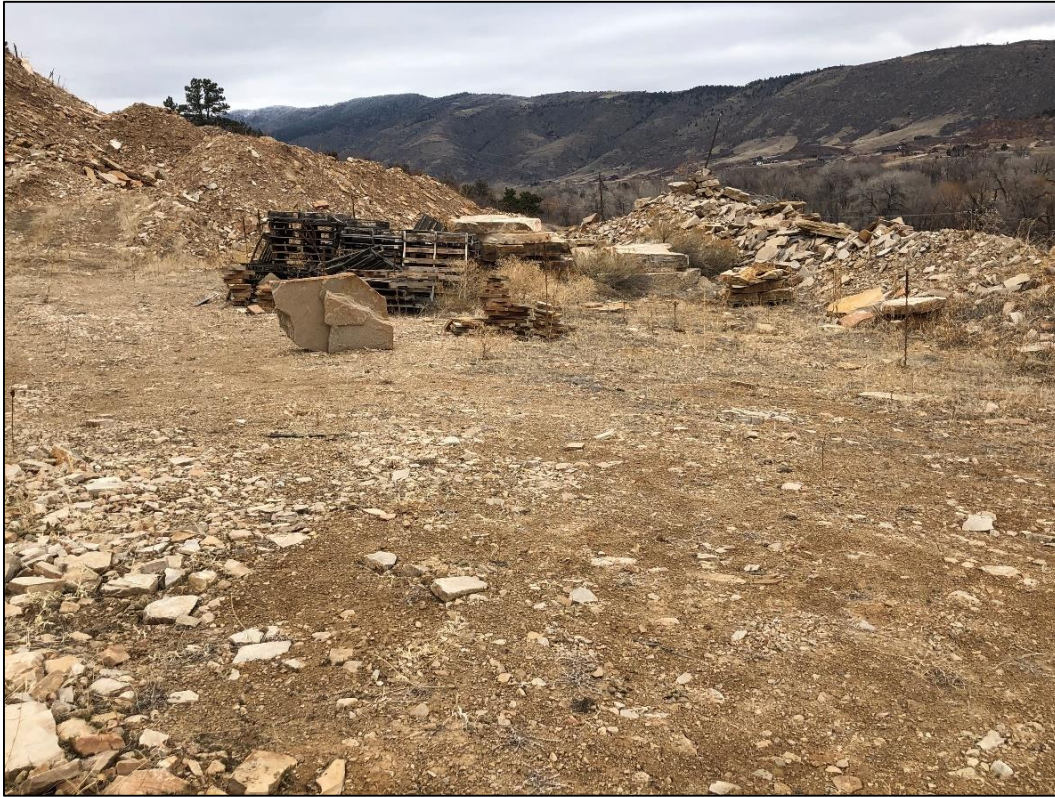
**Photo 3.** View looking north across small work area created near center of quarry disturbance area.

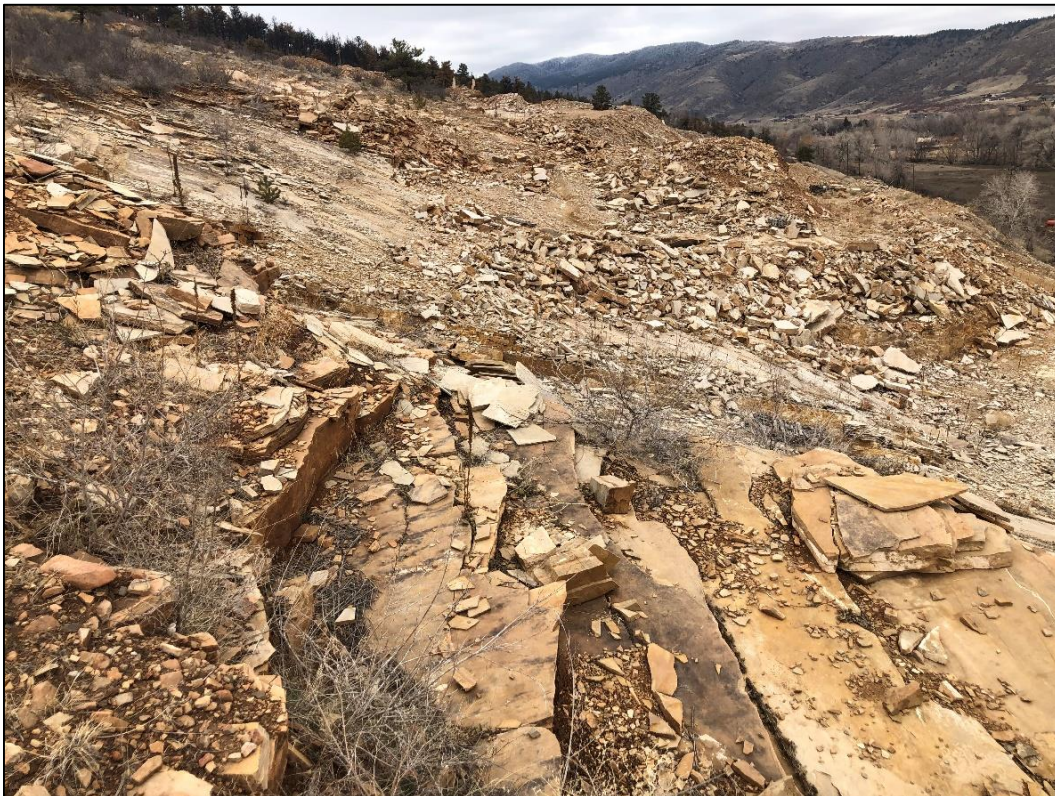
**Photo 4.** View looking north across active quarry area from top of highwall. Note exposed sandstone with natural slopes of 2H:1V to 2.5H:1V.

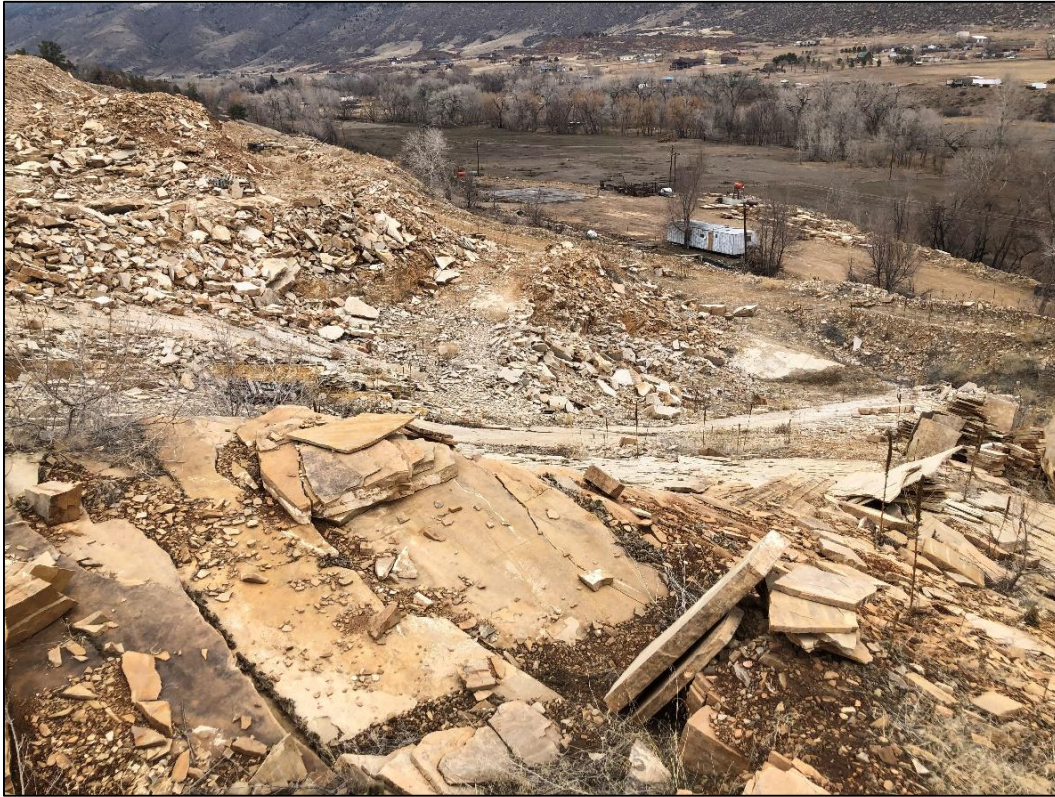
**Photo 5.** View looking northeast across active quarry area from top of highwall. Note shop/storage area visible in background (at base of ridge).

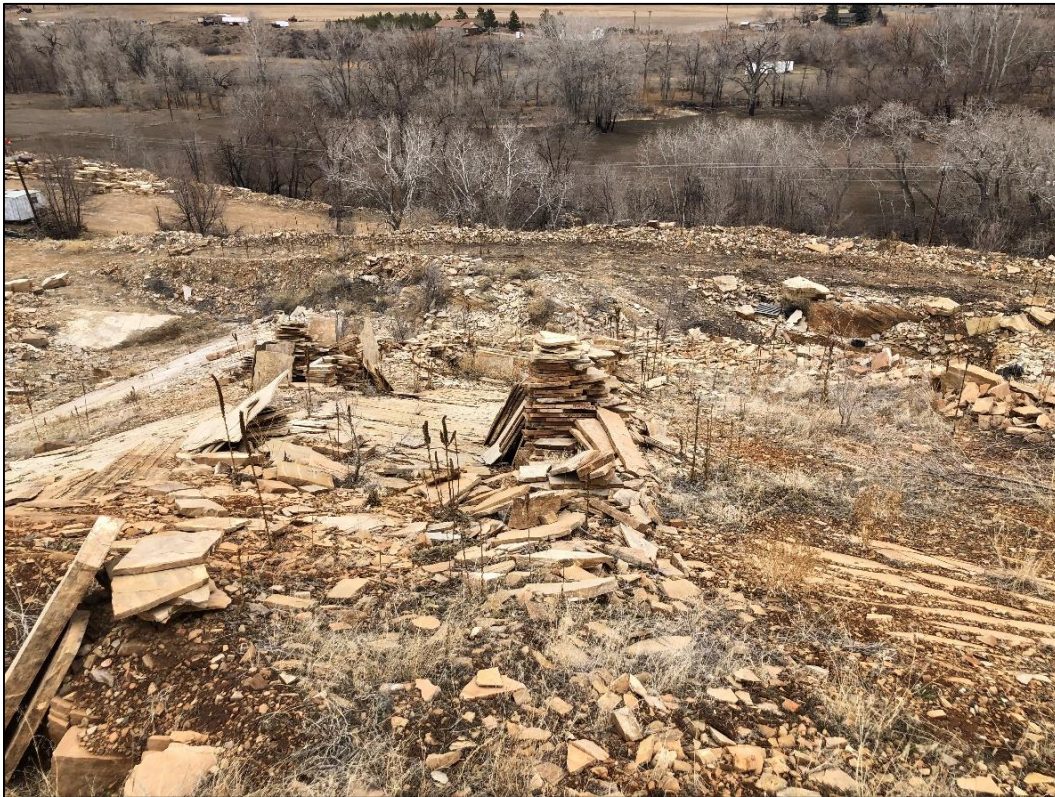
**Photo 6.** View looking east across active quarry area from top of highwall.

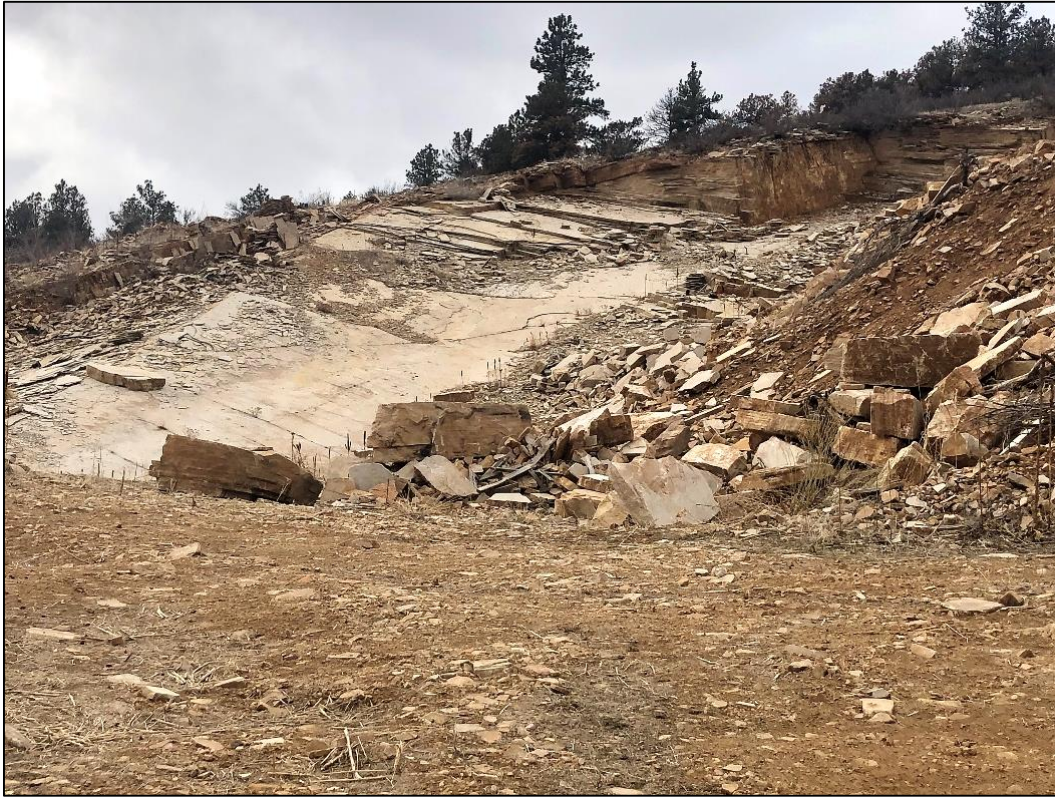
The approved post-mining land use for the site is wildlife habitat. The reclamation plan calls for backfilling any highwalls to a minimum 2H:1V slope, spreading out waste rock stockpiles, replacing approximately 3 inches of

**Photo 7.** View looking south across active quarry, showing exposed sandstone with natural slopes of 2H:1V to 2.5H:1V. Note portion of highwall visible at top right, approximately 5 foot high with near vertical slopes.

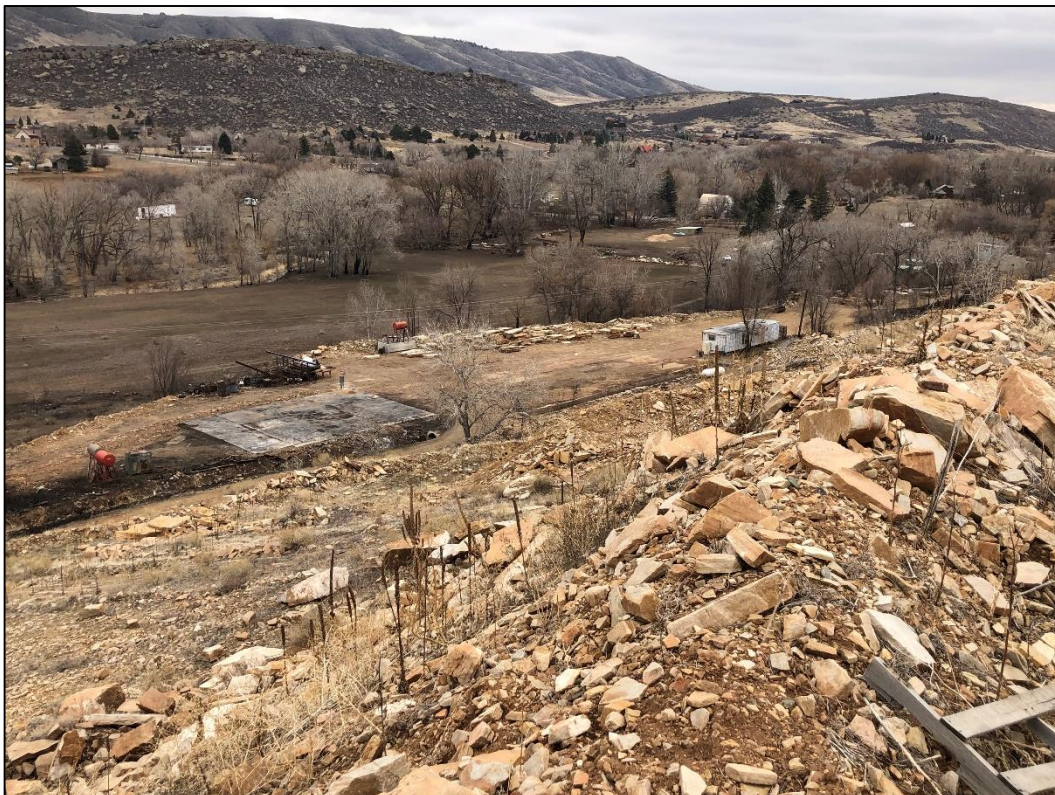
**Photo 8.** View looking east from northeastern edge of quarry disturbance area, showing shop/storage area below. Note blackened areas below from recent wildfire.

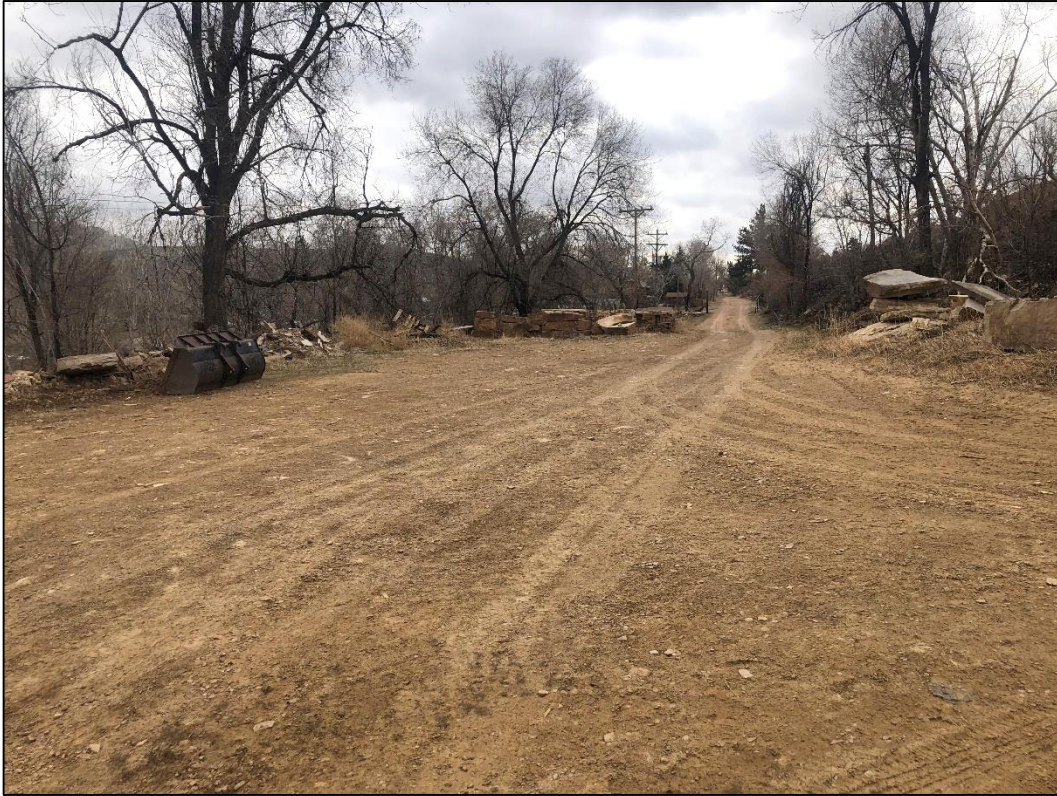
**Photo 9.** View looking south across shop/storage area toward main site entrance.

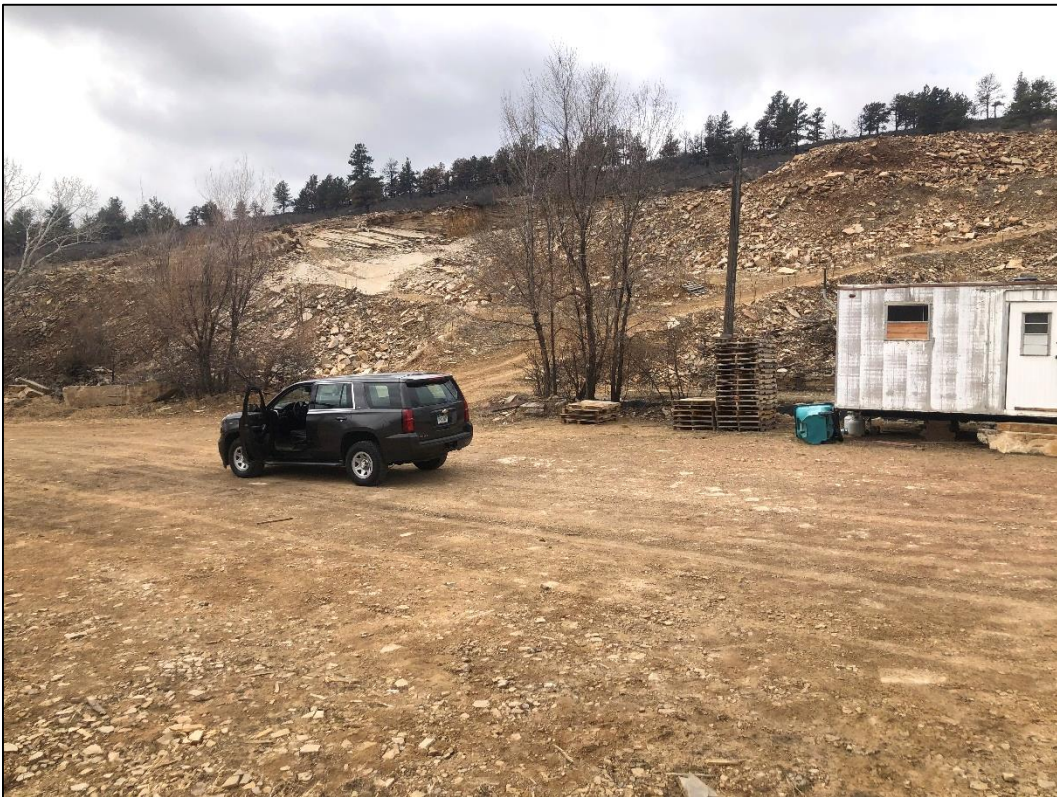
**Photo 10.** View looking southwest across shop/storage area. Note quarry disturbance area in background.

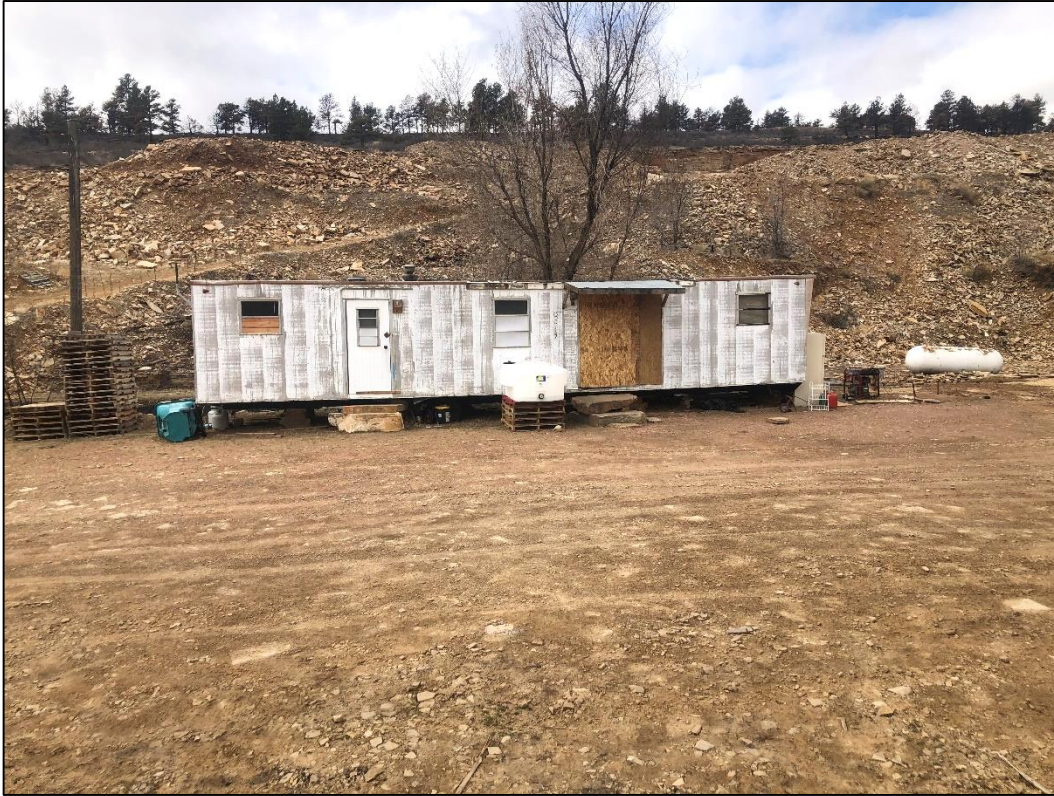
The eastern half of the permit area consists of a flat shop/storage area at the base of the ridge. Prior to the Cameron Peak wildfire which impacted the site in 2020, a shop building, mobile home/office, and storage shed were present in this area. However, the shop building and storage shed burned down in the fire, leaving only the mobile home/office. A low-lying waste rock berm lines the eastern edge of this area. Stacked stone and wooden pallets are stored along its perimeter. A few empty overhead fuel tanks and some miscellaneous pieces of equipment are stored in this area. A lined irrigation ditch runs north-south across the western edge of the shop/storage area. This ditch will not be impacted by the mine operation.

**Photo 11.** View looking west across shop/storage area, showing mobile home/office that remains in this area (other buildings burned in recent wildfire). Note quarry disturbance area in background.

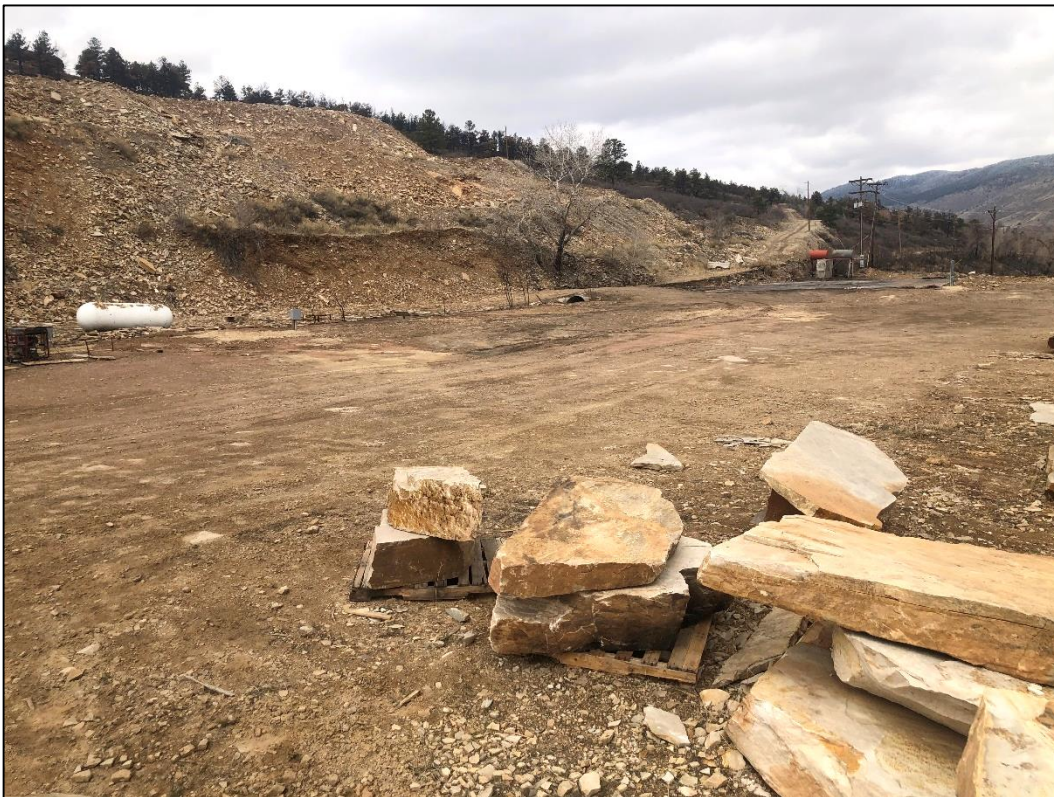
**Photo 12.** View looking northwest across shop/storage area. Note quarry disturbance area in background.

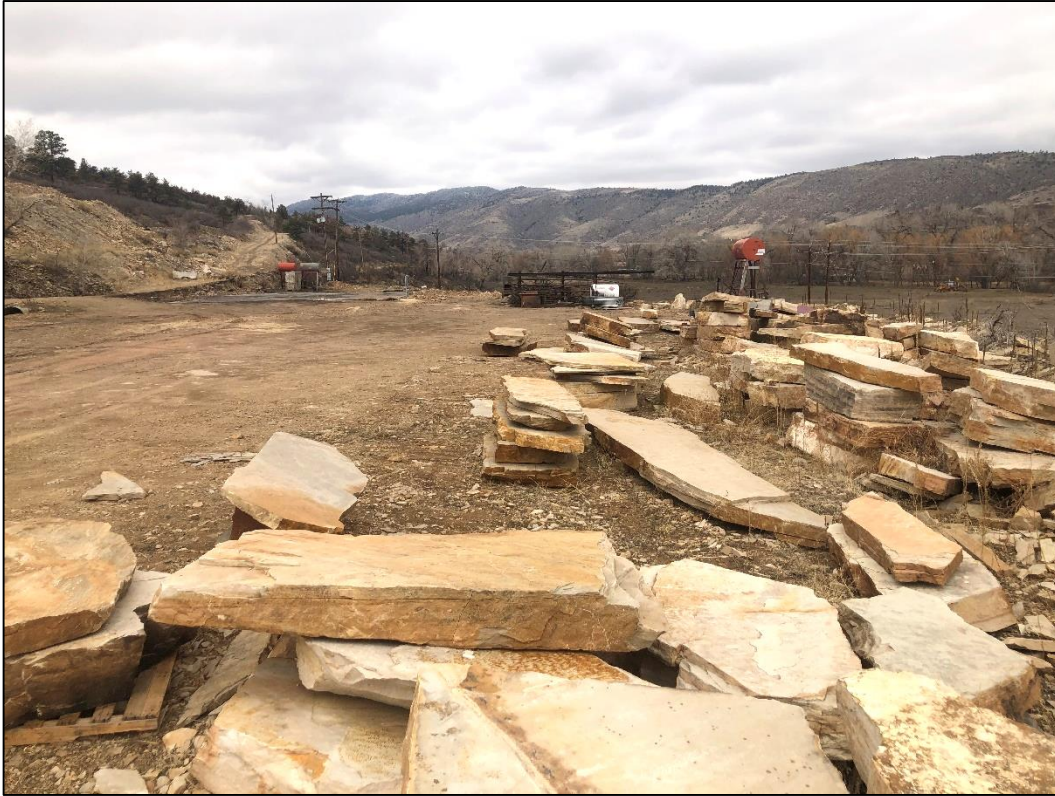
**Photo 13.** View looking north across shop/storage area. Note mined sandstone stacked along perimeter of this area.

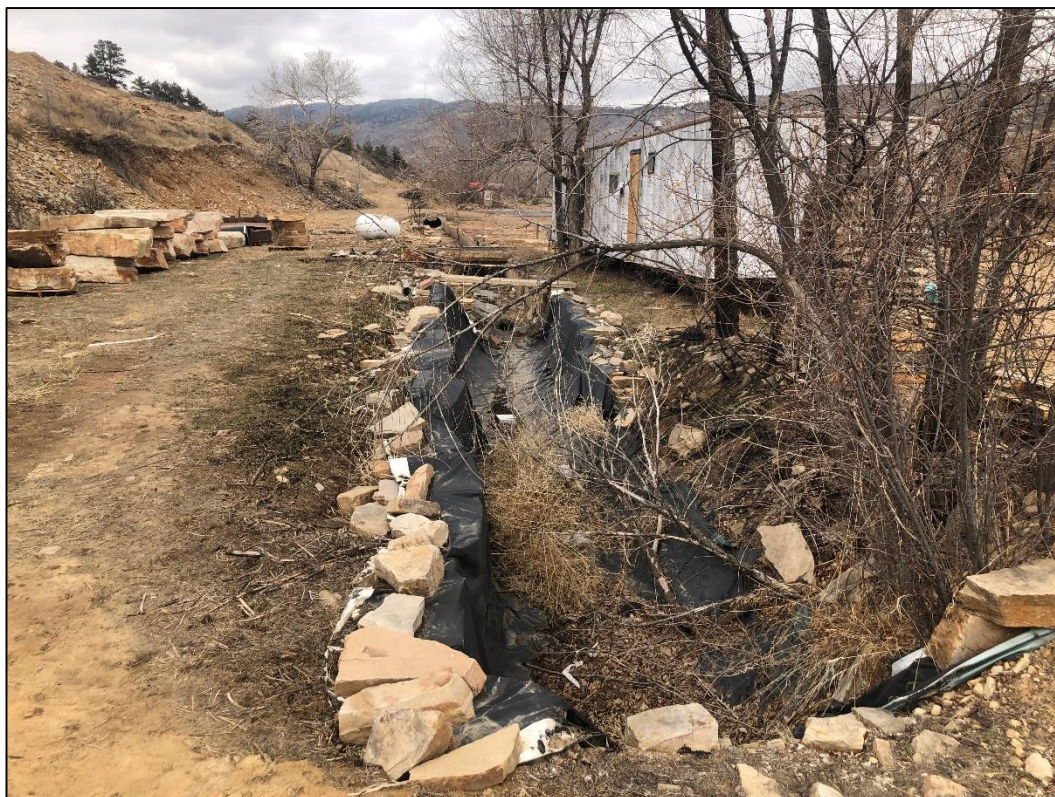
**Photo 14.** View looking north at lined irrigation ditch which runs north-south across western edge of shop/storage area. This ditch was dry during the inspection.
