2021 ANNUAL REPORT STRUCTURAL GEOLOGY EVALUATION SPECIFICATIONS AGGREGATE QUARRY

**Martin Marietta Materials
Golden, Colorado**

20C64005.00
February 17, 2021

**Subject: Project 20C64005.00, 2021 Annual Report, Structural Geology Evaluation,
Specification Aggregates Quarry, Golden, Colorado**

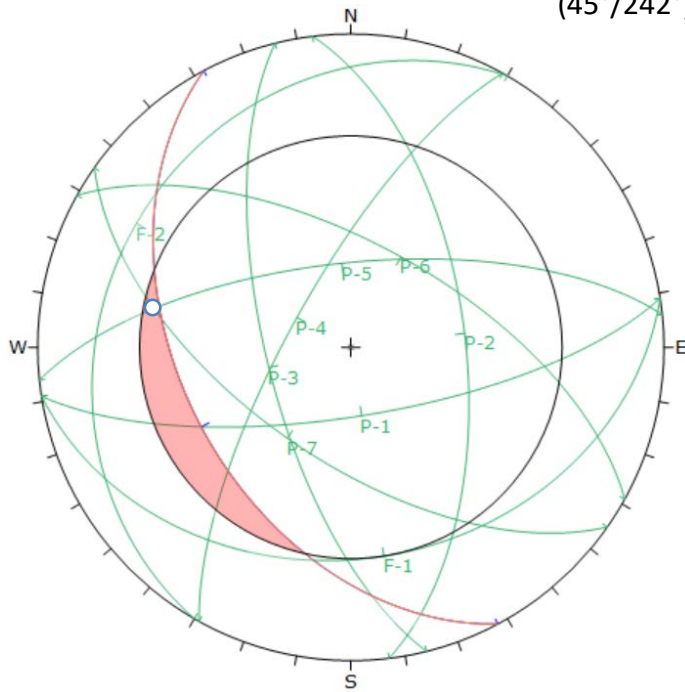
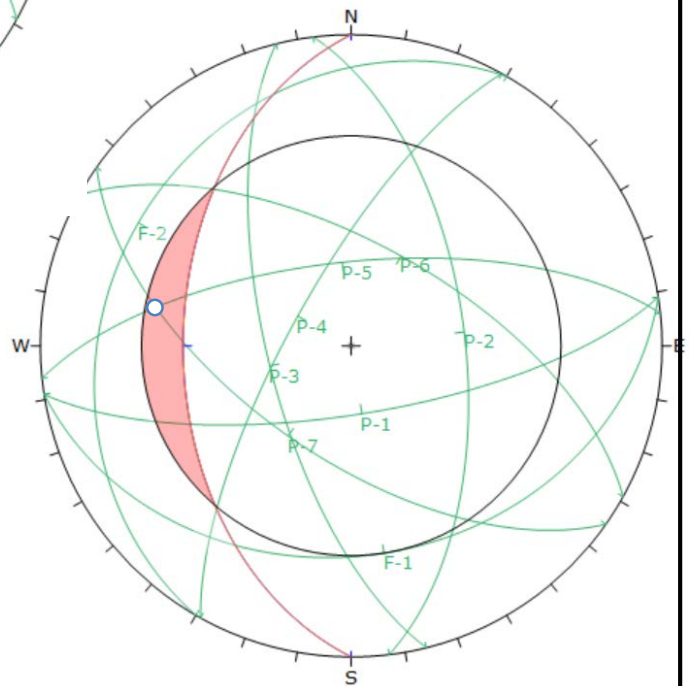
Figure 8

The stereonet plots for East Walls 1 and 2 each show one discontinuity intersection that falls within the failure envelope, suggesting that wedge failure is kinematically possible for these slope orientations (Figure 8). The intersecting set that may result in wedge failure are joint sets P-5 and joint P-7.

The development and size of these wedge failures will be controlled by the variability and limited lateral extent of the discontinuities. Based on the current and previous years' data sets, these two joint sets (P-5 and P-7) have weak signatures represented by relatively few measured orientations (Figure 6). As excavation proceeds in the vicinity of the eastern walls, additional measurements are needed to refine the representative discontinuity orientations of these joint and foliation sets in this area to evaluate their potential to contribute to large-scale slope failure modes.

As shown in Figure 8, the stereonet plot for East Walls 1 and 2 do not indicate the possibility of planar failure.

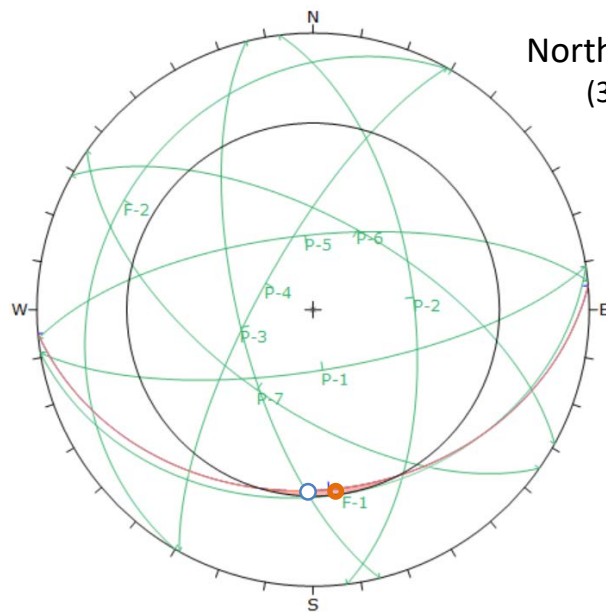
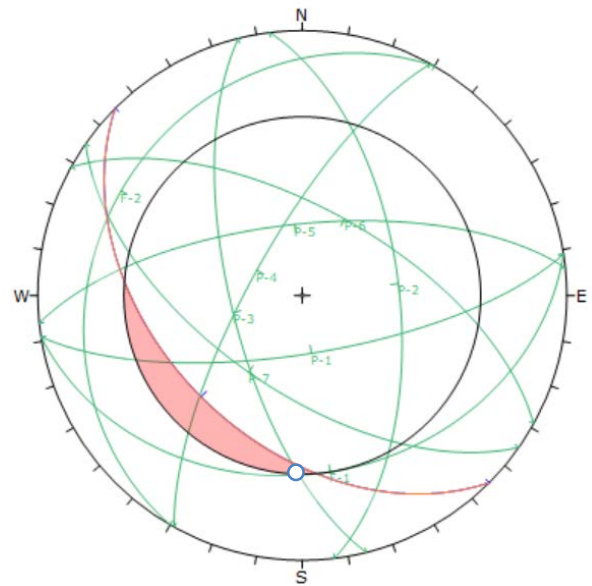
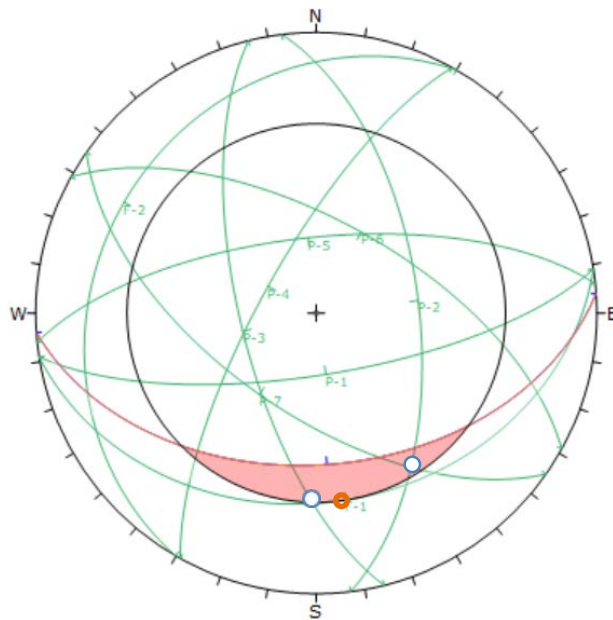
Figure 9

The stereonet plot for Northeast Wall 1 indicates a potential planar failure mode along foliation F-1 for this slope orientation (Figure 9). This is the same foliation orientation that was believed to contribute to the 1998 slope instability (Photo 5). The stereonet plot for Northeast Wall 1 also shows one discontinuity intersection that falls within the failure envelope, suggesting that wedge failure is kinematically possible for this slope orientation (Figure 9). The intersecting sets that may result in wedge failure include foliation F-1 and joint set P-3.

The stereonet plot for Northeast Wall 2 shows one discontinuity intersection that falls within the failure envelope, suggesting that wedge failure is kinematically possible for this slope orientation (Figure 9). The intersecting sets that may result in wedge failure are foliation F-1 and joint set P-3. As described above, the development and size of wedge failures will be controlled by the variability and limited lateral extent of the discontinuities. As excavation proceeds in the vicinity of the northeastern walls, additional measurements are needed to refine the representative discontinuity orientations of these joint and foliation sets in this area to evaluate their potential to contribute to large-scale slope failure modes. Planar failure is not indicated in the stereonet plot for Northeast Wall 2.

The stereonet plot for Northeast Wall 3 indicates a potential planar failure mode along foliation F-1 for this slope orientation (Figure 9). This is the same foliation orientation that was believed to contribute to the 1998 slope instability. The stereonet plot for Northeast Wall 3 shows two discontinuity intersections that fall within the failure envelope, suggesting that wedge failure is kinematically possible for this slope orientation (Figure 9). The intersecting sets that may result in wedge failure are foliation F-1 and joint set P-3, and joint sets P-2 and P-7. Based on the current and previous years' data sets, joint set P-7 has weak signatures represented by relatively few measured orientations representing these features (Figure 6). The Northeast Wall 3 was not accessible for direct measurements or observations during our site visits. Additional measurements and observations are needed to assess the potential for large scale planar sliding along foliation F-1 as excavation continues to extend below Northeast Wall 3 in the future (there is currently no mining activity in this area).

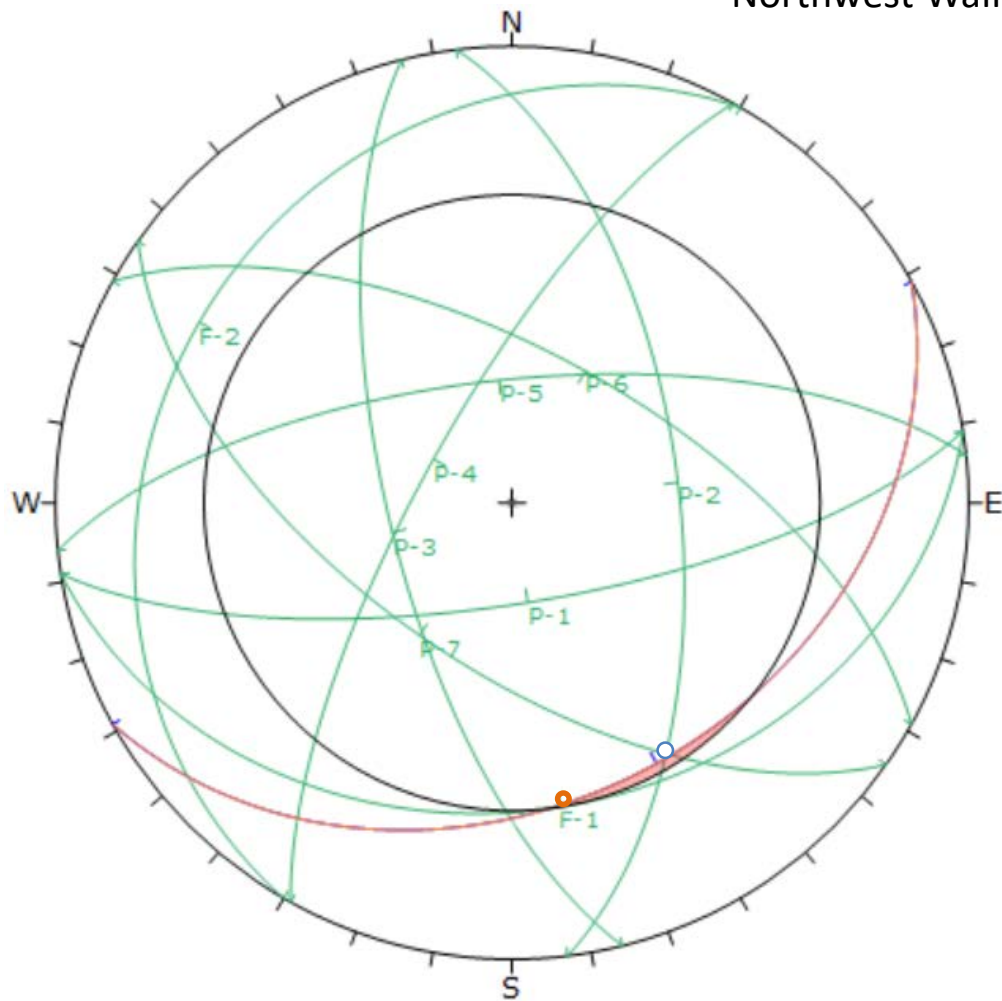
Figure 10

The stereonet plot for the Northwest Wall shows a potential planar failure mode along foliation F-1 for this slope orientation and one discontinuity intersection that falls within the failure envelope, suggesting that wedge failure is kinematically possible for this slope orientation (Figure 10). The intersecting sets that may result in wedge failure are joint sets P-2 and P-7. Based on the current and previous years' data sets, joint set P-7 has weak signatures represented by relatively few measured orientations representing these features (Figure 6). Furthermore, even a slight variability of the orientation of joint sets P-2, P-7 and foliation F-1 would create the potential to form wedges within the critical zone for this wall.

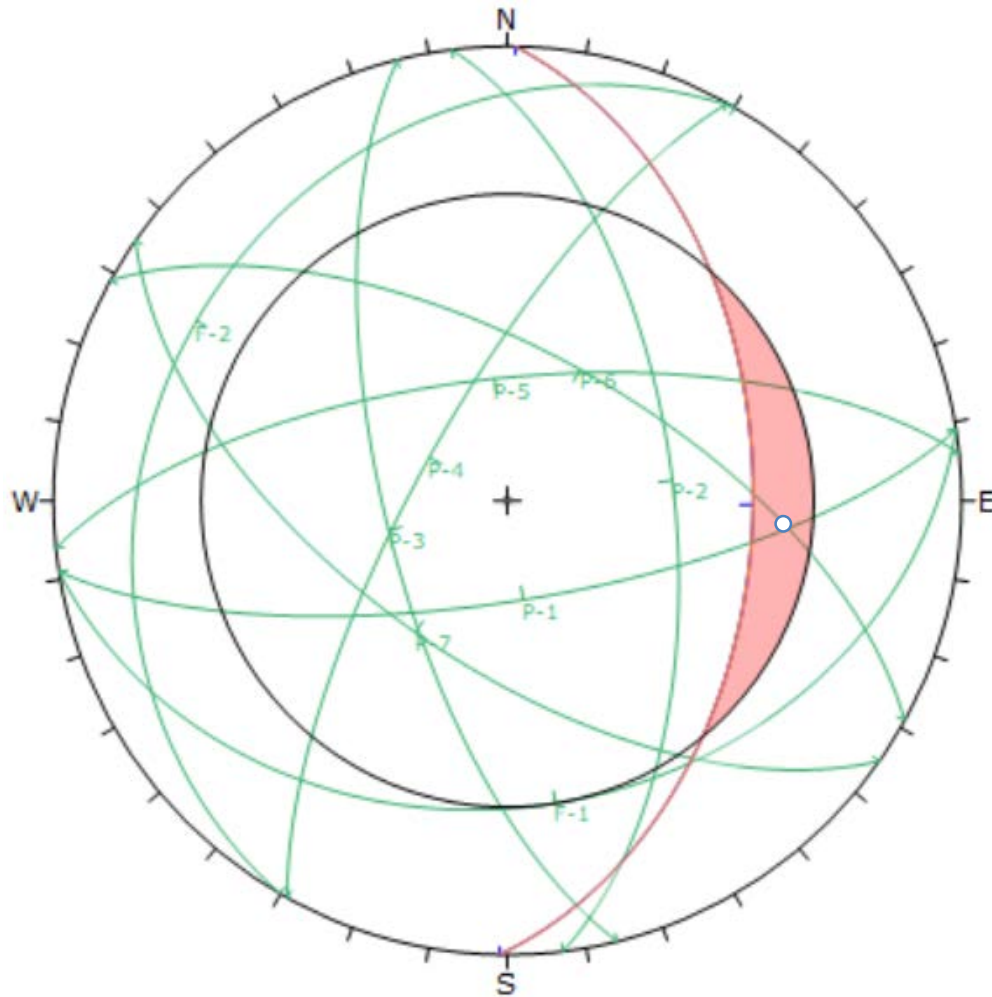
Figure 11

The stereonet plot for West Wall 1 (Figure 11), adjacent to the Main Pit area, shows a discontinuity intersection that falls within the failure envelope, suggesting that wedge failure is kinematically possible for this slope orientation (Figure 11). The intersecting sets that may result in wedge failure are joint sets P-1 and P-6. Based on the current and previous years' data sets, joint sets P-1, P-2, and P-3 are the dominant joint sets observed in the Southern Expansion Area (Figure 6) in the recent years. Joint set P-6 has strong present in this report year. Planar failure is not indicated in the stereonet plot for the West Wall 1 (Figure 11).

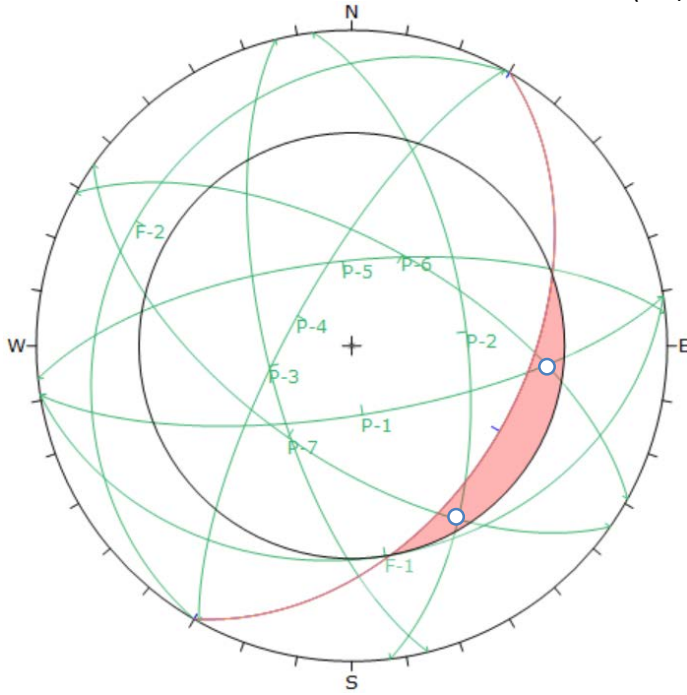
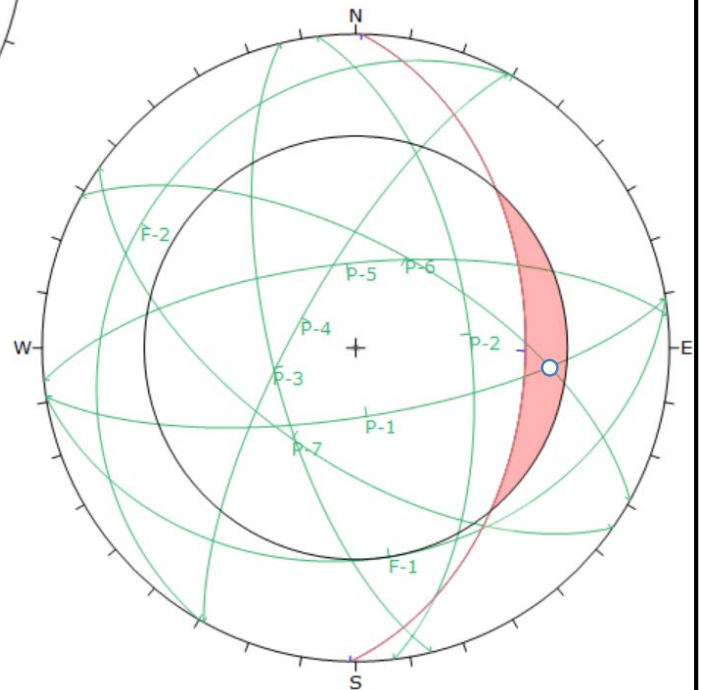
Figure 12

The stereonet plot for West Wall 2, adjacent to the access road in the Southern Expansion Area, shows two discontinuity intersections that fall within the failure envelope, suggesting that wedge failure is kinematically possible for this slope orientation (Figure 12). The intersecting sets that may result in wedge failure include joint sets P-2 and P-7 and joint sets P-1 and P-6. Based on the current and previous years' data sets, joint set P-7 has weak signatures represented by relatively few measured orientations representing these features (Figure 6). Planar failure is not indicated in the stereonet plot for West Wall 2 (Figure 12).

The stereonet plot for West Wall 3 shows a discontinuity intersection that falls within the failure envelope, suggesting that wedge failure is kinematically possible for this slope orientation (Figure 12). The intersecting sets that may result in wedge failure are joint sets P-1 and P-6. Planar failure is not indicated in the stereonet plot for the West Wall 3 (Figure 12).

The development and size of wedge failures will be controlled by the variability and limited lateral extent of the discontinuities. As excavation proceeds in the west walls area, additional measurements are needed to refine the representative discontinuity orientations of these joint and foliation sets in this area to evaluate their potential contribute to large-scale slope failure modes.

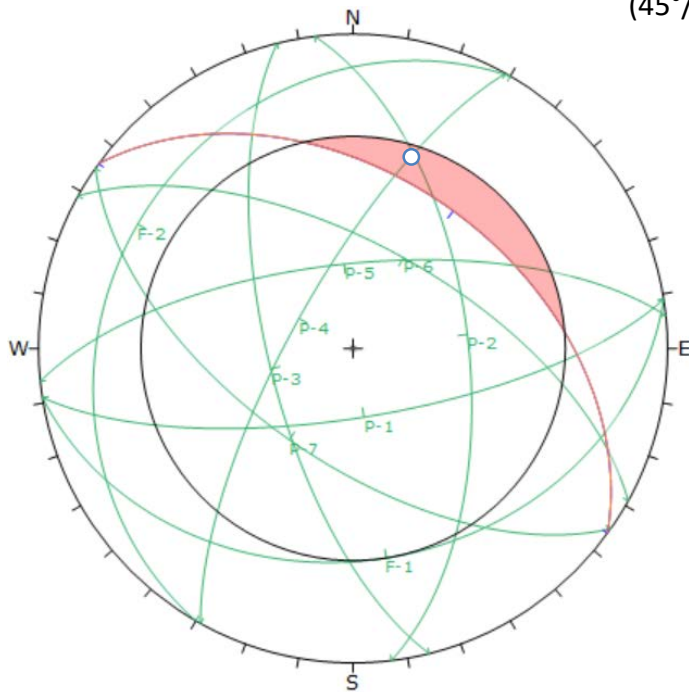
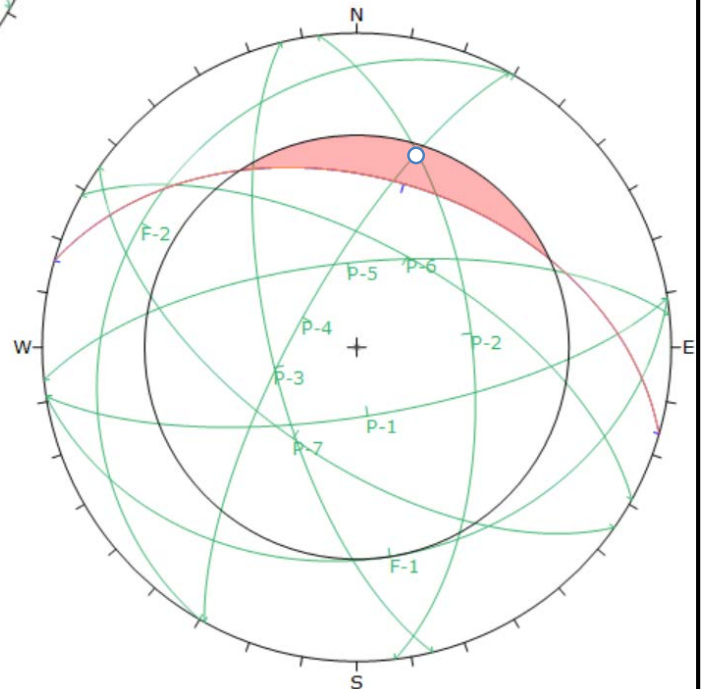
Figure 13

The stereonet plots for the Southwest Wall 1, Southwest Wall 2, and South Wall show one discontinuity intersections that falls within the failure envelope, suggesting that wedge failure is kinematically possible for this slope orientation (Figures 13 and 14). The intersecting sets that may result in wedge failure are joint sets P-2 and P-4. Based on the current as well as previous year's data set, joint set P-4 has weak signatures represented by relatively few measured orientations representing these features (Figure 6). Planar failure is not indicated in the stereonet plot for these three walls (Figures 13 and 14).

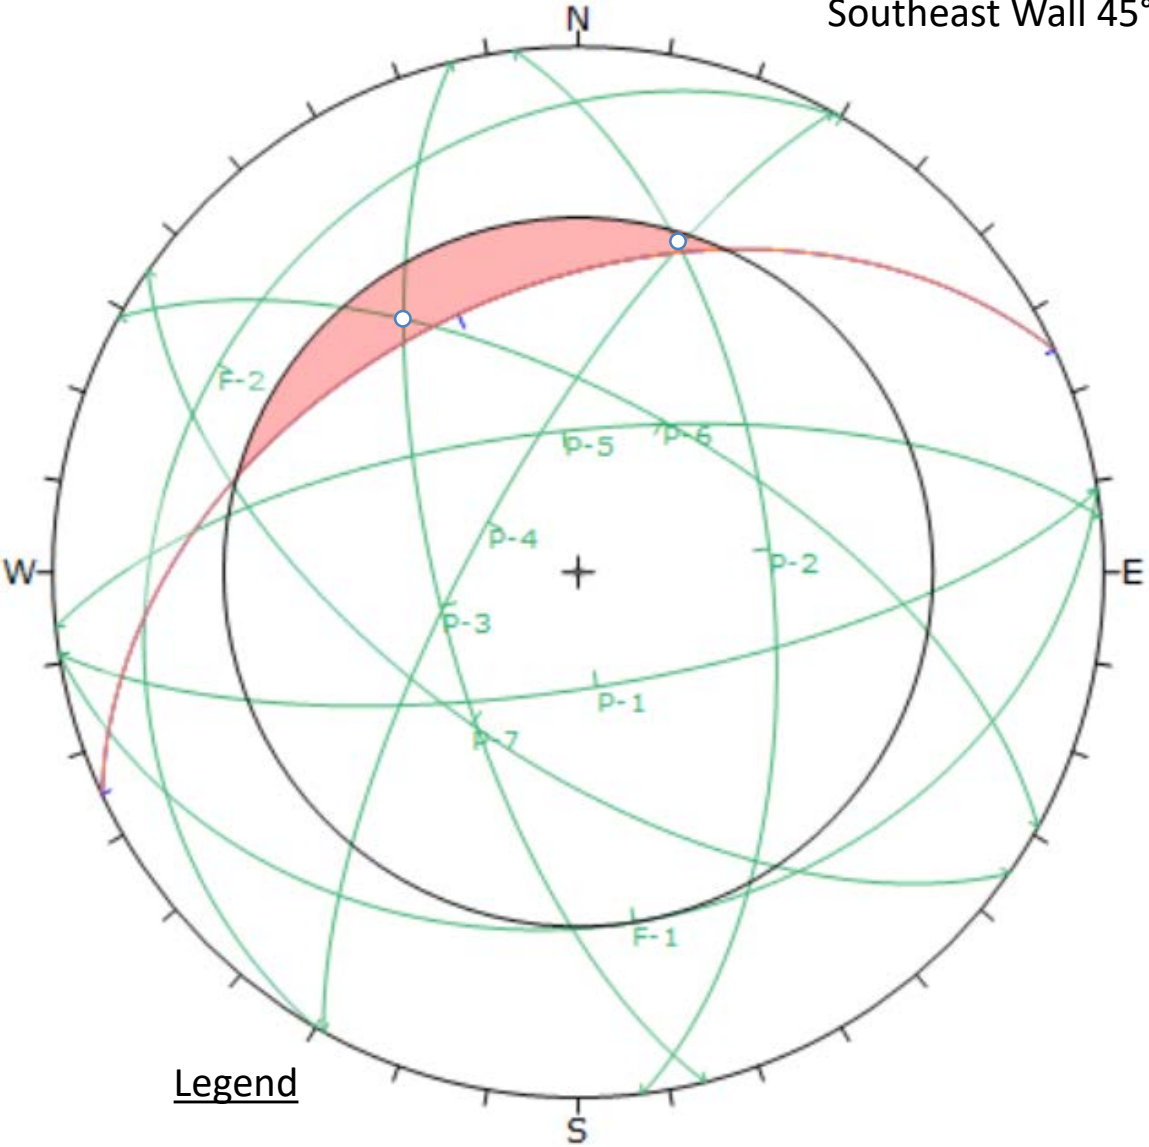
Lachel & Associates <small>A SCHNABEL ENGINEERING COMPANY</small>		
Spec-Agg Quarry Golden, Colorado Project No. 20C64005.00		Kinematic Analysis: Southeast Wall
  Martin Marietta		Figure 15

The stereonet plot for Southeast Wall shows two discontinuity intersections that fall within the failure envelope, suggesting that wedge failure is kinematically possible for this slope orientation (Figure 15). The intersecting sets that may result in wedge failure are joint sets P-2 and P-4 and joint sets P-3 and P-6. Based on the current and previous years' data sets, joint set P-4 has weak signatures represented by relatively few measured orientations representing these features (Figure 6). Additional measurements and observations are needed to assess the potential wedge formed by joint sets P-3 and P-6 as excavation continues to extend below Southeast Wall in the future.

As described above, the development and size of wedge failures will be controlled by the variability and limited lateral extent of the discontinuities. As excavation proceeds in the vicinity of the southern walls, additional measurements are needed to refine the representative discontinuity orientations of these joint and foliation sets in this area to evaluate their potential contribute to large-scale slope failure modes.

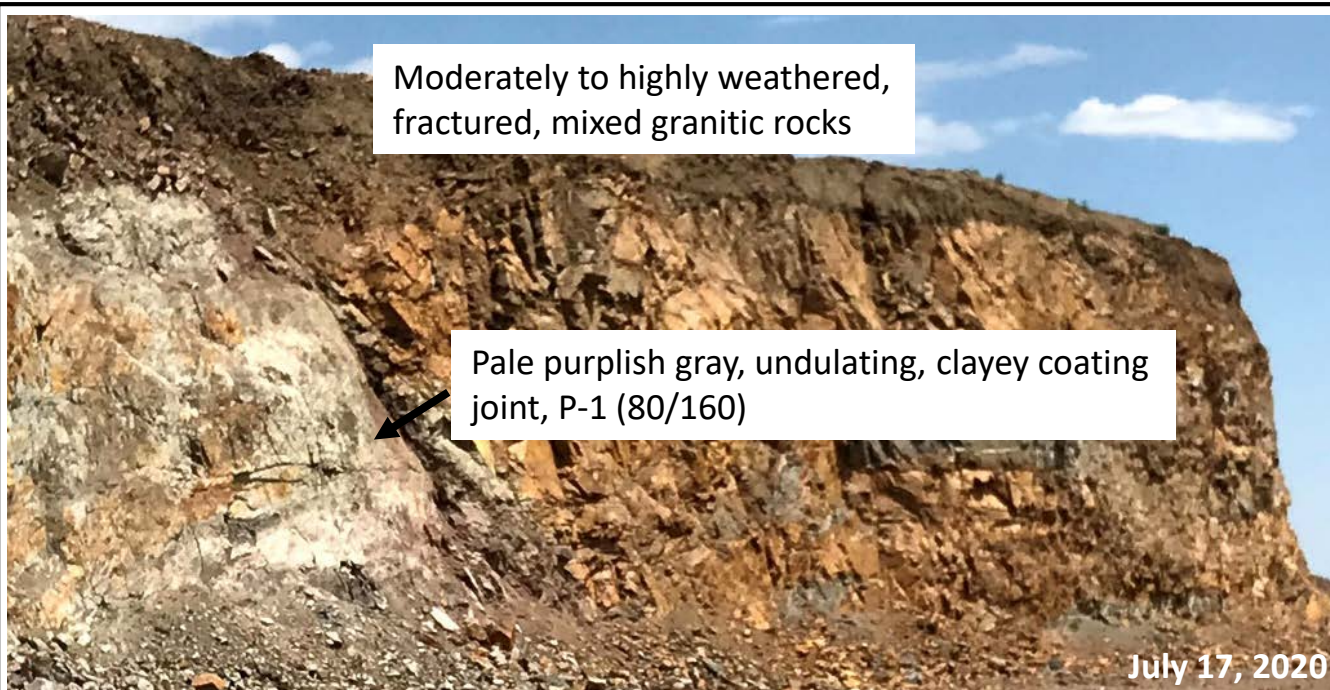
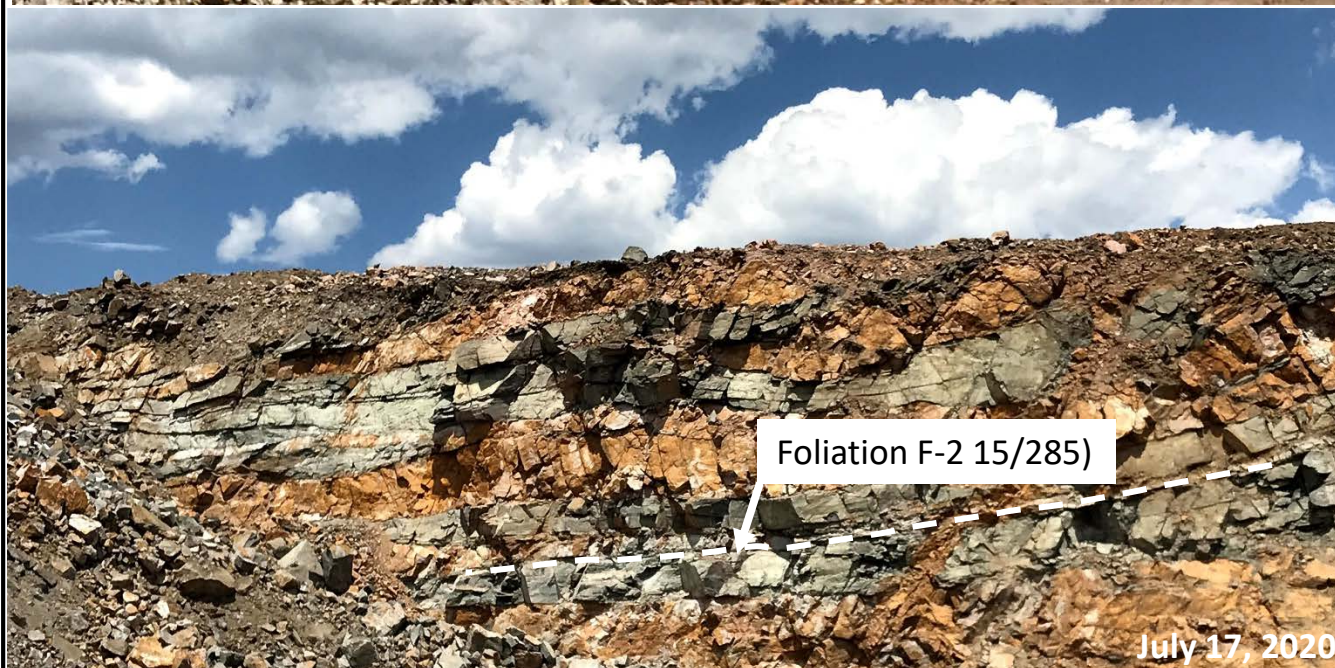
Photo 1

Looking southeast in an newly active mine area (lowest bench, elevation ~6545 ft msl) of the Southern Expansion Area near Station 21-6 (Figure 2).

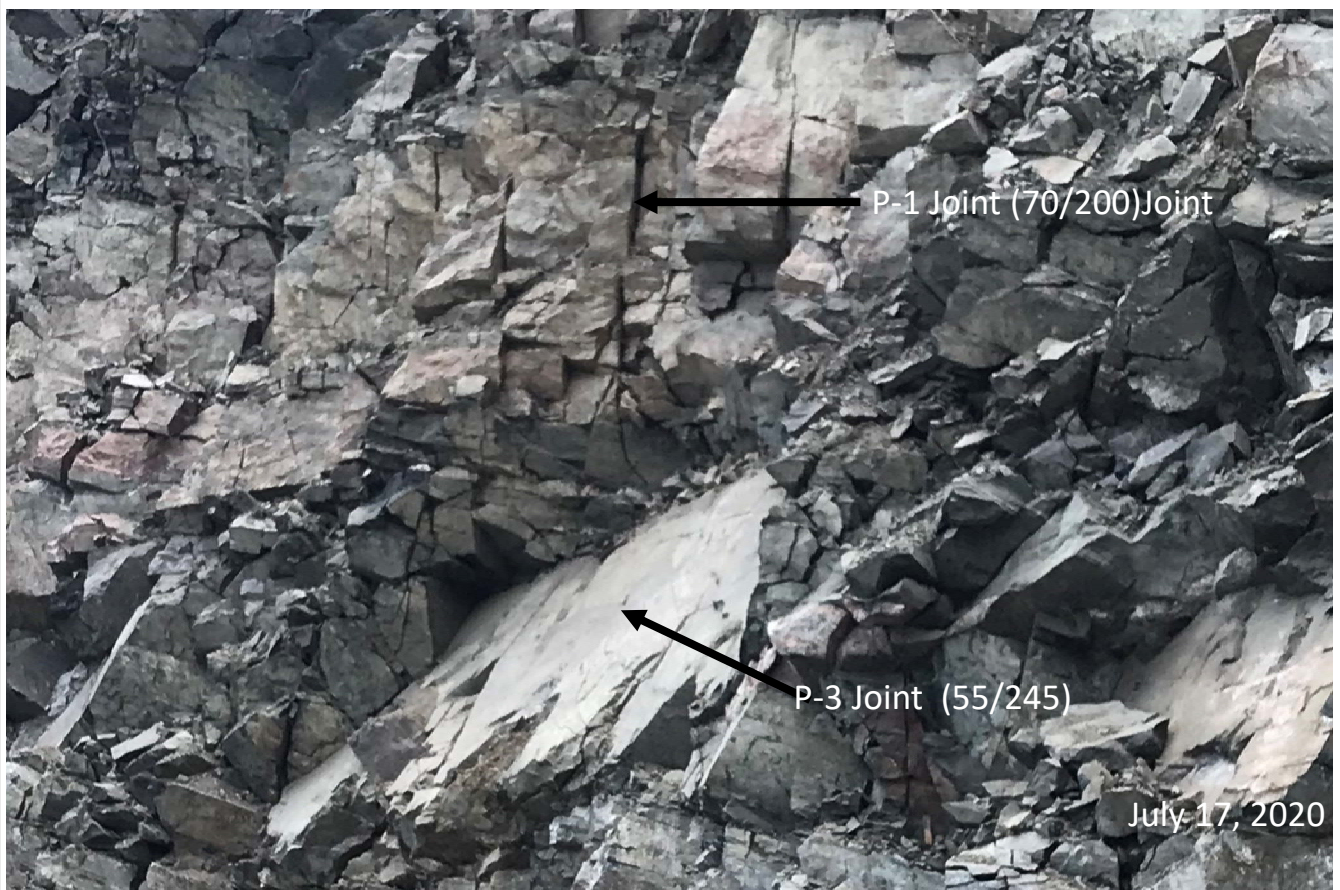
Photo 2

P1 and P-3 joints are the dominant joint sets in the middle temporary bench area the Southern Expansion area (~6580 ft msl).

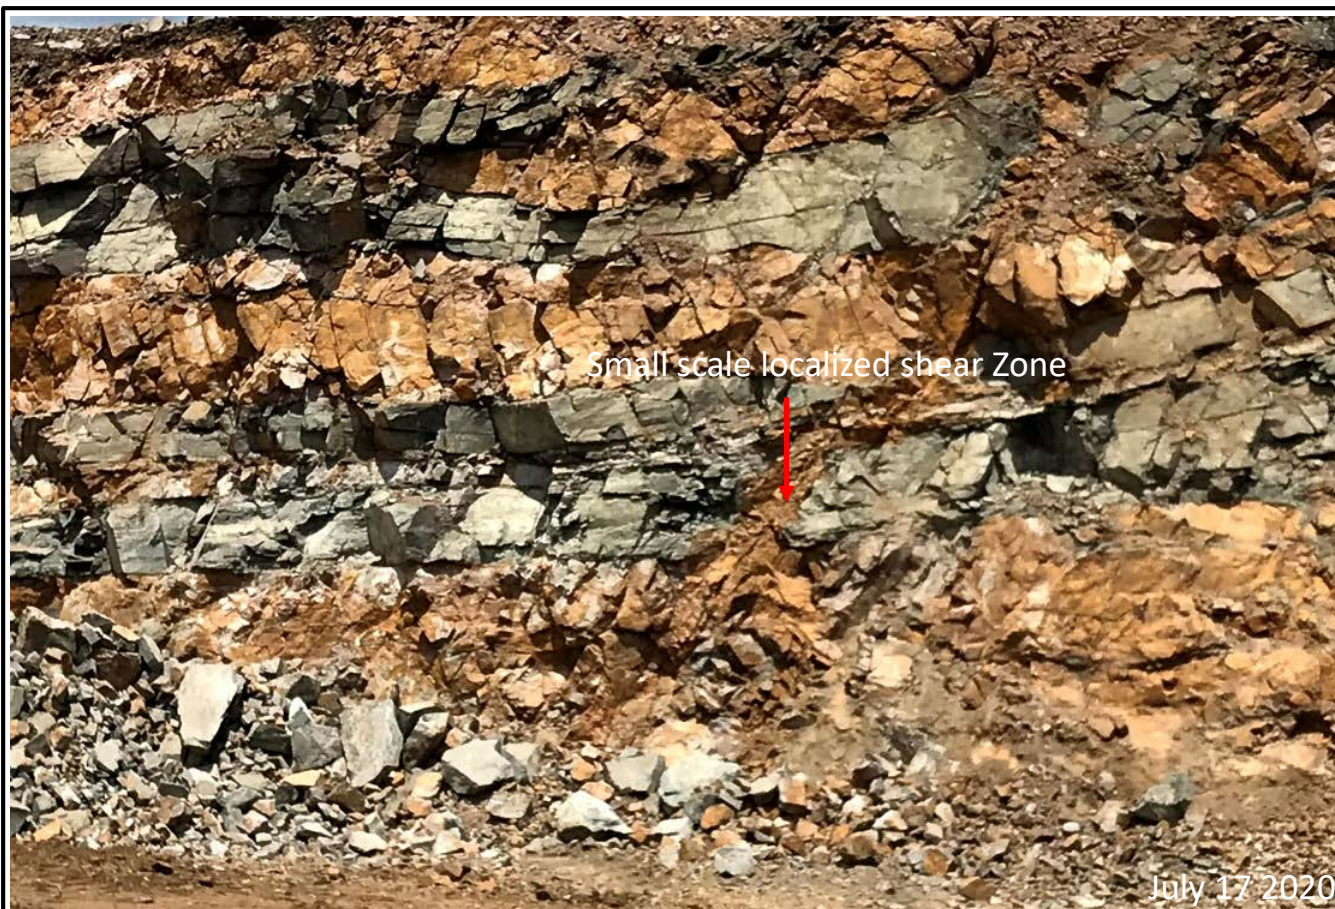
Photo 3

During our 2020/2021 site visits, no major shear zone (fault) exposure along the temporary excavation wall in the Southern Expansion Area was observed, only localized small scale shear zone was observed at station 21-02 (Figure 2, and Photo 3). The localized shear zone is oriented approximately north-south with high angle dipping to the east and was exposed in the north to northwest facing temporary wall of the expansion area. The localized shear zone consists of yellowish-brownish weathered, broken granitic rock, with parallel closed-spacing fractures. This shear zone is most likely localized and is not associated with previously reported faults. Previous fault measurements are shown in Figure 4.

No major shear zone was observed during this report year (in both July 2020 and January 2021 field activities).

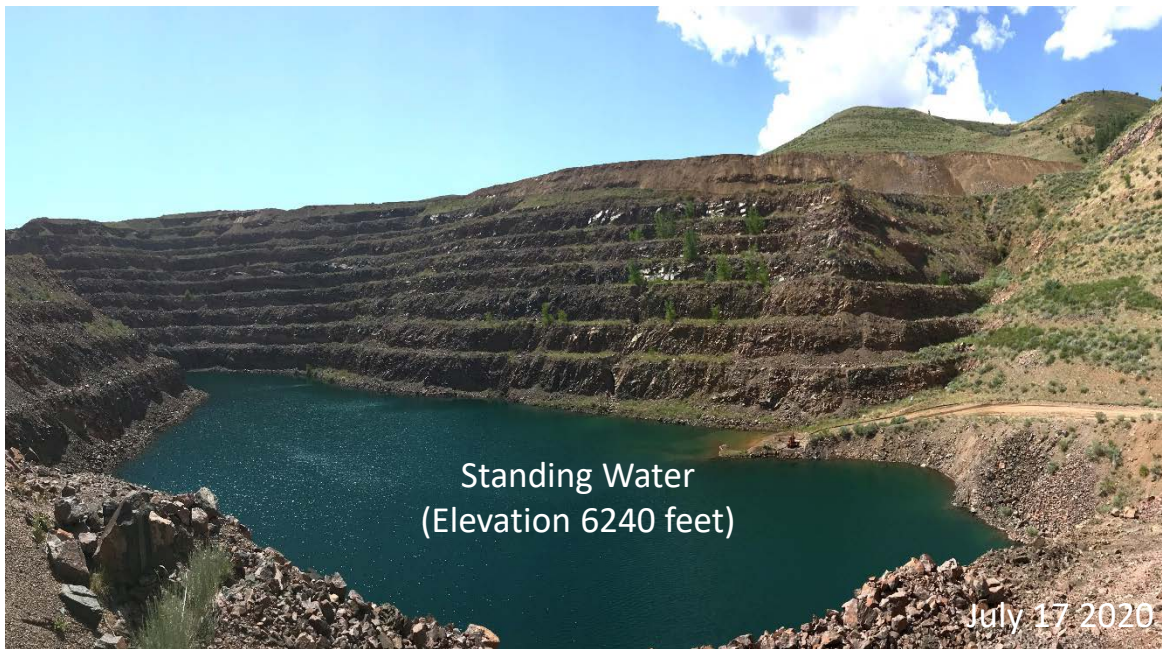
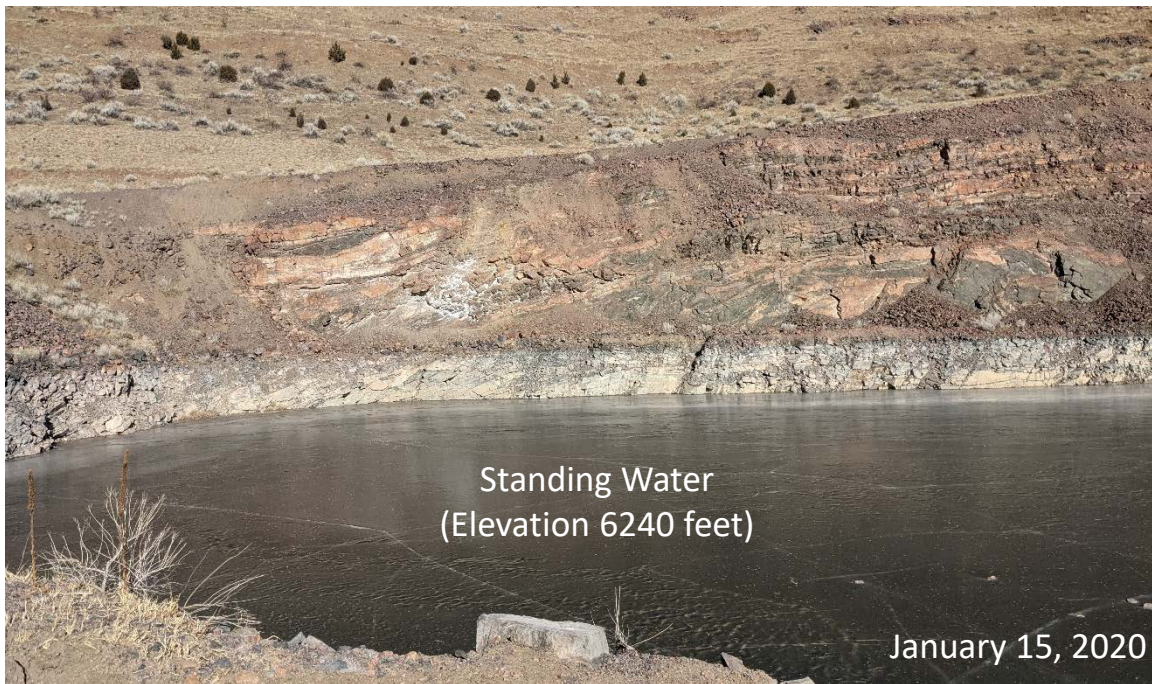
Photo 4

The quarry walls observed during the 2020/2021 site visits appeared to be relatively dry; with the exception of minor seepage visible in the southwest corner of the main pit, which has been documented in the past. Other than minor seepage observed along the temporary access road to the Southern Expansion Areas, no major seepage was observed. Additionally, we observed impounded water in the Main Pit floor (Photo 4). It is our understanding that there has been intermittent pumping of the impounded water to maintain water level during the past year.

Standing Water
(Elevation 6240 feet)

Looking north-northeast (Northeast Walls 1-3)

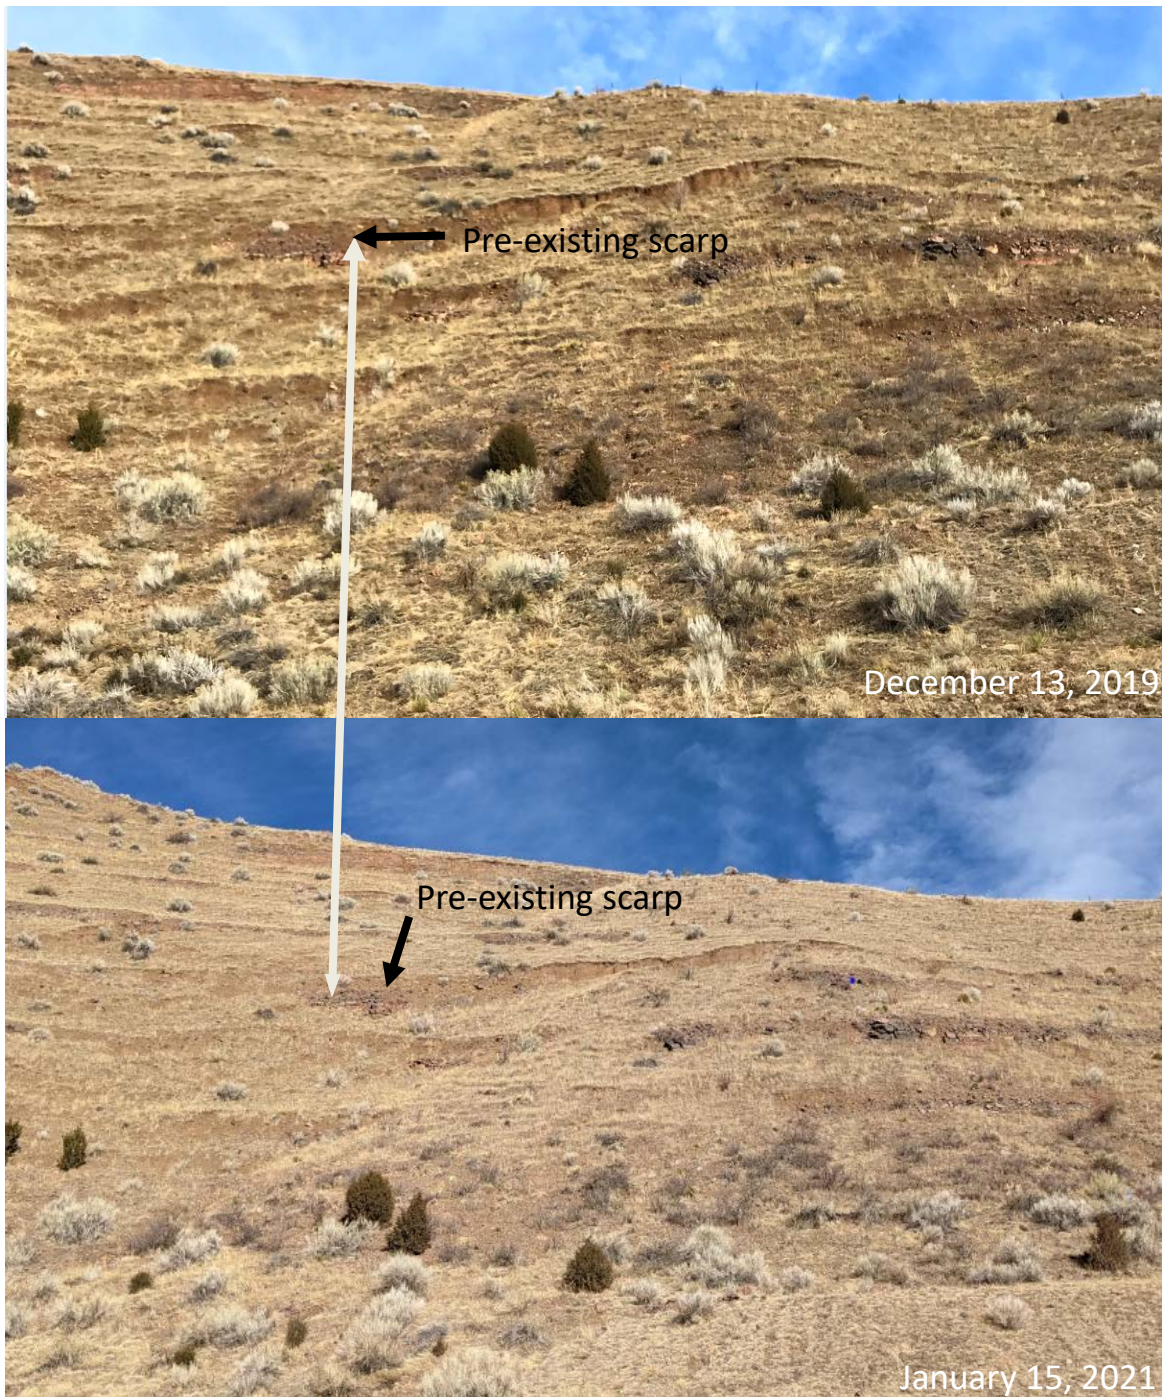
After planar failure along foliation planes in 1998 and 1999, the overall effective angle of the last three benches of the Northeast Wall 1 and the Northwest Wall were reduced to an overall angle of 35°, which is consistent with the 2003 Lachel geotechnical evaluation (Lachel, 2003). The failure surfaces (i.e., the surfaces along which movement has occurred) remain at a “residual strength” and therefore are less resistant to additional loading. Based on visual inspection from the access road and bottom of the pit, these slopes did not appear to show signs of additional movement during the site visits for this study.

(Photo 5). Although the slope configuration is currently stable, the failure mechanism could potentially be reactivated, resulting in movement of additional material. The Northwest Wall, Northeast Wall 1, and Northeast Wall 3 (Figure 2) should continue to be visually monitored for indications of instability.

Looking north from the Main Pit Area showing pre-existing scarp feature on the north slope, it seems unchanged since December 2019.
