MINERALS PROGRAM INSPECTION REPORT
PHONE: (303) 866-3567

MINE NAME: Dawson Gold Project	MINE/PROSPECTING ID#: P-2020-002	MINERAL: Gold	COUNTY: Fremont
INSPECTION TYPE: Monitoring	INSPECTOR(S): Timothy Cazier	INSP. DATE: August 18, 2020	INSP. TIME: 11:00
OPERATOR: Zephyr Gold USA Ltd	OPERATOR REPRESENTATIVE: Driller ONLY	TYPE OF OPERATION: MP - Mineral Prospecting	
REASON FOR INSPECTION: Normal I&E Program	BOND CALCULATION TYPE: None	BOND AMOUNT: Statewide: \$107,290 Allocated: \$14,635	
DATE OF COMPLAINT: NA	POST INSP. CONTACTS: U.S.BLM	JOINT INSP. AGENCY: U.S.BLM	
WEATHER: Clear	INSPECTOR'S SIGNATURE:

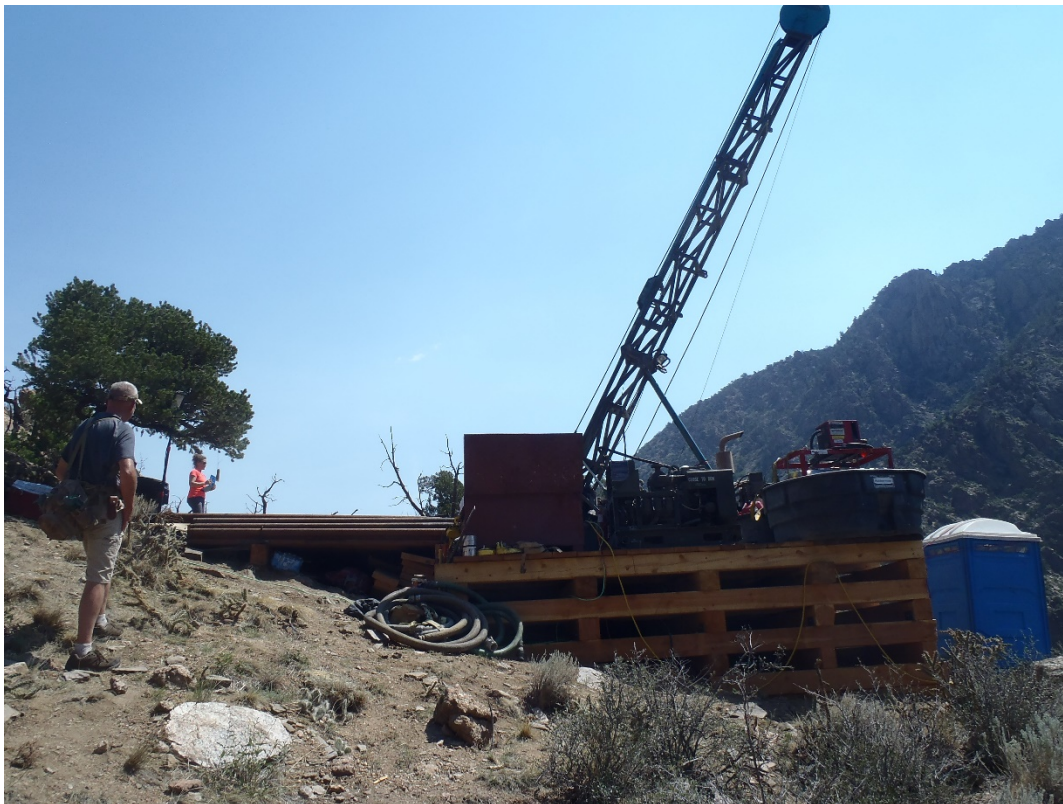
Backfilling and Grading: Ground disturbance was observed to be minimal with a drill platform (see **Photo 1**) constructed from wood timbers brought in via helicopter. Two holes were drilled at this site: the first between August 5th and 7th, 2020 to a depth of 307 feet, and abandoned on 8/7/2020; and the second between August 11th and 27th, 2020 to a depth of 1366 feet, and abandoned on 8/27/2020. The DRMS received completed abandonment reports for both holes on October 19, 2020.

Photo 1. Drill platform and derrick.

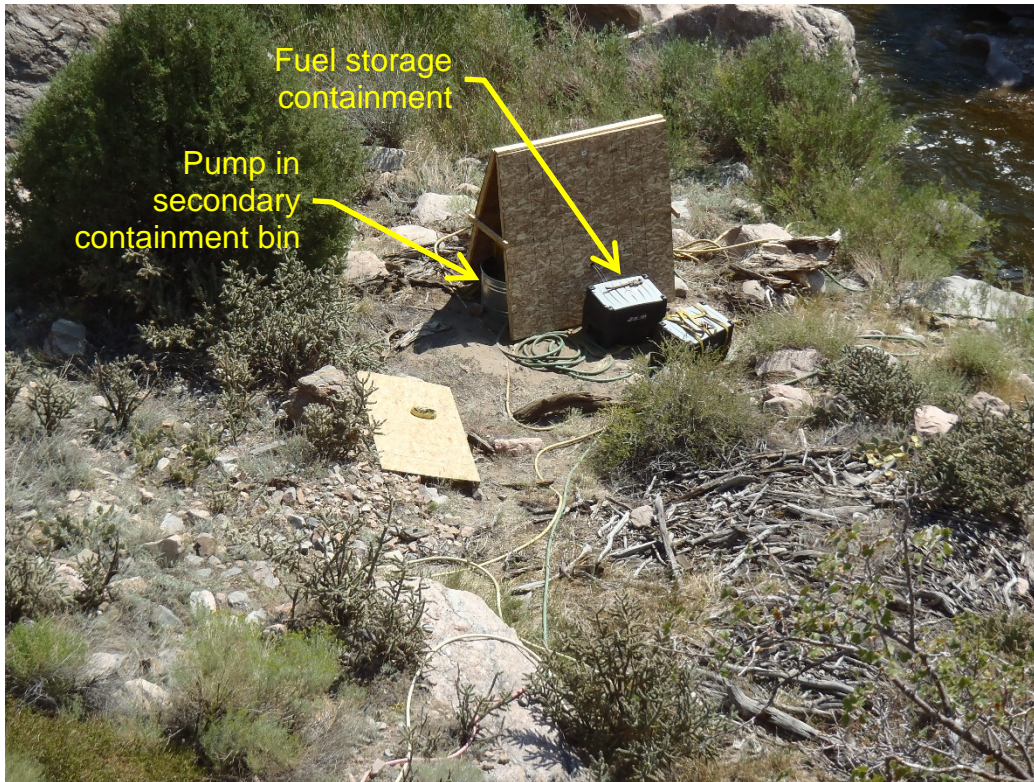
Hydrologic Balance: At the time of the inspection, the second hole depth was 750 feet at the time of the inspection and the driller stated groundwater had not been encountered. Drilling water was being pumped from Grape Creek (see **Photo 2**) as approved in the NOI and piped uphill to the drill platform (see **Photo 3**). Sanitary facilities were also set up at the site (see **Photo 4**). Lubricants and fuel was stored in bins or barrels on the platform over an impermeable barrier (see **Photo 5**).

Photo 2. Pump at Grape Creek.

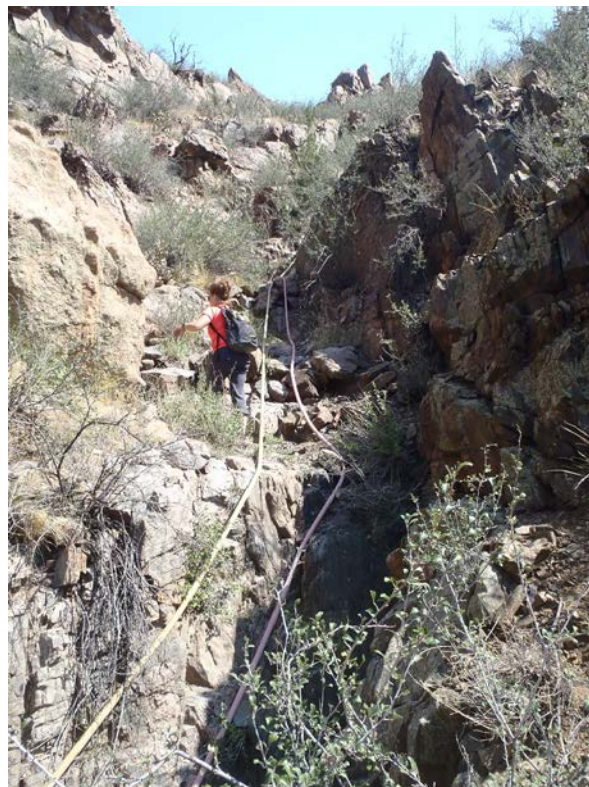
Photo 3. Hoses in gully leading up to drill platform.

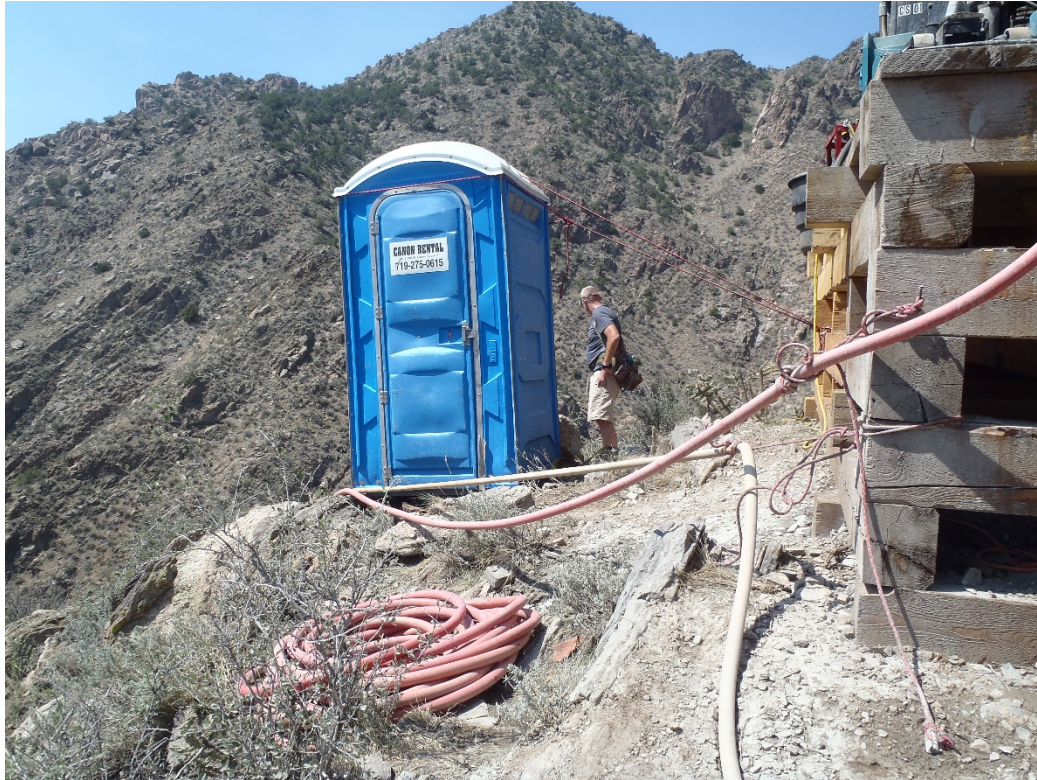
Photo 4. Porta-potty tethered to platform.

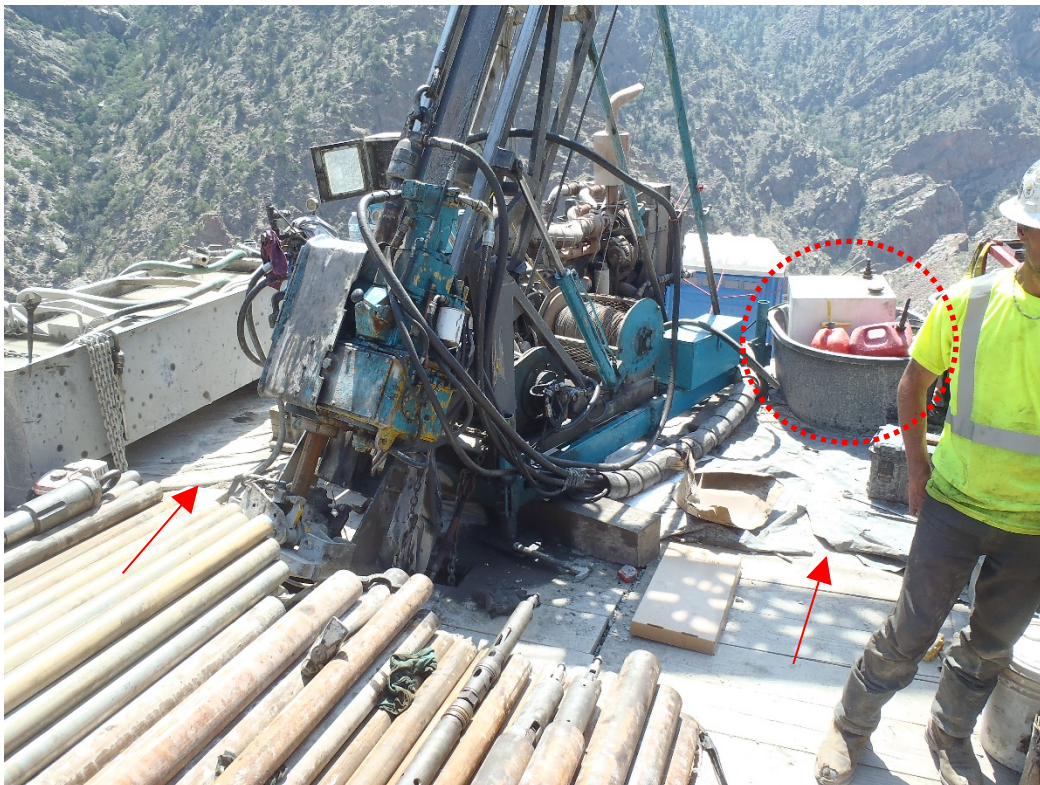
Photo 5. Drill platform – arrows showing impermeable (visqueen) barrier; secondary storage bin circled.

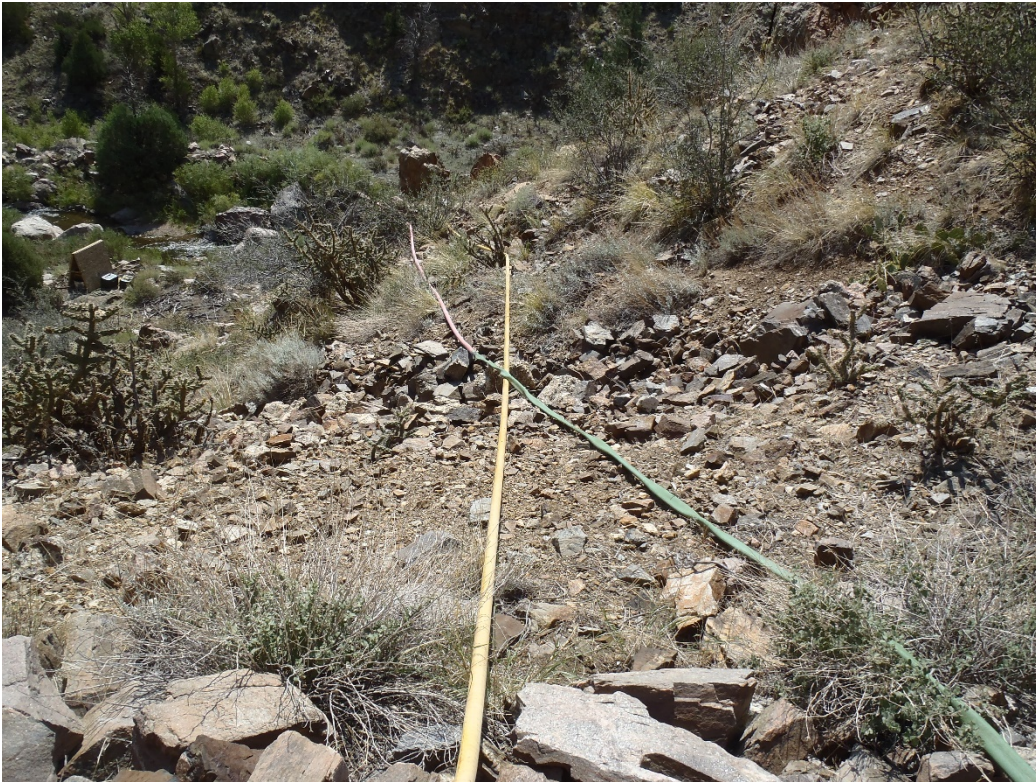
Revegetation: The aforementioned hoses showed limited movement and did not appear to be damaging vegetation (see **Photo 6**). Vegetation was visible under the drill platform (see **Photo 7**). No noxious weeds were observed.

Photo 6. Hose layout – not damaging vegetation (looking down from railroad grade).

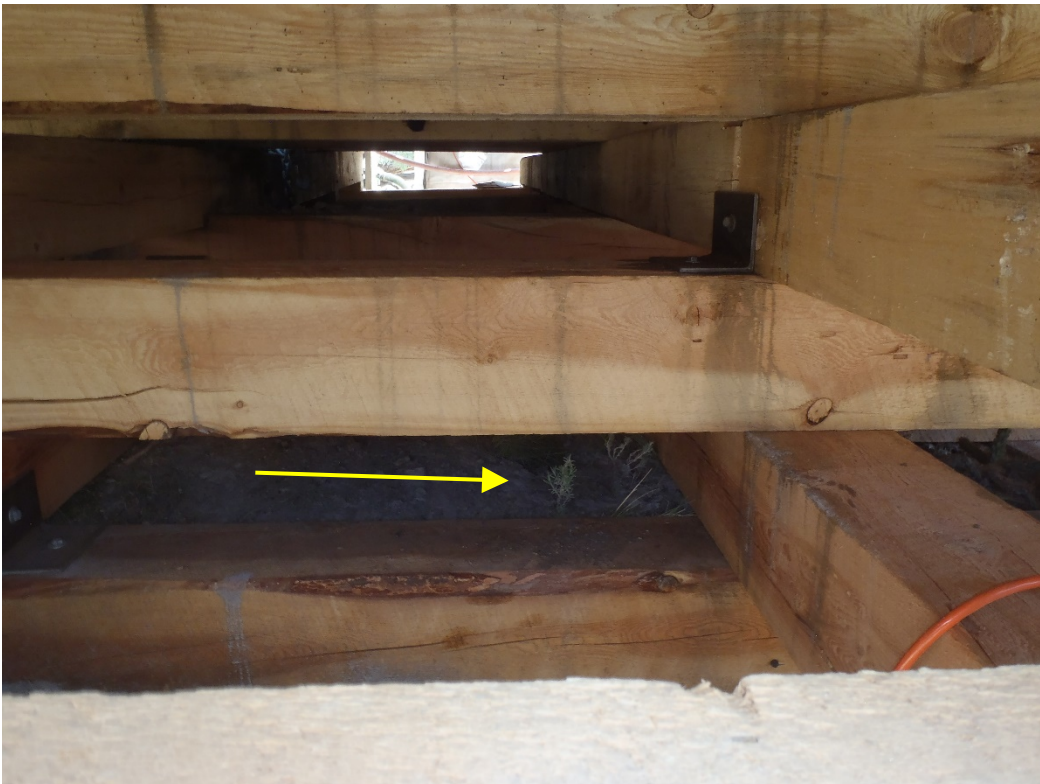
Photo 7. Vegetation visible under platform.
