MINERALS PROGRAM INSPECTION REPORT
PHONE: (303) 866-3567

MINE NAME: Pueblo East Pit	MINE/PROSPECTING ID#: M-1986-015	MINERAL: Sand and gravel	COUNTY: Pueblo
INSPECTION TYPE: Preoperation Inspection	INSPECTOR(S): Patrick Lennberg	INSP. DATE: March 4, 2021	INSP. TIME: 10:30
OPERATOR: Continental Materials Corporation	OPERATOR REPRESENTATIVE: Jerry Schnabel, Dan Tucker	TYPE OF OPERATION: 112c - Construction Regular Operation	
REASON FOR INSPECTION: Preoperation Inspection	BOND CALCULATION TYPE: Complete Bond	BOND AMOUNT: \$2,288,004.00	
DATE OF COMPLAINT: NA	POST INSP. CONTACTS: None	JOINT INSP. AGENCY: None	
WEATHER: Cloudy	INSPECTOR'S SIGNATURE:

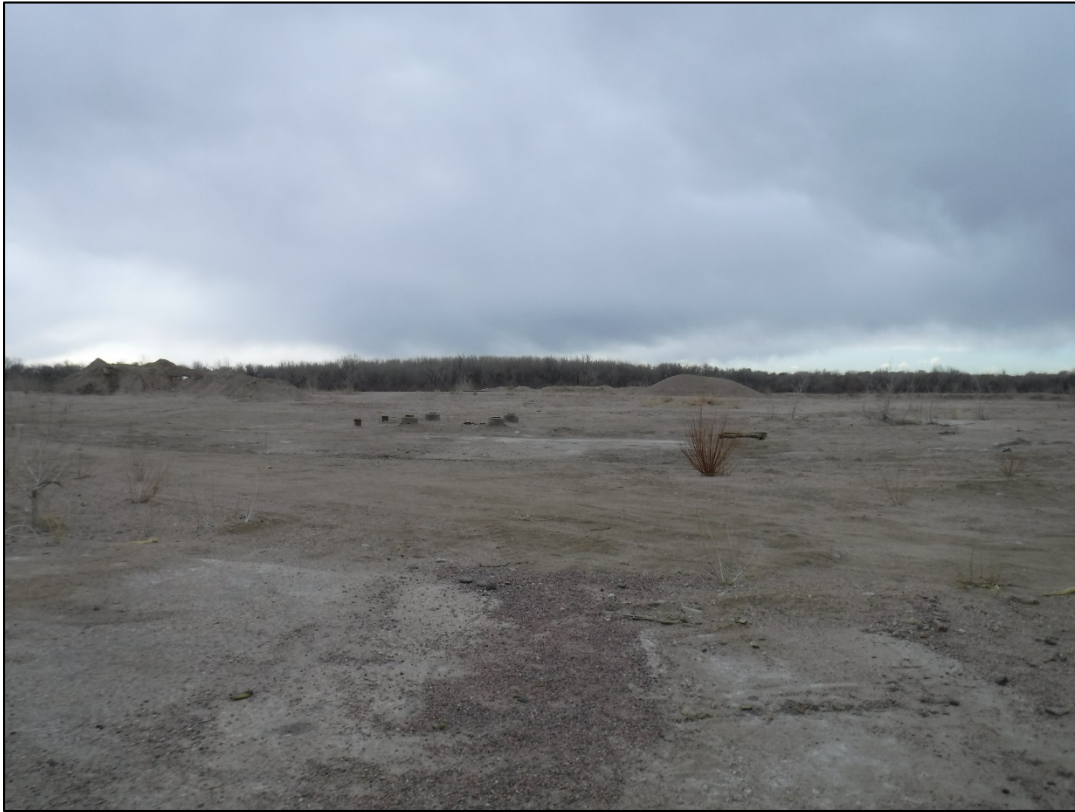
During the inspection it was noted that the processing plant and various conveyor belts observed during the last inspection have been removed from the site. While observing the outfall for Phase 7 it was discussed that the exposed groundwater in the phase no longer has lagged depletions and is covered by the current SWSP and no longer requires to be pumped down. The Division requested additional documentation and explanation of this in its third adequacy review letter. Also, the current and future augmentation of Phase 1 was requested to be clarified.

Photo 1: Former location of processing plant

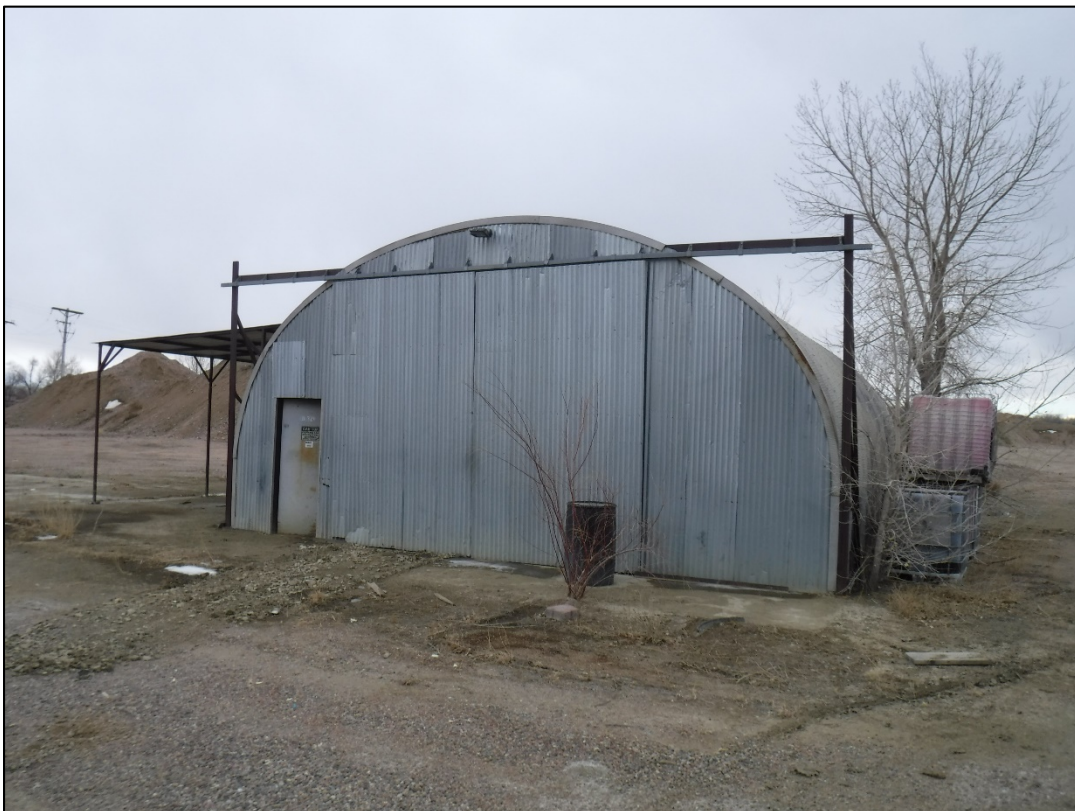
Photo 2: Quonset Hut to remain after reclamation is complete

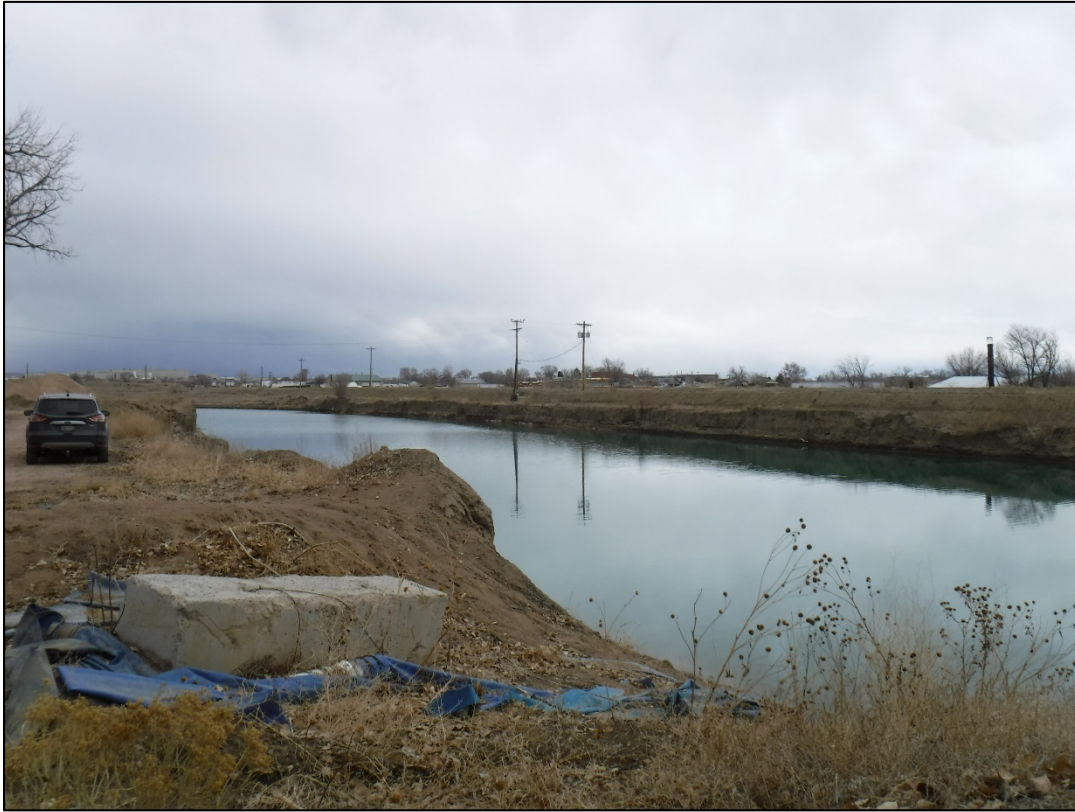
Photo 3: Phase 7 pond area where the pump island used to be

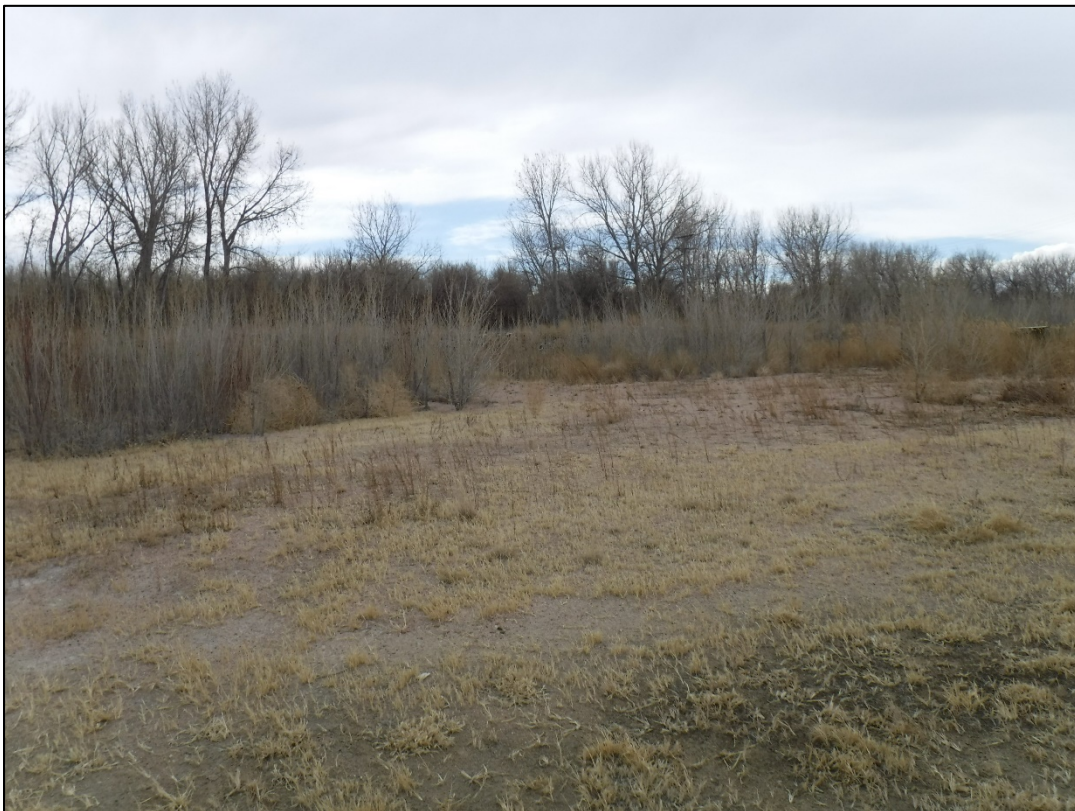
Photo 4: Native vegetation becoming established south of the Phase 7 access road

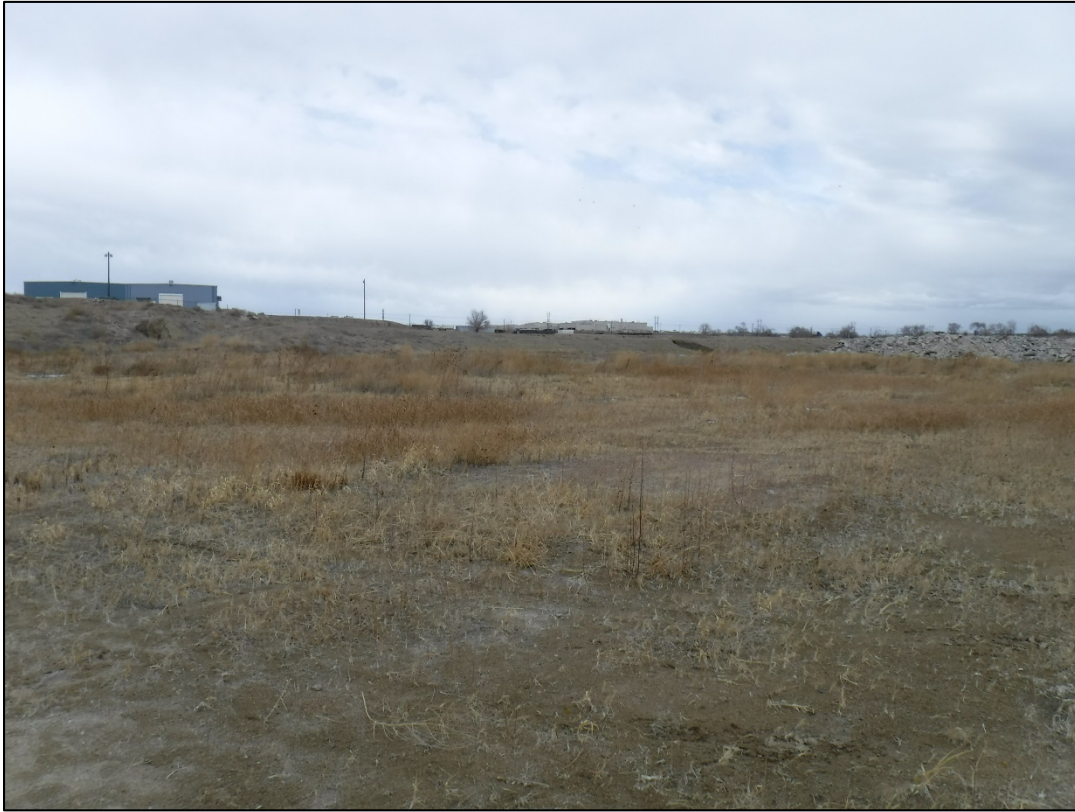
Photo 5: Vegetation conditions north of the Phase 7 access road requiring topsoil and seeding

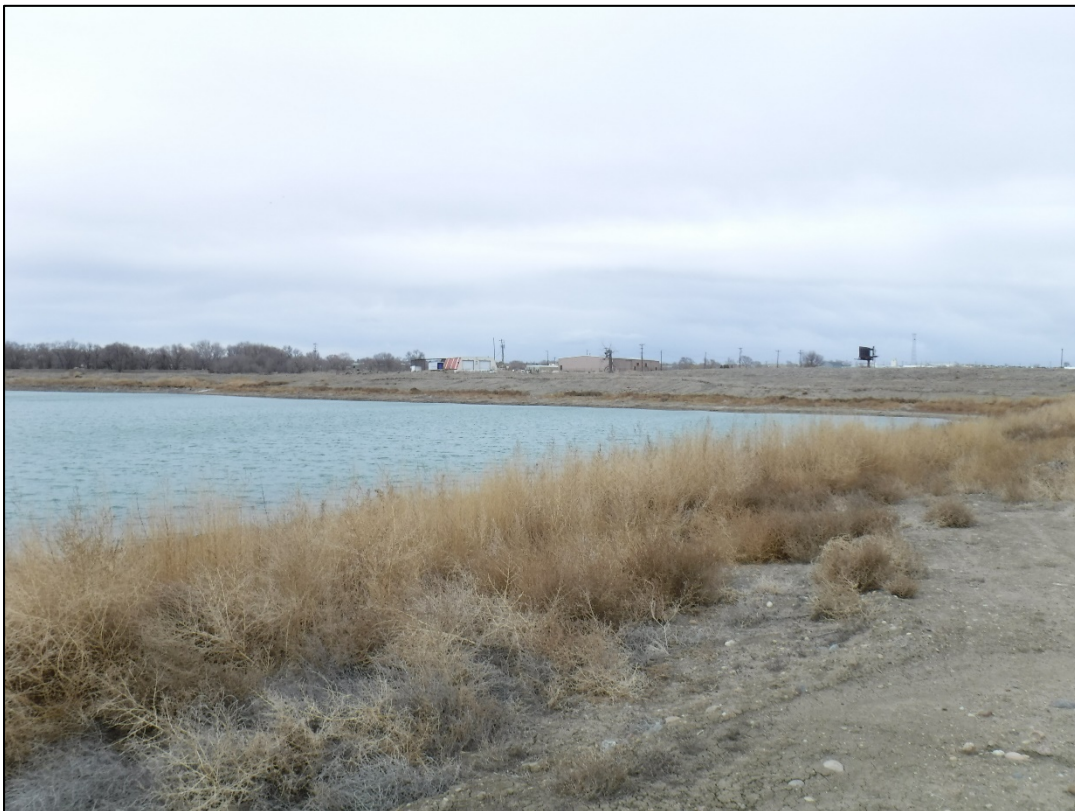
Photo 6: Phase 2 bank area requiring regrading and seeding
