MINERALS PROGRAM INSPECTION REPORT
PHONE: (303) 866-3567

MINE NAME: Gunnison River Gravel Pits	MINE/PROSPECTING ID#: M-2009-048	MINERAL: Sand and gravel	COUNTY: Mesa
INSPECTION TYPE: Monitoring	INSPECTOR(S): Amy Yeldell	INSP. DATE: March 17, 2021	INSP. TIME: 09:00
OPERATOR: CW Construction, LLC	OPERATOR REPRESENTATIVE: Cody Weaver and Kevin McClain	TYPE OF OPERATION: 112c - Construction Regular Operation	
REASON FOR INSPECTION: Priority	BOND CALCULATION TYPE: Complete Bond	BOND AMOUNT: \$91,664.00	
DATE OF COMPLAINT: NA	POST INSP. CONTACTS: DRMS	JOINT INSP. AGENCY: None	
WEATHER: Clear	INSPECTOR'S SIGNATURE:

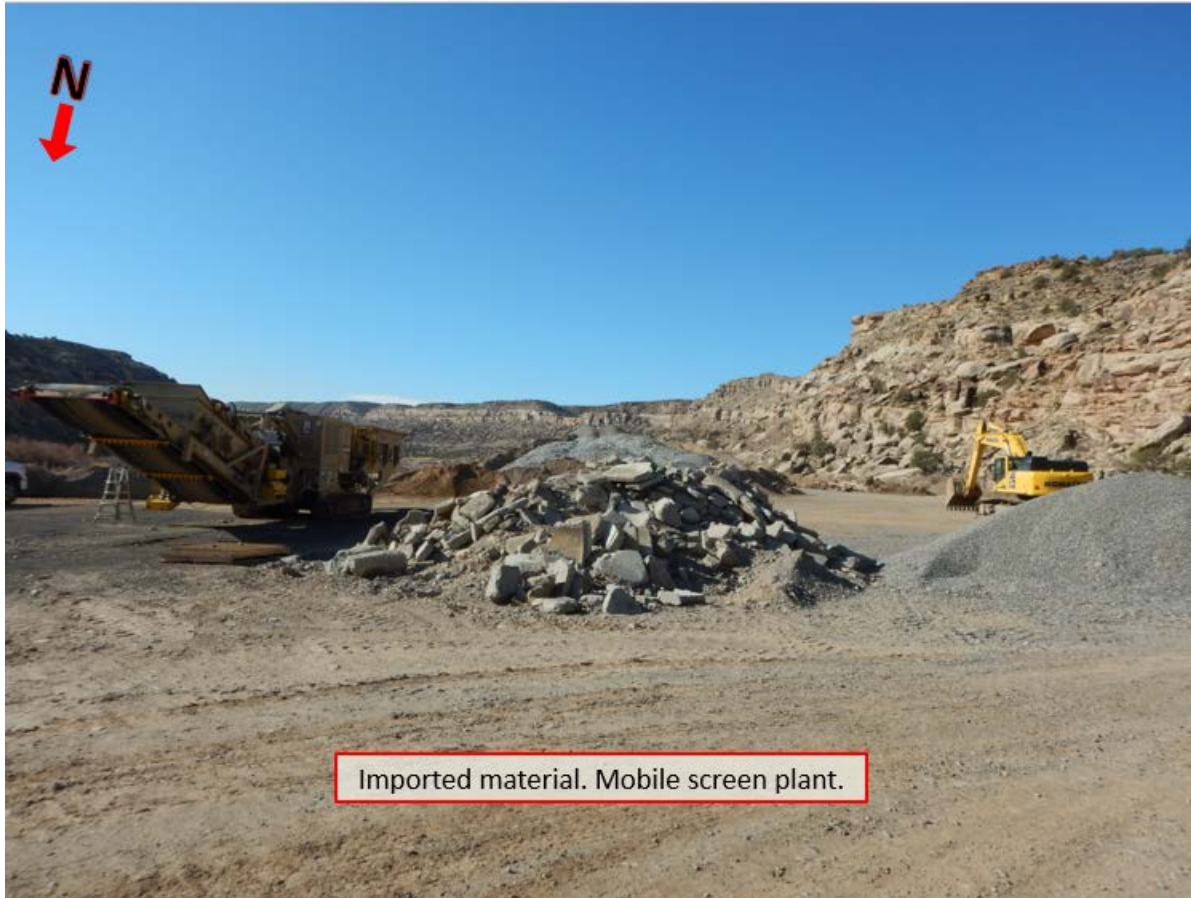
During the inspection trucks were observed importing material. In addition to the large stockpile of asphalt by the scale there are a few other small piles of cement and asphalt located within the Pit 5 area. This permit is not approved for the import of inert fill. This is cited as an inspection problem. In order to import material the operator must provide the office with notice per Rule 3.1.5 (9). The notice shall include but is not limited to: a narrative that describes the approximate location of the proposed activity; the approximate volume of inert material to be backfilled; a signed affidavit certifying that the material is clean and inert, as defined in Rule 1.1(20); the approximate dates the proposed activity will commence and end, however, such dates shall not be an enforceable condition; an explanation of how the backfilled site will result in a post-mining configuration that is compatible with the approved post-mining land use; and a general engineering plan states how the material will be place and stabilized in a manner to avoid unacceptable settling and voids." Please submit this notice in the form of a Technical Revision (TR) with the required revision fee of \$216. Alternatively the Operator may submit a written commitment to no longer import inert material until a TR is submitted and approved.

Imported material. Mobile screen plant.

CORRECTIVE ACTIONS: The Operator shall revise the mine plan to allow for the use of imported materials. Provide a notarized affidavit, stating that the fill is, in fact, inert and addressing all requirements pursuant to Rule 3.1.5(9), which describes the intended use of inert/off-site fill. This information shall be submitted in the form of a Technical Revision with the required \$216 revision fee by the corrective action date.

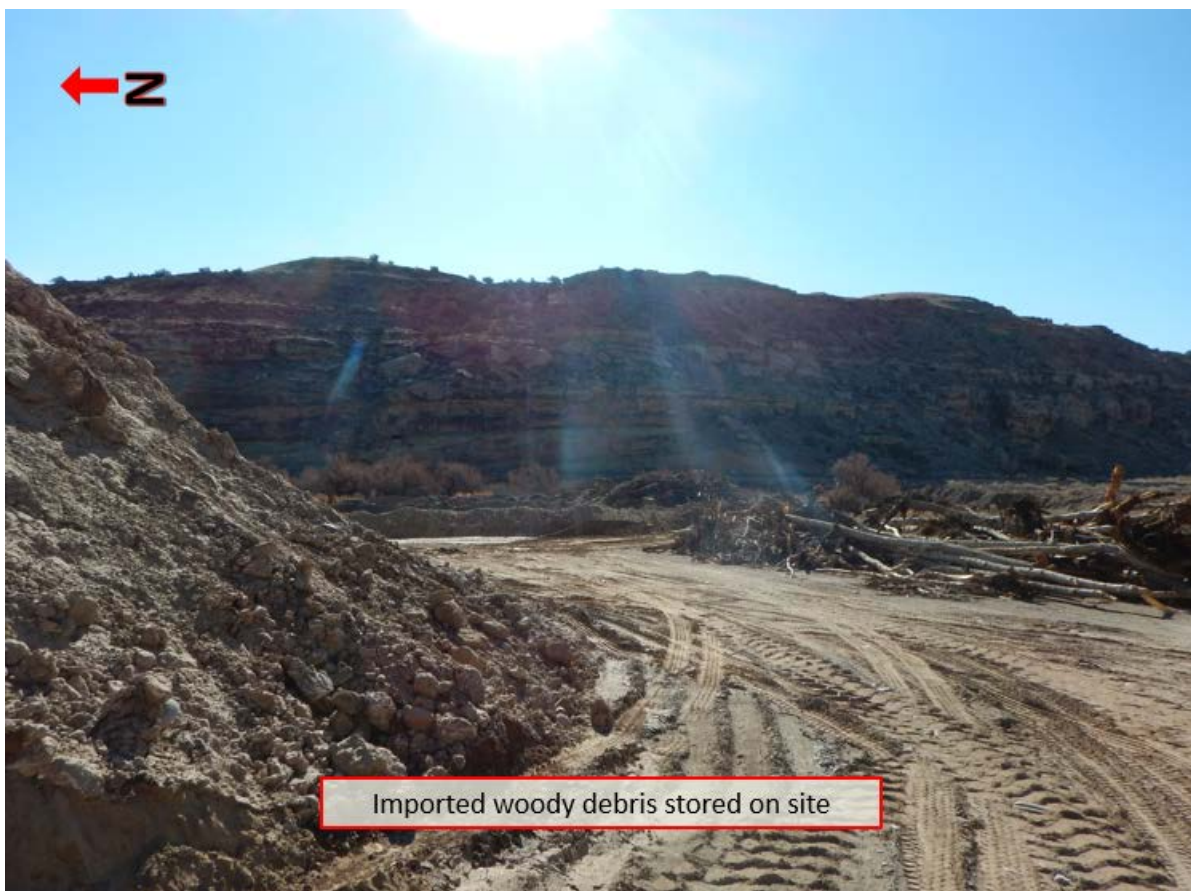
Imported woody debris is stockpiled to the south and west of the new pit. The Operator is reminded that if woody debris is buried whole it could result in voids once it degrades leading to settling issues later on. Material should either be broken down if buried or placed whole above grade to provide micro-niches for plants and animals.

Imported woody debris stored on site
