**MINERALS PROGRAM INSPECTION REPORT**  
**PHONE: (303) 866-3567**

<b>MINE NAME:</b> Riverbend Operation	<b>MINE/PROSPECTING ID#:</b> M-2000-016	<b>MINERAL:</b> Sand and gravel	<b>COUNTY:</b> Weld
<b>INSPECTION TYPE:</b> Monitoring	<b>INSPECTOR(S):</b> Peter Hays	<b>INSP. DATE:</b> March 24, 2021	<b>INSP. TIME:</b> 10:00
<b>OPERATOR:</b> Martin Marietta Materials, Inc.	<b>OPERATOR REPRESENTATIVE:</b> Julie Mikulas	<b>TYPE OF OPERATION:</b> 112c - Construction Regular Operation

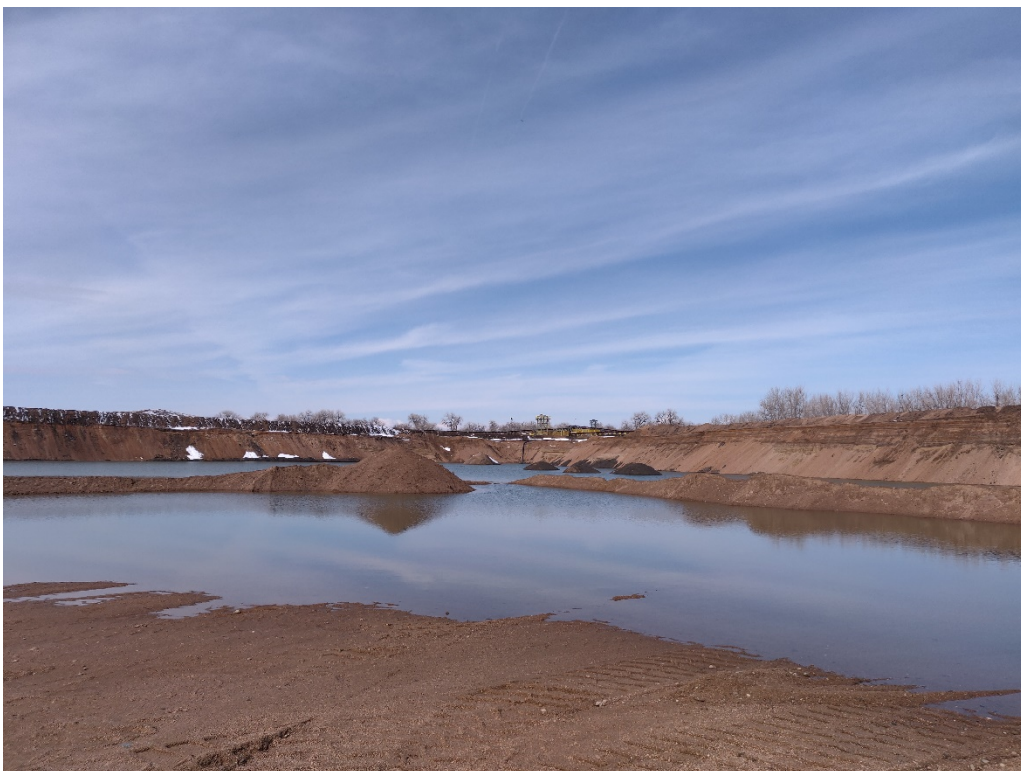
**PROBLEM:** On March 20, 2021, a backhoe operating in the north portion of Cell 1 ruptured a hydraulic line releasing 20-25 gallons of hydraulic fluid into the dewatering trench in the cell.

The area of the spill and the discharge point for the cell were observed during the inspection. The spill location was covered by a shallow pond of water due to the dewatering pump being turned off since the spill occurred. The water in the location of the spill was clear and no oil sheen was observed by the Division. The Operator reported the pumps were turned back on the morning of the inspection. Water was observed being discharged at the dewatering location during the inspection into the South Platte River.

View of the approx. location of the hydraulic fluid spill in the north portion of Cell 1  
(to the right of the mound in the middle of the picture)

**CORRECTIVE ACTIONS:** The Division will require the Operator to collect water quality samples during the next scheduled discharge permit sampling event and test the samples for BTEX and oil & grease. The results of the tests must be sent to the Division by the corrective action date.

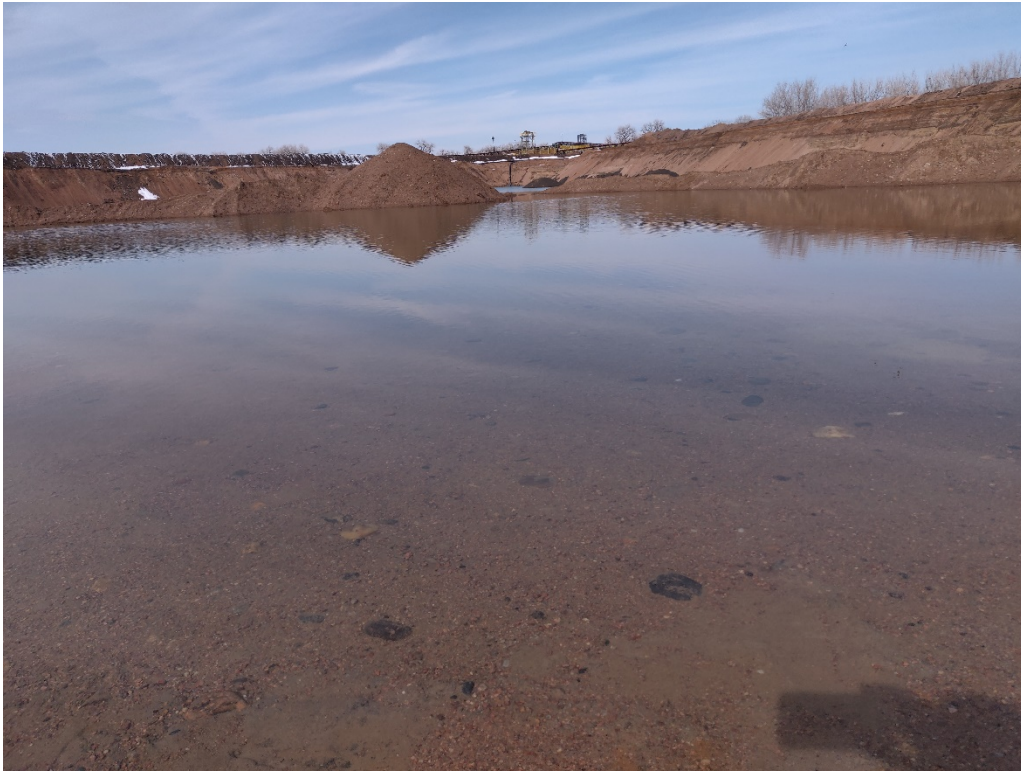
View of the water surface in the location of the spill

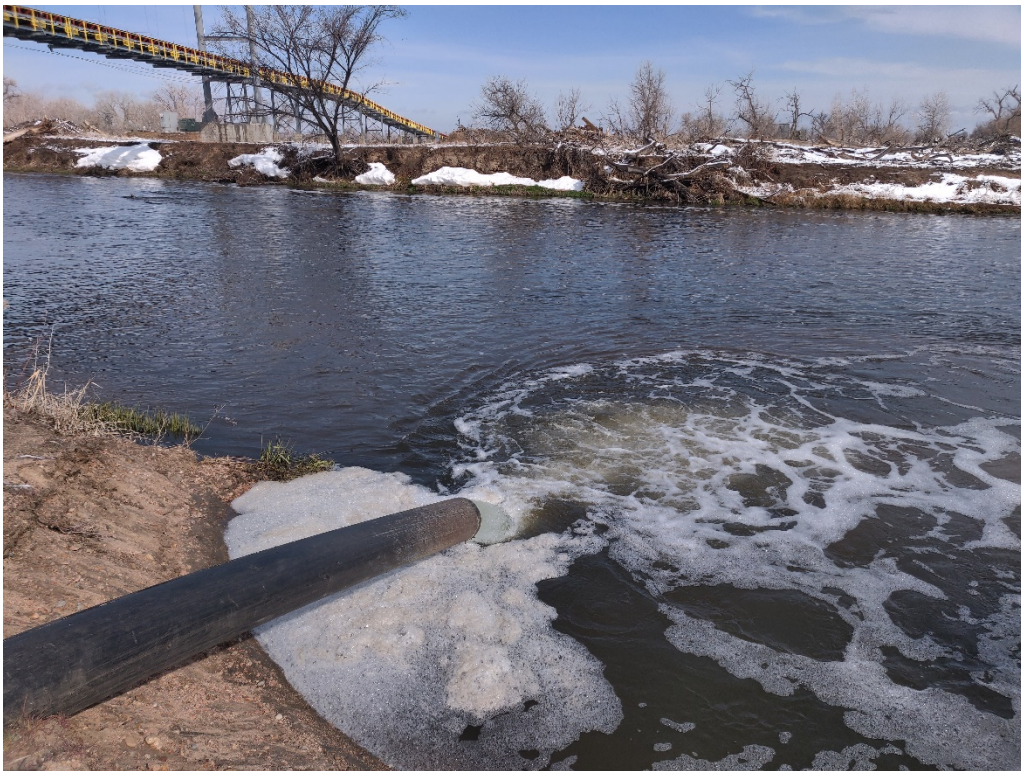
View of the discharge location from Cell 1 into the South Platte River

The Operator is required to sample the discharge water for suspended solids by CDPHE twice a month. As cited as a problem above, the Division will require the Operator to sample the discharge water and test the water for Benzene, Toluene, Ethyl Benzene and Xylenes (BTEX) and oil & grease (sheen) during the next scheduled sampling event. The Operator agreed to perform the testing during the inspection. The Operator stated the next sampling would occur the first week of April. The results of the testing must be reported to the Division by the corrective action date.
