## Inspection report from yesterday

**PERMIT INFORMATION**

<b>Permit Number:</b> C-1981-028 <b>Mine Name:</b> Keenesburg Strip Mine <b>Operator:</b> Coors Energy Company <b>Operator Address:</b> Mr. Ben Moline PO Box 4030 Golden, CO 80402	<b>County:</b> Weld <b>Operation Type:</b> Surface <b>Permit Status:</b> Permanent Cessation <b>Ownership:</b> Private
	<b>Operator Representative Present:</b>  None
<b>Operator Representative Signature:</b> (Field Issuance Only)

<b>Inspection Start Date:</b> March 25, 2021 <b>Inspection Start Time:</b> 09:45 <b>Inspection End Date:</b> March 25, 2021 <b>Inspection End Time:</b> 11:15		<b>Inspection Type:</b> Coal Partial Inspection <b>Inspection Reason:</b> Normal I&E Program <b>Weather:</b> Cloudy	
<b>Joint Inspection Agency:</b>  None		<b>Joint Inspection Contacts:</b>  	
<b>Post Inspection Agency:</b>  None		<b>Post Inspection Contacts:</b>  	
<b>Inspector(s):</b>  Robert Zuber, P.E.	<b>Inspector's Signature:</b>  <i>Robert D. Zuber</i>		<b>Signature Date:</b>  3/26/2021

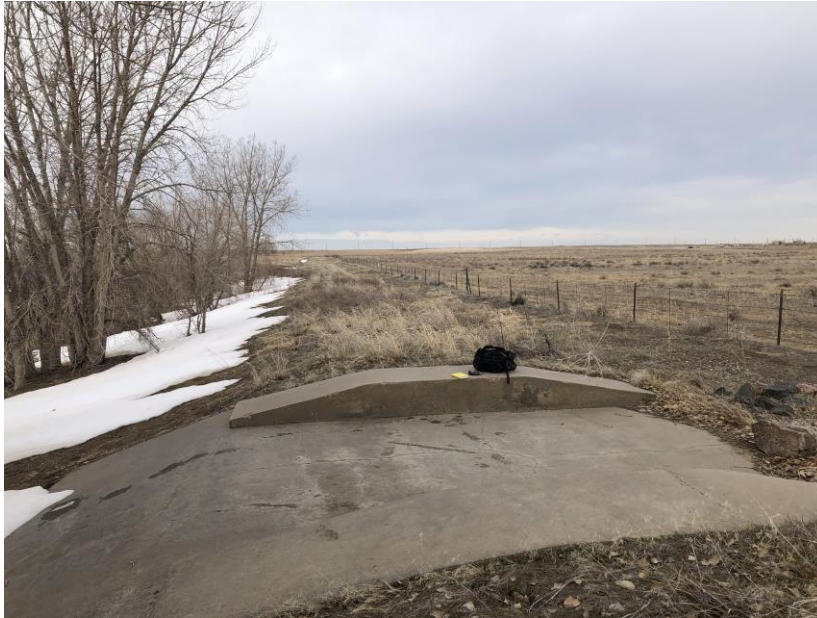
Both Sediment Pond 2 and the Dugout Pond contained small amounts of water. Neither pond was discharging during the inspection. There were no signs that they had discharged recently. As usual, they both contained large amounts of riparian vegetation. No problems were observed with the two ponds.

The northern boundary of the site (including the ditch to Sediment Pond 2) was observed, and no signs of pollutant loading from the mine site, or any other problems, were seen.

**Sediment Pond 2 and north boundary**

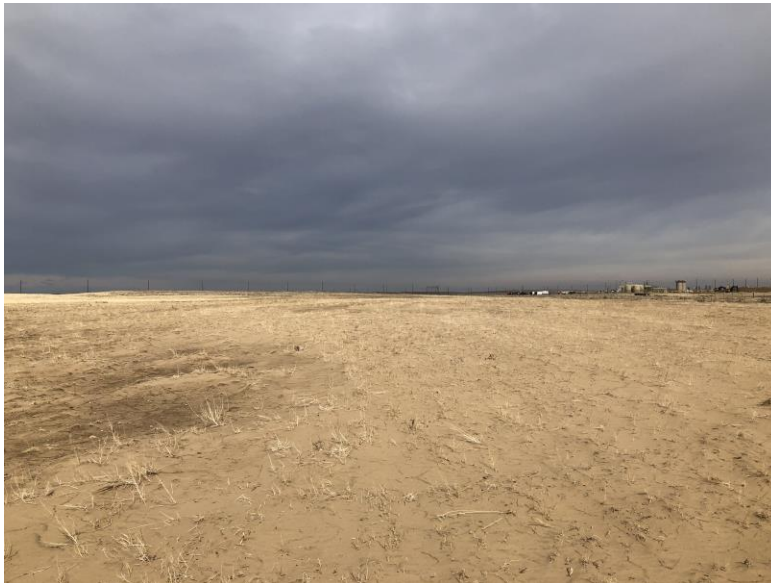
**Area 37 (former topsand storage area)**

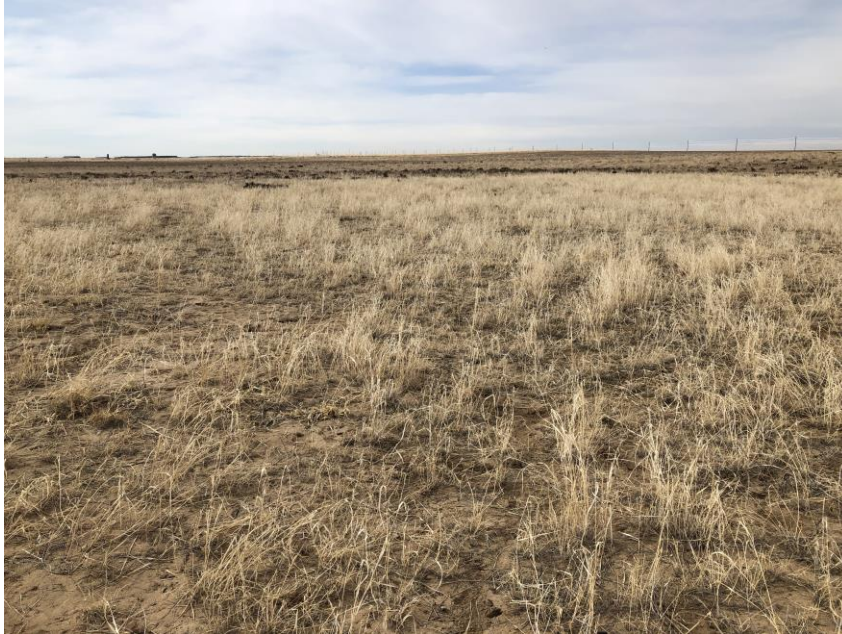
**Dormant vegetation in northwest portion of Long Term Spoil area (looking south)**

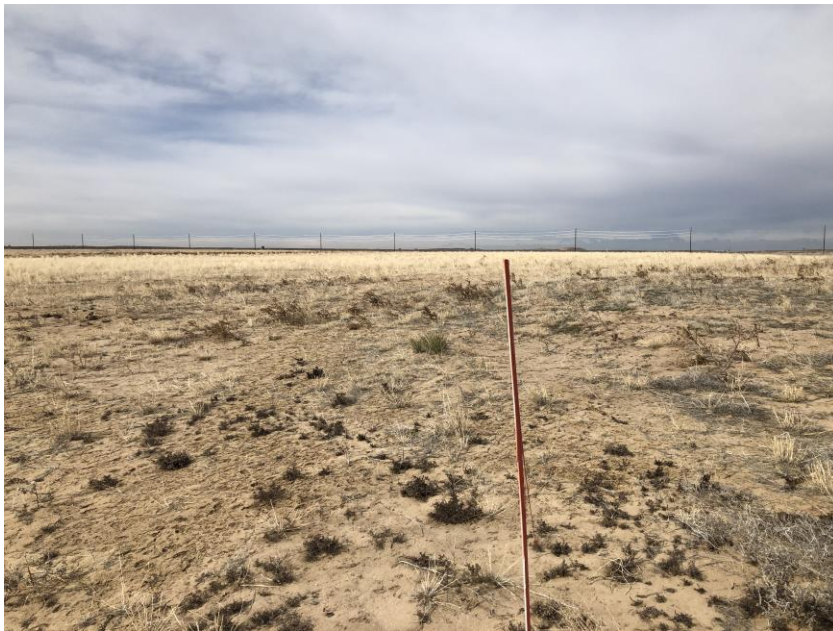
**Northeast corner of B Pit (looking southwest)**

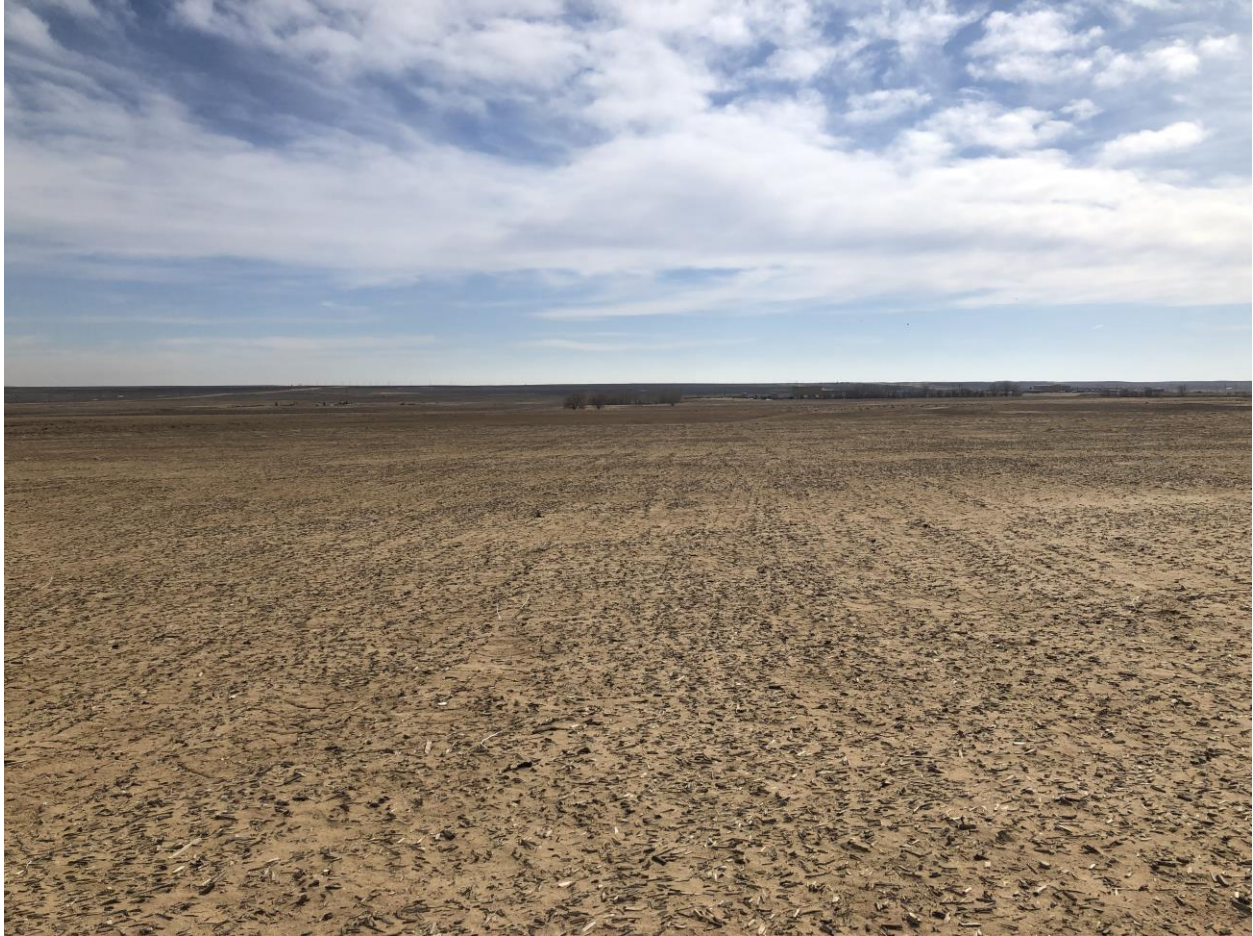
No problems were seen at the facilities area. The yard was being used by a third party. This was approved by Coors Energy, as noted in past inspections.

**Looking east towards facility area from B Pit with Long Term Spoil area in center of photo**

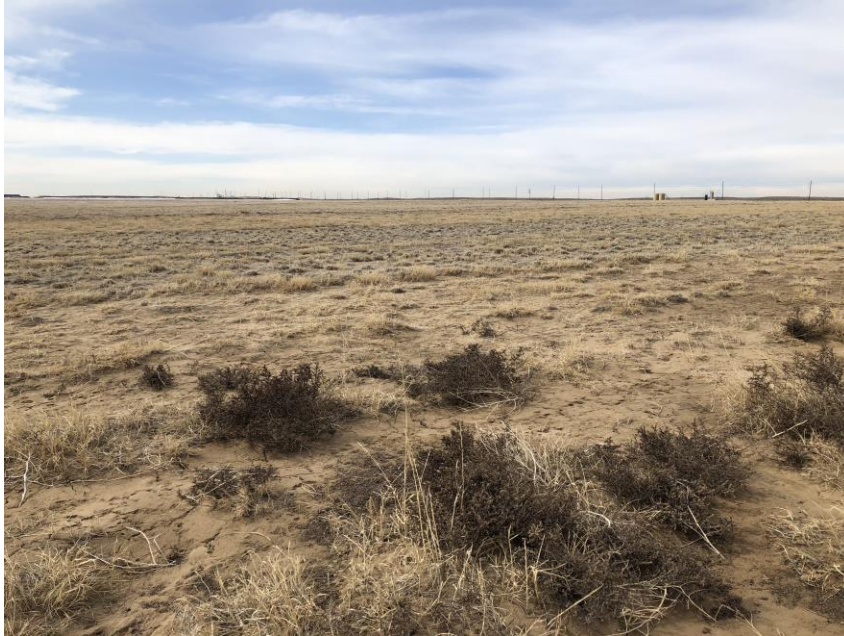
The southwest corner was viewed from afar (a location a few feet south of B Pit), and no problems were identified. The vegetation cover in Area 32 is very good and consistent with past months.

**Southwest corner of site, looking south (Area 32 in foreground)**

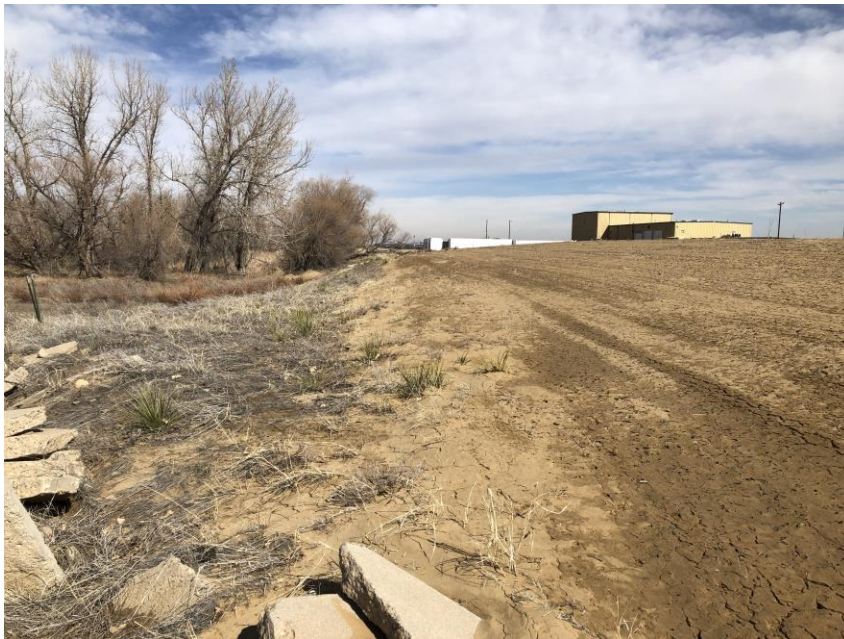
**Dugout Pond on left and reclaimed topsand storage area on right**
