MINERALS PROGRAM INSPECTION REPORT
PHONE: (303) 866-3567

MINE NAME: Silt Pit	MINE/PROSPECTING ID#: M-1981-202-SG	MINERAL: Sand and gravel	COUNTY: Garfield
INSPECTION TYPE: Monitoring	INSPECTOR(S): Amy Yeldell	INSP. DATE: March 22, 2021	INSP. TIME: 09:00
OPERATOR: Flag Resources Inc	OPERATOR REPRESENTATIVE: Eric Frie	TYPE OF OPERATION: 112c - Construction Regular Operation	
REASON FOR INSPECTION: Normal I&E Program	BOND CALCULATION TYPE: Complete Bond	BOND AMOUNT: \$264,210.00	
DATE OF COMPLAINT: NA	POST INSP. CONTACTS: DRMS	JOINT INSP. AGENCY: None	
WEATHER: Clear	INSPECTOR'S SIGNATURE:

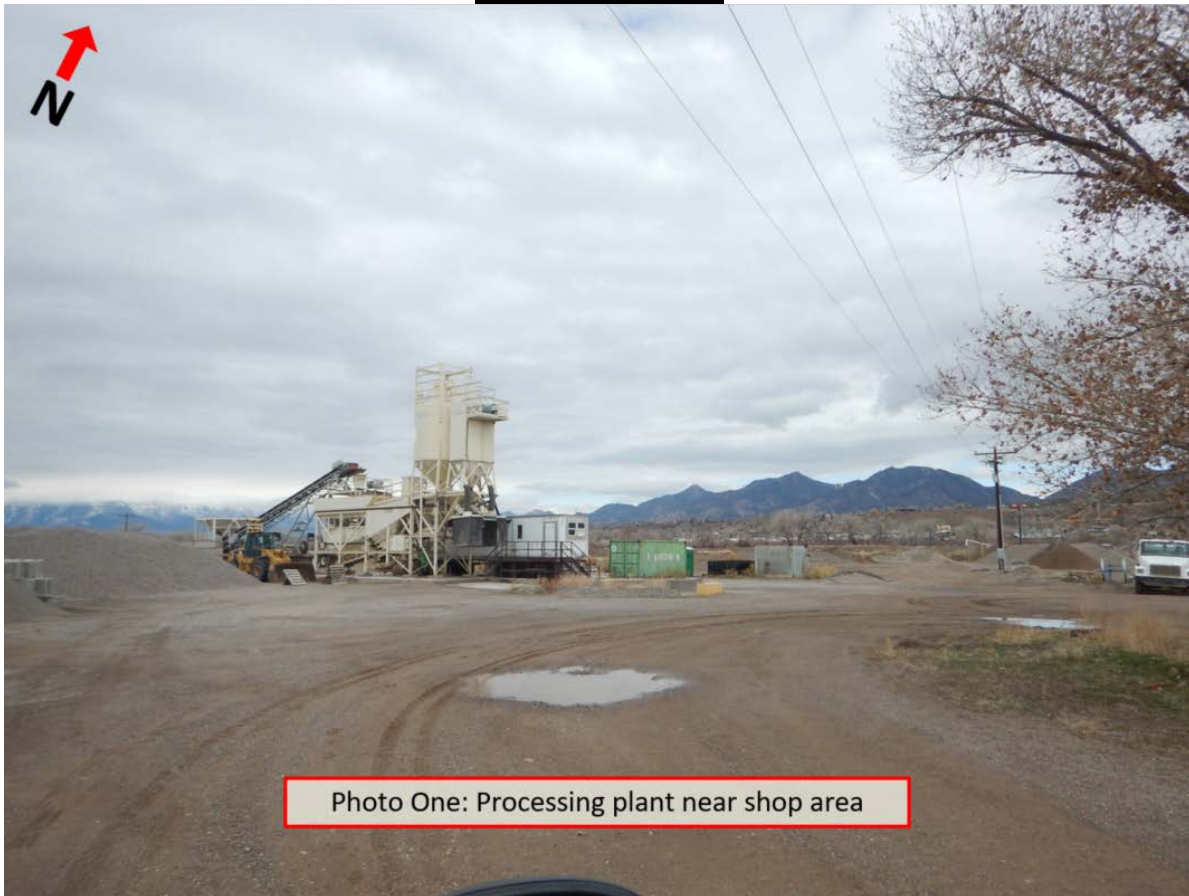
The site was active at the time of the inspection. There were several processing plants and pieces of heavy equipment located throughout the site. Fuel is located in a cement secondary containment structure. Several buildings are located within the permit. The leased cement batch plant remains on site though it was inactive at the time of the inspection.

Photo One: Processing plant near shop area

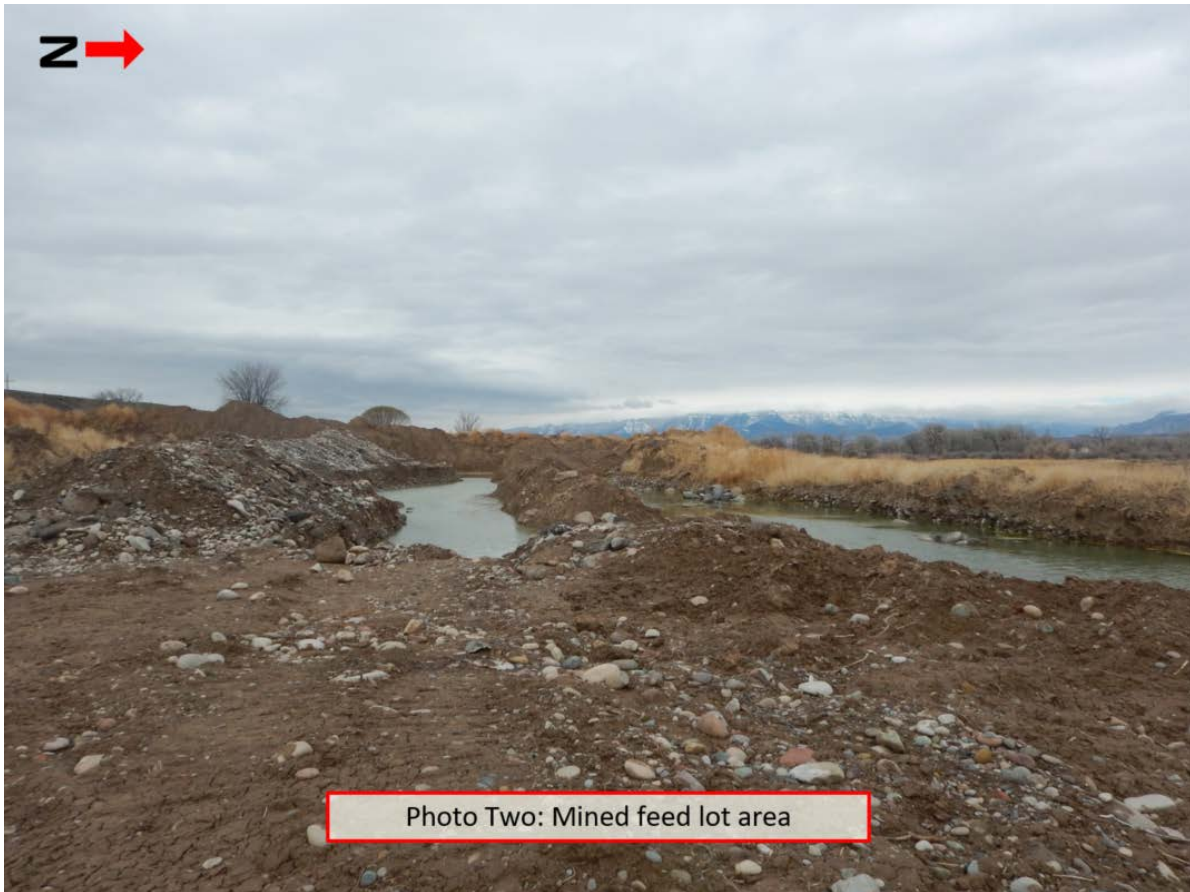
Last year the Operator also mined the feed lot area which is approximately 6 acres. Material in this area is poor. The operator intends to remove the remaining pit run and then begin final reclamation. The area should be contoured and ready for seed this fall.

Photo Two: Mined feed lot area

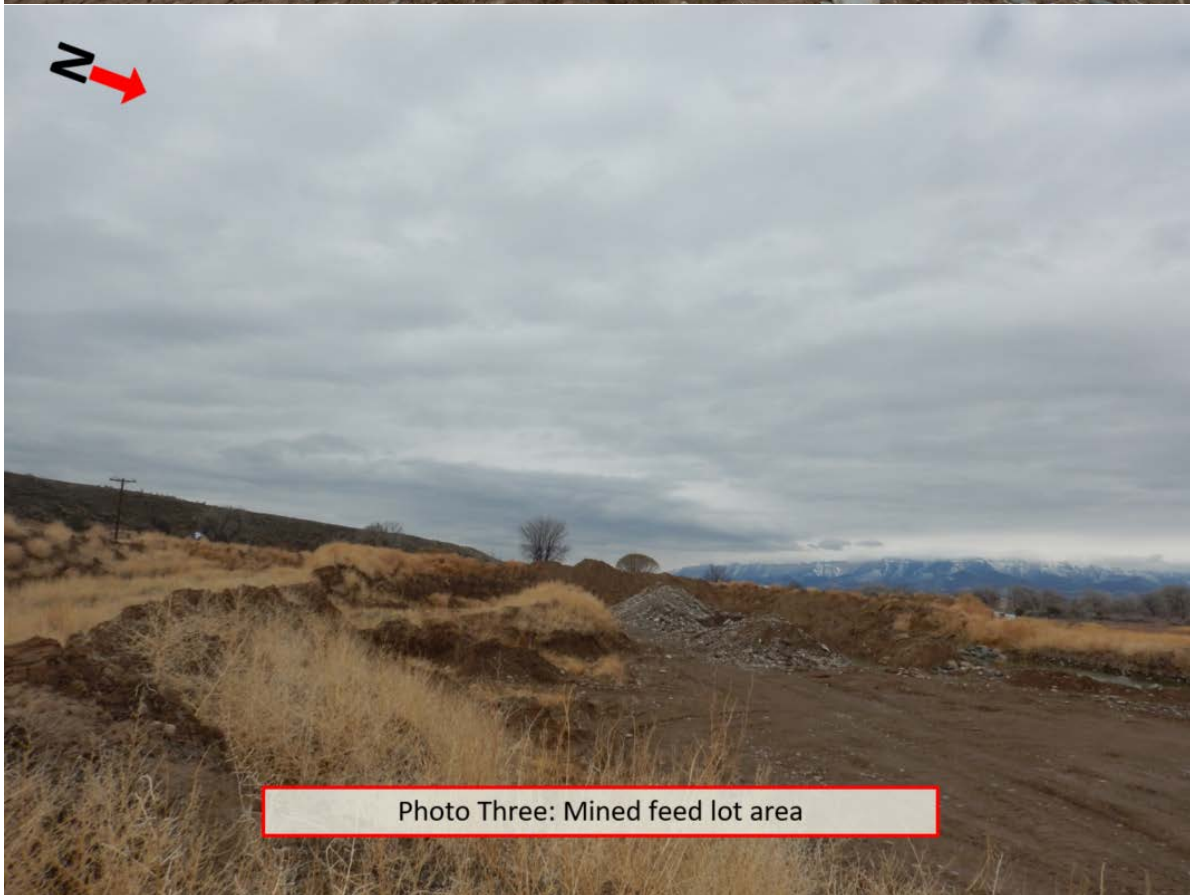
Photo Three: Mined feed lot area

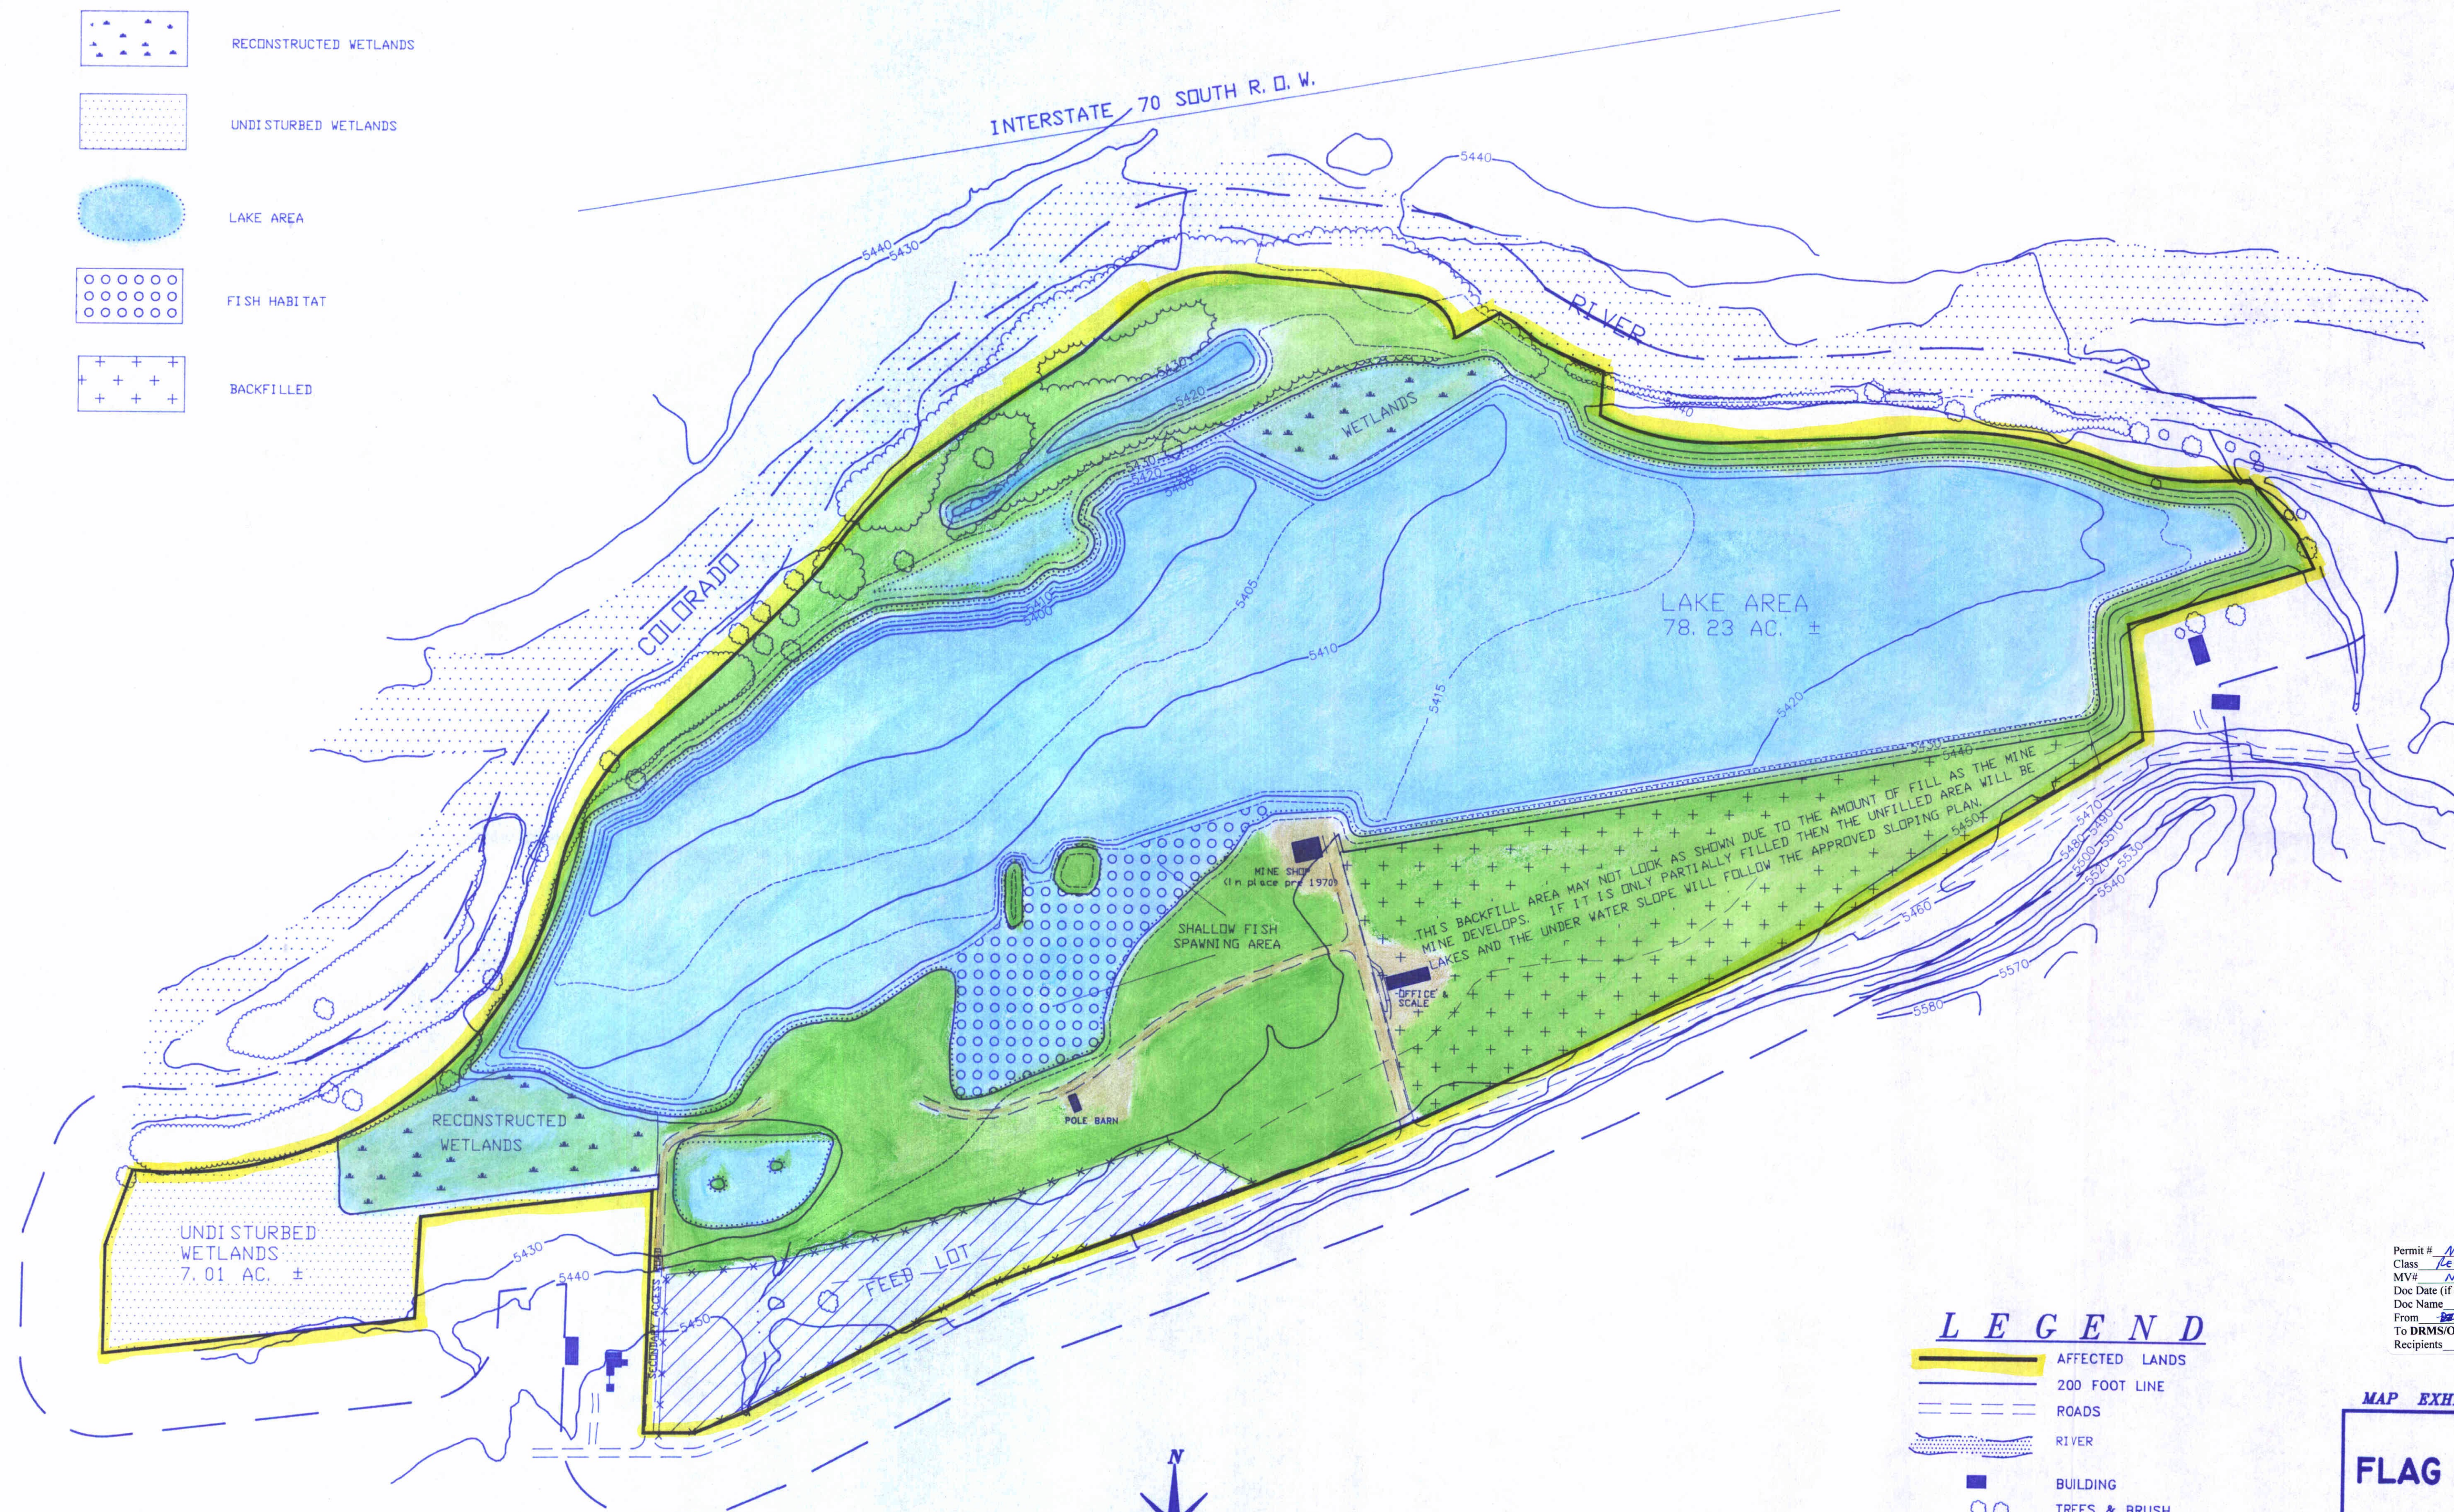
MAP EXHIBIT F

As the site nears final reclamation the reclamation plan and map will likely need to be updated to reflect the as-built site conditions. The Division has attached the current reclamation plan map as last revised under TR-4. Per TR-4 the mine office, shop and two pole barns are all permitted to stay post mining. The map also shows limited graveled roads and parking areas. Currently there are several roads, graveled storage areas and

structures that are present that are not on the final reclamation plan. Many of these features support the post-mining land use of recreation however prior to reclamation being released the operator needs to revise the reclamation plan and map to match site conditions.
