**MINERALS PROGRAM INSPECTION REPORT**  
**PHONE: (303) 866-3567**

<b>MINE NAME:</b> Goldman Gravel Pit	<b>MINE/PROSPECTING ID#:</b> M-1978-279	<b>MINERAL:</b> Gravel	<b>COUNTY:</b> Garfield
<b>INSPECTION TYPE:</b> Monitoring	<b>INSPECTOR(S):</b> Amy Yeldell	<b>INSP. DATE:</b> March 22, 2021	<b>INSP. TIME:</b> 10:30
<b>OPERATOR:</b> Flag Resources Inc	<b>OPERATOR REPRESENTATIVE:</b> Eric Frei	<b>TYPE OF OPERATION:</b> 110c - Construction Limited Impact	
<b>REASON FOR INSPECTION:</b> Normal I&E Program	<b>BOND CALCULATION TYPE:</b> Complete Bond	<b>BOND AMOUNT:</b> \$20,408.00	
<b>DATE OF COMPLAINT:</b> NA	<b>POST INSP. CONTACTS:</b> DRMS	<b>JOINT INSP. AGENCY:</b> None	
<b>WEATHER:</b> Clear	<b>INSPECTOR'S SIGNATURE:</b>

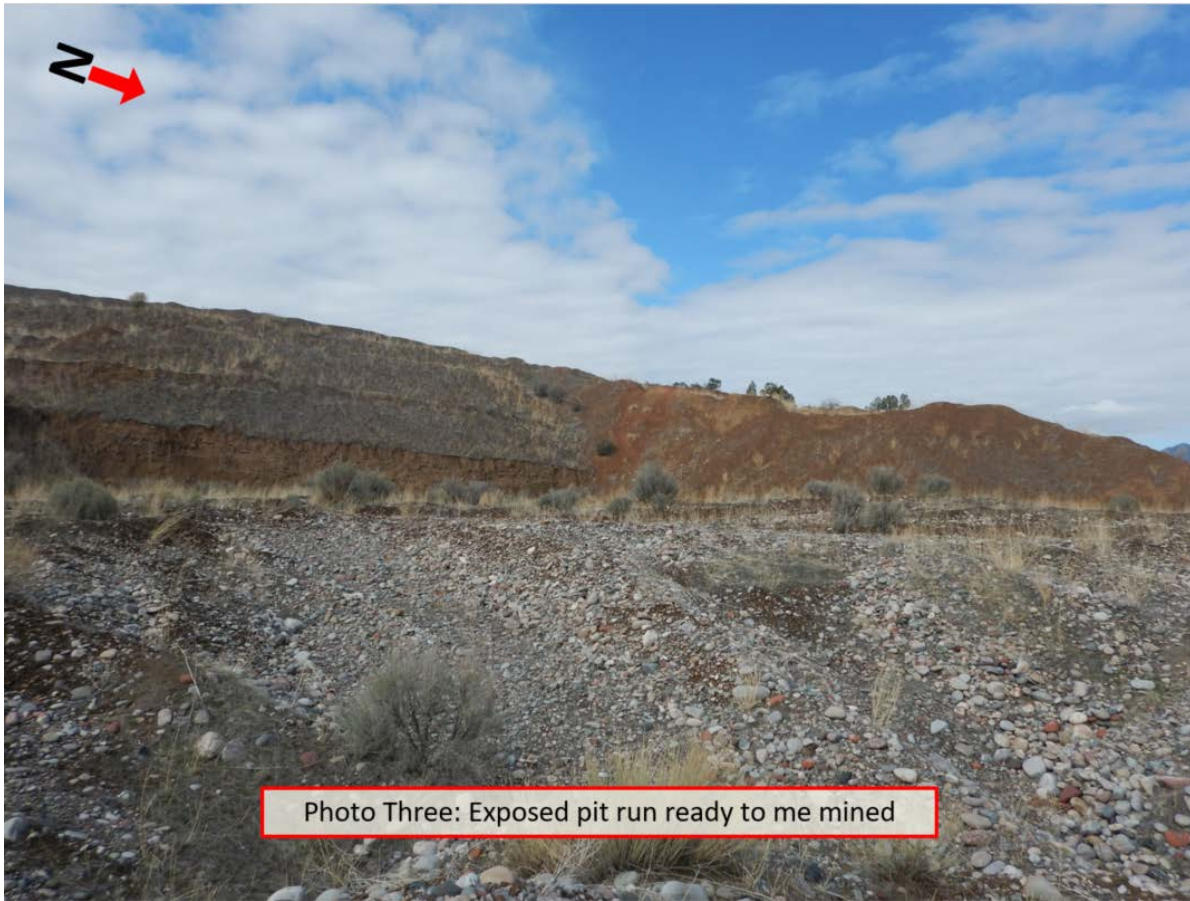
The adjacent gas pad is scheduled to be reduced in size this spring which will allow the pit more working room. Mining is anticipated to resume in April 2021. Exposed pit run will be pushed down the slope to be processed on site. After pad reconstruction finalizes there will be enough room to strip overburden and access new material. The existing highwall conditions have not changed since the previous inspection. The slope is mostly graded to a 3:1 with some interstitial benches. The main pit floor to the top of the cut is approximately 70 ft. Slopes appear to be stable with minimal erosion. The slope that daylights to the north will be the last area mined to retain the visual berm as long as possible.

Photo Three: Exposed pit run ready to be mined

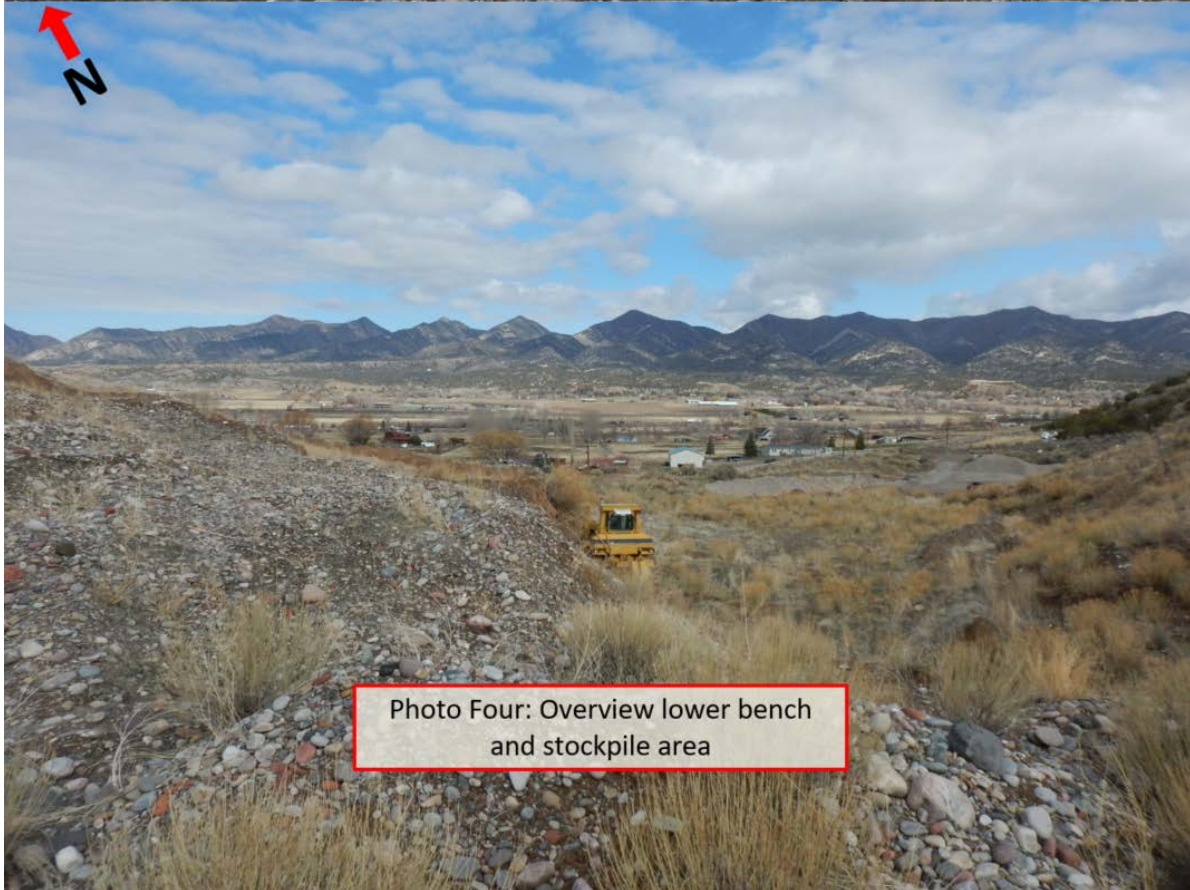
Several smaller stockpiles of processed material are located on the main bottom pad area. A dozer is on site, no other equipment, structures or fuel is present at this time.

Photo Four: Overview lower bench  
and stockpile area
