**NEW ELK MINE**  
**Permit No. C-1981-012**

**QUARTERLY COAL WASTE BANK INSPECTION REPORT**  
**March 17, 2021**

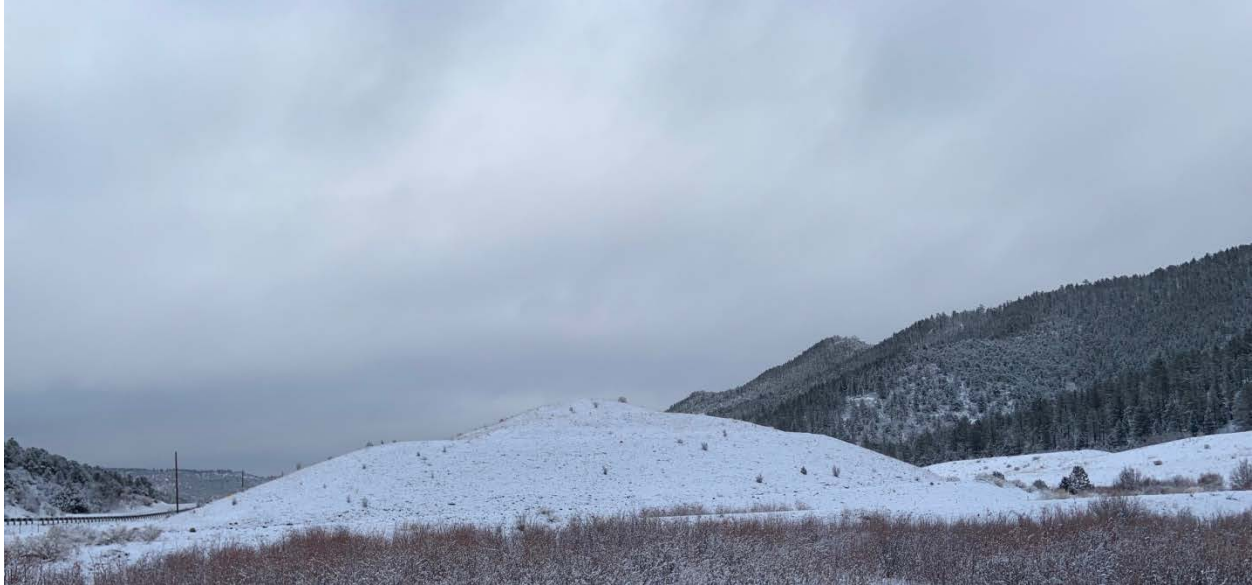
Surface and out slopes of the pile were inspected for visible signs of potential failure or instability. None were observed.

Overall the disposal area is in good condition.

**DWDA #1 – West Facing Slope**

None at this time.

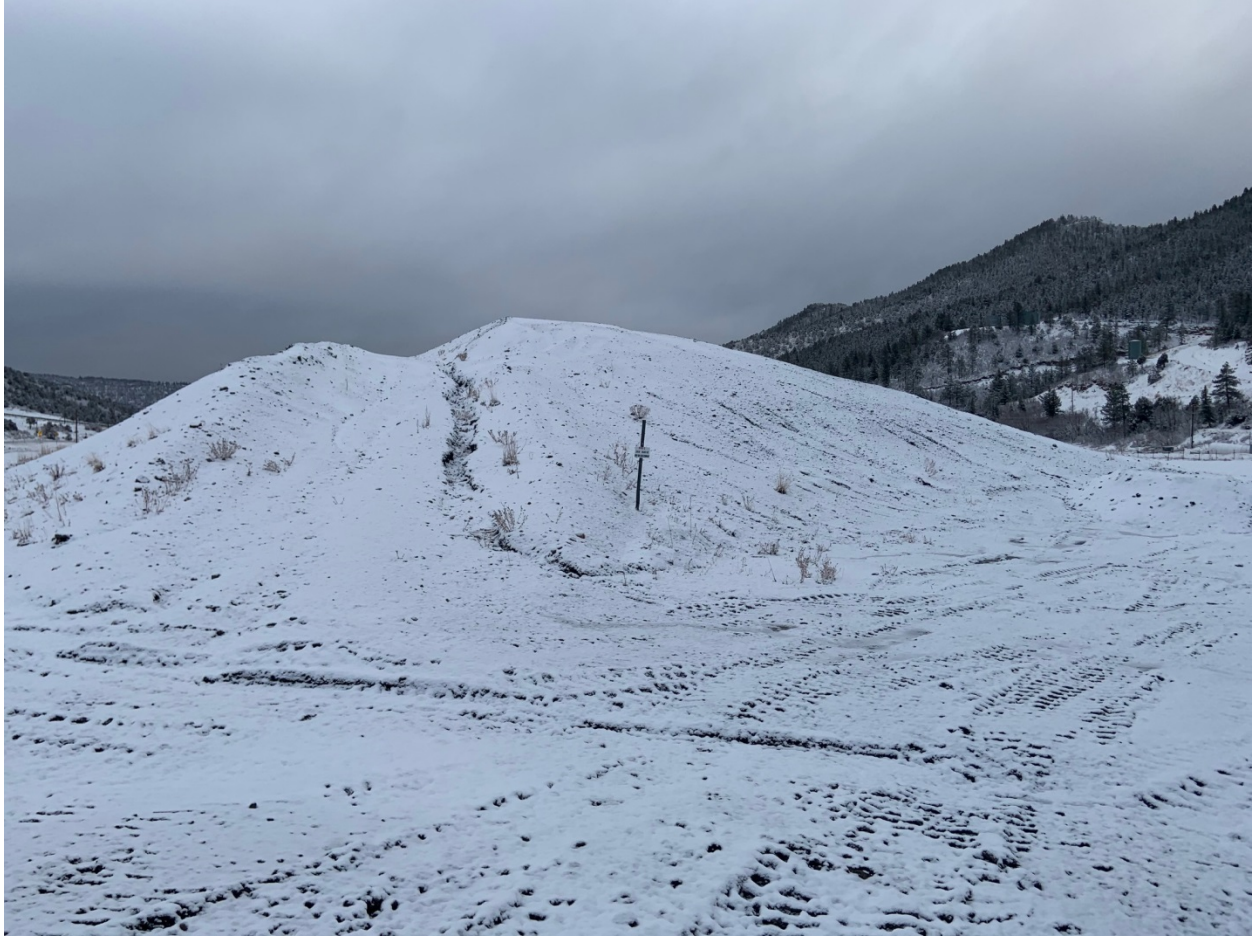
Positive Drainage is maintained on the surface of the DWDA. Sump on East end of pile was recently cleaned and is in good working order. Rills on the disposal area are being monitored. No evidence of springs nor seeps were observed.

Surface and out slopes of the pile were inspected for visible signs of potential failure or instability. There was some surface erosion but not enough to make the area unstable. In all no signs of failure or instability were observed.

Overall the disposal area is in good condition. The sign with the name of the area was recently replaced.

**DWDA #2 – West Facing Slope**

The Rills are being monitored and have not gotten any bigger and there is no sediment loading. Operator is evaluating either reclamation of the area or permitting alternative uses of the land north of the Purgatoire River and south of Highway 12.

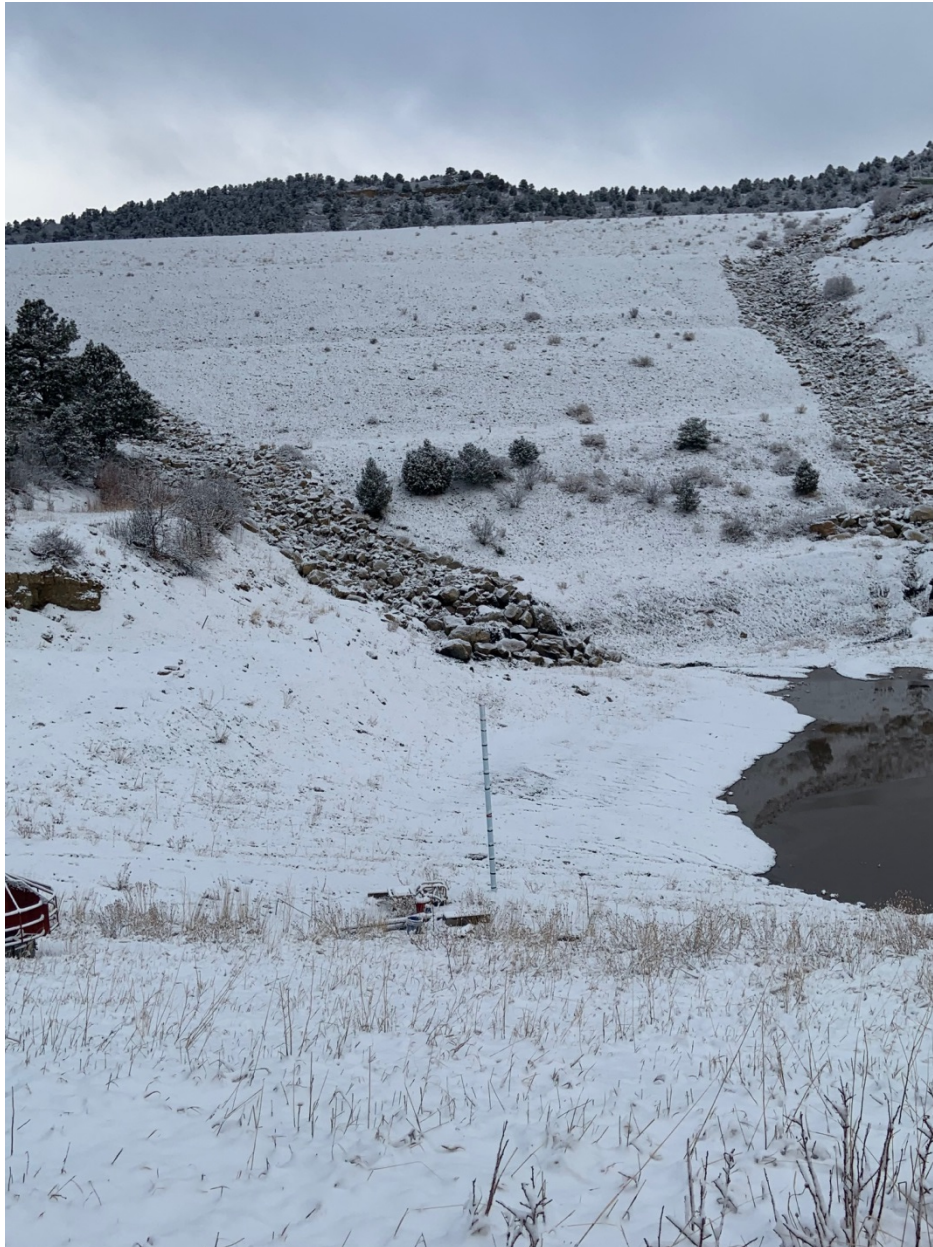
Positive Drainage is maintained on the surface of the RDA. Sumps on top of the RDA have been recently cleaned. There is no ponding on the top of the pile. No evidence of springs nor seeps were observed.

Overall the site is in good condition.

**Refuse Disposal Area – Reclaimed Benches and Armored Drainage**

None required at this time.
