QUARTERLY SEDIMENTATION POND INSPECTION REPORT

CDMR Rule 4.05.9(17)

Mine: New Elk

Inspection Period: First Quarter 2021

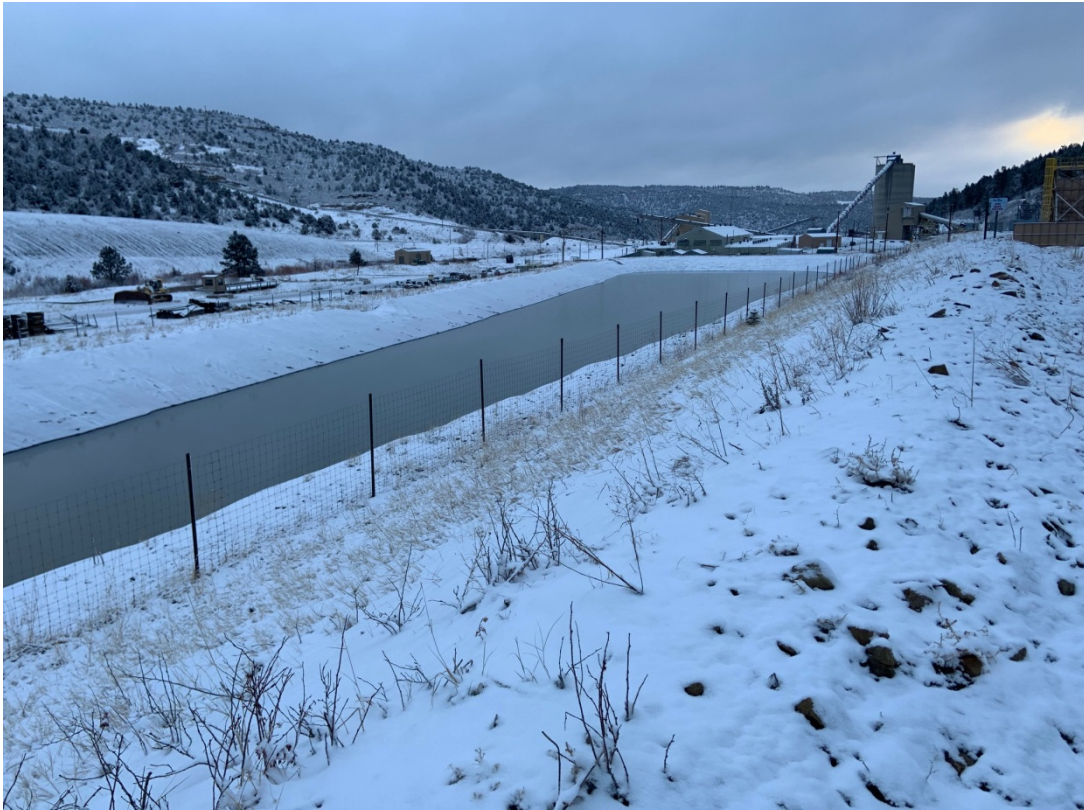
Pond 1

Pond liner is in good working condition at time of inspection. Pond was holding water at time of

Inspection. Mine dewatering in the Bates Portal is currently underway so the water level is rising

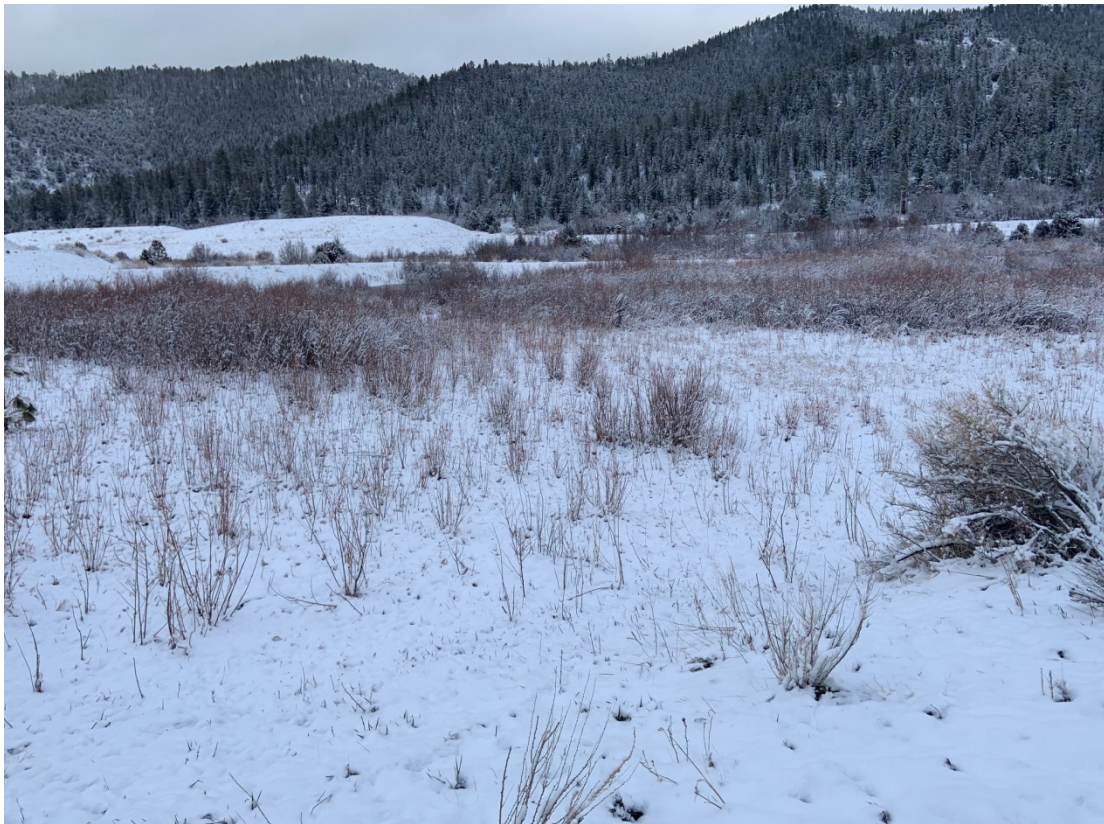
Pond 4

Pond is holding very little amount water but is not close to discharging.

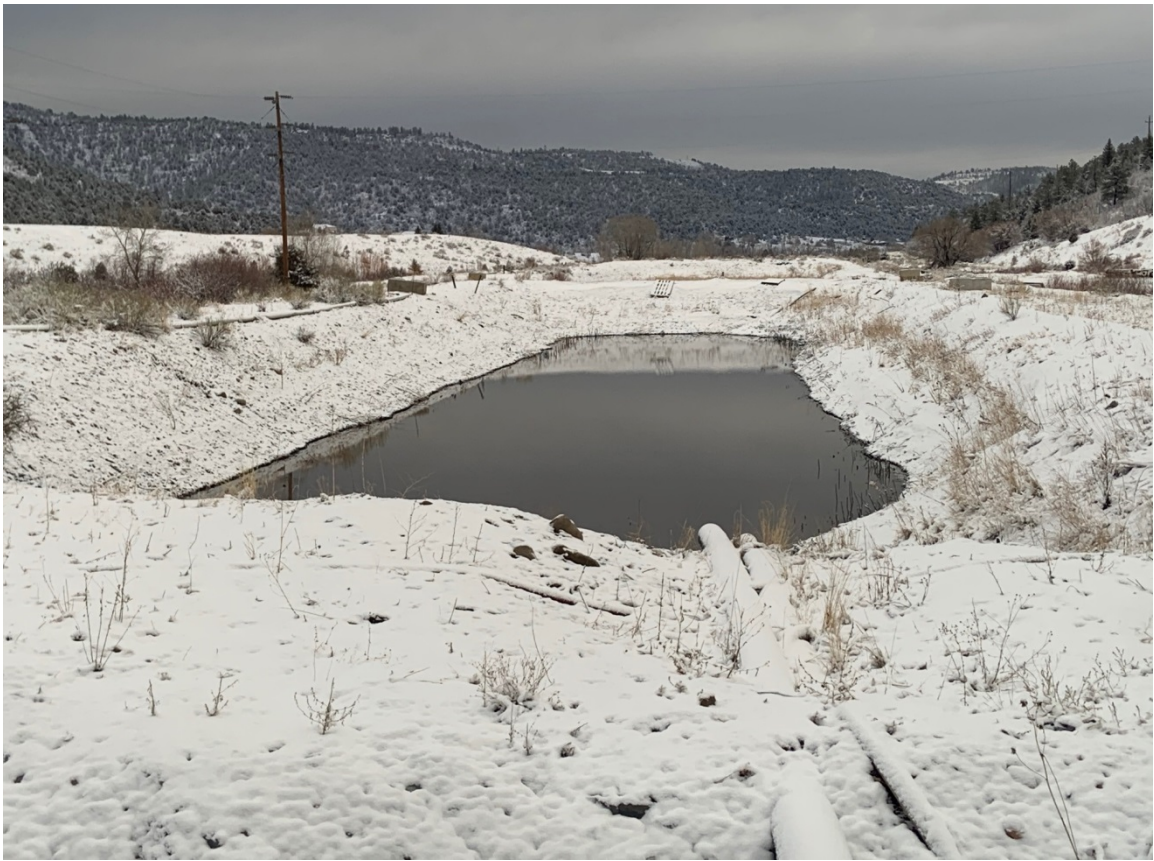
Pond 6

Pond is holding water, not close to full.

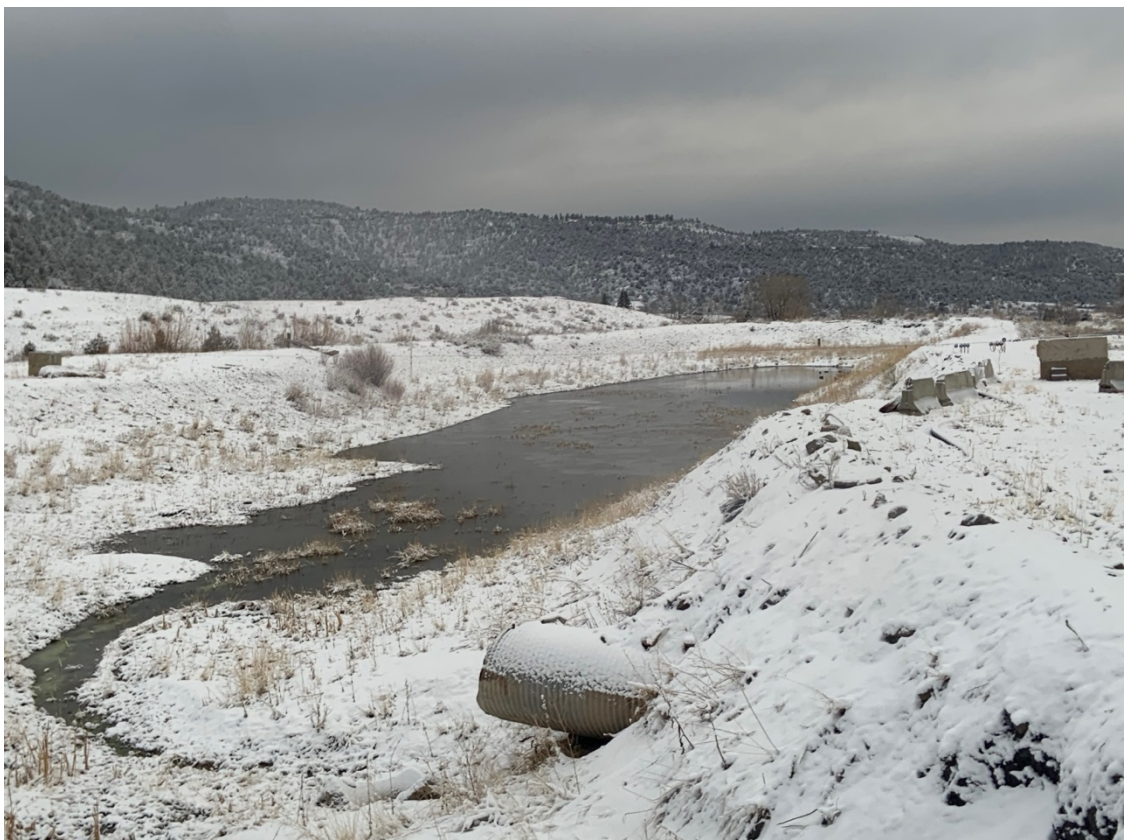
Pond 7

Pond is holding some water, not near the decant level. The pond has about 6 inches of sediment.

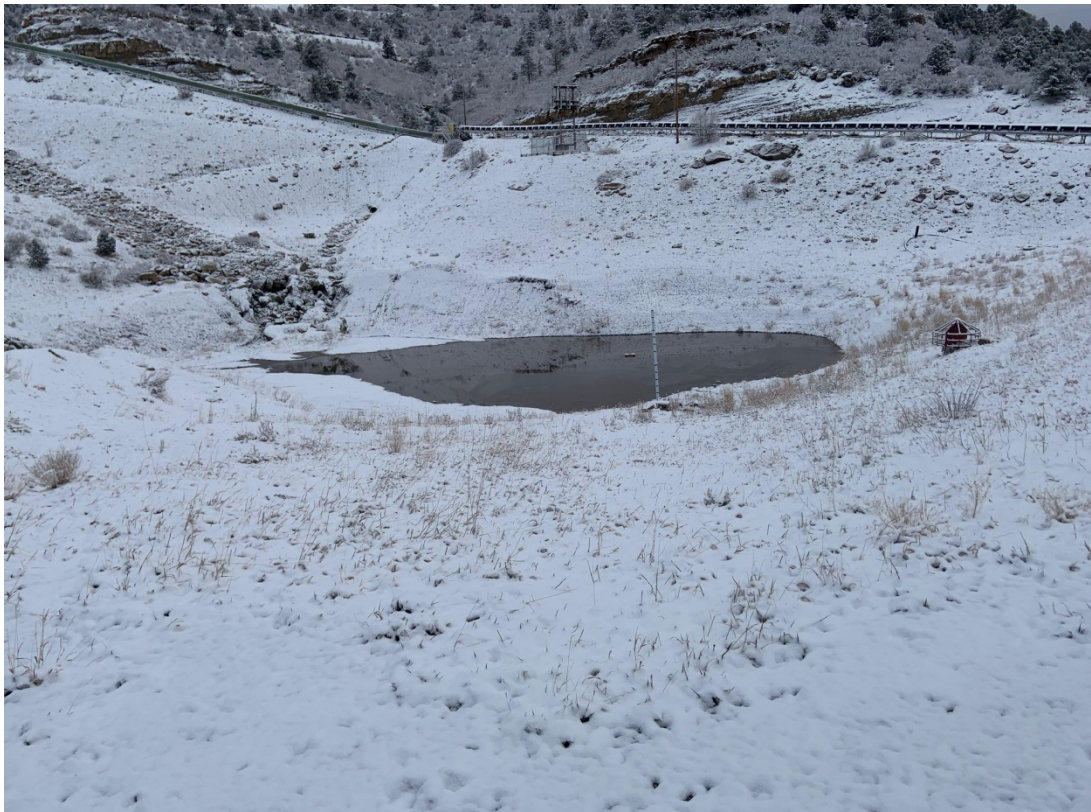
Pond 8

Pond is holding water, not near the decant level. No new sediment has been deposited.

There is very little sediment in the pond.

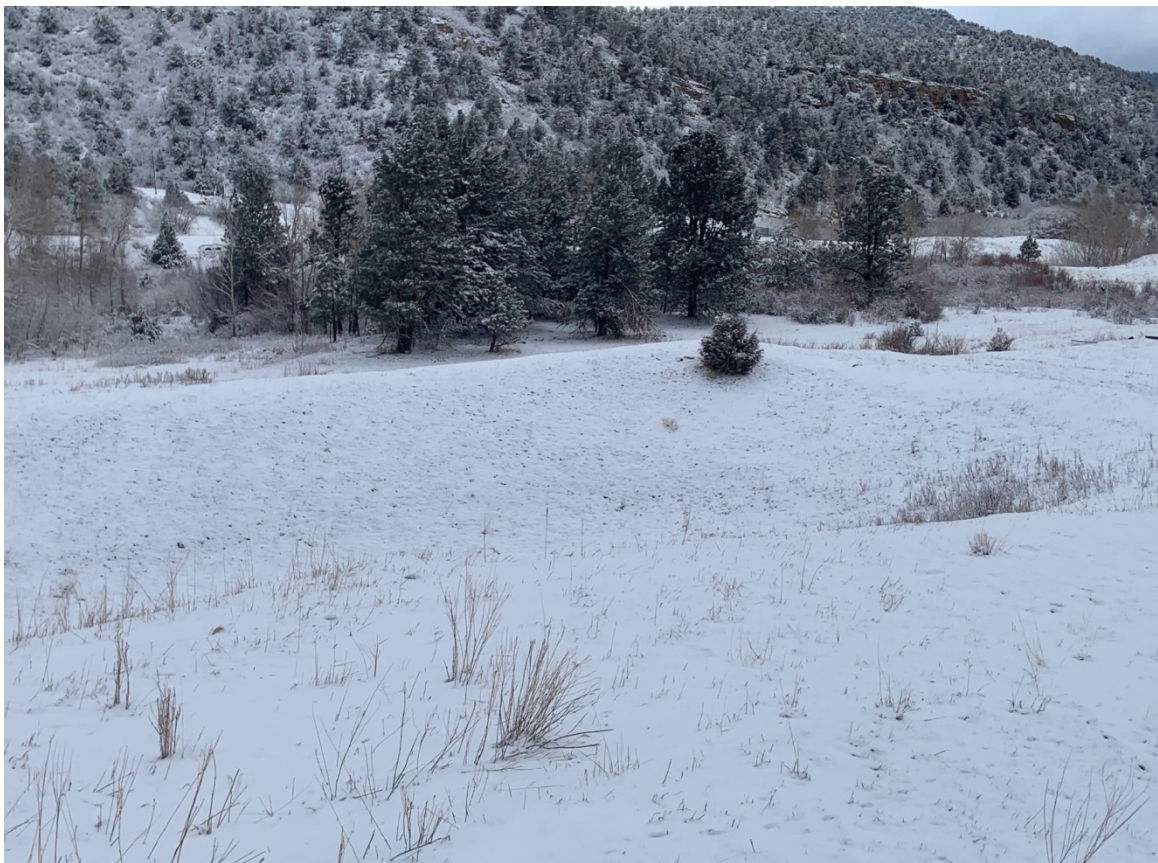
Containment Area #1

Containment area has little water.

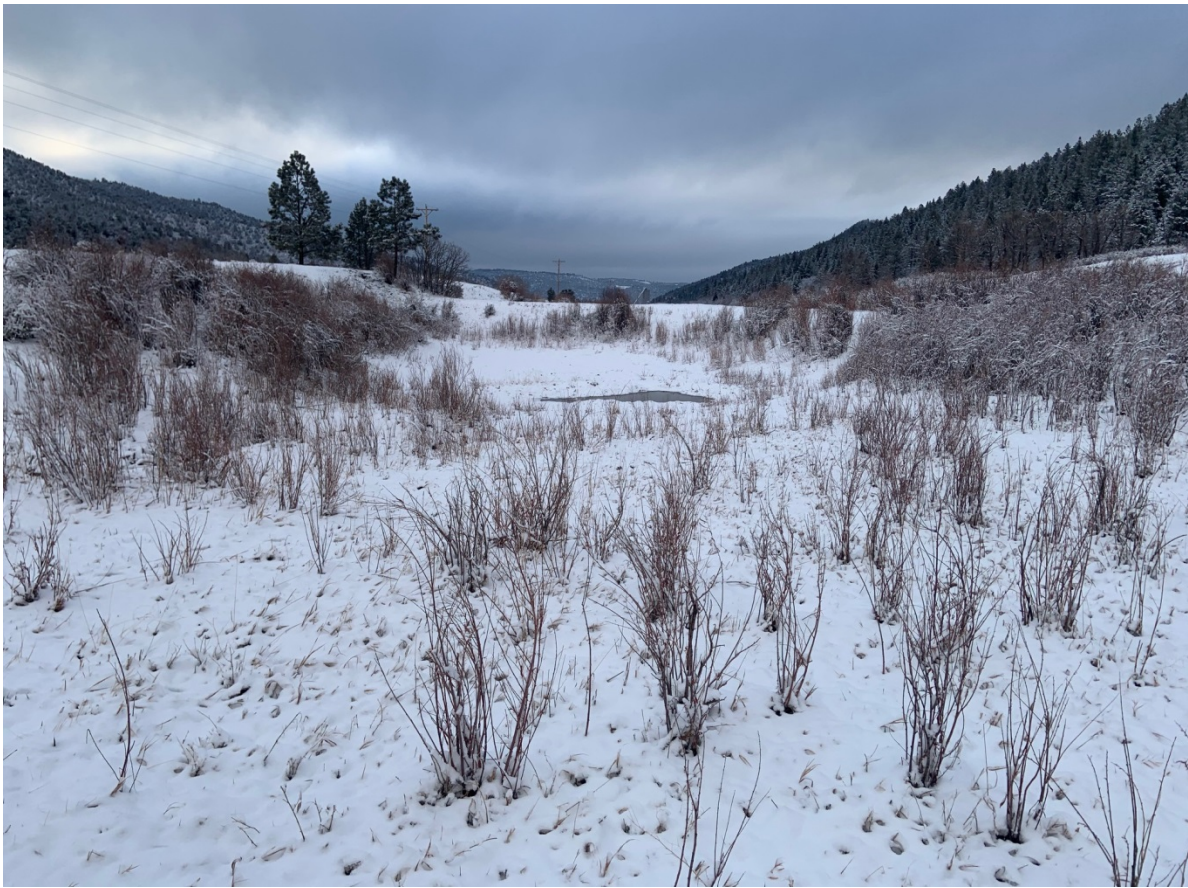
Containment Area #2

Containment is empty.

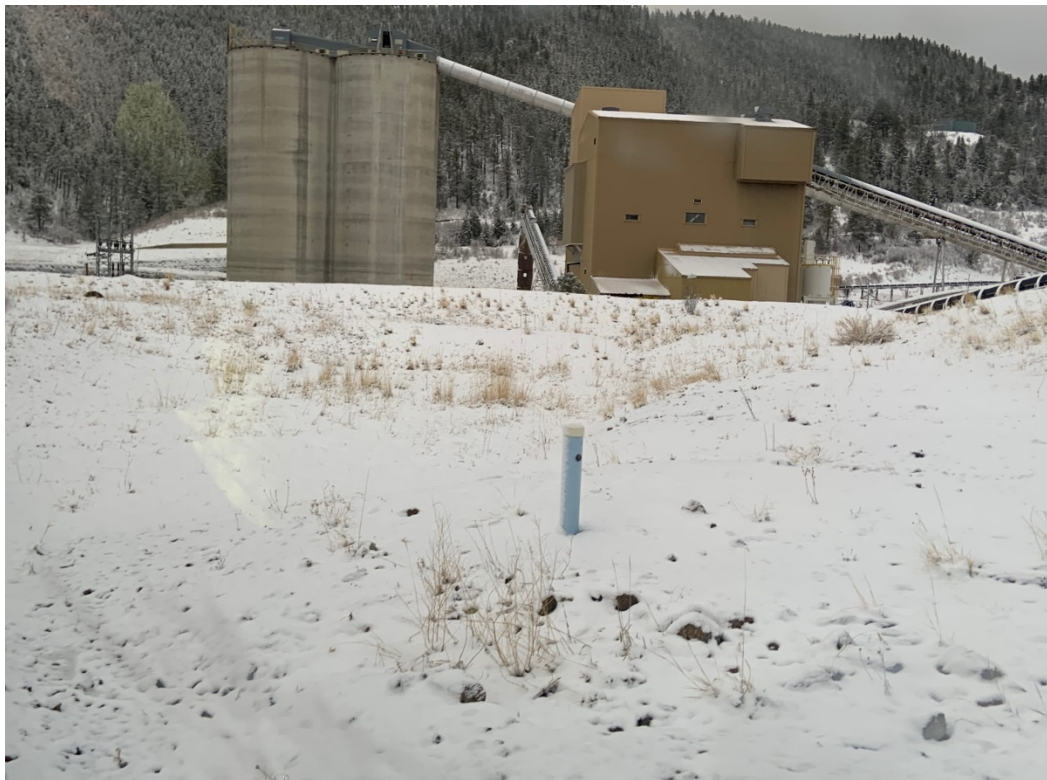
Containment Area #3

Containment Area is dry.

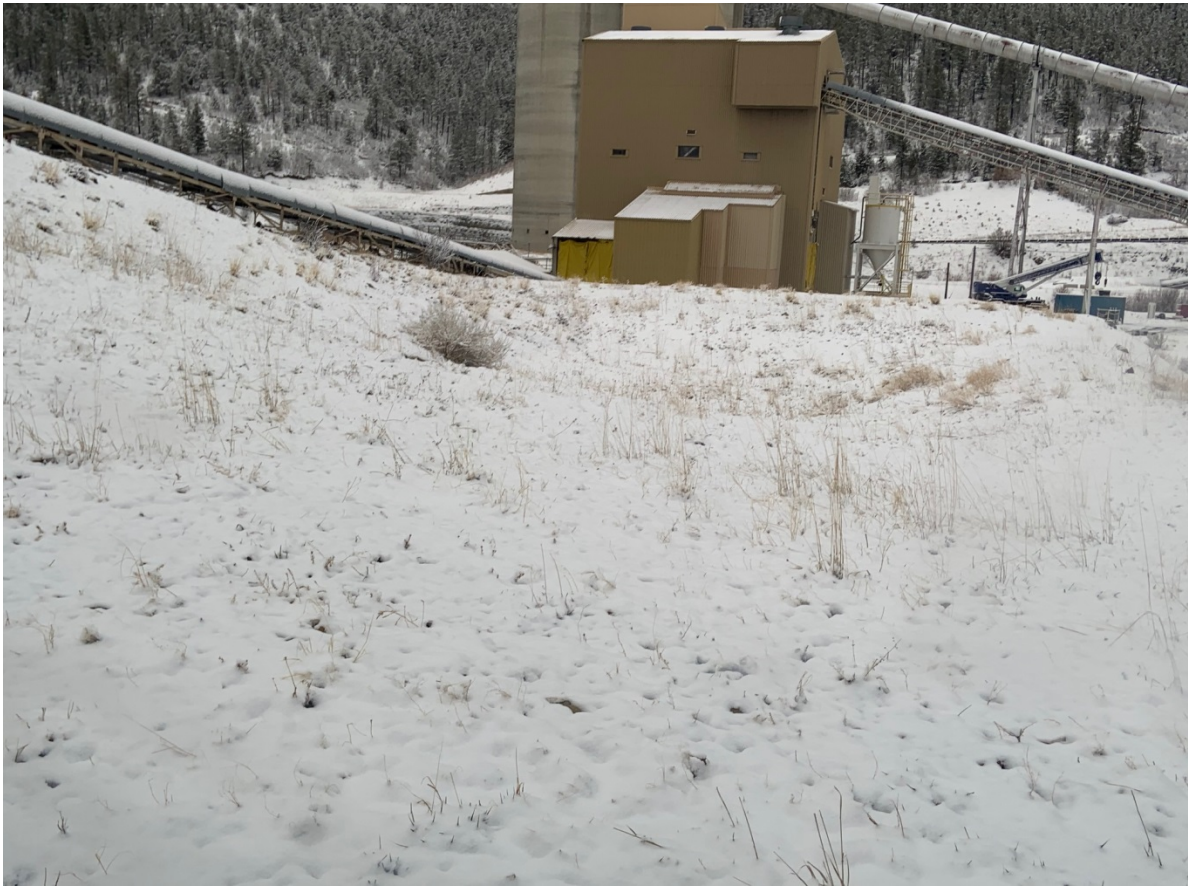
Containment Area #4

Containment Area is dry.

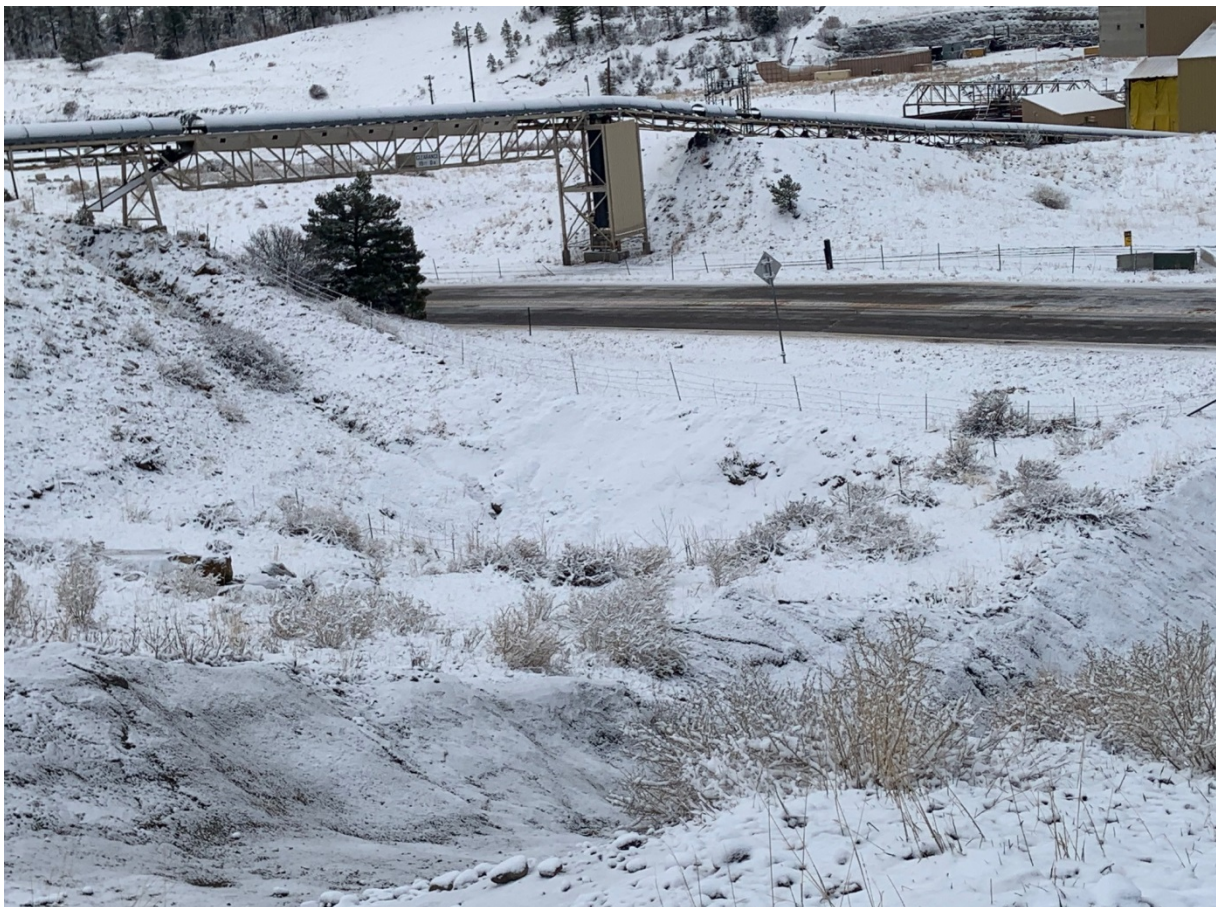
Containment Area #5

Containment Area is empty. Sediment was cleaned in quarter 2 of 2020.
