QUARTERLY SEDIMENTATION POND INSPECTION REPORT

Mine: Lorencito

Inspection Period: First Quarter 2021

Inspection Date: 3/17/2021

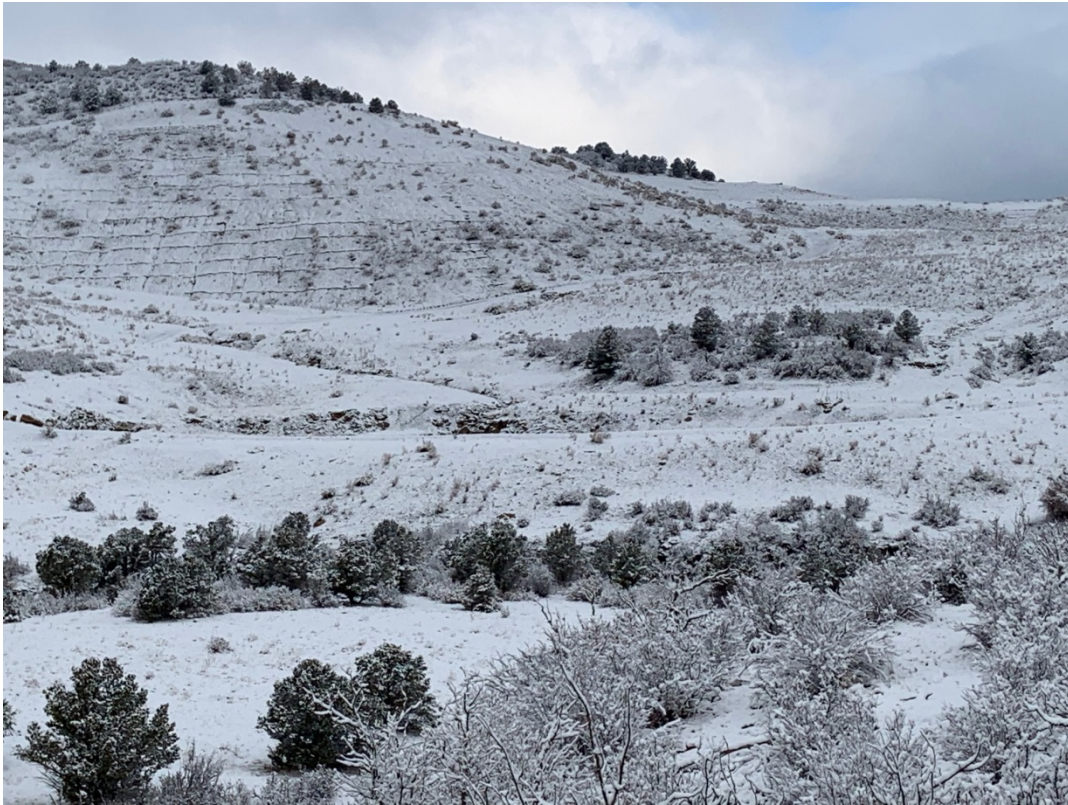
Pond 6 – South Facing Embankment

Pond was empty at time of inspection.

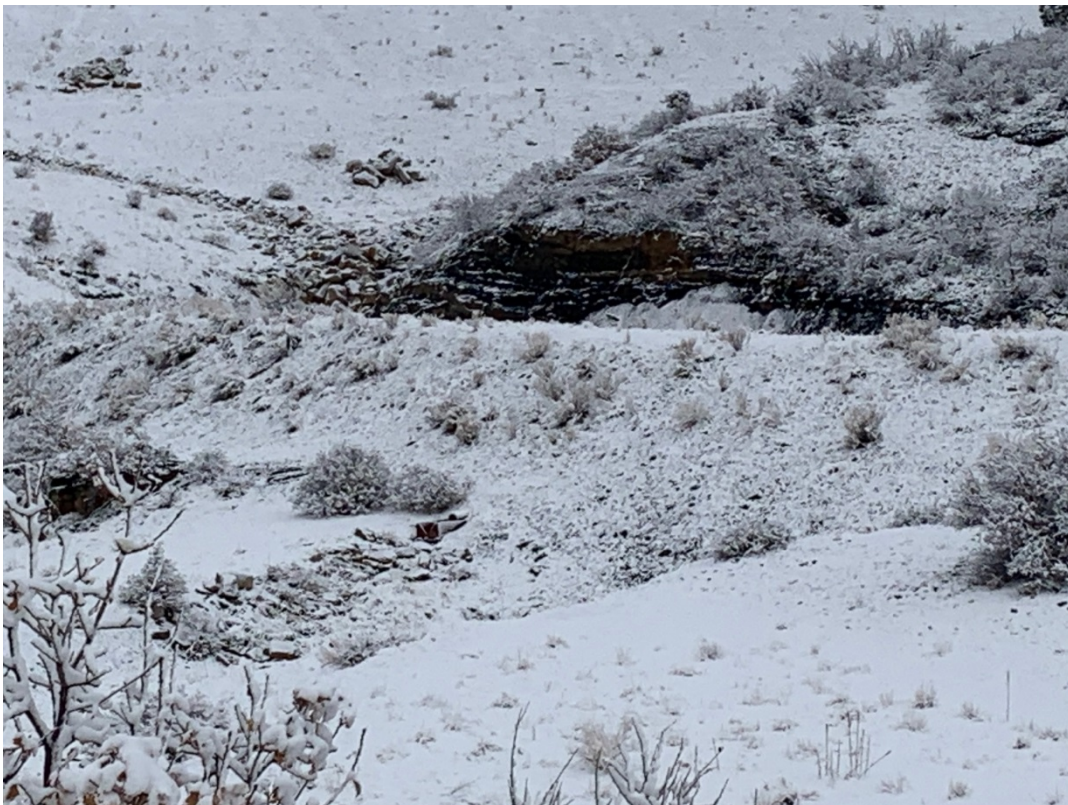
Pond 7 – South Facing Embankment

Pond empty at time of inspection.

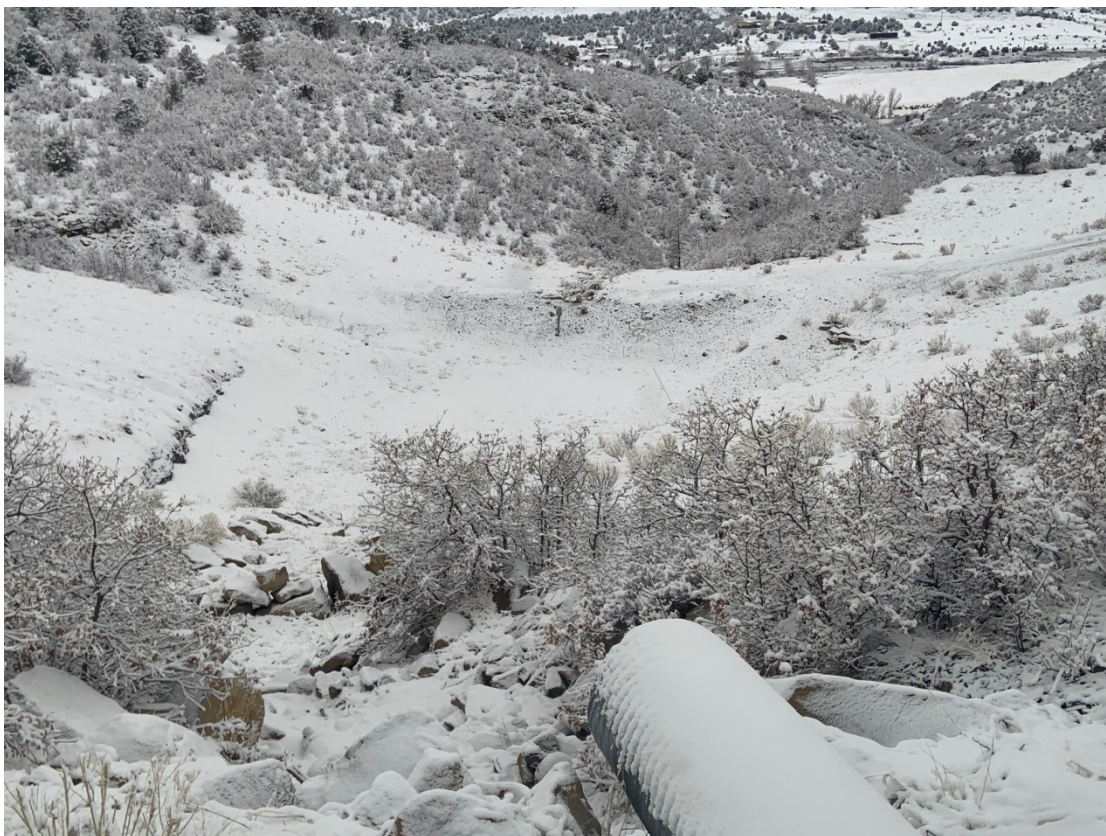
Pond 9

Pond empty at time of inspection.

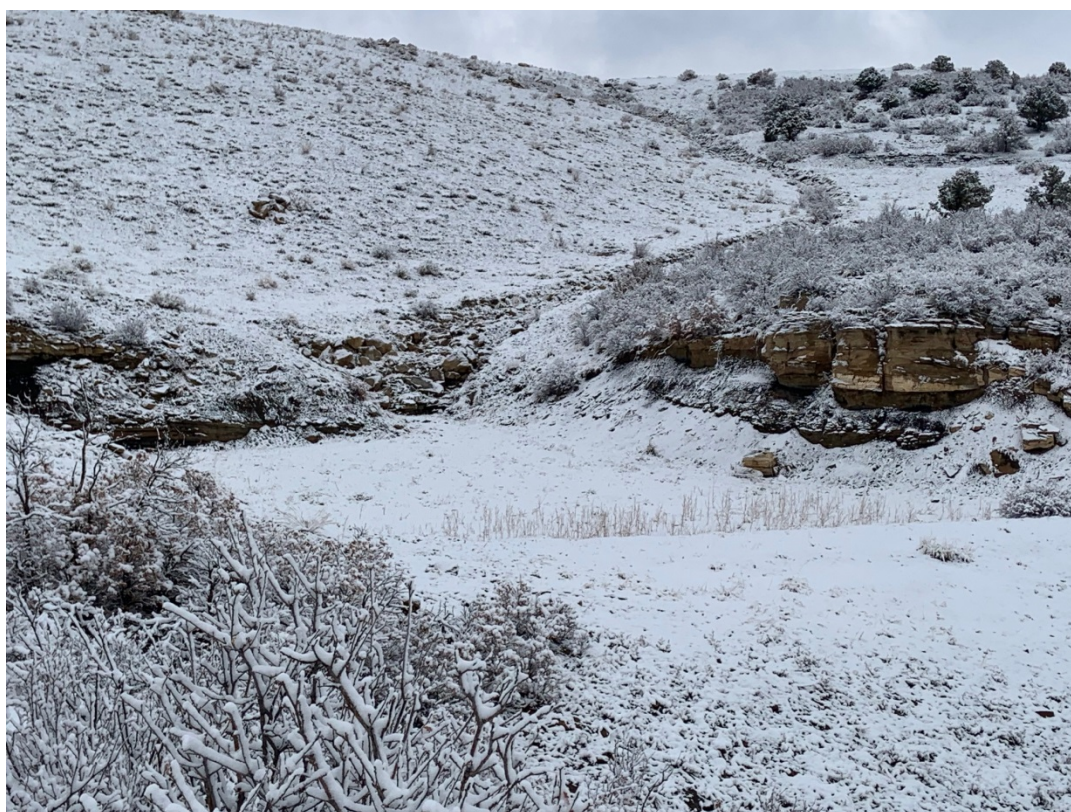
Pond 9a

Pond was not holding water at time of inspection.
