LORENCITO CANYON MINE
Permit No. C-1996-084

INSPECTION OF EXCESS SPOIL-FILLS 7, 8, & 9
March 17, 2021

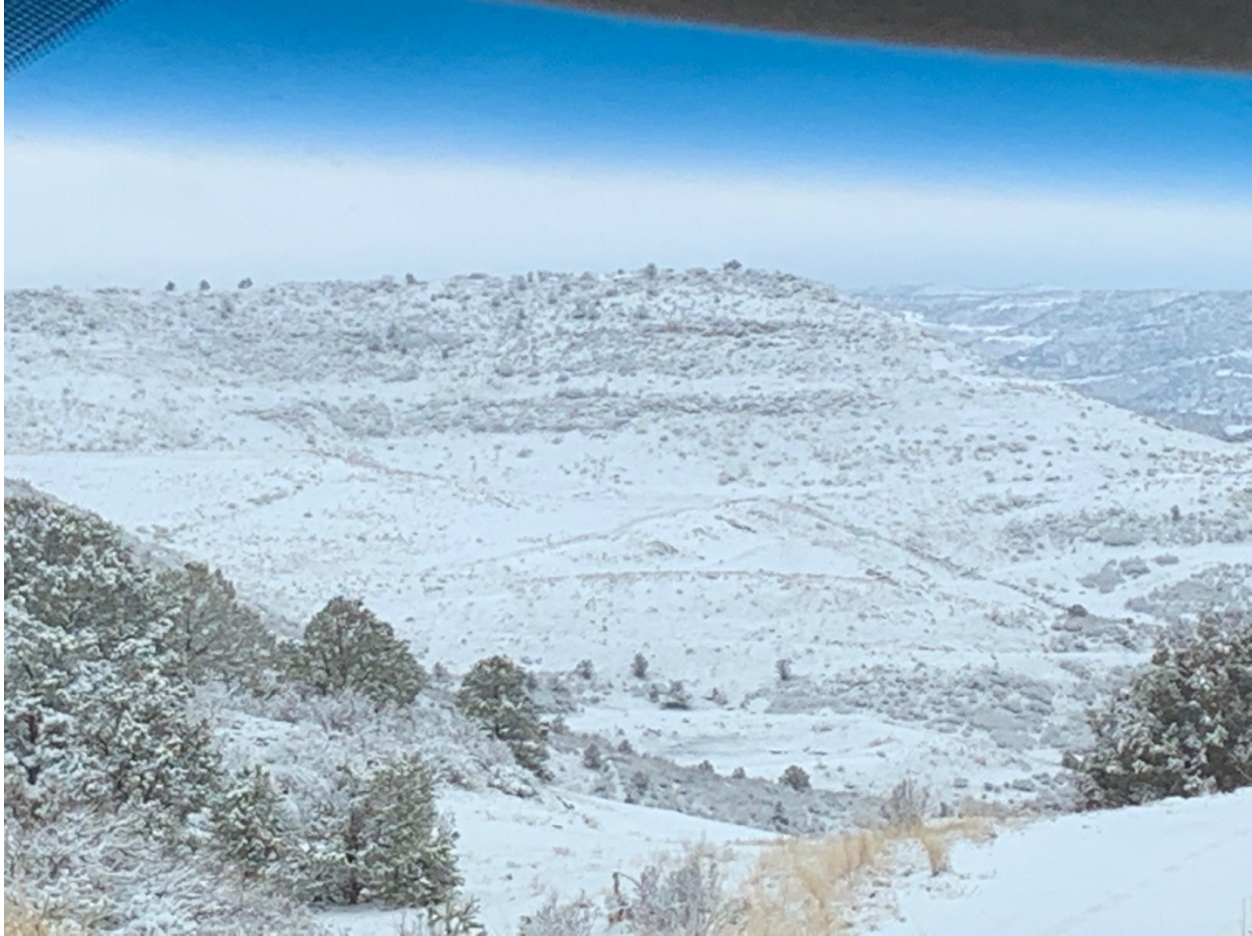
Fill #7

The entire excess spoil fill facility was examined for signs of failure and instability such as tension cracks, ground movement, springs and seeps, and standing water. There was no indication of potential instability at time of inspection.

Overall the site is in good condition. The vegetation on the fill is encouraging.

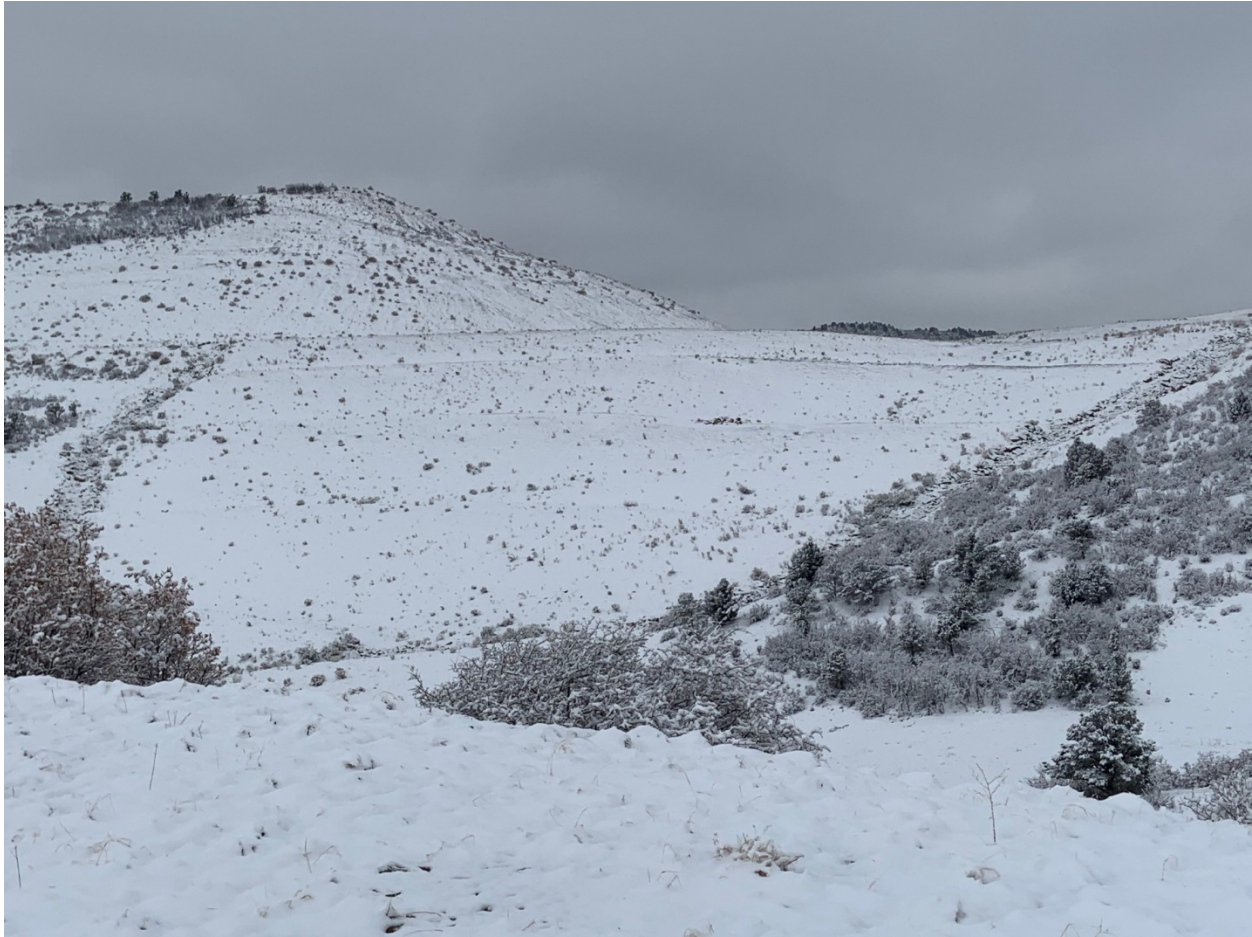
Fill #8

The entire excess spoil fill facility was examined for signs of failure and instability such as tension cracks, ground movement, springs and seeps, and standing water. There was no indication of potential instability at time of inspection.

Overall the site is in good condition. Vegetation is very good on the fill.

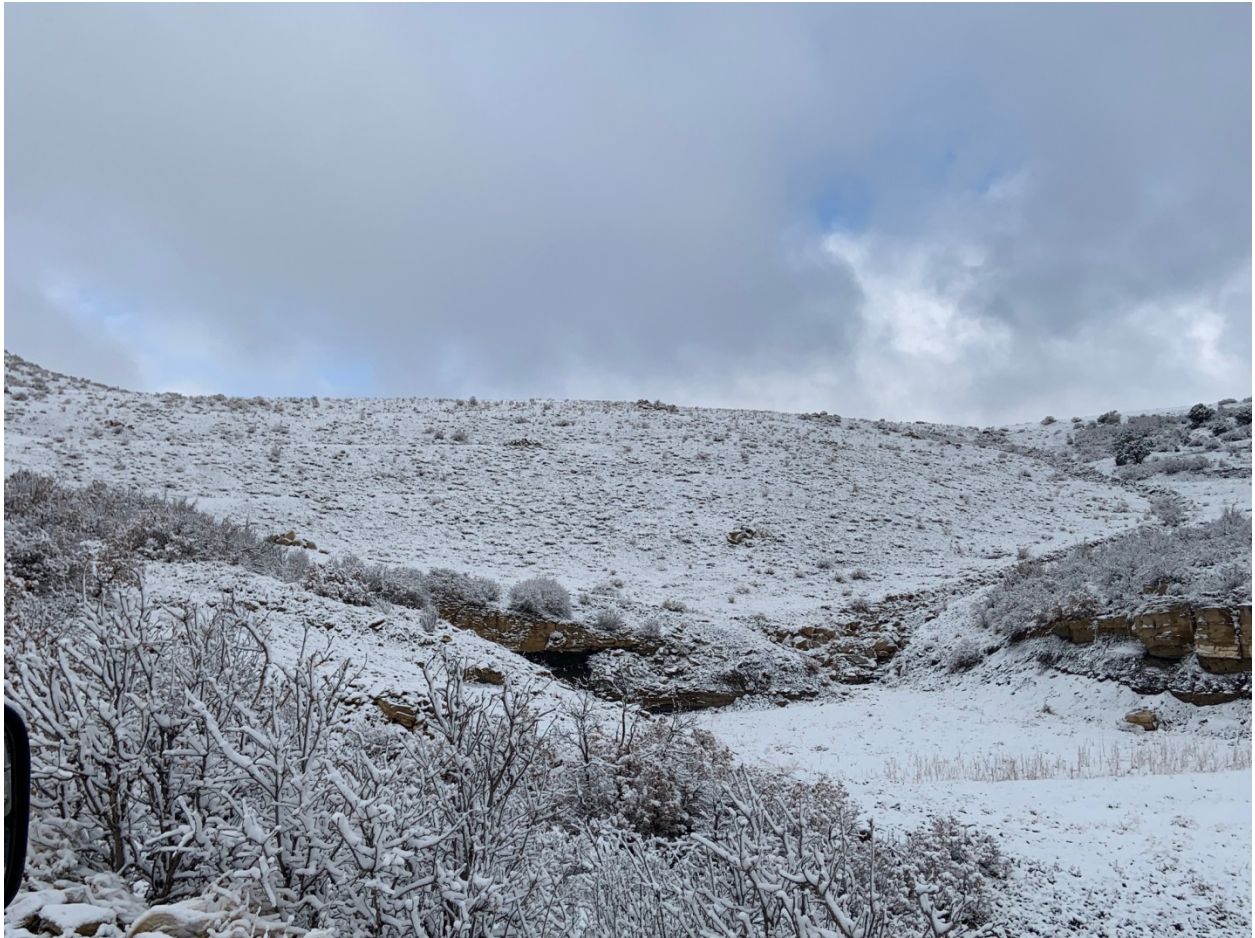
Fill #9

The entire excess spoil fill facility was examined for signs of failure and instability such as tension cracks, ground movement, springs and seeps, and standing water. There was no indication of potential instability at time of inspection.

Overall the site is in good condition.
