MINERALS PROGRAM INSPECTION REPORT
PHONE: (303) 866-3567

MINE NAME: Dakota Clay Pit	MINE/PROSPECTING ID#: M-1989-052	MINERAL: Clay	COUNTY: Jefferson
INSPECTION TYPE: Monitoring	INSPECTOR(S): Elliott Russell	INSP. DATE: September 11, 2020	INSP. TIME: 09:00
OPERATOR: The Denver Brick Company	OPERATOR REPRESENTATIVE: Richard Murphy	TYPE OF OPERATION: 110c - Construction Limited Impact	
REASON FOR INSPECTION: Normal I&E Program	BOND CALCULATION TYPE: None	BOND AMOUNT: \$43,926.00	
DATE OF COMPLAINT: NA	POST INSP. CONTACTS: None	JOINT INSP. AGENCY: None	
WEATHER: Clear	INSPECTOR'S SIGNATURE:

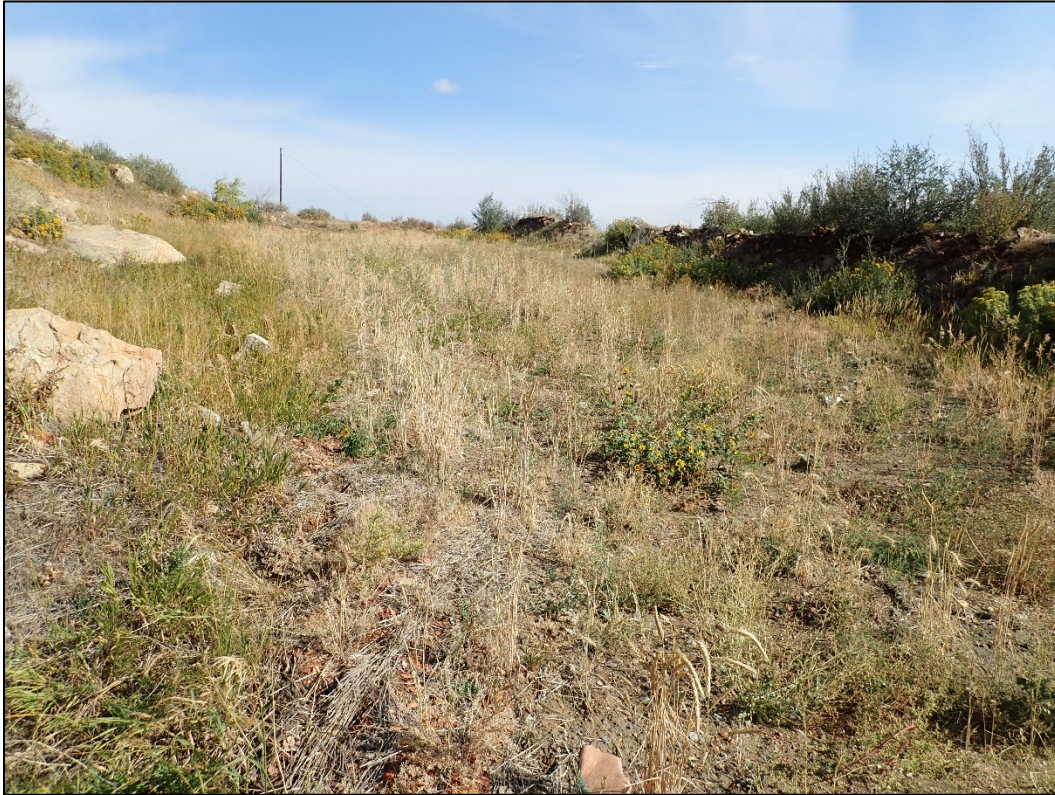
Photo 1: Lower bench; looking north.

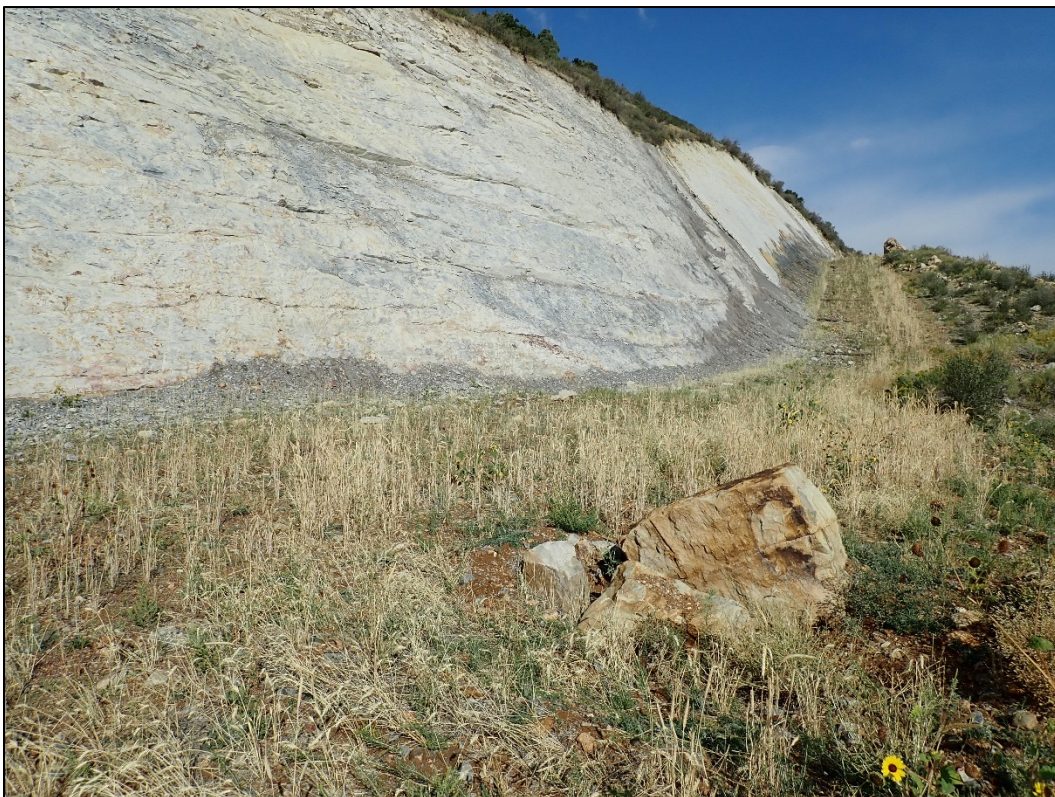
Hydrologic Balance: Some small pools of standing water was observed on the middle bench of the site, however this is likely from a recent storm event. No issues regarding the hydrologic balance were present.

Photo 2. Middle bench; looking northwest.

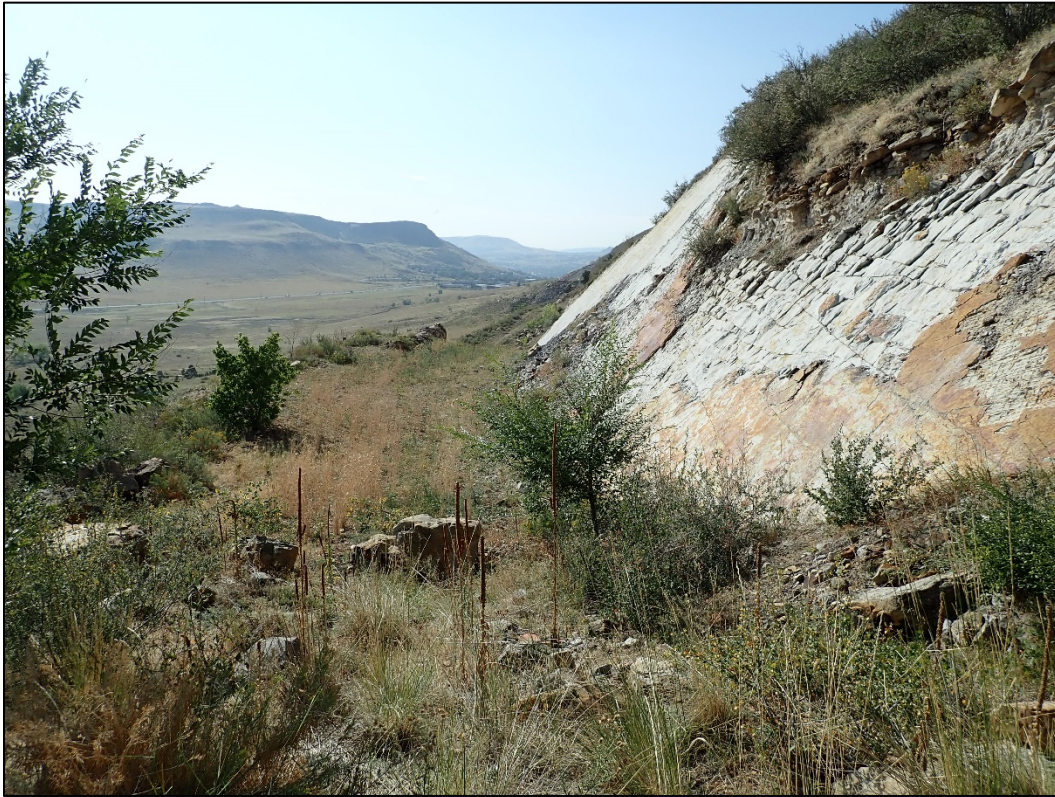
Photo 3. Upper bench; looking south.

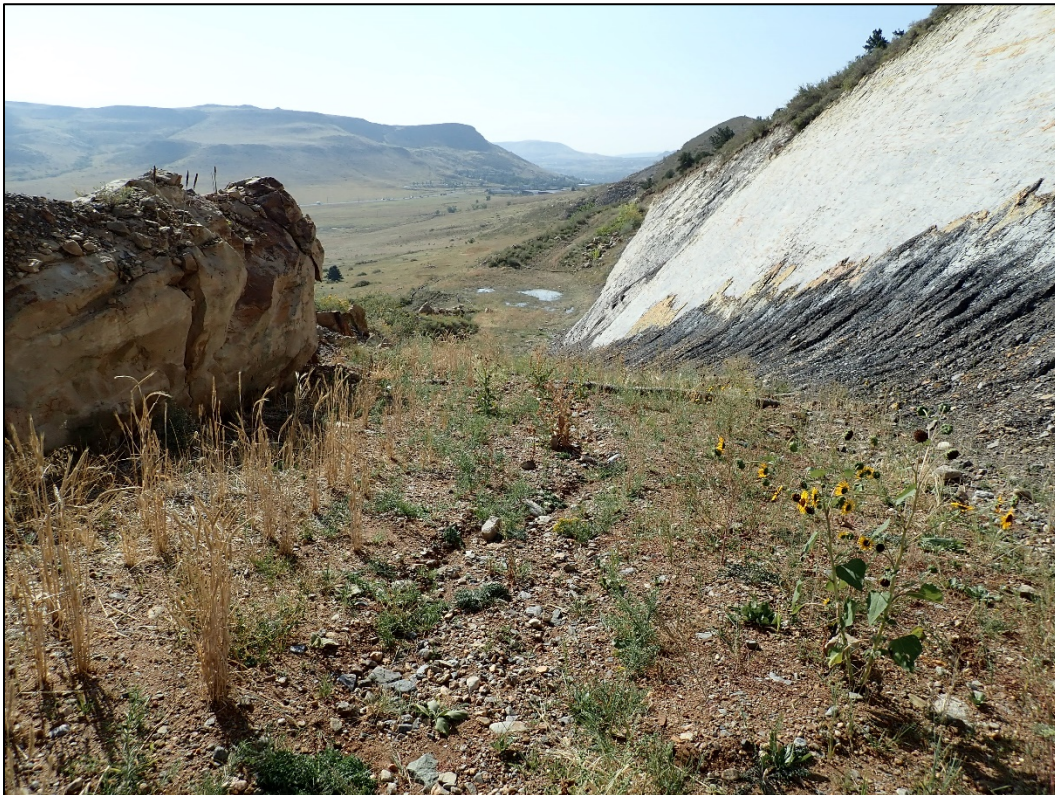
Photo 4. Crest of access road between middle and upper bench; looking south.

Sediment Control: The Division recommends the Operator monitor the road between the lower and middle benches as some erosion control measures may be needed in the future to prevent off-site sedimentation. No other erosion problems were observed and no BMPs were needed at the time of the inspection.

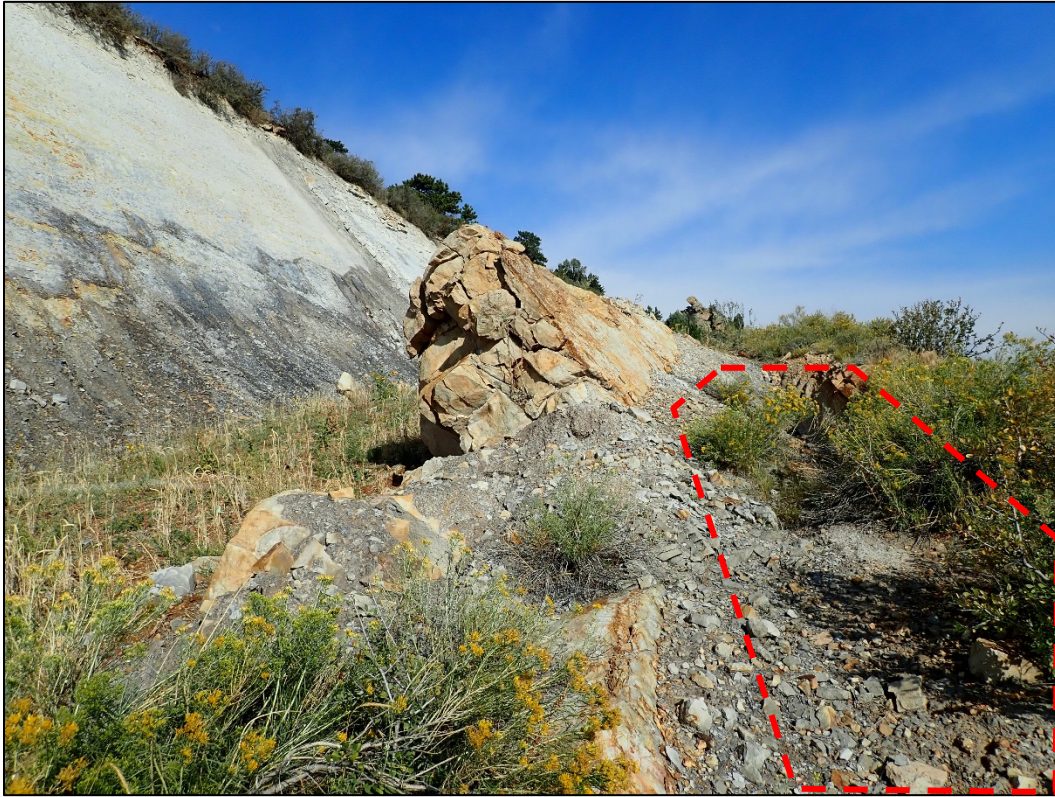
Gen. Compliance With Mine Plan: The operation appeared to be in compliance with the approved mine plan. Google Earth was used to measure the disturbed area, which was estimated to be approximately 1.8 acres. During the inspection, the Division discovered four small open stopes just east of the upper bench at the crest of the access road between the middle and upper bench (located at 39°47'42.46"N 105°14'29.71"W). These stopes pose a hazard and will need to be safeguarded prior to final release of the permit. The Division recommends the Operator work with the Inactive Mines Program to determine the best approach to safeguard these stopes. The Operator stated they were familiar with the closure specifications of the IMP based on previous work the Operator has completed on site regarding historical mine features. The specifications are available on the Division's website at <https://drms.colorado.gov/>.

Photo 5. Area where the four open stopes are located (outlined in red); looking northwest.

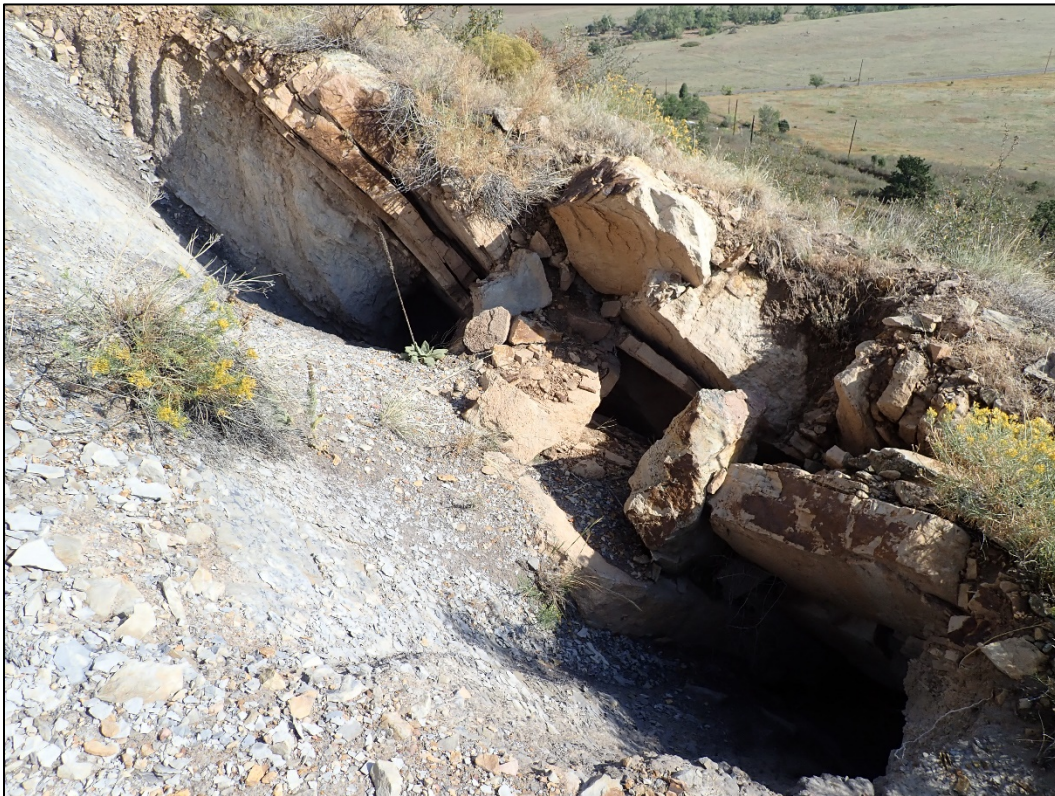
Photo 6. Two of the four open stopes; looking north.

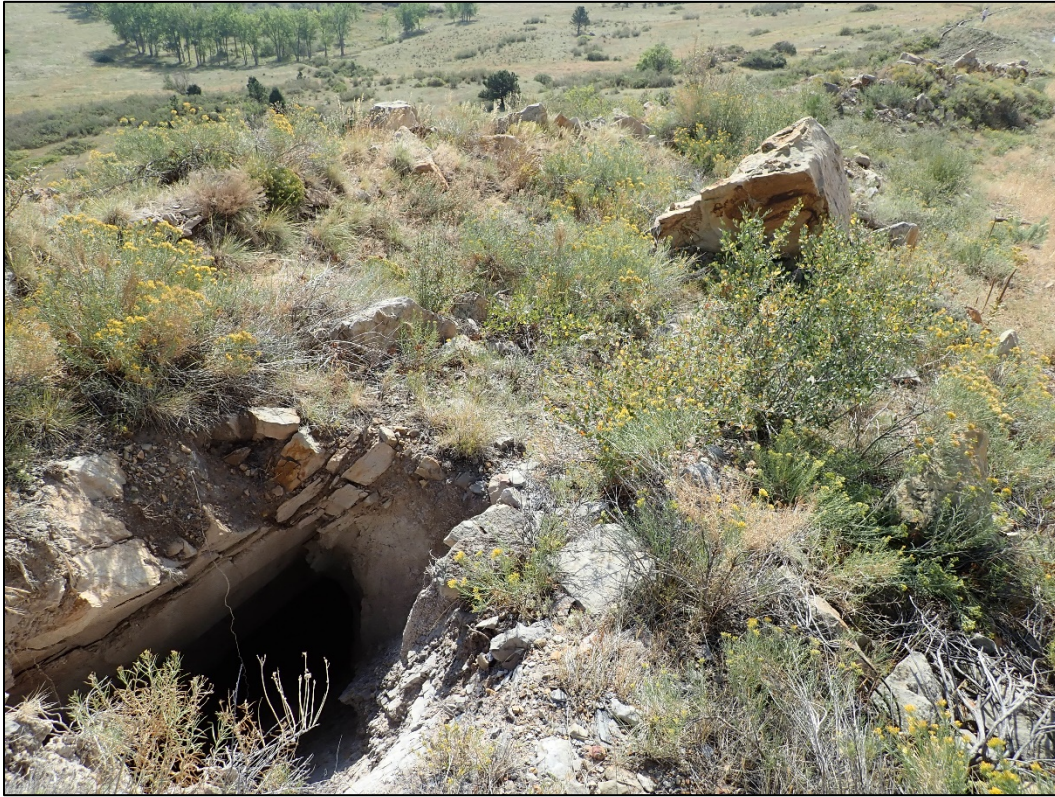
Photo 7. One of the four open stopes; looking southeast.
