MINERALS PROGRAM INSPECTION REPORT
PHONE: (303) 866-3567

MINE NAME: Stevens Clay Lease	MINE/PROSPECTING ID#: M-1996-064	MINERAL: Clay	COUNTY: Douglas
INSPECTION TYPE: Monitoring	INSPECTOR(S): Elliott Russell	INSP. DATE: September 11, 2020	INSP. TIME: 11:15
OPERATOR: The Denver Brick Company	OPERATOR REPRESENTATIVE: Richard Murphy	TYPE OF OPERATION: 112c - Construction Regular Operation	
REASON FOR INSPECTION: Normal I&E Program	BOND CALCULATION TYPE: None	BOND AMOUNT: \$148,000.00	
DATE OF COMPLAINT: NA	POST INSP. CONTACTS: None	JOINT INSP. AGENCY: None	
WEATHER: Clear	INSPECTOR'S SIGNATURE:

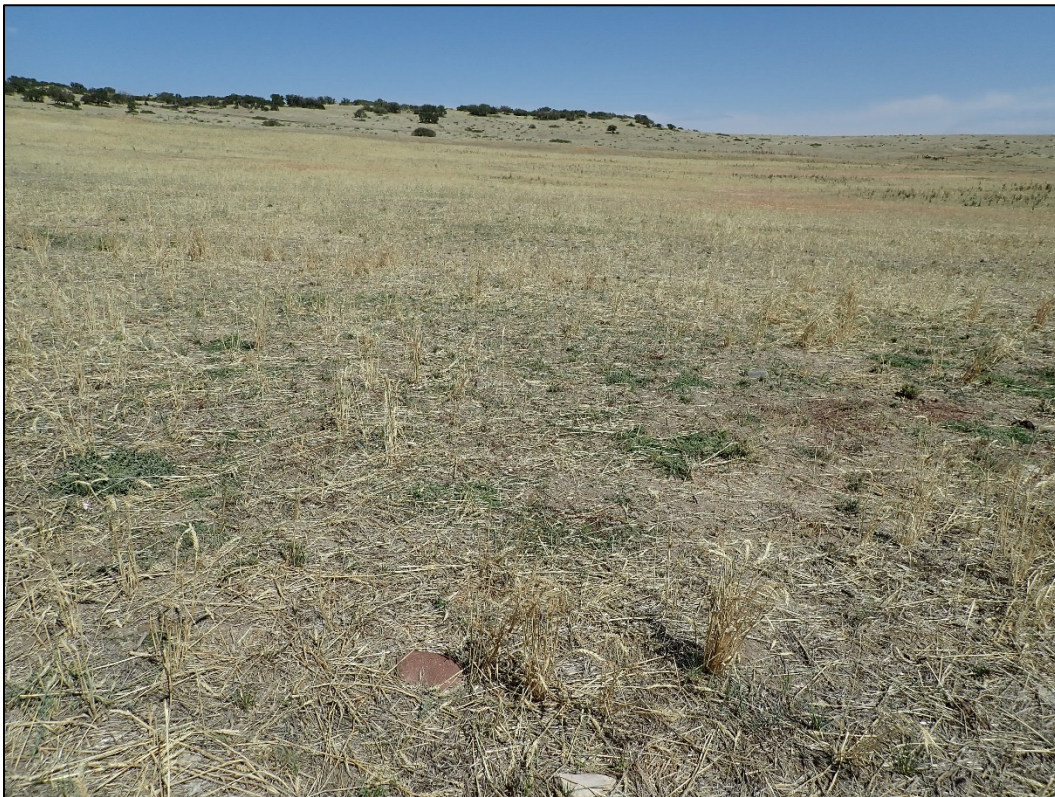
Photo 1. Northern portion of the site; looking north.

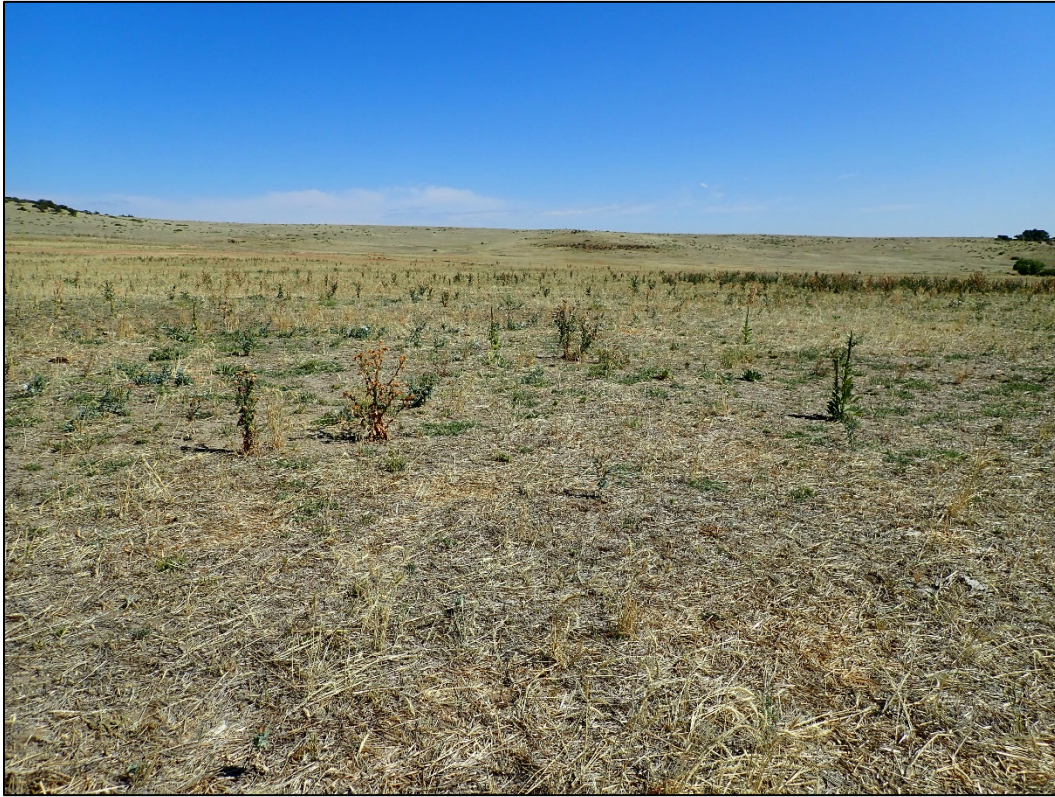
Photo 2: Southern portion of the site; looking northeast.

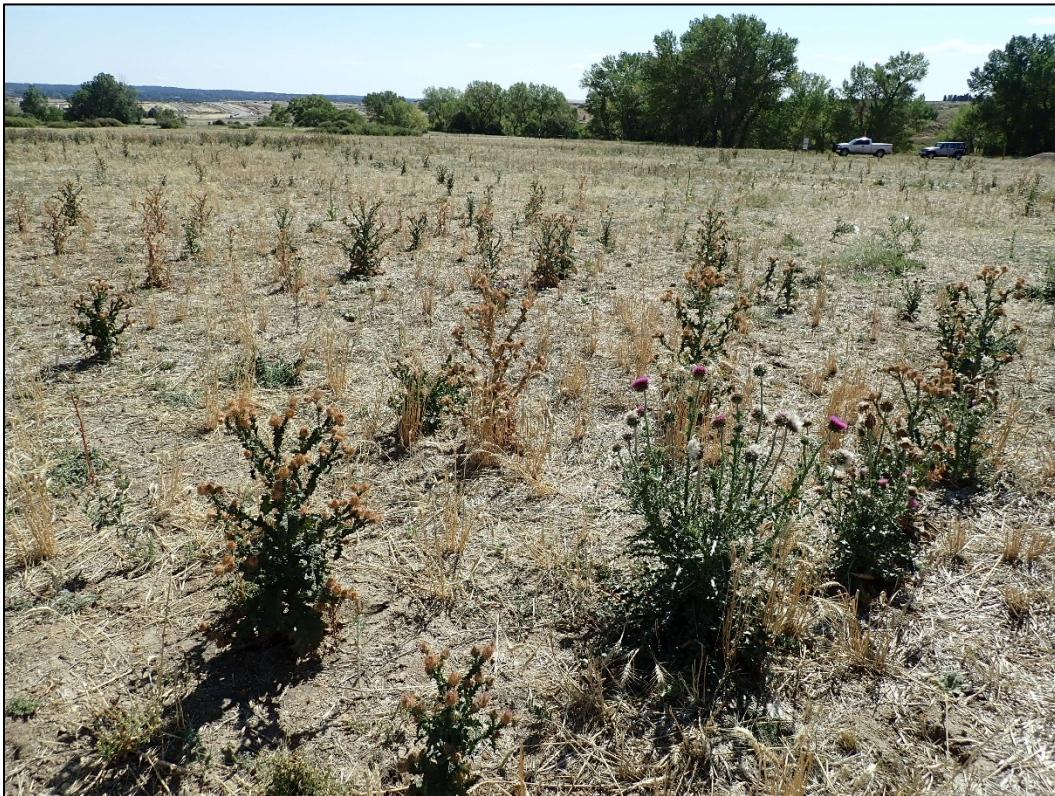
Revegetation: A large amount of listed noxious weed species were present on the southern half of the site. The Division observed common mullein, musk thistle, bull thistle, and field bindweed. The Operator will need to treat the noxious weeds in accordance with Rule 3.1.10(6). The Division observed only some beneficial grass species had germinated but the most of the site was the cover crop, weedy species, or noxious weeds.

Photo 3. Musk and bull thistle in the southern portion of the site; looking east.

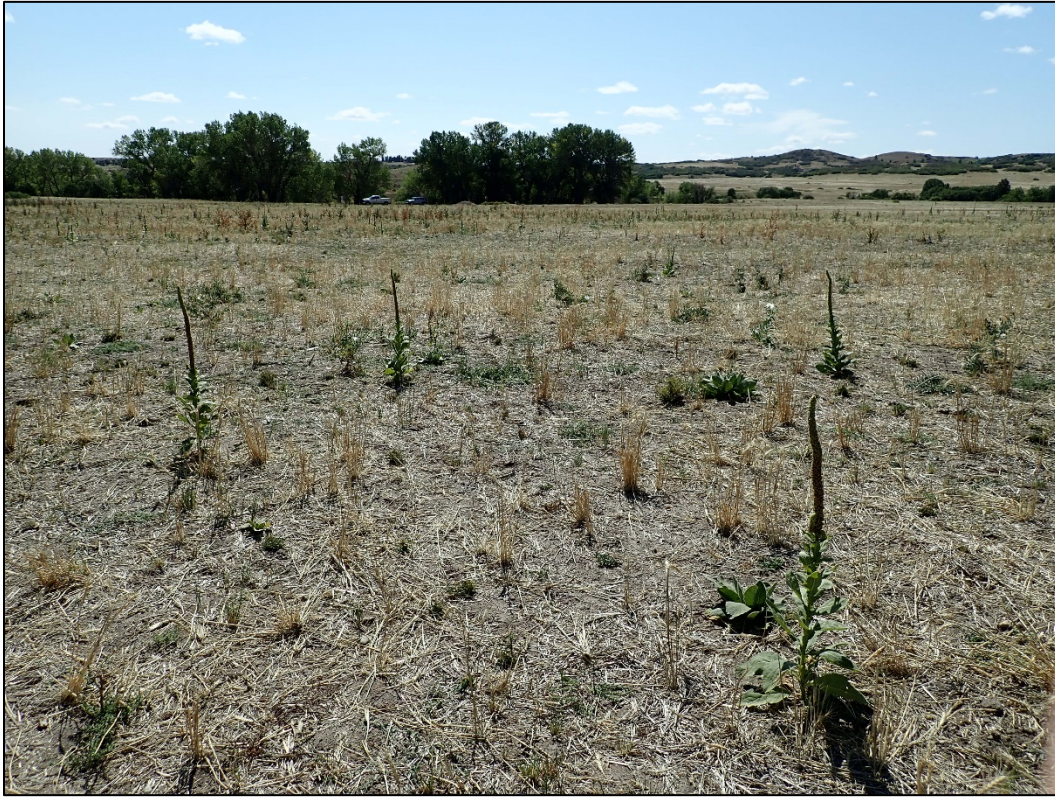
Photo 4. Common mullein in the southern portion of the site; looking east.
