Horse Gulch Fill Quarterly Inspection Report

First Quarter 2021

**Trapper Mining Inc.
Trapper Mine
Craig, Colorado**

HORSE GULCH FILL
QUARTERLY FILL CERTIFICATION

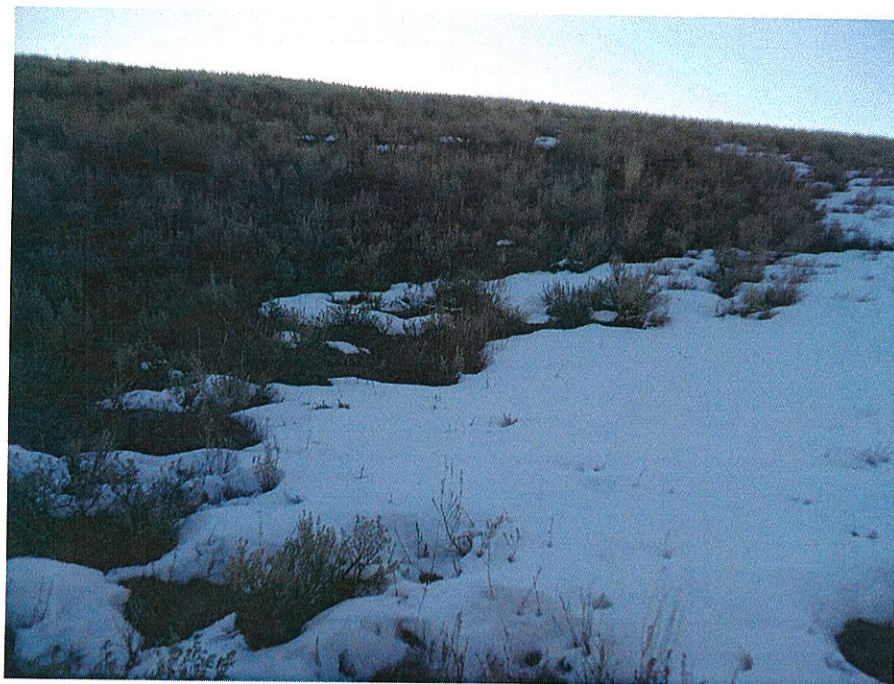
The two spots above the 7350' elevation on the south side of the dump that showed some differential settling in the second quarter of 2013 were inspected and there was no additional settling (Photographs 1 and 2).

Photograph 1: South Site above the 7350 Bench Elevation (3/24/2021)

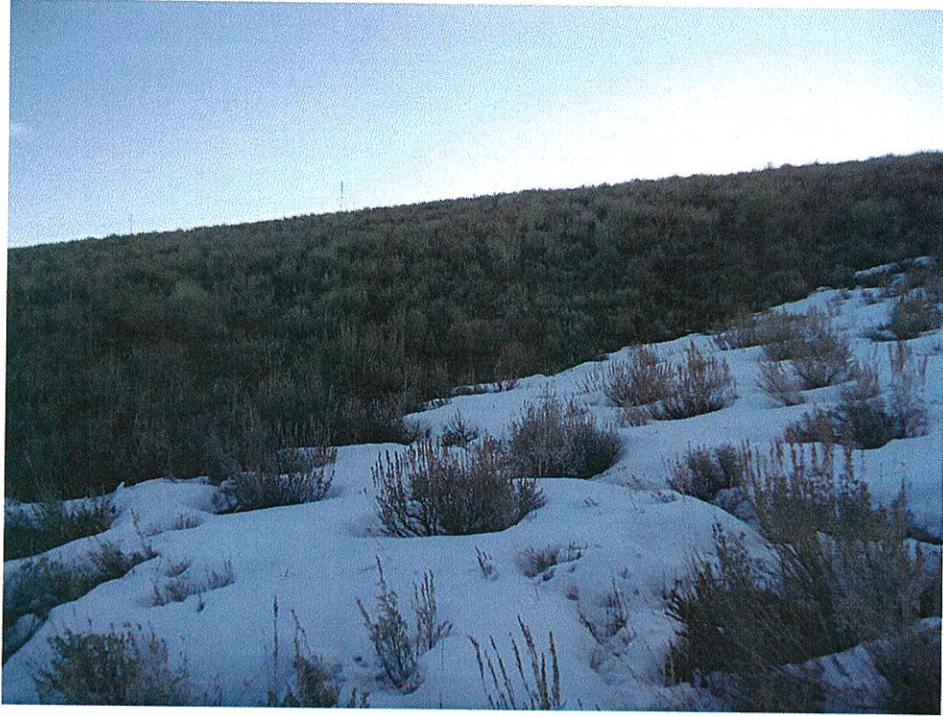
Photograph 2: North Site above the 7350 Bench Elevation (3/24/2021)

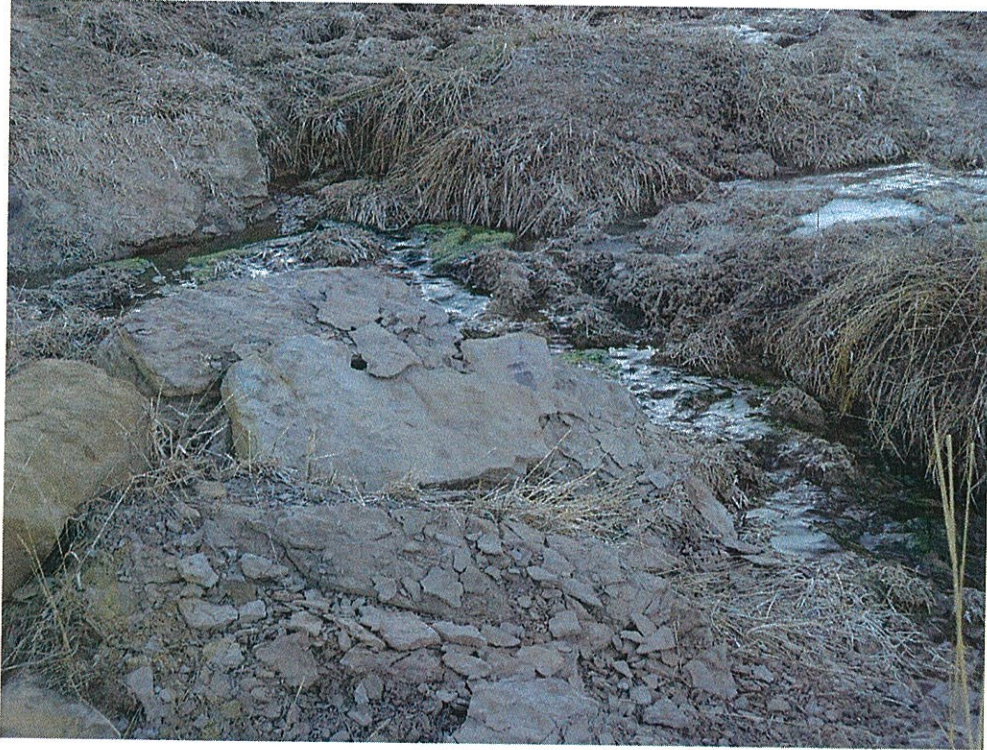
The underdrainage system was completed in the first quarter of 2010; additional work on this system is not anticipated. During the time of the inspection, there was approximately a gallon per minute of water flow. (Photograph 3).

Photograph 3: Water from the Underdrainage System (3/24/2021)

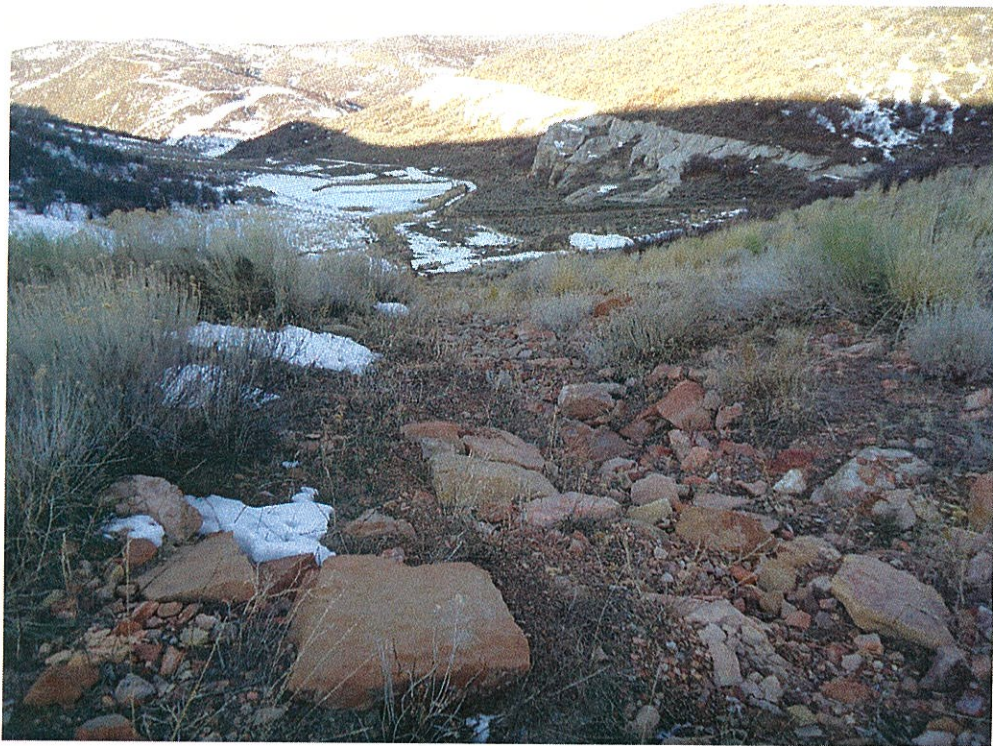
Both the north and south surface drains were inspected (Photographs 4 and 5). At the time of the inspection there was no water flow.

Photograph 4: North Surface Drain Looking West (3/24/2021)

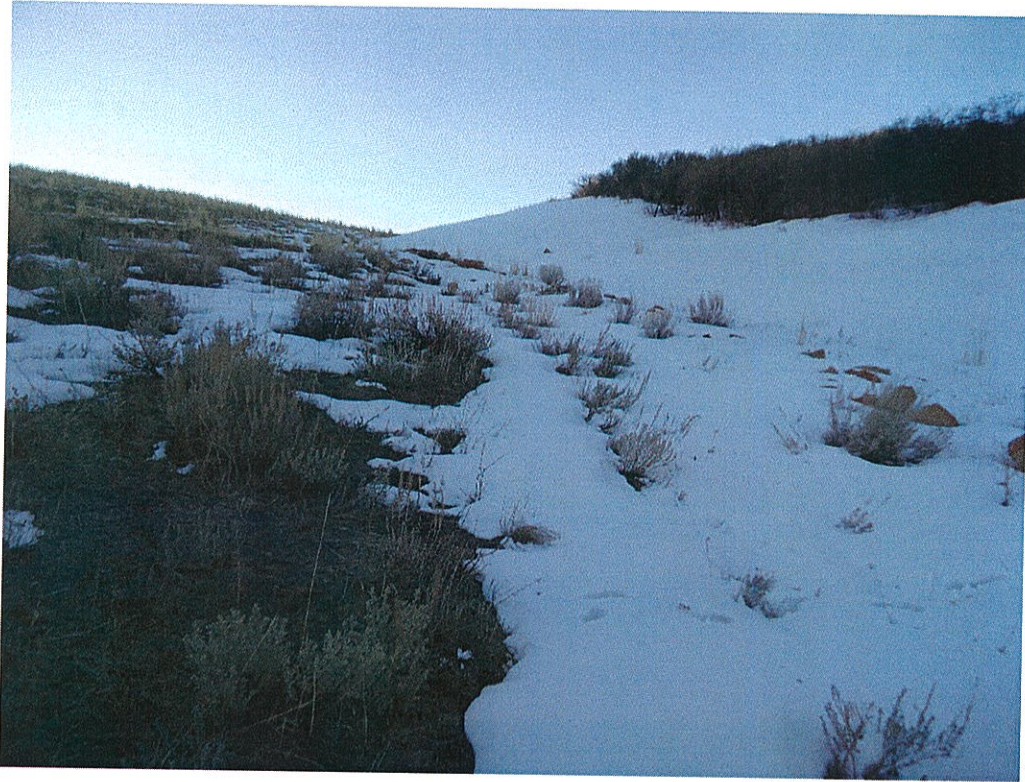
Photograph 5: South Surface Drain Looking East (3/24/2021)

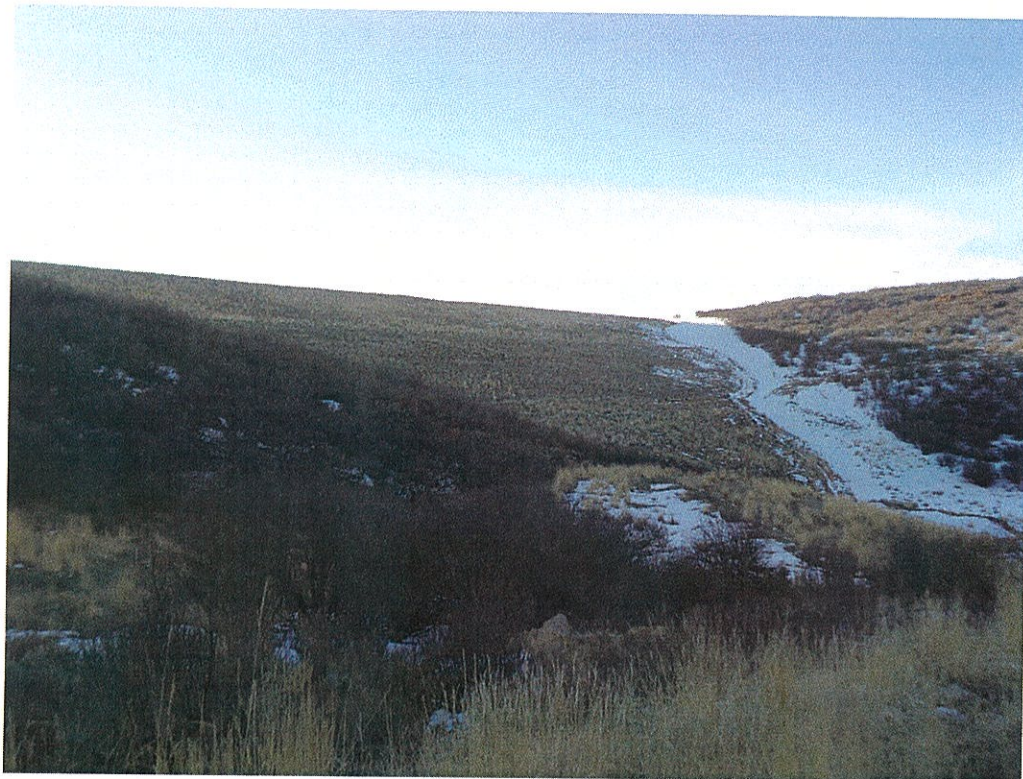
Photograph 6 depicts the west facing slope of the fill in the area where the slope of the fill is at 3H: 1V.

Photograph 6: West Side Fill 3H: 1V Face Looking South-East (3/24/2021)
