Bowie #1 inspection report

PERMIT INFORMATION

Permit Number: C-1981-038 Mine Name: Bowie No. 1 Mine Operator: Bowie Resources, LLC Operator Address: Mr. Basil R Bear P.O. Box 1488 Paonia, CO 81428	County: Delta Operation Type: Underground Permit Status: Active Ownership: Private
	Operator Representative Present: None
Operator Representative Signature: (Field Issuance Only)

Inspection Start Date: March 30, 2021 Inspection Start Time: 12:45 Inspection End Date: March 30, 2021 Inspection End Time: 16:15		Inspection Type: Coal Complete Inspection Inspection Reason: Normal I&E Program Weather: Clear	
Joint Inspection Agency: None		Joint Inspection Contacts: 	
Post Inspection Agency: None		Post Inspection Contacts: 	
Inspector(s): Robert Zuber, P.E.	Inspector's Signature:

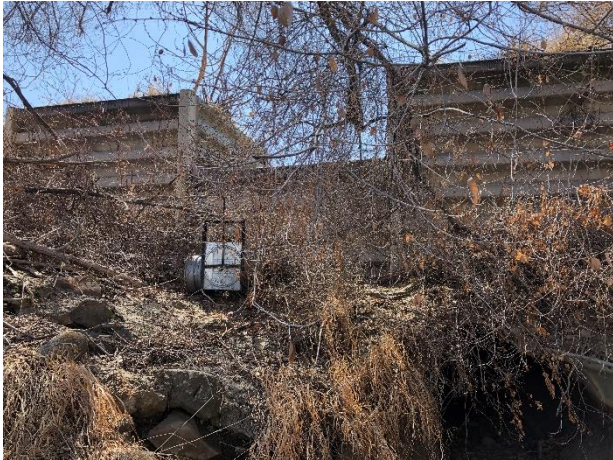
The ponds at the loadout, the Coal Storage Area (near Black Bridge Road), and at the West Mine were dry, and no problems were identified with these ponds, with one exception: **a dead animal was seen in the primary spillway at the loadout pond, and it should be removed.**

Spillways for Loadout Pond

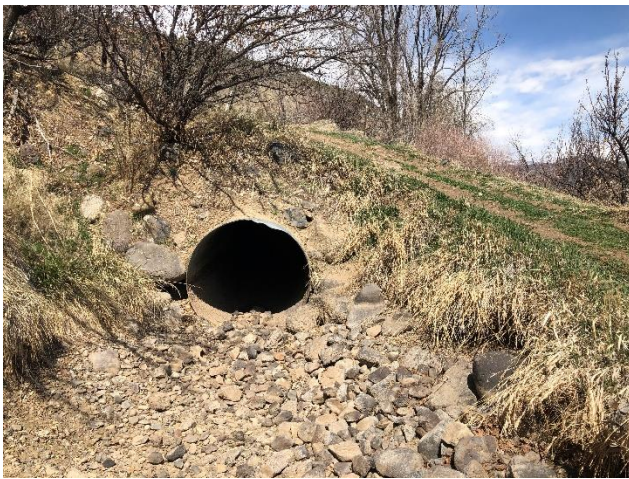
The irrigation canal that flows through the loadout (Farmers Ditch) was dry. No problems were observed with the ends of the 600-foot long, 60-inch diameter culvert. The lower end of this culvert appears to be in excellent condition. The upper end is slightly bent, and a few inches of rocks are in the bottom of the pipe, but these minor issues should not affect the function of the culvert.

Lower end of long culvert for Farmers Ditch

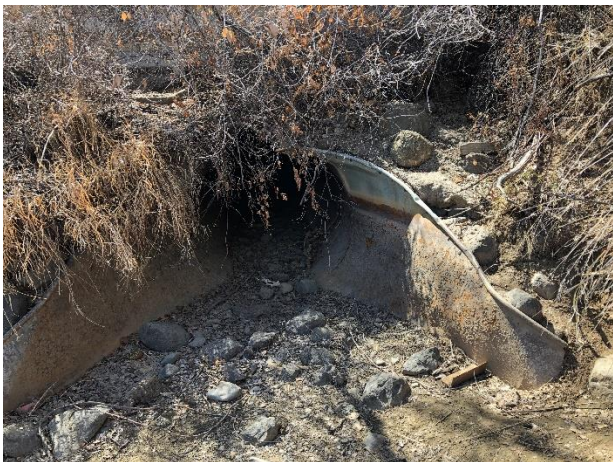
Upper end of long culvert for Farmers Ditch

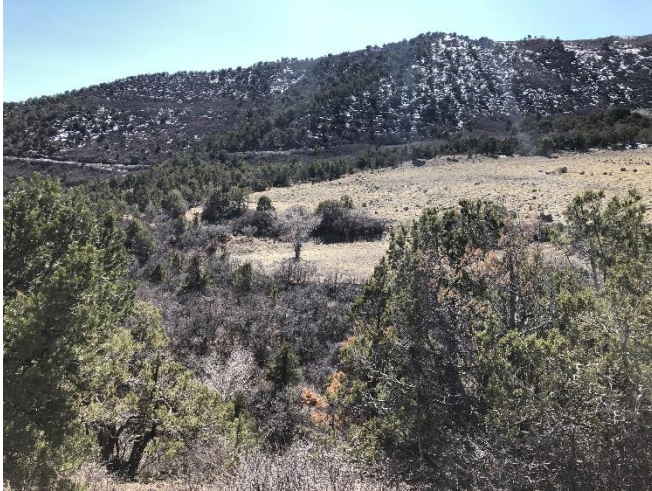
No erosion or other problems were seen at the reclaimed area of the East Mine, the ROM and Timber Storage areas, or the West Mine. In particular, the undisturbed area below the ROM Storage looked good from the road above.

Area below ROM Storage Area

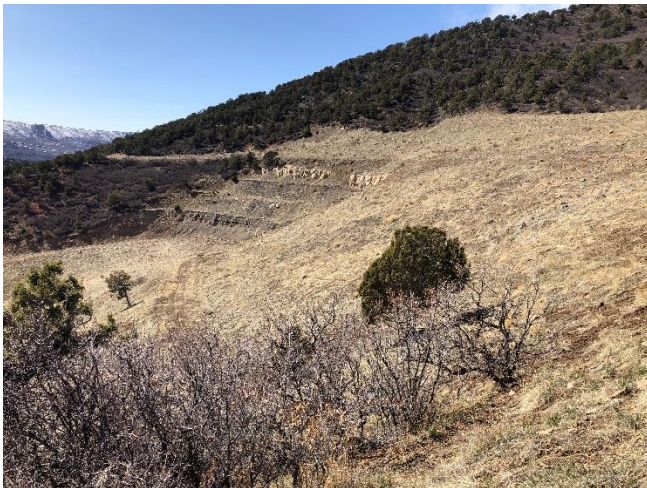
East Mine portal area

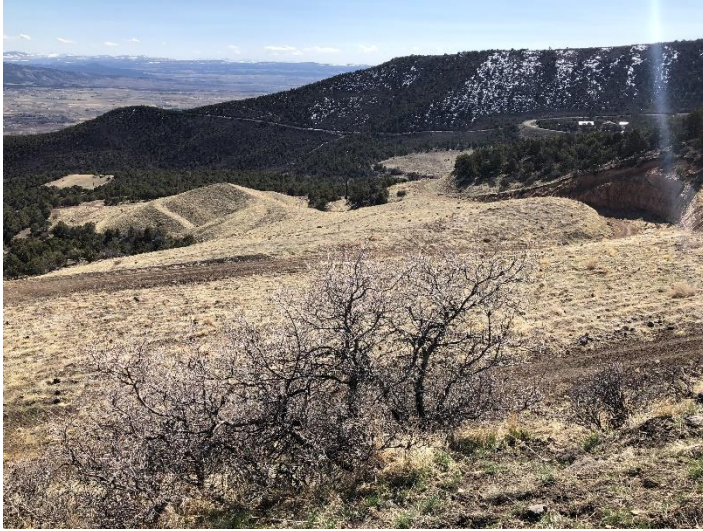
Lower portion of East Mine, including RDA

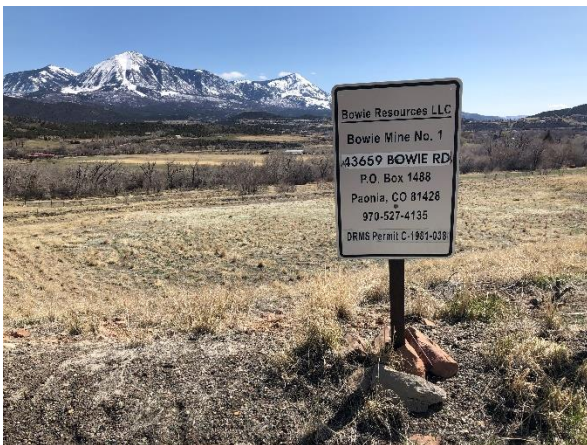
Coal Storage Area by Black Bridge Road

Mine identification signs were seen at the Coal Storage Area by Black Bridge Road, the East Mine entrance, the loadout entrance, and in other locations. Disturbance boundary markers were seen in several locations, including at the upper portion of the East Mine.

No problems were seen with the Coal Storage Area by Black Bridge Road.

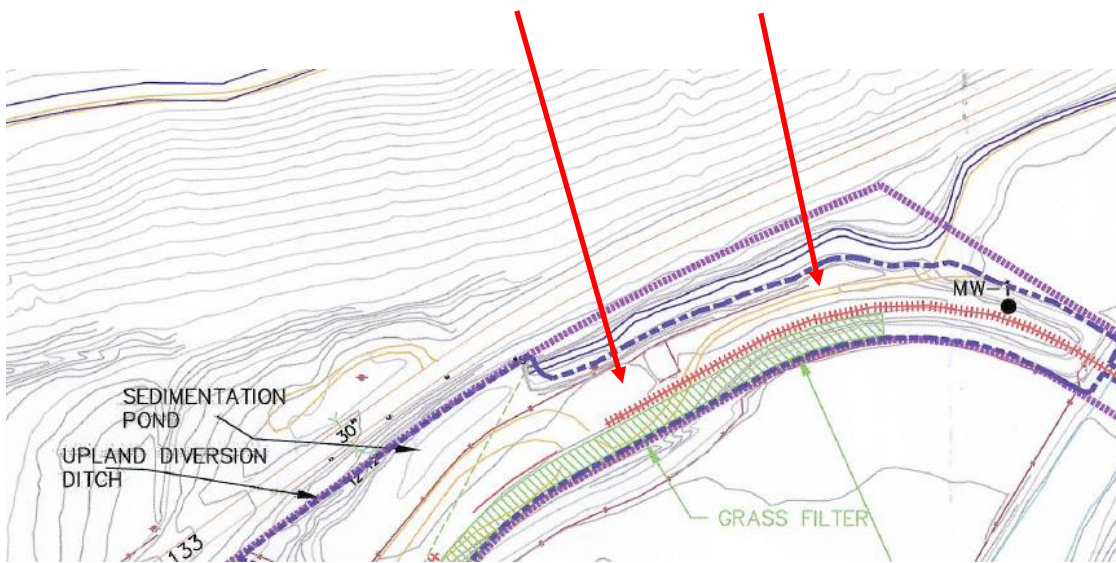
Excerpt from Map 7 in PAP

The slope below the loadout is stable. **At the east end of the loadout area, there is an area that does not drain to the pond, and this area appears to be larger than the SAE area shown on Map 7, Loadout Facilities, in the Bowie No. 1 PAP. BRL should review this and discuss with the Division. It is possible that a Minor Revision should be submitted to edit the map to expand the SAE area.**

Area that is not SAE and does not report to pond
