COLORADO
Division of Reclamation,
Mining and Safety
Department of Natural Resources

Permit Number: C-1981-038 Mine Name: Bowie No. 1 Mine Operator: Bowie Resources, LLC Operator Address: Mr. Basil R Bear P.O. Box 1488 Paonia, CO 81428	County: Delta Operation Type: Underground Permit Status: Active Ownership: Private
	Operator Representative Present: None
Operator Representative Signature: (Field Issuance Only)

Inspection Start Date: March 31, 2021 Inspection Start Time: 11:30 Inspection End Date: March 31, 2021 Inspection End Time: 11:35		Inspection Type: Aerial Inspection Inspection Reason: Normal I&E Program Weather: Clear	
Joint Inspection Agency: None		Joint Inspection Contacts: 	
Post Inspection Agency: None		Post Inspection Contacts: 	
Inspector(s): Robert Zuber, P.E. Brock Bowles	Inspector's Signature: <i>Robert D. Zuber</i>		Signature Date: 4/5/2021

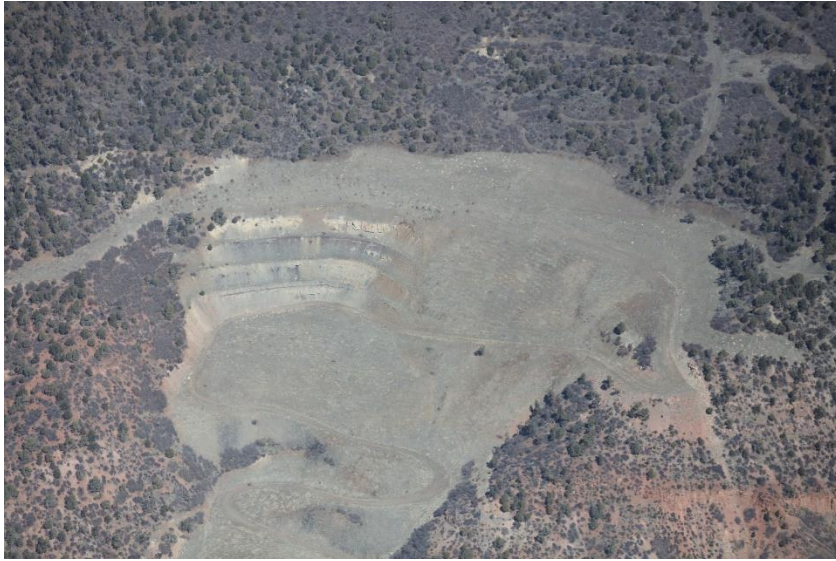
Upper portion of East Mine

No erosion or other problems were identified with the road at the East Mine.

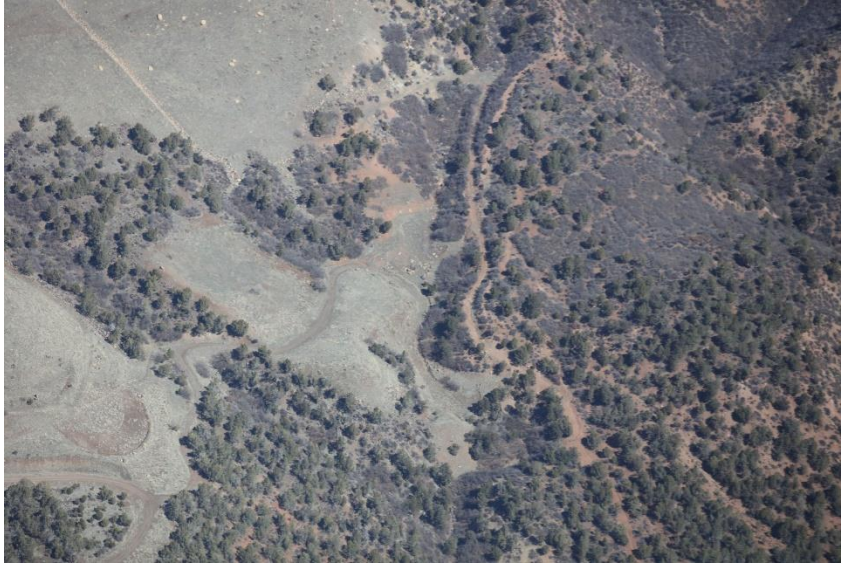
Reclaimed Ponds 1 and 2, Old Waste Disposal Area

No erosion problems were identified. The vegetation was brown, as expected in March.

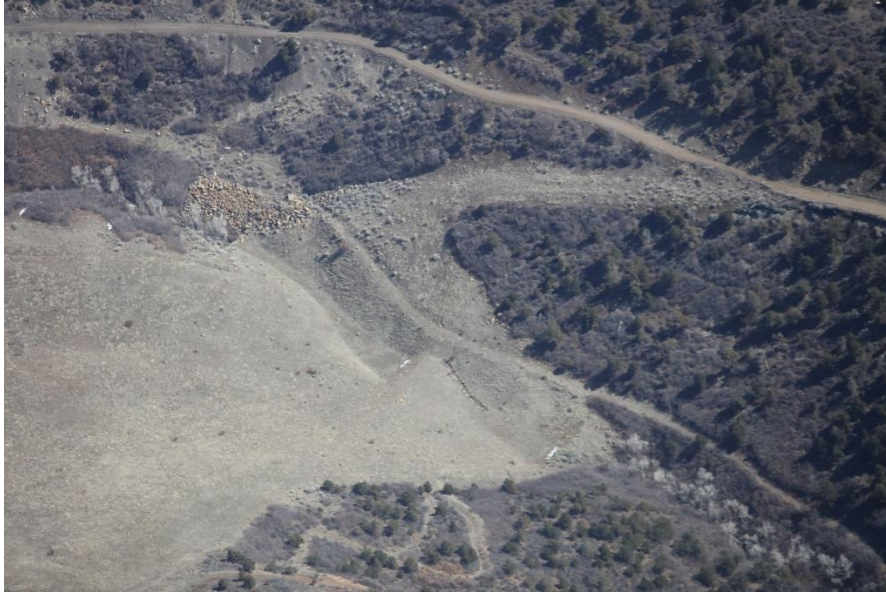
West Mine ponds

The ponds at the West Mine, the pond at the former coal storage area by Black Bridge Road, and the pond at the loadout were dry or mostly dry. No problems were seen with the embankments or other portions of these ponds.

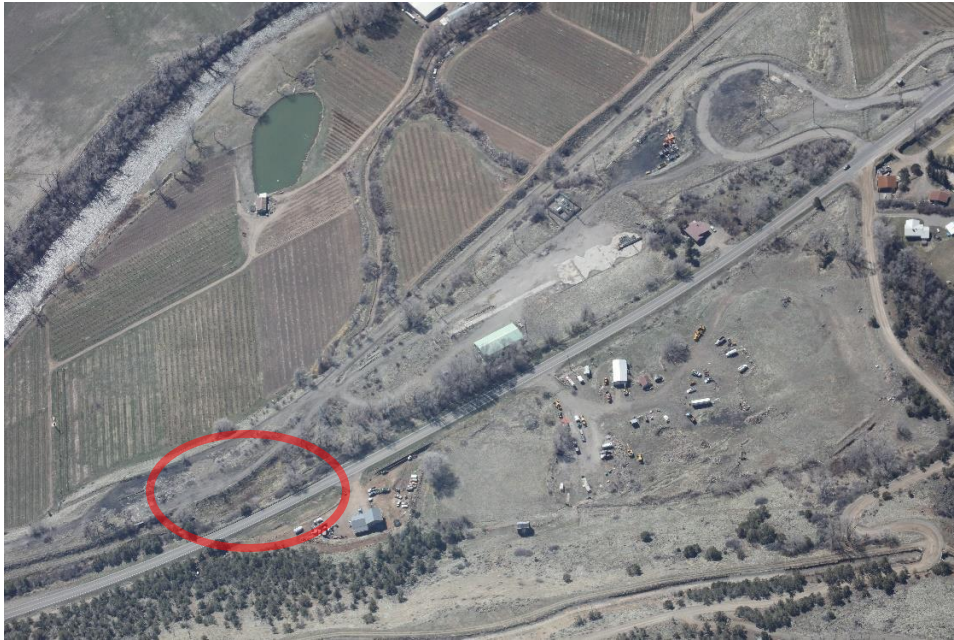
Loadout – pond is circled

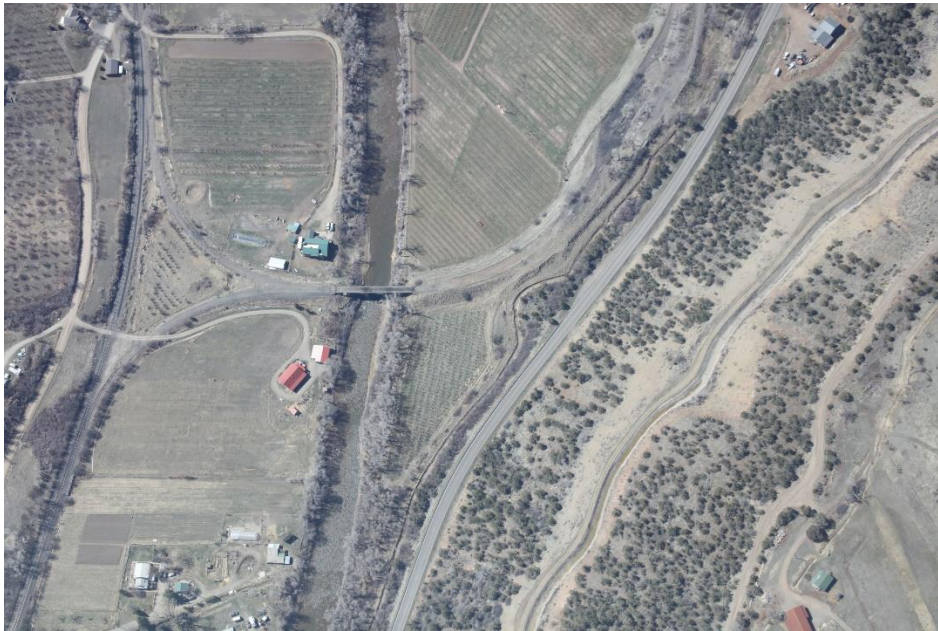
Loadout – north end including trestle across river

No erosion or other problems were identified at the loadout. This includes the eastern portion, along the UPRR tracks and adjacent to Grange Road and Black Bridge Road.
