**COLORADO**Division of Reclamation,
Mining and Safety

PERMIT INFORMATION

Permit Number: C-1981-015 Mine Name: Fruita No 1 & 2 Operator: Dorchester Coal Company Operator Address: Greg Lewicki 9054 South Forrest Drive Highlands Ranch, CO 80126	County: Mesa Operation Type: Underground Permit Status: Revoked Ownership: Private
	Operator Representative Present: NA
Operator Representative Signature: (Field Issuance Only)

INSPECTION INFORMATION

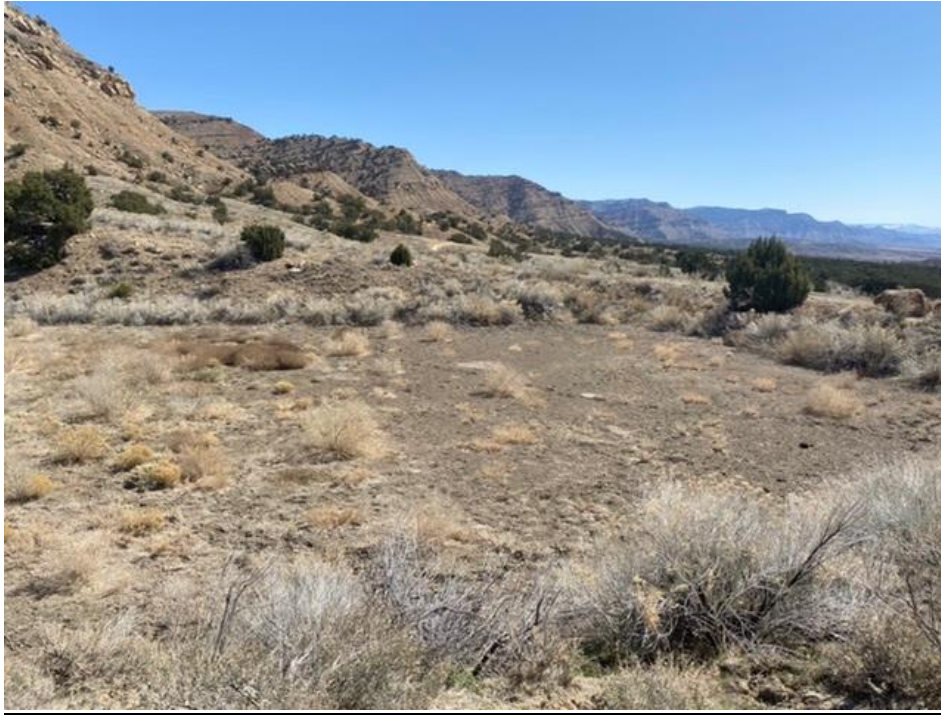
At the southern end of the permit area there is one sediment pond. The pond is permitted to remain as a permanent feature at the site. The pond was dry at the time of the inspection (Photo 1). The embankment was stable with vegetation. No erosional features were identified. The Spillway was stable and lined with riprap. There were no erosional issues.

Photo 1: The southern end of the sediment pond and embankment.

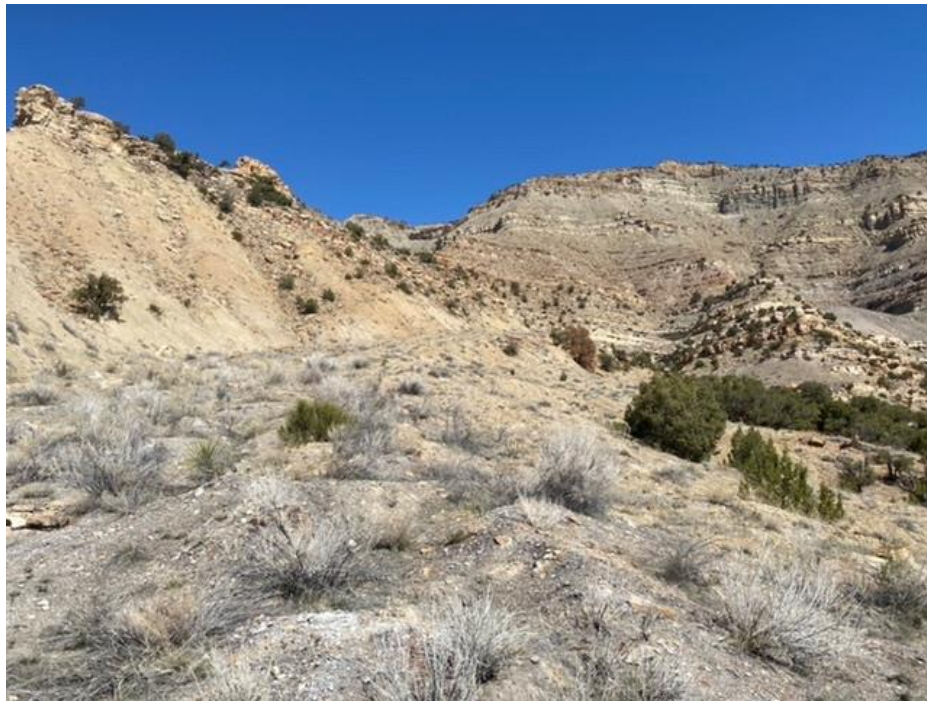
The reclaimed haul road was vegetated and stable (Photo 2). There were no new erosional features identified. The existing rills and gully have not increased in size since the previous inspection. There were no indications of these erosional features affecting the reclamation's stability. The cut slopes were stable with no indications of failure observed. The fill slopes were also stable with no issues noted.

Photo 2: The reclaimed haul road, west of the reclaimed bench.

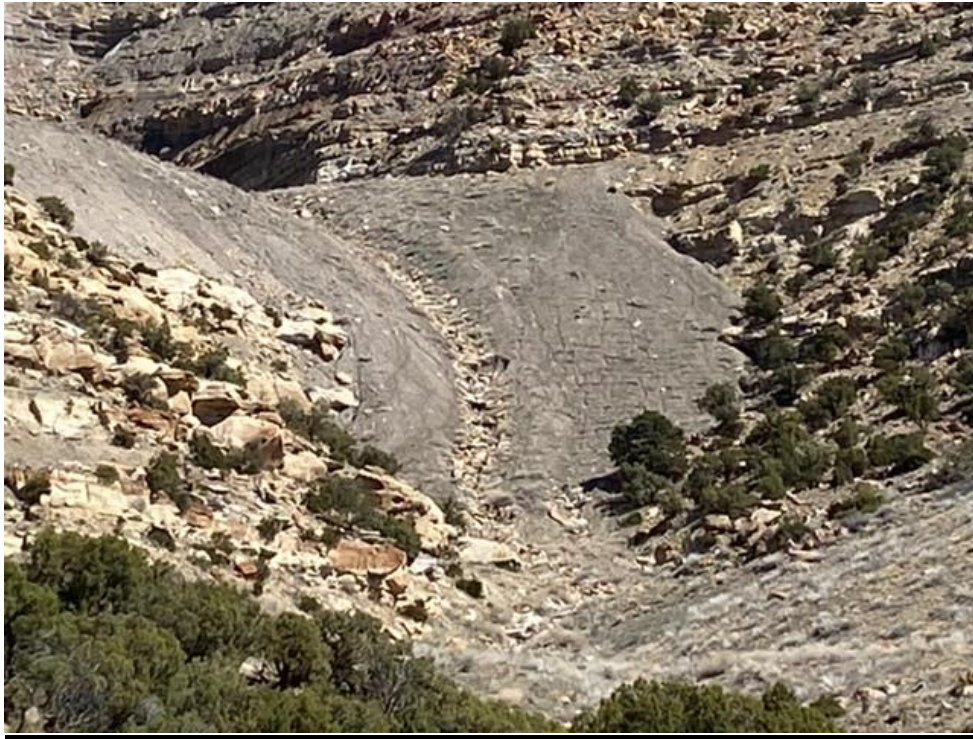
The slope of the reclaimed bench was stable with no new erosional features (Photo 3). There were no indications of slope failure. The riprap lined channel was in good condition. There were no observed indications of instability.

Photo 3: The reclaimed slope on the south side of the bench.
